Flow Slides in Uzbekistan: Overview and Case Studies

Rustam Niyazov, Bakhtiar Nurtaev, Gani Bimurzaev, and Mansur Tashpulatov

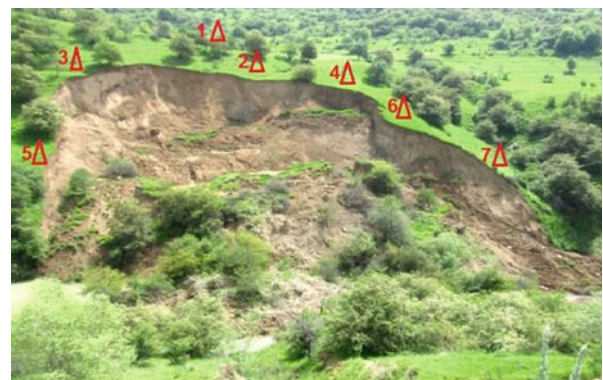
Fig. 3 The Achiyak landslide and location of seismometers (1–7)

The sliding surface zone of the landslide is gently dipping with an angle of 4–6°. The seismometric measurements were carried out at 7 points located around the headscarp (see Fig. 3). Recorded resonance frequencies at measurement points 1, 3, 4, 6—were 1, 2; 2.2; 2.5 Hz, while at the lower marginal zones at points 5 and 7, they vary from 3.0 to 3.5 Hz. The horizontal to vertical ratios of the spectra (HVSR) vary from 2.6 to 3.4. The coefficient of seismic liquefaction of soils ranges from 3 to 9.6, which characterizes fairly dense rocks. It can be assumed that loess mass excitation most likely started at the upper and central part of the landslide where frequency of earthquake vibrations was close to natural vibration frequency of 2.2–2.5 Hz.

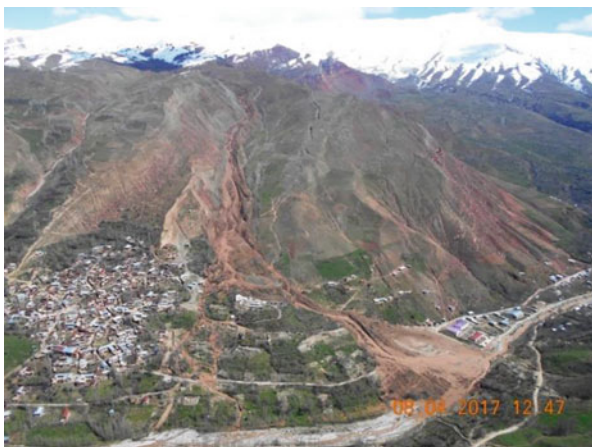
Fig. 4 The Khandiza flow slide after its reactivation in March 2017

The Khandiza flow slide (38.587° N, 67.5727° E) 1.5 million m³ in volume was formed on April 6, 2015 (Fig. 4). It occurred in loess with a thickness of 12–15 m to 30 m, lying on the Cretaceous clays with interbeds of sandstones. It was preceded by the intensive (43 cm in one day) snow fall on February 24, 2015, and its fast melting with a rate of 2–8 cm per day during the last days of March that caused significant watering of subsurface soils. In addition, according to local residents, from April 2 to 5 there was watering the garden located on the landslide body. Landslide was triggered, likely, by the M 4.2 Hindu Kush earthquake that occurred on April 5, 2015 at 5:22 (local time) at a focal depth of 128 km.

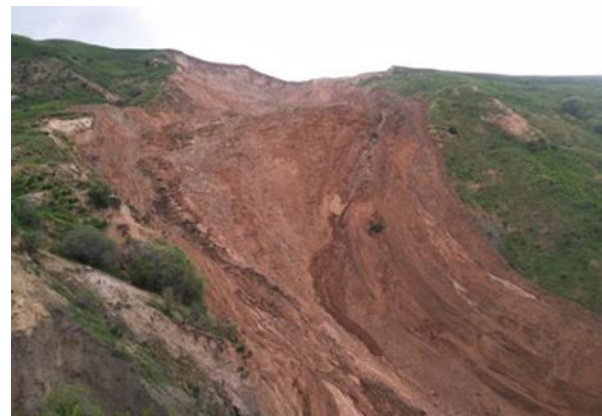
Fig. 6 The Otbokarsai flow slide source zone

On April 23–28, 2019 a landslide of 1.5 million m³ in volume originated on the upper part of the left-bank slope of the Otbokarsai River—the tributary of the Djinnidarya River (39.2048° N, 67.3735° E) (Fig. 6) and converted into highly mobile flow slide.

Its source zone was composed of loess and of the underlying Cretaceous sandy-clayey red beds. The landslide formation took place in three nearby circus-like headscarps. The first—the central one—was located at the transition from the slope to the watershed surface, the second one

occurred simultaneously to the right from the first. In plan view the landslide had a conical shape with a very narrow (12–15 m) exit at the headscarp base through which the landslide had to pass moving downslope. The steep backwall was up to 300 m long and 35–40 m high.

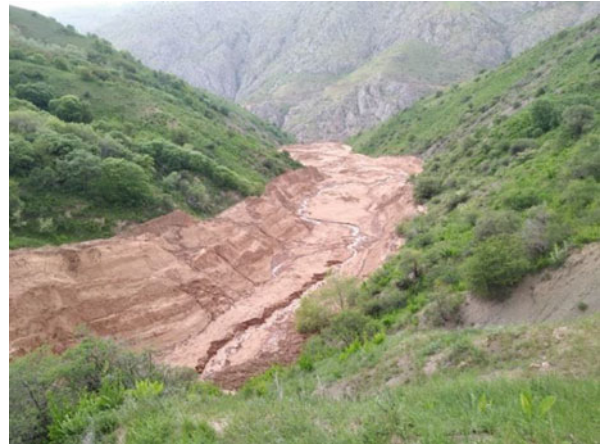
Fig. 7 The Otbokarsai channel after the mud flow

Photo of the Otbokarsai Creek made on May 16, 2019 (Fig. 7) show that mud flows were 10–12 m thick, with a

flow width of 35–40 m, a gradient of 6–8°, and that practically no debris accumulated in the channel.
