2020 Kyoto Japan

Oso Landslide: Failure Mechanism and Runout Analyses

Timothy D. Stark and Zhengdan Xu

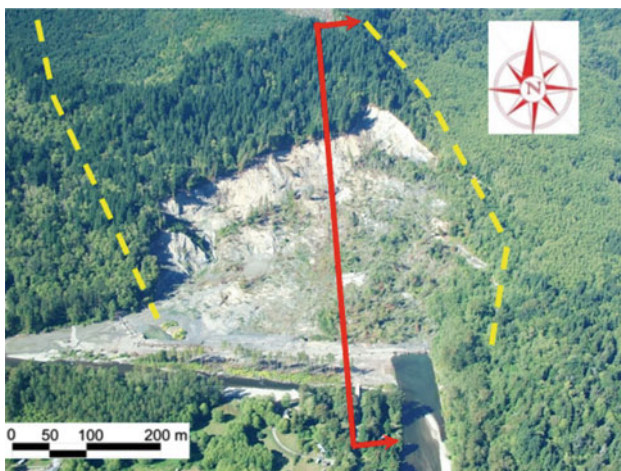
Fig. 1 Aerial view of 2006 landslide, location of cross-section in Fig. 2 (solid line), and outline of sides of 2014 landslide (dashed lines) (image courtesy of Rupert G. Tart)

about 200 m. The width of the Stillaguamish River Valley floor at this location varies from 2.0 km to more than 6.0 km. This slope is part of a large overconsolidated glacial terrace deposit that developed after the last advance of continental glacial ice sheets into the Puget Sound. The 2014 landslide occurred at a relatively narrow reach of the river, where it flows north and then west along the slope toe. The river erosion, especially at the eastern end, has caused a number of landslides in the lower portion of the slope including landslides in 1937, 1951, 1952, 1967, 1988, and 2006, (see 2006 landslide in Fig. 1).

Knowledge of the pre-2014 landslide subsurface conditions is important for understanding the failure mechanism, because a comparison of the initial and final locations of the various glacial soil deposits aided the understanding of landslide initiation, movement, number of phases, and run-out. Based on the exposed landslide headscarp, hand and shovel excavations during various site visits, geologic maps, borings before (Shannon and Associates 1952) and after the landslide (Badger and D'Ignazio 2015), and soil samples collected and tested herein, the subsurface profile prior to the 2014 landslide is shown in Fig. 2 and is located at the cross-section location shown in Fig. 1.

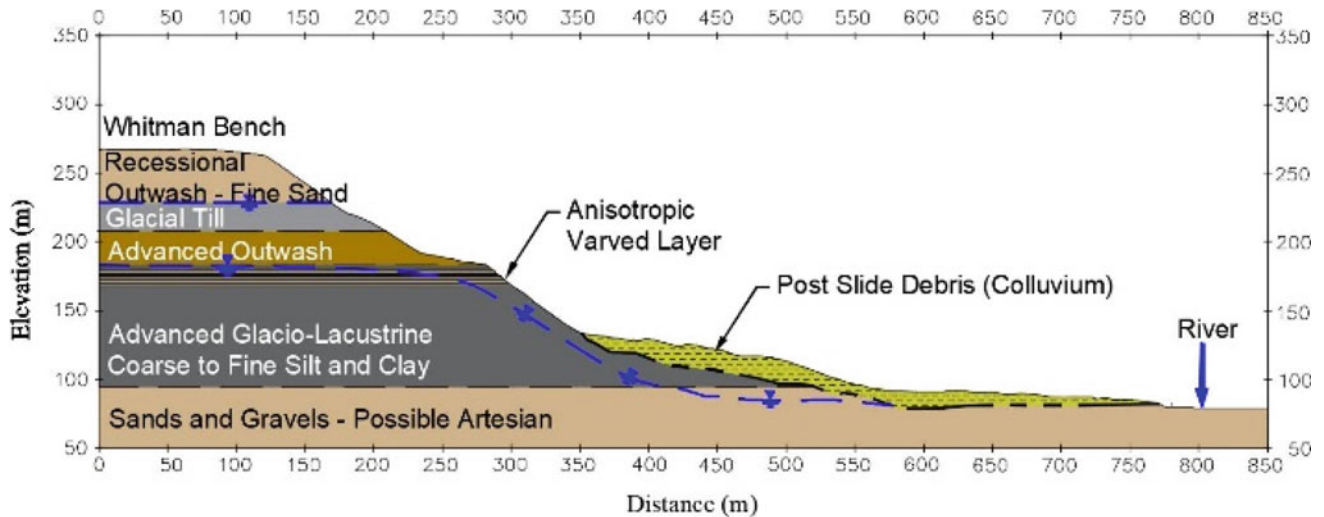
Fig. 2 Slope cross-section at location shown in Fig. 1 prior to 2014 landslide with phreatic surfaces inferred from inverse stability analyses except where observed in borings drilled from the Whitman Bench or in the slide mass

The slope subsurface profile consists of (from top to bottom):

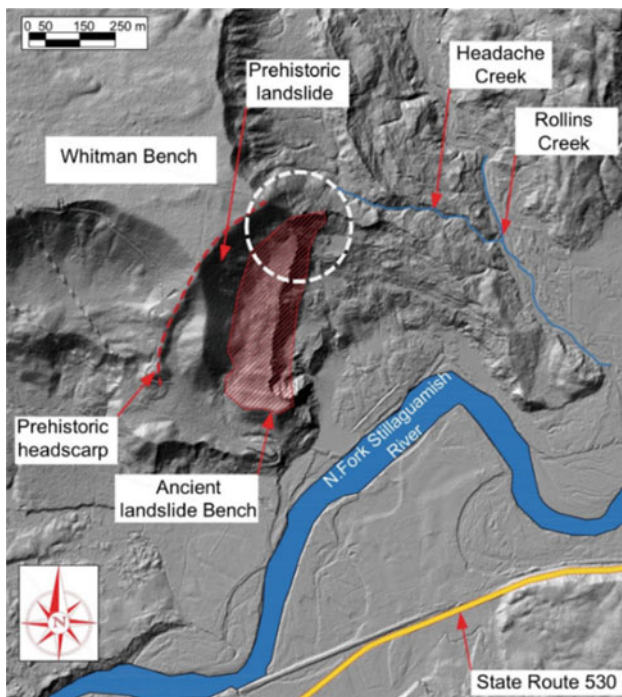
Fig. 3 2013 LiDAR-derived topography showing the Oso landslide in context with the Ancient Landslide Bench (see shaded area) (base courtesy of Puget Sound Lidar Consortium)

The 2014 landslide occurred in a slope with a history of prior landslides. Modern accounts of landslides in the lower portion of the slope date back to 1932 (Thorsen 1969). More recent high resolution topographic relief images generated by LiDAR (Light Detection and Ranging) show many large prehistoric landslides including one at the location of the 2014 landslide have occurred in this valley (see Fig. 3).

The occurrence of a large prehistoric landslide at the location of the 2014 landslide is important because it created the Ancient Landslide Bench shown in Fig. 3 that supported and protected the Whitman Bench from landslides primarily caused by river toe erosion and precipitation. Based on the geometry of neighboring high elevation landslides also

shown in Fig. 3, it is anticipated that the ancient landslide at this location occurred through the weak varved lacustrine layers in the upper portion of the Advanced Glacio-Lacustrine deposit and evacuated some of the overlying Whitman Bench. After this landslide, a bench or ledge was created that supported the overlying Whitman Bench slope and protected the Whitman Bench from oversteepening by landslides in the lower portion of the slope until after 2006.

As a result, a different failure mechanism than river toe erosion had to initiate the 2014 landslide. The first factor considered for the 2014 landslide is precipitation. The 2014 landslide occurred during a dry sunny morning after a period of unusually intense rainfall. Nearby precipitation gauges with 86 years of data indicate that the rainfall during the twenty-one days (March 1 through 21) preceding the landslide was significantly greater than average (Keaton et al. 2014). In particular, these data show the 45-day period before the landslide was wetter than 98% of the same 45-day period in the 86-year historical record (Iverson et al. 2015). Cao et al. (2014) and Henn et al. (2015) show that the cumulative precipitation for the 21 days prior to the 22 March 2014 landslide corresponds to a return period of about 97 years making the 21 days prior to the landslide the wettest (403 mm of rainfall) on record at the Darrington, Washington rain gauge. It is anticipated that this intense rainfall, higher groundwater, and increased runoff along the eastern side of the 2014 landslide mass triggered a landslide that removed the small remaining portion of the Ancient Landslide Bench on the eastern end (see dashed circle in Fig. 3), and undermined the Whitman Bench discussed

The Phase I instability initiated in the eastern portion of the Ancient Landslide Bench slope (see Fig. 3) where the bench had been oversteepened by prior sliding in the lower portion of the slope. The failure surface in Fig. 5 is based on field observations and inverse stability analyses that yielded a factor of safety of about unity (1.0) for a variety of compound failure surfaces and piezometric levels estimated from the inverse analysis of the 2006 landslide.

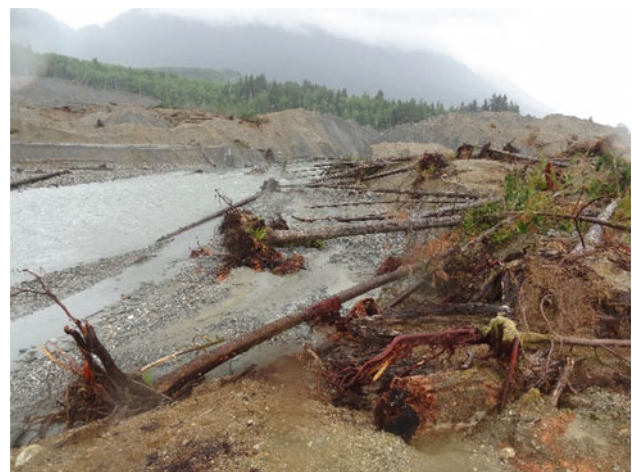
Fig. 4 Erosion of sandy outwash deposits by Stillaguamish River two months after landslide

images, as shown in Fig. 4, is important to evaluate the landslide hazard and risk with time as discussed below.

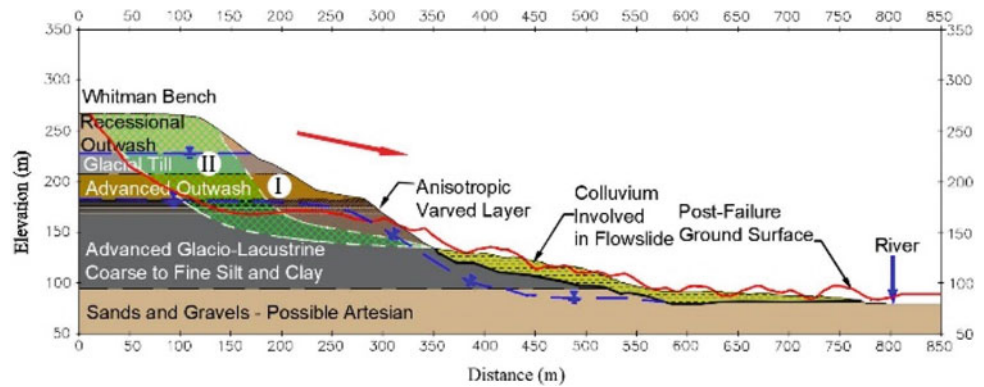
Fig. 5 Two-phase failure mechanism prior to 2014 landslide with the Phase I failure surface based on field observations and inverse slope stability analyses at cross-section location shown in Fig. 1

Based on inverse 2D limit equilibrium stability analyses using the software packages SLIDE and SLOPE/W and the soil properties in Stark et al. (2017) that are reproduced in Table 1, Fig. 5 shows the probable failure surface for the initial instability that triggered the first phase (Phase I) of the 2014 two-phase failure mechanism. Table 1 shows the measured drained fully softened and residual strength envelopes for the fine-grained deposits. These strength envelopes are stress-dependent and Table 1 presents the range of effective stress friction angle from low to high normal stress.

Figure 5 illustrates the large slope movements involved in the two-phase failure mechanism, which was initially described in a 1 June 2015 Seattle Times newspaper article (Doughton 2015). The Phase I slide mass moved first with significant speed and momentum, as described by an eyewitness (described below), and impacted the water-filled colluvium that had accumulated along the lower part of the slope. The Phase I slide mass pushed some of the water filled colluvium in front of it across the river, the valley, the unexpected neighborhood, SR530 highway, and beyond. The steep valley slope then remained unsupported and some two minutes later the Phase II slide mass slid down the evacuated slope but did not move far because the materials were primarily unsaturated, dense, and frictional so it stopped at the back edge of the Phase I slide mass.

Unlike other large flow landslides, e.g., La Conchita in 2005, videos of the slide are not available so the proposed failure mechanism may not represent all aspects of the failure mechanism. For example, the geometry of the Phase I slide mass is subjective because the slide mass and scarp were removed. The Phase I slide mass geometry was estimated using results of inverse analyses of the 1967 and 2006 landslides to estimate groundwater and shear strength conditions that were used to predict the 2014 critical compound failure surface shown in Fig. 5.

The two-phase failure mechanism shown in Fig. 5. is used below to conduct runout analyses and assess the accuracy of existing runout models. This is important because the failure mechanism is the first and most important input parameter for a runout analysis. If the failure mechanism is incorrect, the runout analysis will not accurately predict the slide mass runout because the kinematics of the slide movement will not be correct.

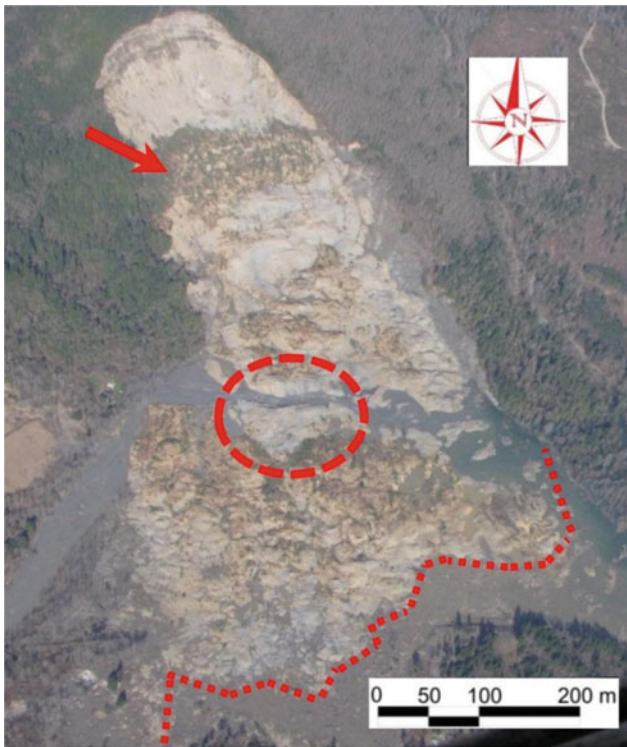
Fig. 6 Aerial view and extent of sand (dashed line) pushing and over-riding fluidized colluvium from slope toe, a new landslide bench (see arrow), and the Phase II slide mass overriding the back end of Phase I slide mass (dashed circle) (image courtesy Rupert G. Tart)

Figure 6 shows the Phase II slide mass stretched or spread out as it moved down the slope but did not become highly mobile like the colluvial flowslide. The runout of the Phase II slide mass was limited, because it was mainly frictional and its leading edge collided with the back edge of the Phase I slide mass. On the western end, the Phase II slide mass actually over-rode the northern edge of the Phase I slide mass because some Advanced Glacio-Lacustrine Clay from the Phase II slide mass was found overlying the trees and outwash sands of the Phase I slide mass (see dashed circle in Fig. 6).

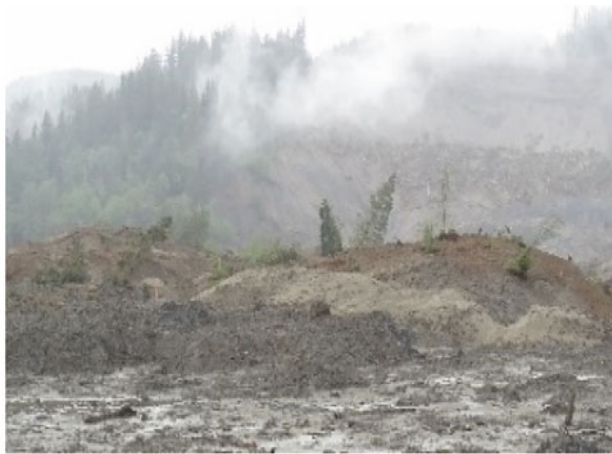
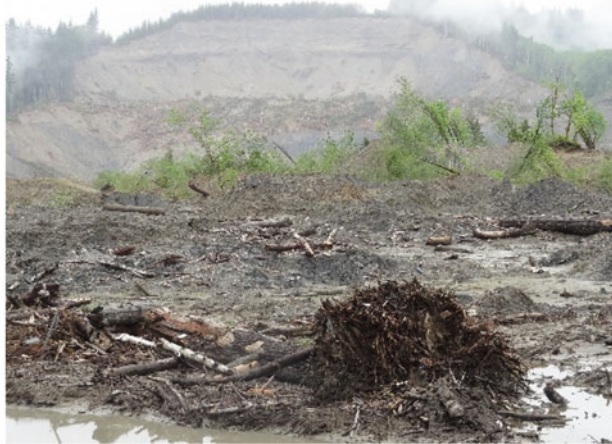
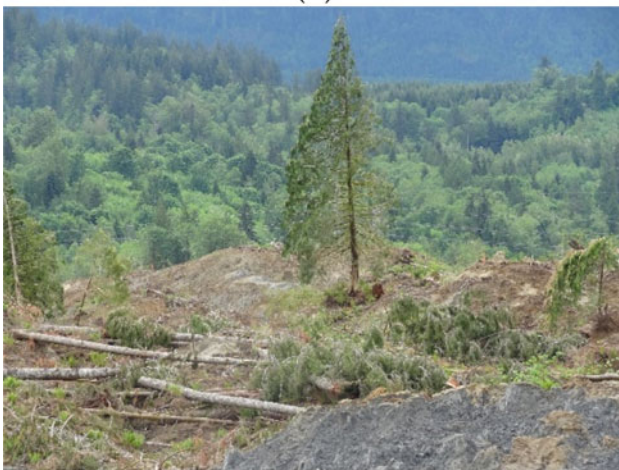
Fig. 7 Photographs showing: **a** recessional outwash sands and near vertical trees stopped north of SR530, **b** disturbed colluvium in foreground, blocks of outwash sand with trees in valley, and new landslide bench and scarp in background, and **c** nearly vertical tree from upper plateau in Phase I just south of override zone of Phase II

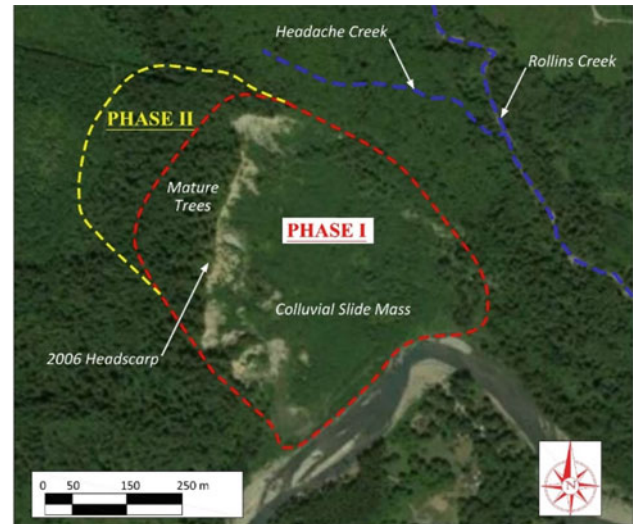
Fig. 8 Aerial view of slope in July 2013 and outline of the 2014 Phase I and II slide masses ((c) 2014 Google)

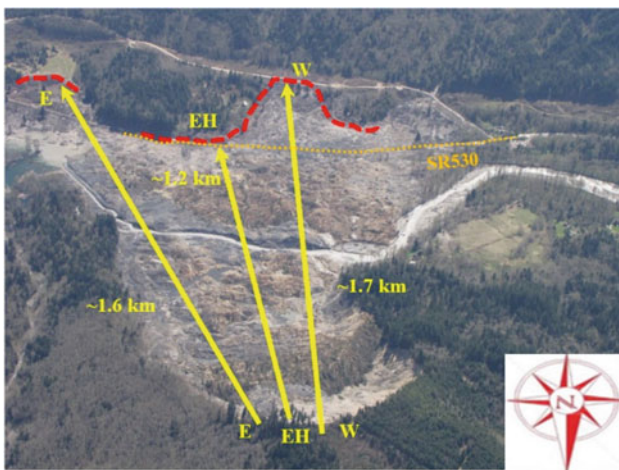
Fig. 10 Aerial view after 2014 landslide showing: observed boundaries of runout (see red dash lines) and travel distances (see yellow solid lines) on both east and west side of Engineer Hill (EH) (image courtesy of Rupert G. Tart and dated 24 March 2014; IMG_5806.jpg)

cross-section that passes through Engineer Hill (see Fig. 10) are also interesting because a splash height was observed in some of the trees on top of Engineer Hill. The top of Engineer Hill is about 16 m above the SR530 pavement and there was slide debris on and damage to trees on top of Engineer Hill about 3 m above the ground surface. The force of the slide mass was evident by the presence of at least one vehicle being pushed to the top of Engineer Hill.

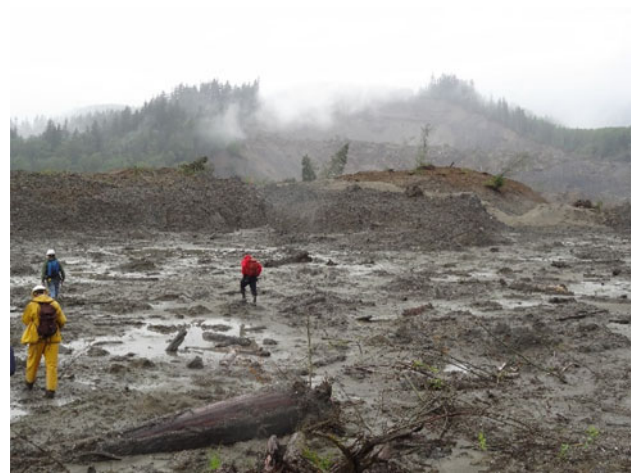
Fig. 11 Photograph showing Phase I intact grey glaciolacustrine silts and clays and recessional outwash sands behind fluidized colluvium north of SR530

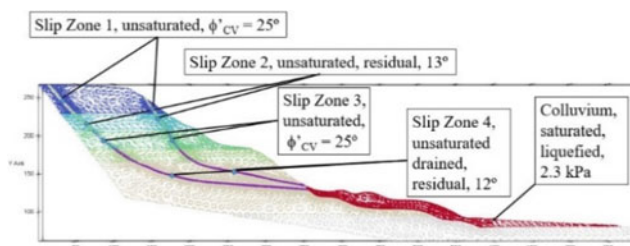
Fig. 12 Slope stratigraphy and failure surfaces for Anura3D runout model

The stratigraphy, material properties, and two-phase failure mechanism used in the Anura3D model are illustrated in Fig. 12 and shown in Table 1. The residual strength

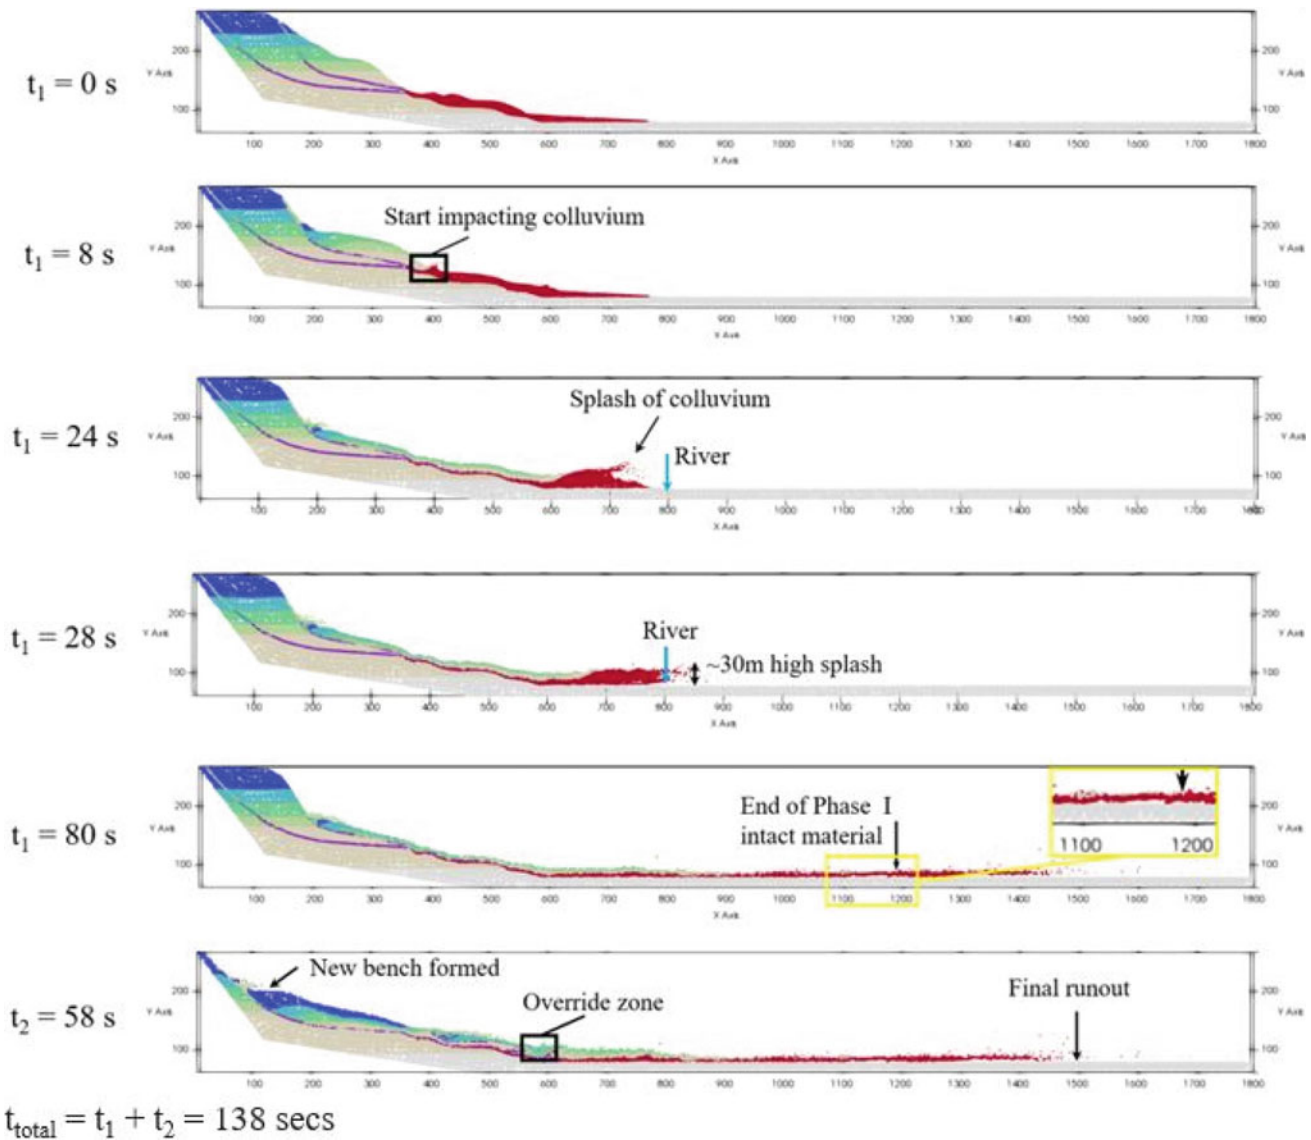
Fig. 13 Anura3D runout behaviors for west cross-section at time steps of: 0, 8, 24, 28, 80, and a total of 138 s in Phases I and II (80 + 58 s)

The cross-section after twenty-four seconds of slide movement shows a splash of colluvium occurring on the north side of the river, which decreases in height as it continues across the river. These results also match field observations of slide debris and tree damage occurring as high as 10 m in trees just on the southside of the river near the western edge of the slide mass. The field observations show a splash height of over 12 m west of the cross-section analyzed and west of the main direction of runout. As result, it is reasonable that the splash height observed is less than that calculated by Anura3D, which shows a splash height of about 30 m just past the river at a time of 28 s (see Fig. 13).

The cross-section and surface topography for the eastern cross-section are similar to the western cross-section (see Fig. 13 at t_1 at 0 s). As a result, the east cross-section is not presented herein before discussing the results in this paragraph. In the eastern cross-section, the Phase I slide mass also reached the river after about twenty-four seconds of

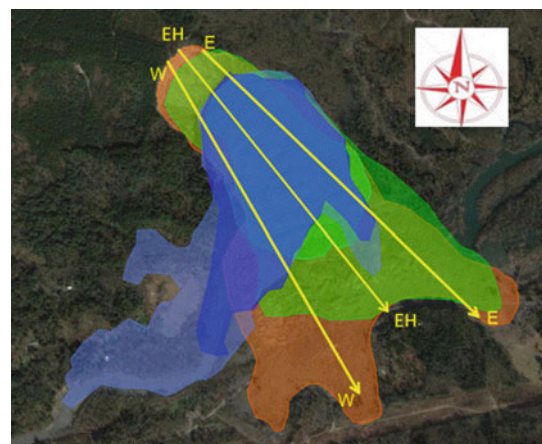
Fig. 14 Comparison of runout zones for: FLO-2D using mudflow properties (see dark blue area) and water for the colluvium (light blue area), DAN3D (green area), Anura3D (yellow lines), and observed impact zone (orange area)

The FLO2D runout (blue) is compared to the actual (orange) and DAN3D (green) runout zones in Fig. 14. In particular, Fig. 14 shows the FLO-2D analysis significantly under predicts the runout on the east side of Engineer Hill and the largest portion of the runout goes towards the west along the channel of the Stillguamish River. The runout goes primarily west along the river channel because of the decrease in elevation of the channel instead of across the river valley. This is due to FLO-2D only allowing surface topography to influence flow direction and distance instead of potential energy or kinematics of the slide mass as discussed below.

In Fig. 14 the DAN3D results include both Phases I and II with Phase I being darker green in color than Phase II, which stops just south of the river. The DAN3D results are in excellent agreement with field observations on the east side of Engineer Hill and a little short of the observed runout on the west side of Engineer Hill. The DAN3D results are also in excellent agreement with the runout reaching Engineer Hill in the middle of the debris field and causing some splashing on the top of the hill. The Anura3D runout results east and west of Engineer Hill are in good agreement with field runout observations (orange) but the results are only available for the three cross-sections analyzed.
