Structural Rehabilitation of Historical Masonry Buildings

The article also presents a case study, in which a heritage building is analyzed. The monument is located in the Moldavia region from Romania. Its main damages and the proposed rehabilitation methods are shown, in order to ensure the structural safety increase, and to obtain a target structural safety level for the structure.

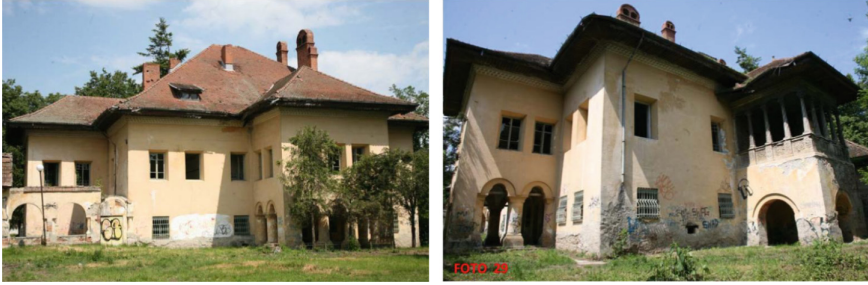
Fig. 5. Main façade of Cantacuzino manor
