Chapter 17

Soil and Water Conservation Technology and Sediment Retention Assessment

Sileshie Mesfin Leyew, Tesfahun G/Michael, Arega Mullu,
and Assefa M. Melesse

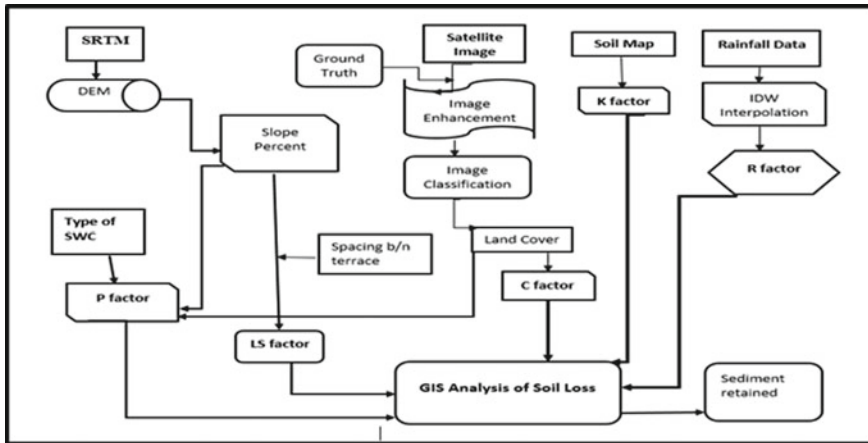
Fig. 17.2 Flowchart of soil loss analysis and sediment retention

where D = soil depth increment, m = mass of soil retained by SWC, a = unit area of grid cell, and d' = bulk density of the retained soil taken from laboratory analysis for samples taken from representative samples for physical and chemical analysis of deposited soil. Figure 17.2 shows the methodology flowchart followed in this study.

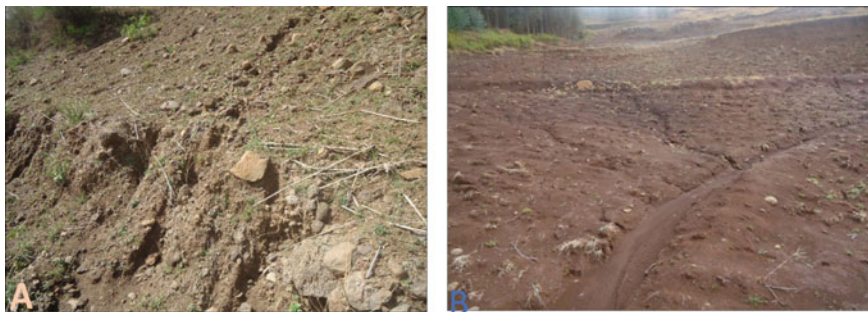
Fig. 17.3 Rill erosion formed in poorly constructed soil bund in Dibakuhan watershed (a). Earth crusting, smoothing of cultivated land and rills formed in Andit Tid watershed (b)

Splash, sheet, and rill erosions were seen in all watersheds. Earth smoothing and crusting, which is the effect of splash, are the common phenomena of farmlands. Soil deposit at the high side of obstructions and most lately constructed bunds and hill side terraces formed benching. These indicate the presence of the movement of soil as a sheet flow and indication of soil loss as sheet erosion. Rill erosion as a result of wide spacing of bunds and weakly constructed bunds was observed in all watersheds (Fig. 17.3).

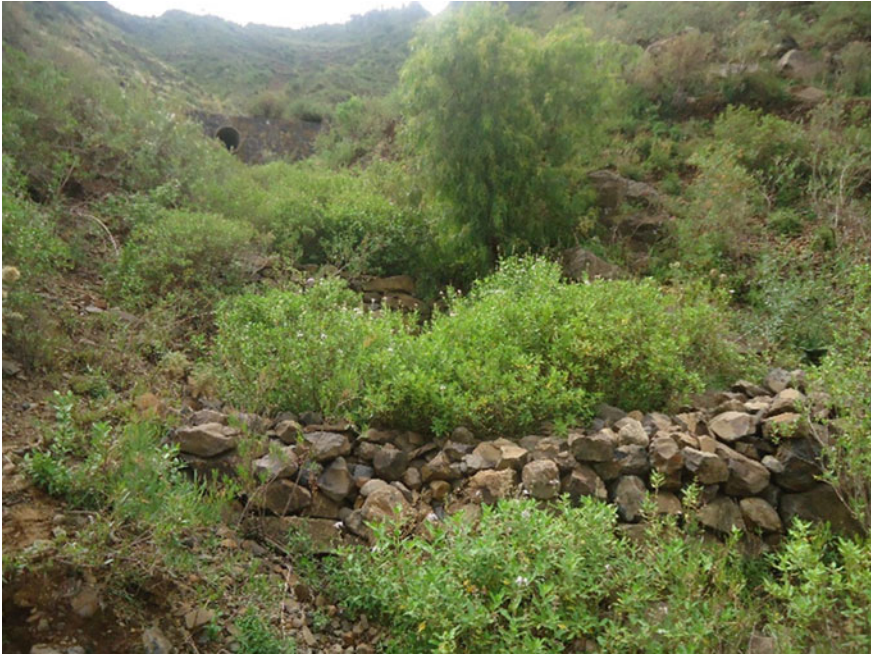
Fig. 17.6 Gully formed by road culvert; it is treated by check dam in Abiager watershed

in community watersheds were stabilized with different types of trees and grasses selected according to the agro-ecology (Fig. 17.6). It is shown that in some parts of the study areas footpath was a contributing factor for gully formation (Fig. 17.7).

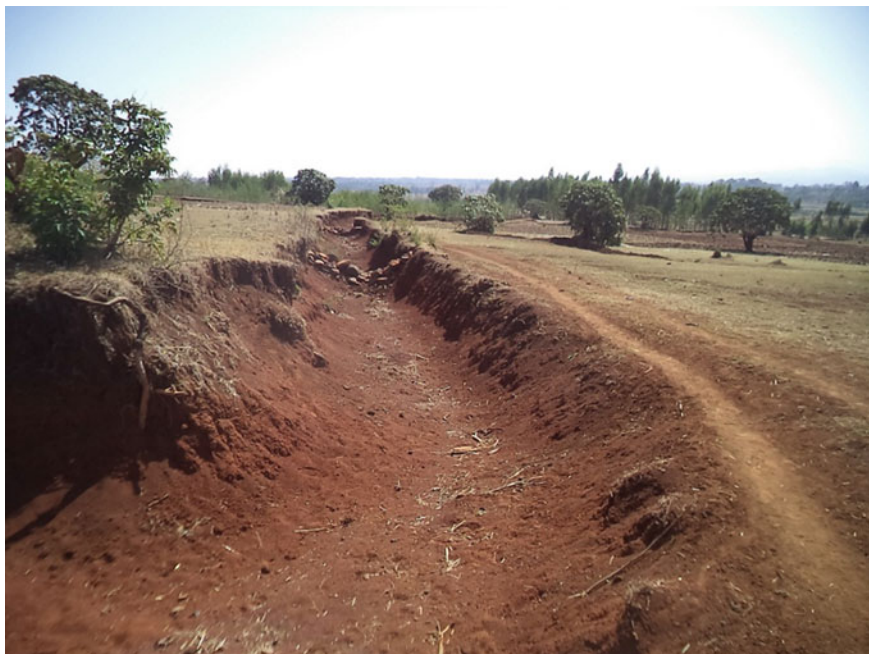
Fig. 17.7 Gully formed by footpath and cattle trafficking line in Gadila watershed

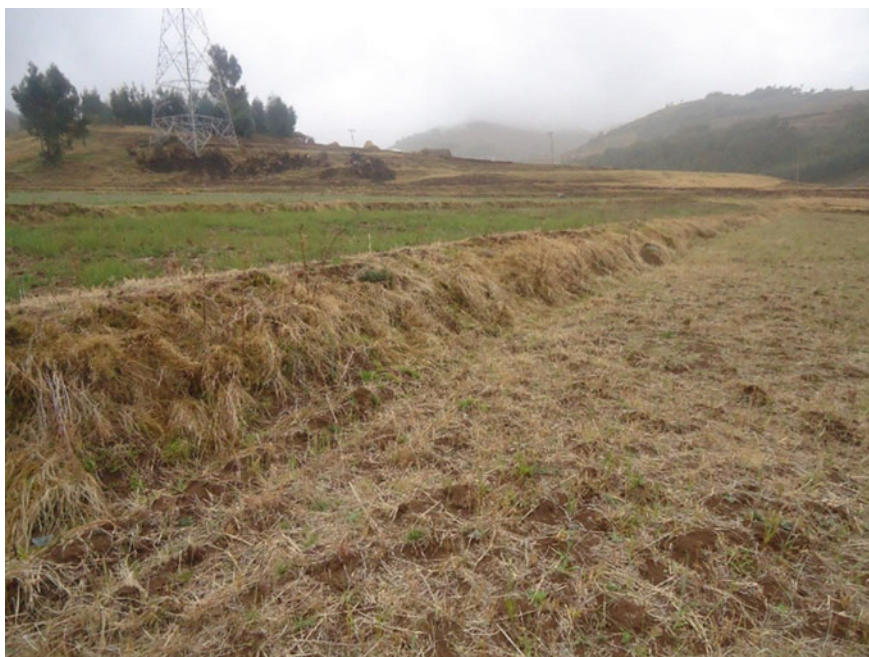
Fig. 17.8 Soil bund in Andit Tid watershed

Soil bund is constructed in slopes ranged from 3 to 33% with 6 to 32-m horizontal distance and 0.7 to 3.45-m vertical interval. As indicated in Table 17.3, the height and the vertical spacing of the soil bund is found to be supporting the hypotheses that there is no a significant difference between the existing and standard one. This implies that the construction of soil bund in watersheds in the region is carried out as per the recommended standards. On the other hand, embankment depth and width of soil bunds are found to be highly significantly different from recommended standard. This implies that the width and the depth of soil bunds are incorrectly constructed in the watersheds throughout the region in the probability of ($p = 0.0005$) and ($p = 0.000$), respectively, at 5% level of significance.

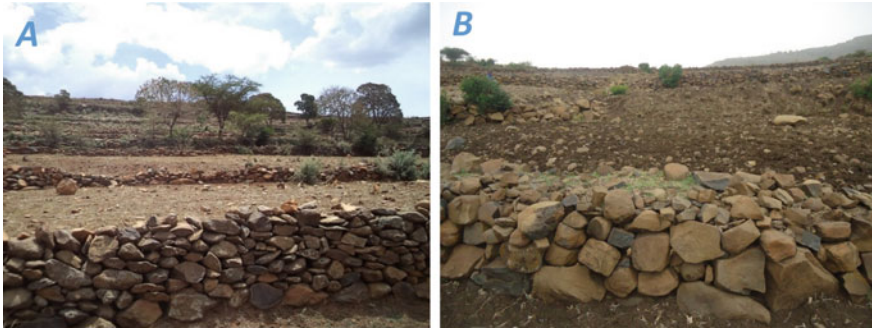
Fig. 17.9 Stone bund in (a) Aguat wuha, and (b) Bruhtesfa watersheds

The mean height of the stone bund is 0.87 m (Table 17.4) with minimum of 0.33 m and maximum of 2.5 m which is observed in old stones that the height is added by frequent maintenance through time. About 25.6% of the bunds have greater heights from the recommended values. The mean value of the stone bund vertical interval is 2 m, but the standard recommended value is 2.13 m.

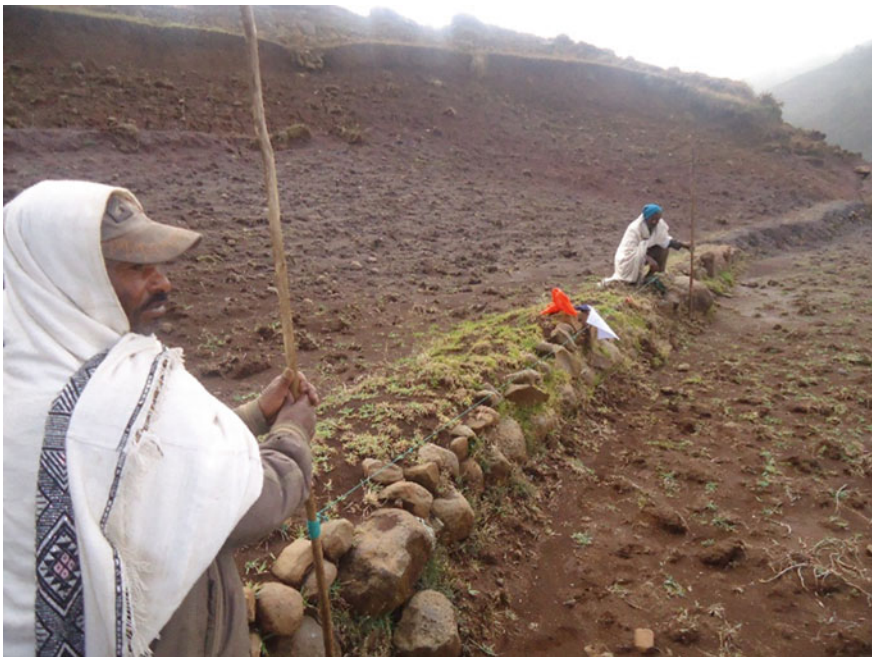
Fig. 17.10 Stone-faced soil bund in Andit Tid watershed

The minimum standard of the height of the stone-faced soil bunds is 0.7, and it can extend up to 1 m according to the topography and availability of quality of stones (Table 17.5). The mean height of the stone-faced soil bund is 0.63 m with the minimum of 0.2 m and maximum of 1 m. However, 77% of the height of stone-faced soil bund is less than the recommended value. Height and vertical interval are not significantly different with the standard at 0.05 significance level, and the *p*-values are 0.13 and 0.40, respectively, but width and depth of the ditches are different from standards.

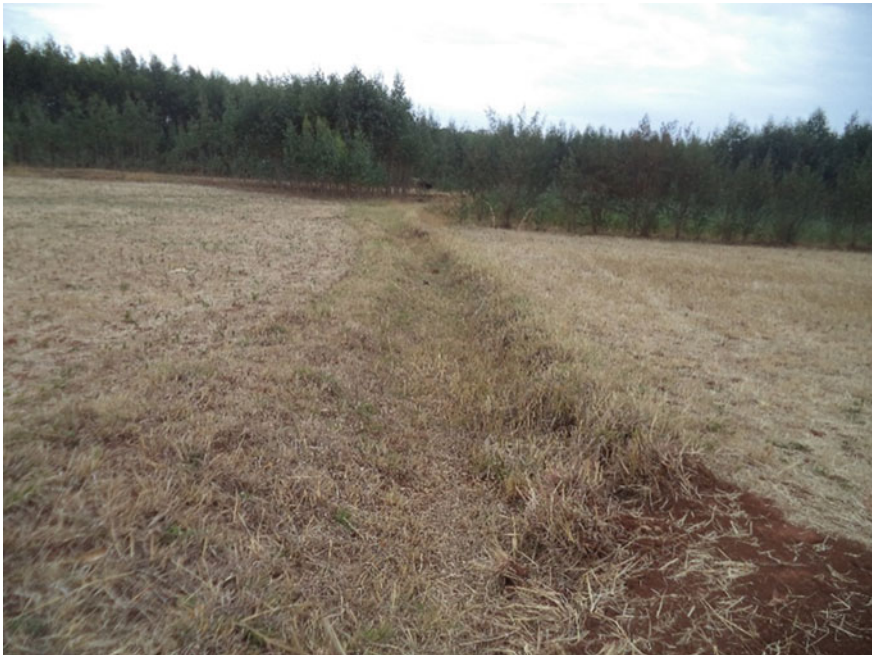
Fig. 17.11 Stabilized fanya juu in Argedifo community watershed

Fanya juu is applied in cultivated lands with slopes 2–15% which is constructed in recommended slope with 9–25 m horizontal distance and 0.28– 2.67 m vertical interval. Heights and vertical intervals were not significantly different with the recommended standard at 0.05 level of significance since the *p*-value is 0.207 and 0.17, respectively, which is greater than 0.05. However, the mean height of these bunds is greater than the standard. The mean value of heights of fanya juu is 0.667 m, but the recommended standard is 0.6 m. About 64% of the measured height is less than the recommended and 36% is above 0.6 m. The maximum height was 1.96 m which is very old fanya juu in Anjeni watershed, and the minimum height is 0.2 m.

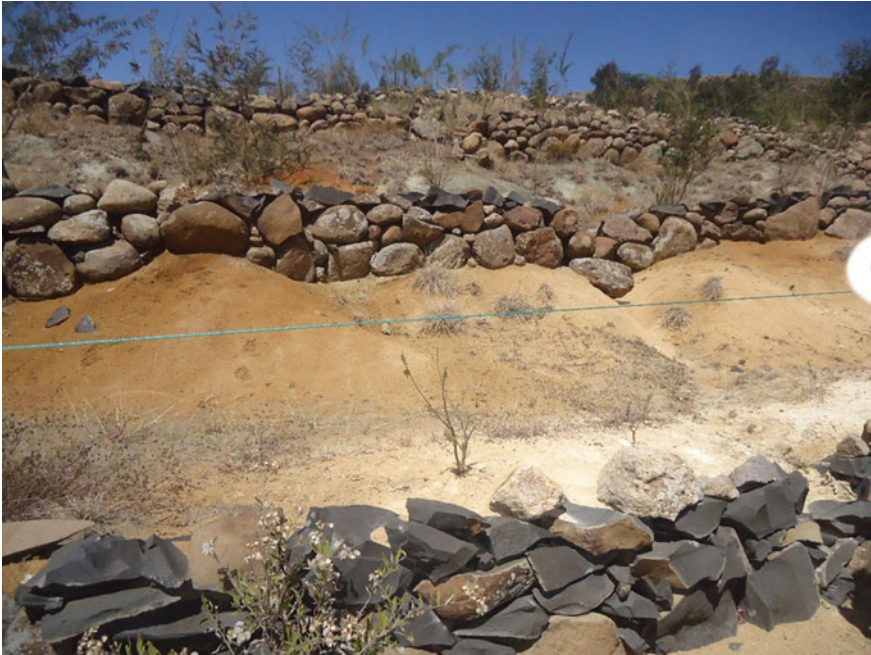
Fig. 17.12 Newly constructed hill side terrace in Nekubish watershed

The height and vertical intervals are significantly different from the standard, and the *p*-values (0.042) and (0.007), respectively, are less than the significance level 0.05 (Table 17.7). From the analysis, we can conclude that height and vertical intervals of hill side terrace were not constructed according to the recommendation in the region.

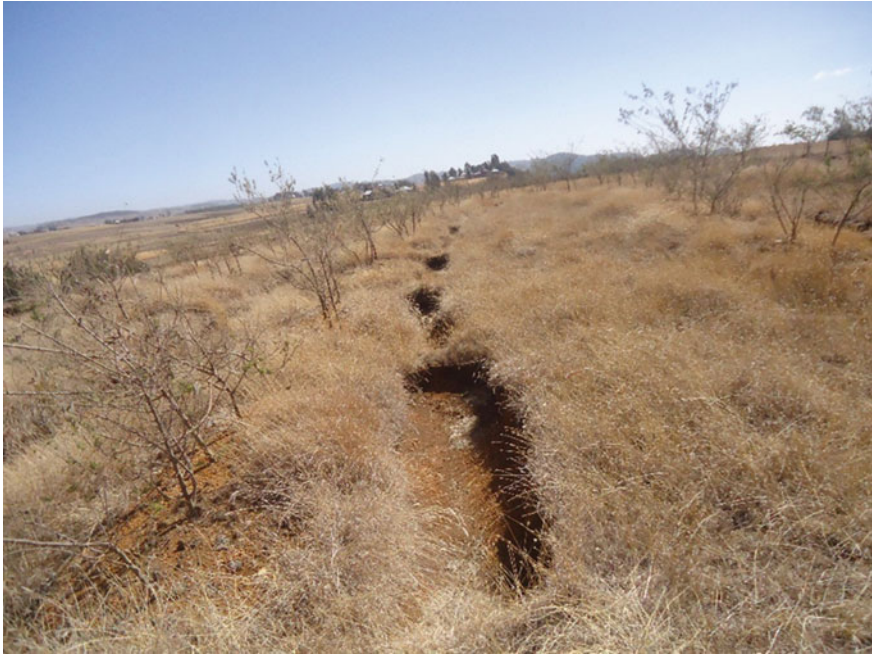
Fig. 17.13 Trench in Deresinilih watershed

Trenches were constructed at an interval of 3–5 m depending upon on the suitability of the land. The values of the existing average trench length, width, and depth were not significantly different from recommended standard. This showed that the average height, width, and depth of the already existing trenches in the catchment were up to the MoARD recommended standard (Table 17.8) and can be conclude that they are constructed as per the recommendation in the region.

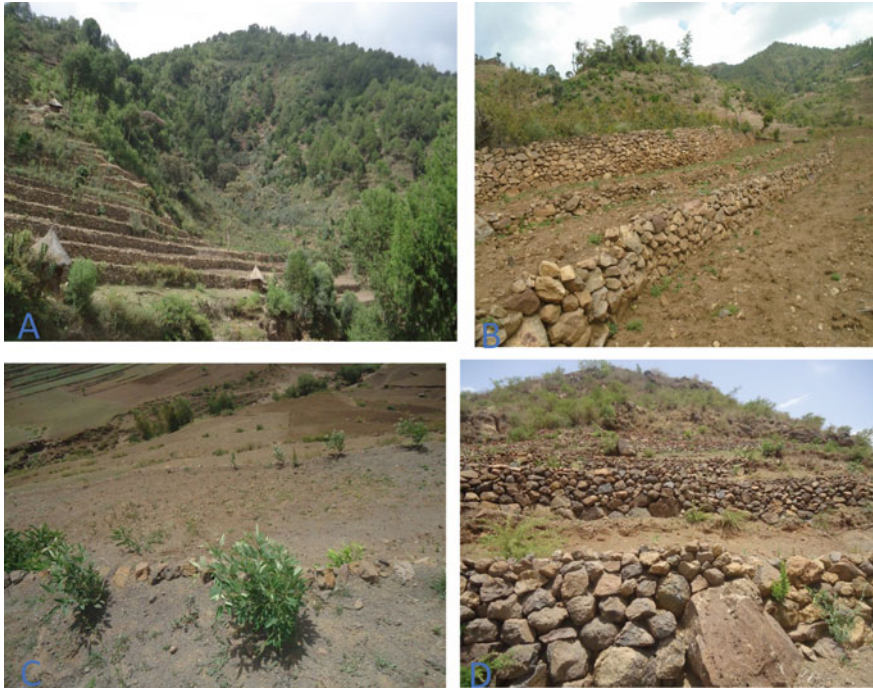
Fig. 17.14 Bench terrace in Godiguadit watershed (a and b), Side view of Bench terrace (c), Front view of Bench terraces Gidbenu watershed (d)

The spacing between existing bench terraces ranged from 0.85–2.17 m with an average of 1.56 m on 14–50% slope lands. About 86% did not meet the minimum technical standard of vertical interval (Table 17.9). It was significantly different; the null hypothesis is rejected since the *p*-value is less than 0.05 significance level. The analysis shows that it is narrower than the recommended standard.

- VII. If bench terrace is also to be done in loose soils, the embankment should be stone faced, and the width is also to be according to the soil depth since it may be unproductivity if sub soils exposed entirely.

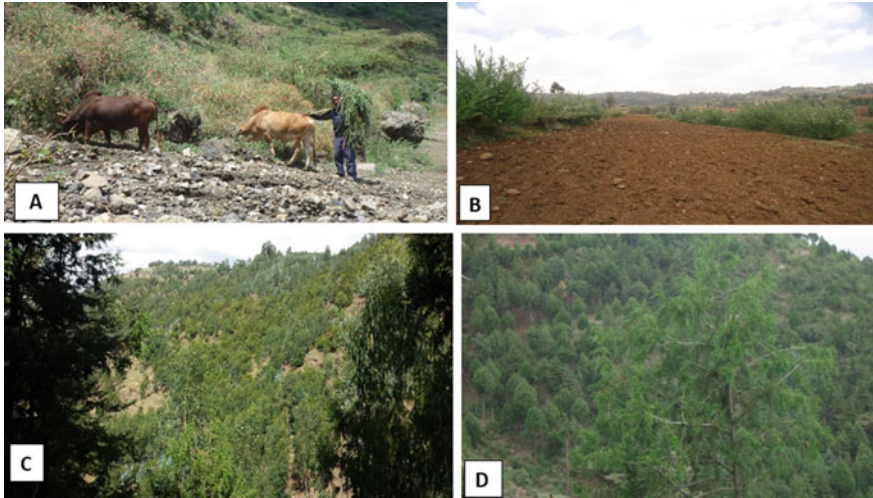
Fig. 17.15 a Area closure and a man used cut and carry system in Abiager watershed, b Hedge row plantation in Aseida watershed, c plantation of Eucalyptus trees in Maybar watershed, and d protected forest in Godguadit watershed

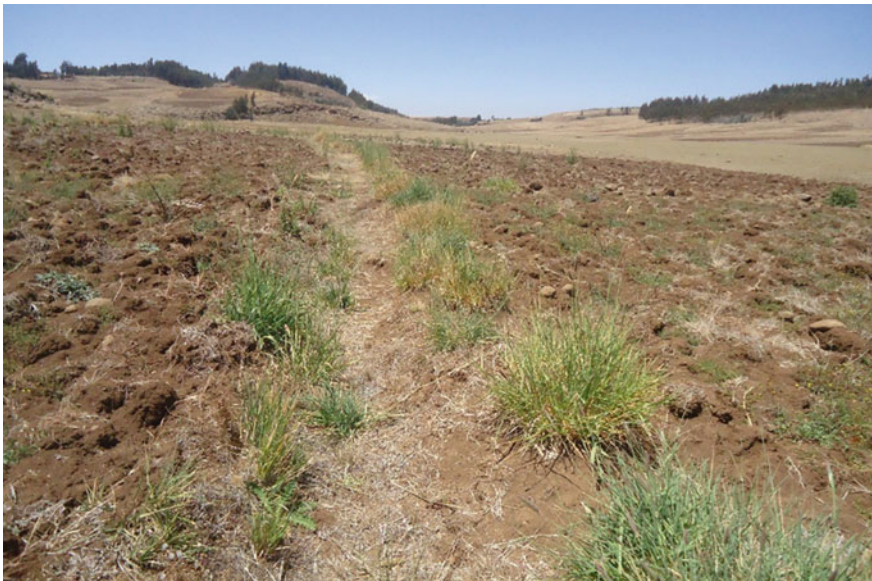
Fig. 17.16 Grass strip in Deresnilih watershed
