Deployment of a High Sensor-Count SHM of a Prestressed Concrete Bridge Using Fibre Optic Sensors

F. I. H. Sakiyama, F. Lehmann, and H. Garrecht

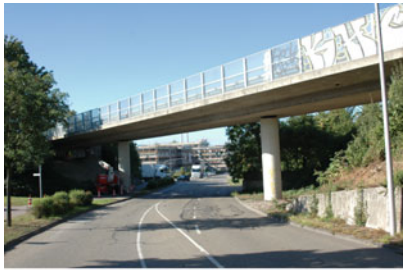
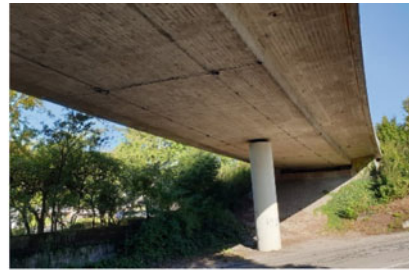
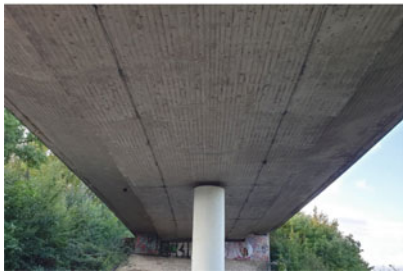
a. Overview of the bridge.

b. View of the configuration of the sensor

c. View of the configuration of the sensor

d. An LGFBG sensor with 2.05 m gauge.

Fig. 5 Overview of the bridge and the monitoring system

in the shear direction, with seven LGFBG sensors each. For every LGFBG strain sensor, an embedded temperature sensor is present for temperature compensation on the FO. Besides, the concrete temperature is monitored at five different points in the middle bridge field, and the acceleration is measured at 2 locations. The sensors were divided into eight quasi-distributed arrays equipped with redundancy connection fibres, which enable measurements to be continued if a primary connection cable fails. A schema of the sensors is given in Fig. 4 and overview photos are shown in Fig. 5. The following sensors are installed on the structure:
