João M. P. Q. Delgado *Editor*

Masonry: Building Pathologies and Design

Building Pathology and Rehabilitation

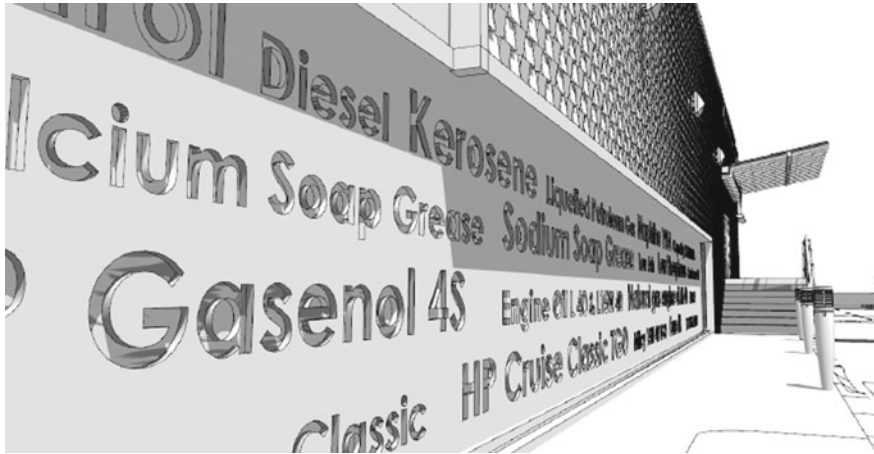
Fig. 7 View of in situ text art in front facade of building

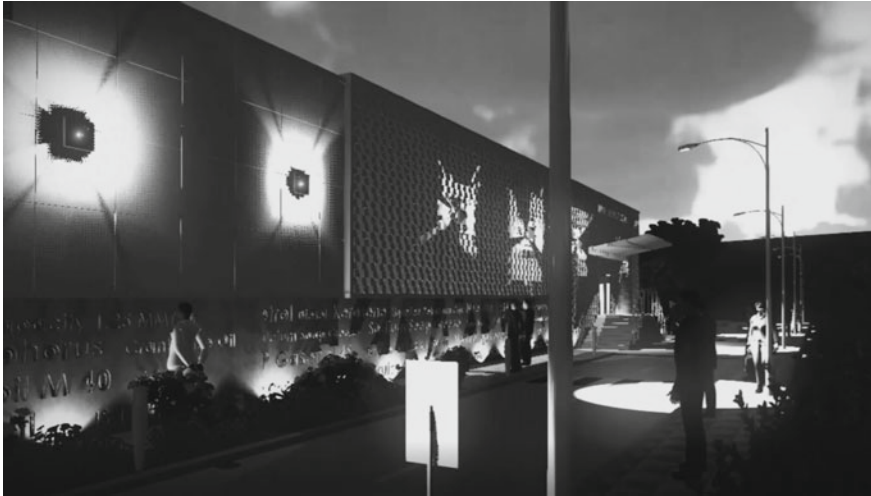
Fig. 12 View of building during night

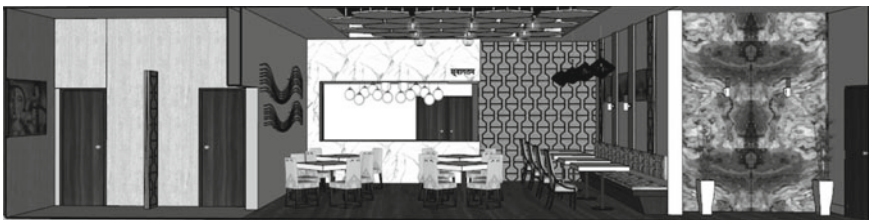
Fig. 5 Section of Cafeteria

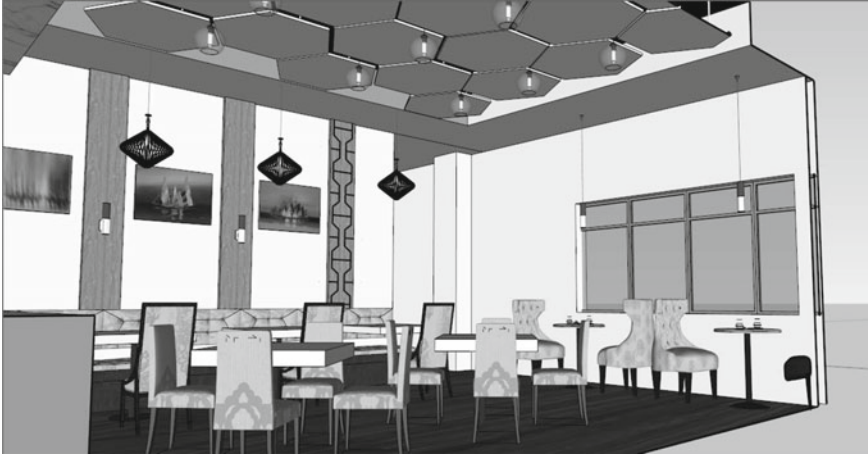
Fig. 9 Sectional view

(b) round suspended lights, (c) wall surface lights, (d) art work with spot lights. Lee et al. [14] had explained that the combination of the lighting system enhances the overall ambience of the interior. When the lighting fixtures varied, the ceiling shape was perceived as a significant factor in providing differences in perceptions of amenity (Figs. 7, 8, 9 and 10).

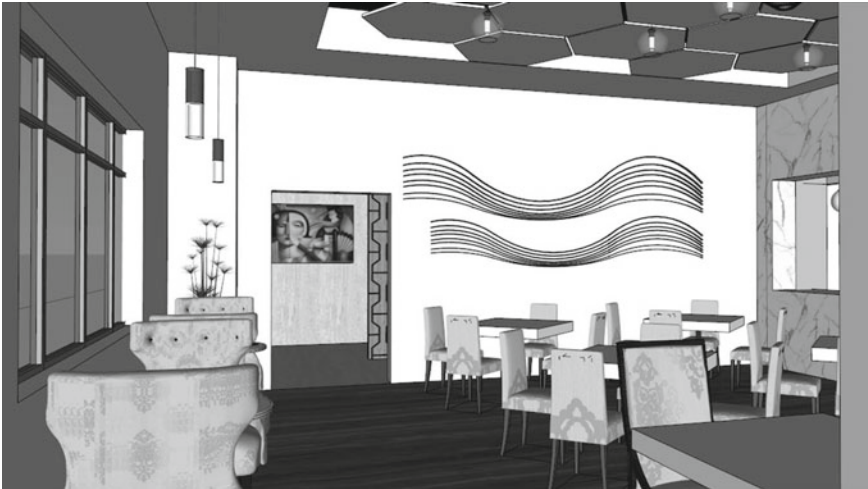
Fig. 10 Sectional view

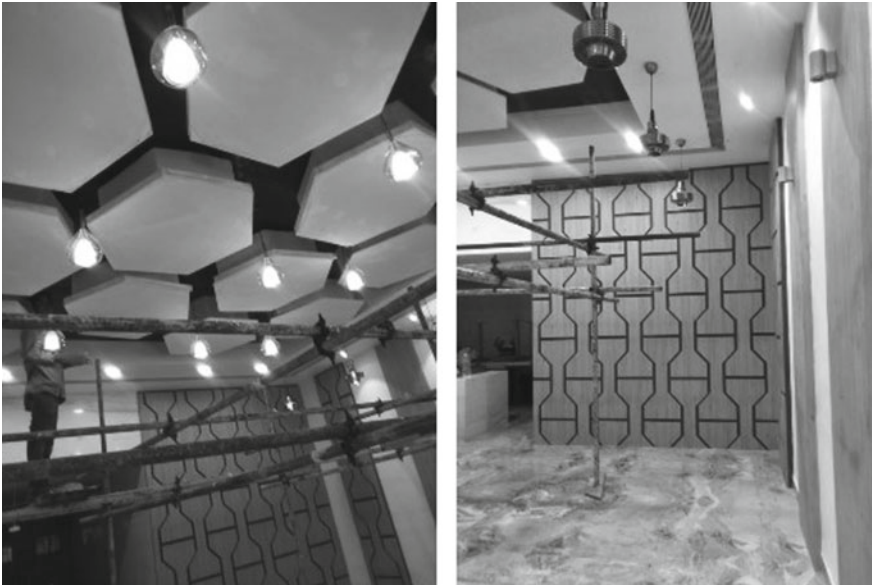
Fig. 12 Hexagonal patterns construction

This marble with the porous veins gives an impressive finish in the interior. Further the hand wash is placed in on the black marble top. The hand wash area is further enhanced by use of large mirror and golden finish taps and accessories (Figs. 11 and 12).

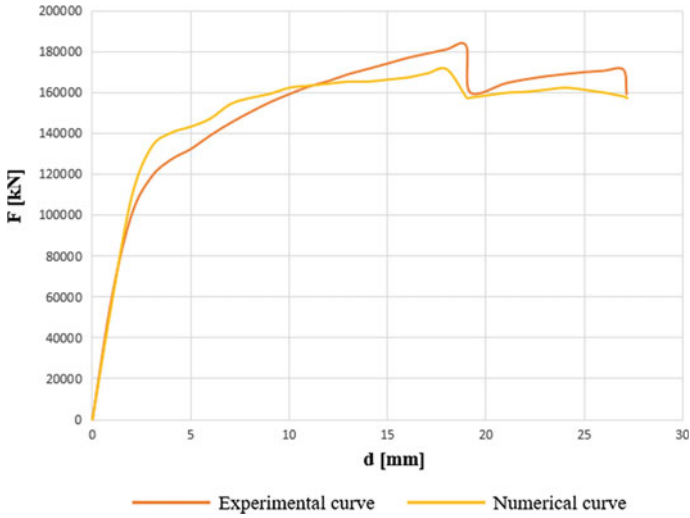
Fig. 6 Comparison between experimental and numerical curves

Figure 6 shows the comparison in term of force–displacement curve between the experimental test and the numerical one. By the comparison is clear that numerical calibration has been done very accurately. Figure 7 shows, instead, the comparison

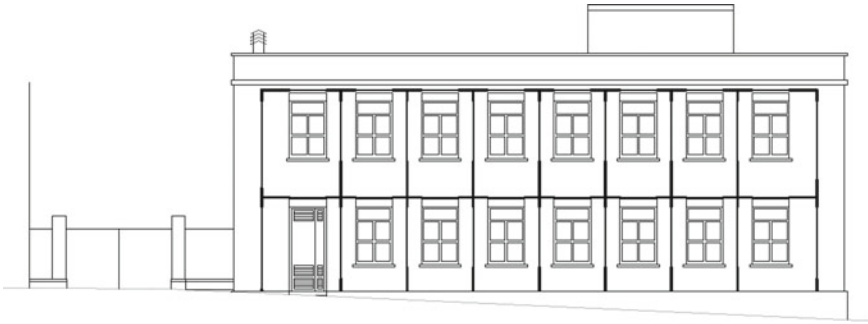
Fig. 17 Equivalent frame schematization of the east wall of the building

The equivalent frame model is used to model masonry walls (Fig. 17), where piers and spandrels are schematized through one-dimensional element which are deformable towards axial and shear actions (Fig. 18). These elements are connected to each other by rigid links. Masonry walls are connected all together through a diaphragm constraint.

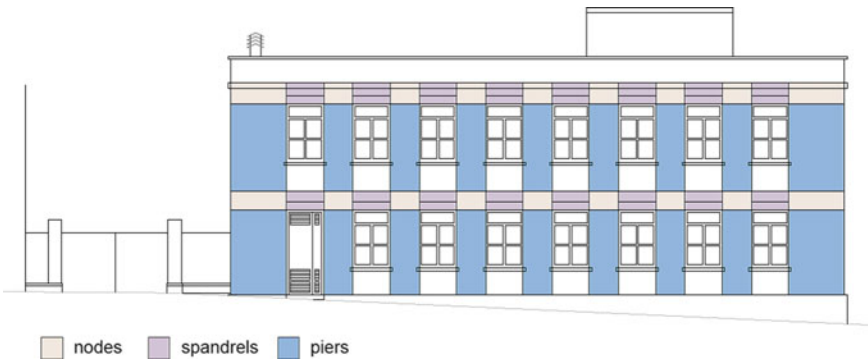
Fig. 18 Nodes, spandrels and piers of the east wall of the building

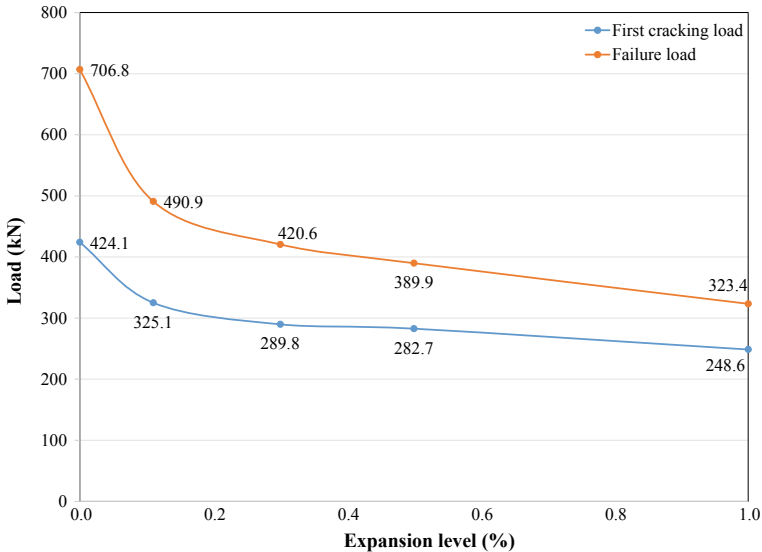
Fig. 11 First cracking and failure loads for each expansion level for the fully affected panel

Figure 11 shows the evolution of the first cracking and failure loads with the expansion levels, for the fully affected panel. It can be seen that the intact panel, represented by the point of no expansion, presented a first cracking load of about 421 and 325.1 kN, for the low expansion level. This means that for a relatively low level of expansion (0.11%), the first cracking load decrease was approximately 23%.

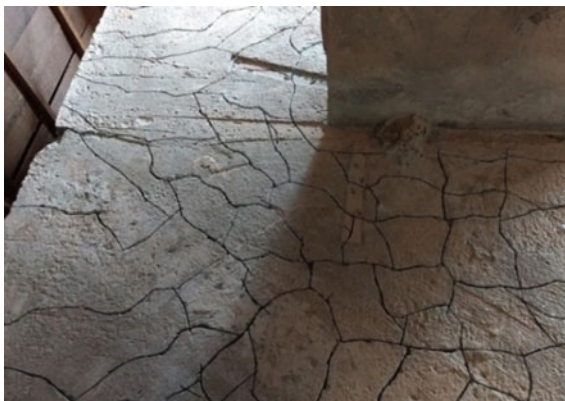
Fig. 4 Map cracking on the surface of the pile cap block

Visual inspections were performed on the pile cap block itself as well as on the concrete samples extracted to identify naked eye signs of expansive reactions or chemical attacks to the concrete. From these inspections, it was possible to observe to see features of these expansion reactions already in place by observing the cracking in map forms on the external surface of the pile cap block. It is worth mentioning that at the time of the extraction a report had already been made to detect the causes of degradation, as well as several tests and analyses, and the pile cap block was in the process of recovery (see Fig. 4).

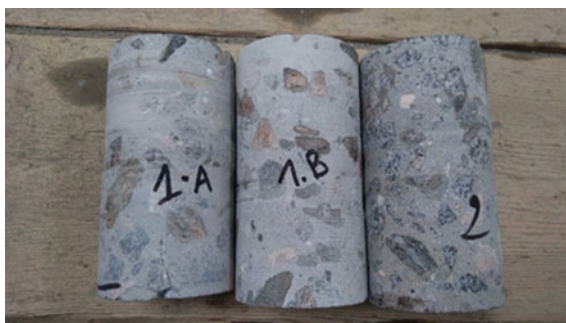
Fig. 2 Drilled concrete cores extracted from the deep pila cap investigated

Three drilled concrete cores were identified and prepared to perform compression tests (see Fig. 2). The ends of core specimens were prepared in order to have a flat and perpendicular to the longitudinal axis surface. Sawing was made prior to capping and it was performed to meet the following requirements: (a) projections, if any shall

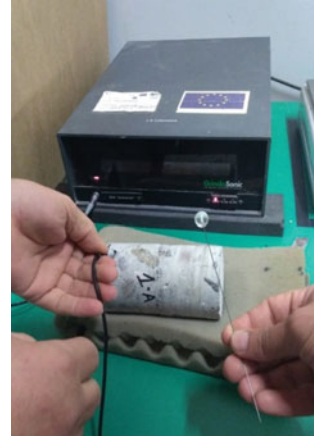
Fig. 4 Dynamic modulus of elasticity test scheme

The procedure comprises of firstly exciting a test object by means of a light external mechanical impulse, and secondly of the analysis of the transient natural vibration during the subsequent free relaxation. This excitation is given in such a way as to favor the desired vibration mode, i.e., a flexural vibration, a torsional vibration or a longitudinal vibration. In the test, the vibration probe was placed at one end of the specimen and the other received a pulse with the impactor, then the frequency was automatically generated in the apparatus, and subsequently the module was calculated, based on the standard [20]. The test procedure is illustrated in Fig. 4 and the Eq. (1) used to obtain the dynamic modulus used was the following:

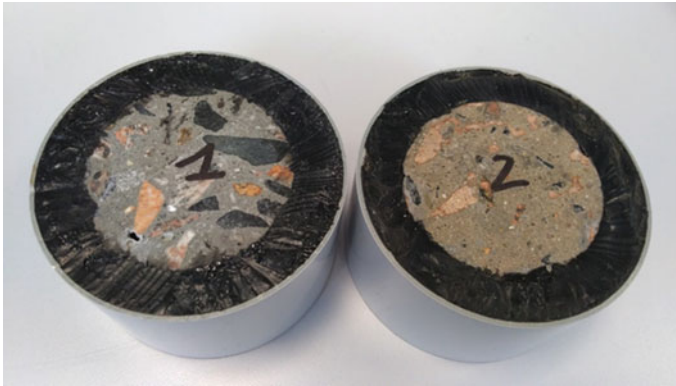
Fig. 6 Samples P-01 and P-02 prepared for the gas permeability test

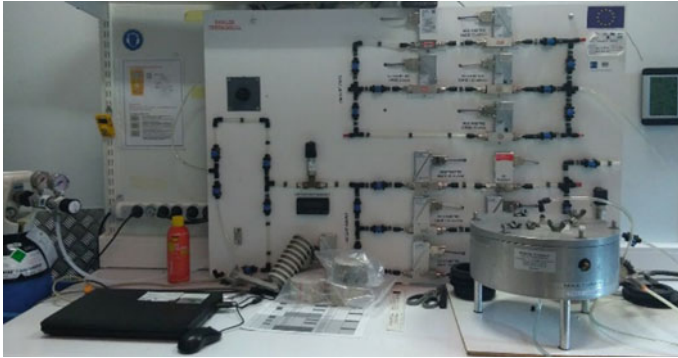
Fig. 8 Flowmeter equipment

The scheme of the permeability equipment was shown by [23] and demonstrates how the sample is confined in the permeability cell (see Fig. 7). The complete apparatus of the permeability equipment used in the test is shown in Fig. 8. Nitrogen was the neutral percolating gas used and laboratory temperature and relative humidity (RH) were controlled and kept constant during the tests— $T = 17.8\text{ }^{\circ}\text{C}$ and $\text{RH} = 76\%$).

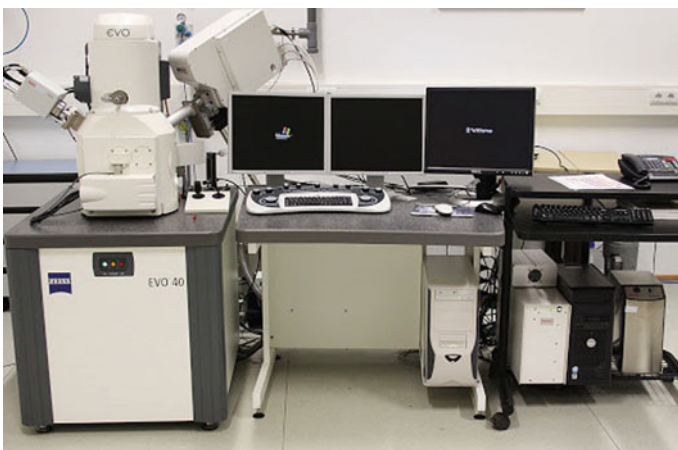
Fig. 9 SEM equipment used

The SEM used for tests performed was a ZEISS EVO[®] 40 equipped with a Back-scattered Electron (BSE) detector to determine the chemical composition. The microscopic characterizations were performed on fresh fractures sections on concrete specimens. The specimens were coated with a gold deposit for observations using the SEM in High-Vacuum (HV) model.

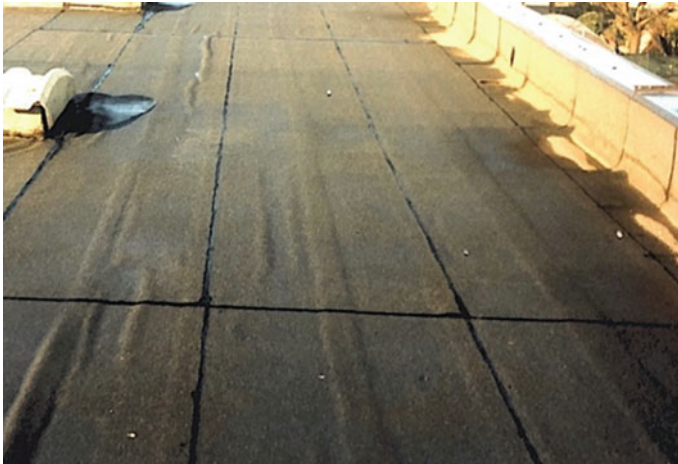
Fig. 3 Corrugations due to gap presence between insulation panels

By the way, let us observe that a defective restraint of the insulation panels to the support exposes the membrane to repeated lifting due to wind gusts. This can generate stresses on cuffs which may bring the restraint to collapse.

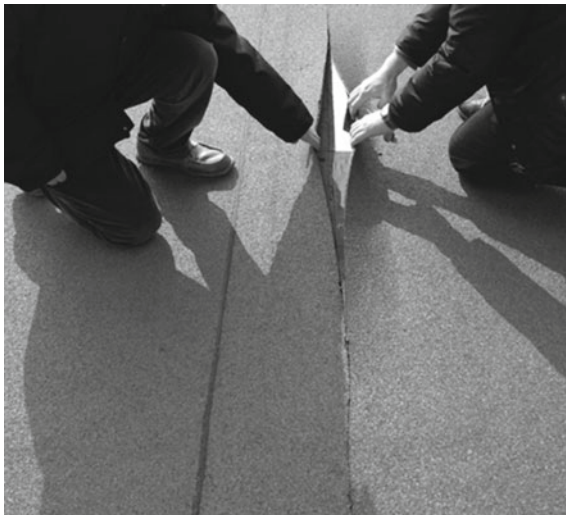
Fig. 4 Cracking due to thermal contraction before precompression destabilization phase. Cracking is favored by reinforcements anisotropy and the continuous joint between panels oriented in the longitudinal direction of the sheet

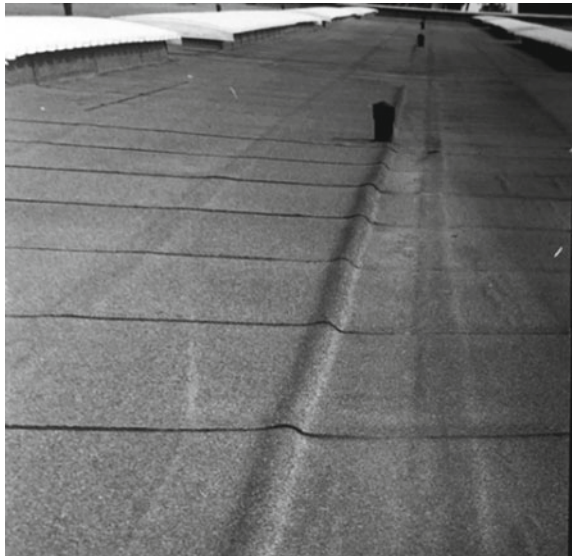
Fig. 5 Transversal wrinkling due to detachment from orthogonal edges to the direction of sheet installation

After a thermal contraction, the following longitudinal expansion is partially prevented by support friction. The membrane expands more easily by corrugating transversally with respect to the direction of installation (see Fig. 5).

Sooner or later, repeated “fatigue” bending of the bitumen-polymer mass leads to cracking.

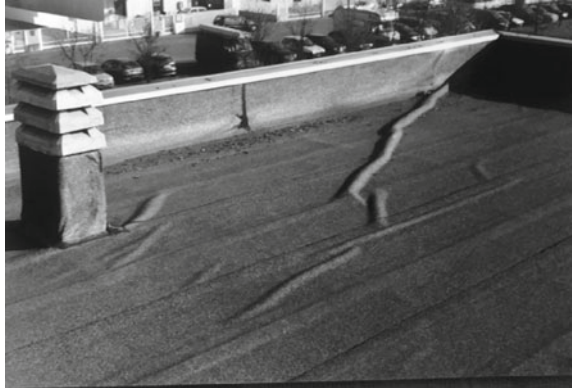
Fig. 7 Corner corrugation, horizontal and vertical

Detachment from transversal edges with respect to the sheet direction occurs far away from the corner, while it is prevented or resisted at corners. As a matter of fact, dislocation of the sheet end is retained by vertical side cuffs (see Fig. 7).

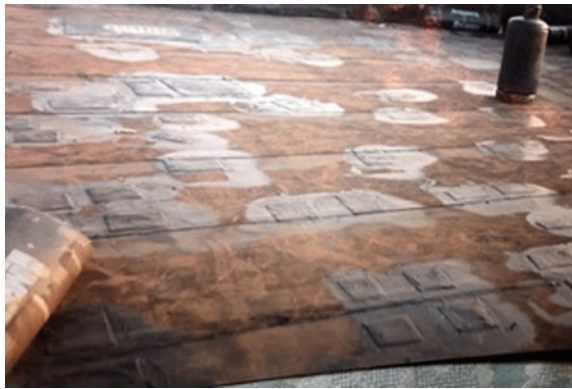
Fig. 10 Deformation of the mechanical fixing shaft due to direct load

In the case of plate attached underneath the shaft (pull over), device dimensions prevent puncturing for near sinking under load. However, they generate traction. Load on top of overlaps next to the plate might lead to local detachment.

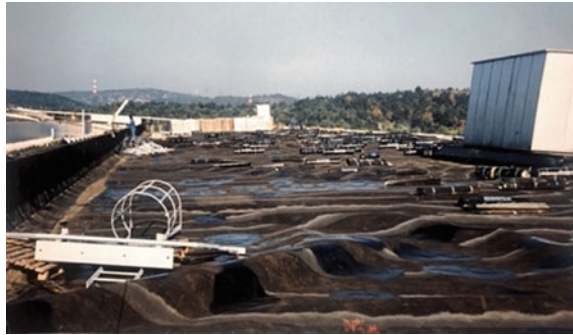
Fig. 12 Urgency ballasting of a membrane detached by the wind

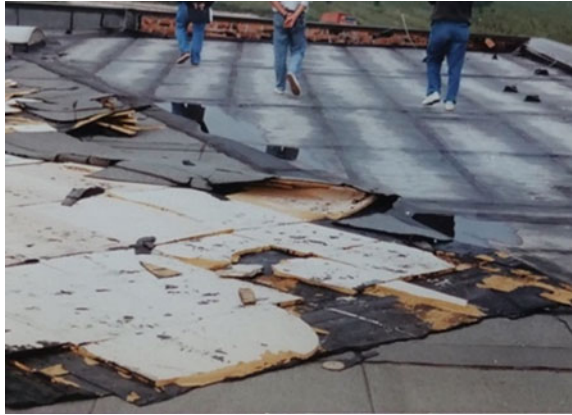
Fig. 13 Dislocation due to wind for insufficient adherence of the membrane to the support

In the presence of less constrained zones, these vibrating liftings generate peeling actions that gradually lead to the enlargement the detached area. These actions are mainly concentrated on edges and cuffs and can lead to the complete dislocation of the membrane (see Fig. 13).

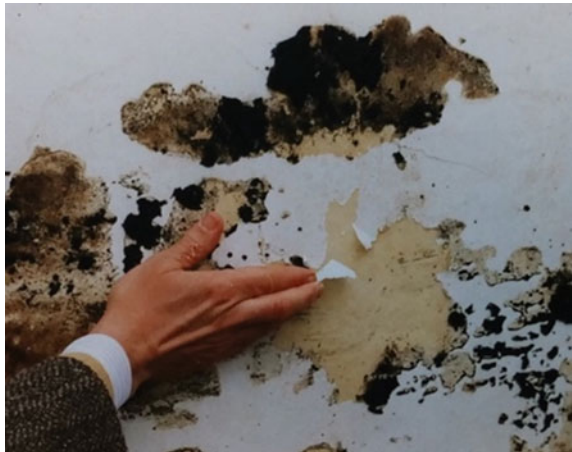
Fig. 14 Delamination of surface treatment of polyurethane panels

Adherence bond between membrane and insulation panels does not only depend on adherence medium quality (primer, glue), but also from panel quality itself. These must have a perpendicular tensile strength with respect to the main faces in agreement with wind-generated tractions on the membrane. Actually, the critical aspect is the delamination of the insulation panel. For such reason, it is necessary to set mechanical quality of insulating materials with respect to the meteorological conditions of the site. Less-durable materials require special attention and, if necessary, further mechanical fasteners especially at cover edges (see Fig. 14).
