Concrete Samples Extracted from Pile Caps and Affected by Internal Swelling Reactions: A Diagnostic Analysis

Abstract In this work, it was analyzed in detail the problem of the extensive cracking in the pile cap foundation originated by the delayed ettringite formation, possibly from a high heat of hydration coming from the concreting of the large volume of concrete. Laboratory tests were performed to evaluate the transport properties of concrete samples, as well as their physical and chemical composition using advanced analyses. The tests performed were apparent porosity, gas permeability, scanning electron microscopy, X-ray diffraction and Raman spectroscopy. The presence of crystalline products of the alkali-aggregate reaction was proven through physical–chemical analyses, such as Raman spectroscopy and EDS. As well as the ettringite crystals found in XRD standards, SEM images and the chemical composition of EDS. The porosity showed a high value (between 9 and 10%), as well as the concrete permeability (10^{-16} and 10^{-15}), determining the negative influence of ISR on the transport properties. Therefore, the methods used have proven to be effective in understanding the probl

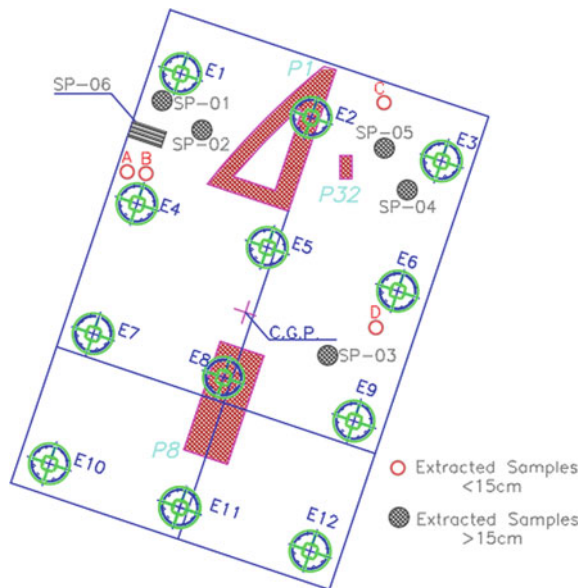
Fig. 1 Place of extraction of the samples in the Pile Cap Block S(P1 + P8 + P32)

Figure 1 represents the pile cap S(P1 + P8 + P32), with the extraction sites of each core, identified by the notations (SP-01, SP-02, SP-03, SP-04, SP-05 and SP-06). The points identified by (A, B, C and D) are where were extracted the samples of smaller sizes also used for analysis and characterization. All samples were extracted in the direction parallel to the launching of the concrete and only the SP-06 was in

the direction perpendicular to the launching. The face chosen was where there was longitudinal cracking along the pile cap block.

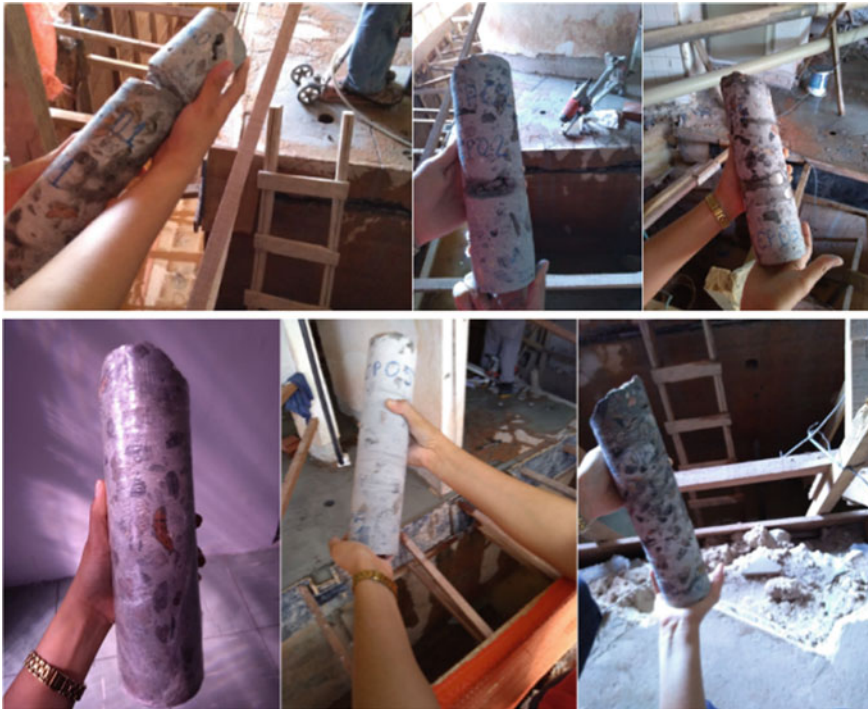
Fig. 2 Samples extracted from the block (SP-01 to SP-06)

The concrete samples were extracted with two single-phase electric drills of such dimensions with 75 mm diameter—Model Husqvarna dm2 240 and Tyrolit dk32. The extraction procedure was executed in such a way that the sectioning of the block reinforcements was avoided as much as possible. The specimens were extracted from the upper part and from lateral faces of the pile cap block, totalling 6 (six) cylindrical concrete samples with dimension of $15.0 \times 7.5 \text{ cm}^2$ —height and diameter, respectively. The entire sample extraction process was performed in a single day and lasted approximately 7 h (see Fig. 2).

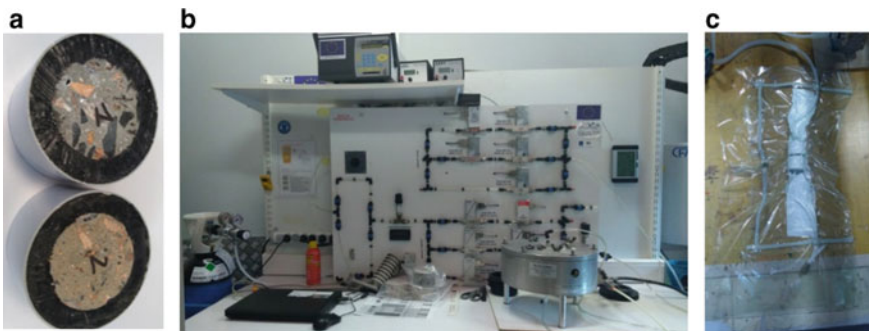
This resin also had the function of waterproofing the lateral surface of the samples. Figure 3a illustrates how the concrete samples were ready for the test. The concrete gas permeability measurement test is easy and quick to perform and its results are important for assessing the durability of the material. These aspects should be considered so that its use can be more widespread in the practice of concrete structure execution.

The complete apparatus of the permeability equipment (“debitmètre massique”) used in the test is shown in Fig. 3b. The intrinsic permeability is measured through a permeameter, with nitrogen being the neutral percolating gas. A manometer reads

Fig. 3 a Samples P-01 and P-02 prepared for the air permeability test; b flowmeter massique equipment; c system used for the apparent porosity test

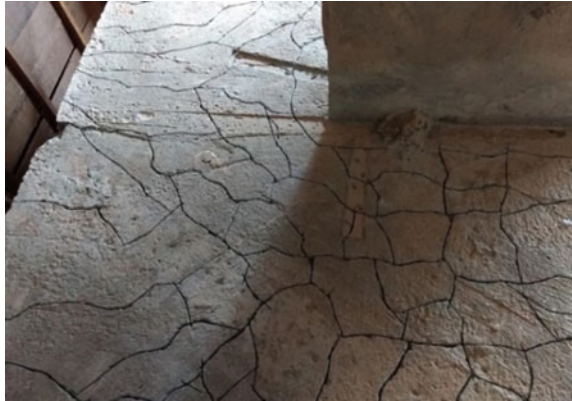
Visual inspections were performed on the pile cap block itself as well as on the concrete samples extracted to identify naked eye signs of expansive reactions or chemical attacks to the concrete. From these inspections, it was possible to observe to see features of these expansion reactions already in place by observing the cracking in map forms on the external surface of the pile cap block. It is worth mentioning that at the time of the extraction a report had already been made to detect the causes of degradation, as well as several tests and analyses, and the pile cap block was in the process of recovery (see Fig. 4).

Fig. 4 Map cracking on the surface of the pile cap block

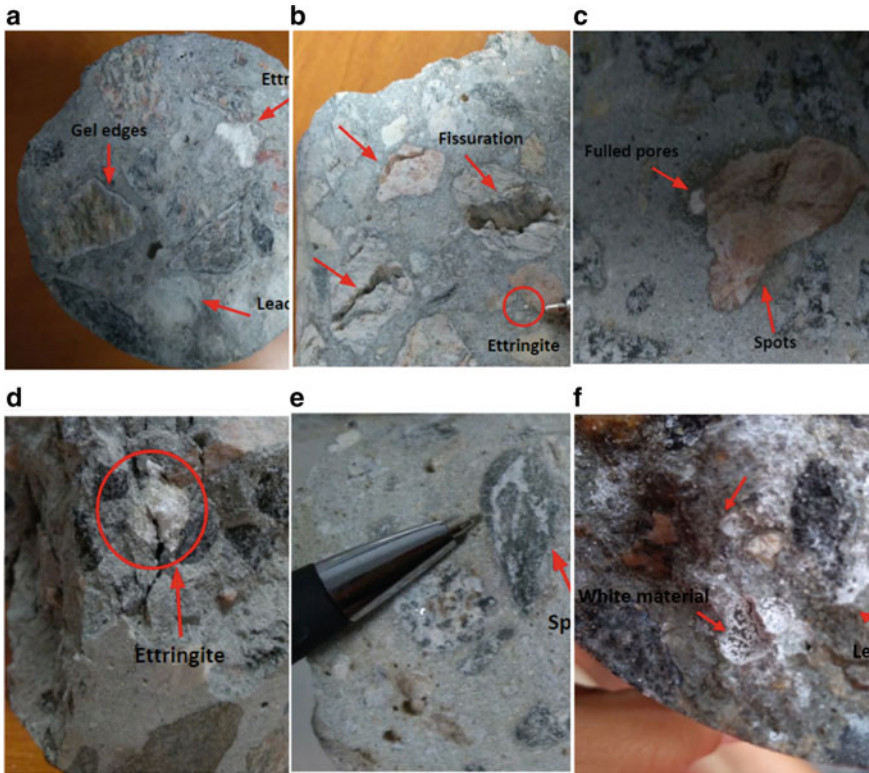
The samples were first visually examined in order to find clues of chemical attacks to concrete such as AAR and DEF. Macroscopically, gel edges from the alkali-silica reaction were observed in the aggregates. Cracks on the coarse aggregates, following to the cement paste, were observed as well as cracks on transition zone reaching the larger pores.

At some locations it was possible to observe detachment between the aggregate and the paste. Some aggregates contained a kind of whitish reaction product inside, very close to its extremities and many dark edges or spots were found around the coarse aggregate.

Several micropores were filled with ettringite and many pores were completely filled with white material. In some fragments a large amount of white material was found covering the concrete, like as leaching. It was also observed in some larger pores little deposition of white material, a fact also observed by Hasparyk [4] in the visual inspection of concrete cores with alkali aggregate reaction.

- Alkali-silica gel edges in the aggregates;
- Pores with white material deposited at the bottom;
- White mass in several places in the concrete;
- Pores completely filled with ettringite;
- Cracking in coarse aggregates;
- Dark spots around the aggregate;
- White spots inside the aggregate;
- Leaching;
- White spot covering the concrete, mainly the mortar;
- Displacement between the aggregate and the paste;

Fig. 5 Symptoms of the expansion mechanisms found: **a** gel edges; **b** ettringite in the micropores and cracking; **c** spots in the aggregate; **d** pores filled with ettringite; **e** spots in the aggregate; **f** white material in the pores and leaching

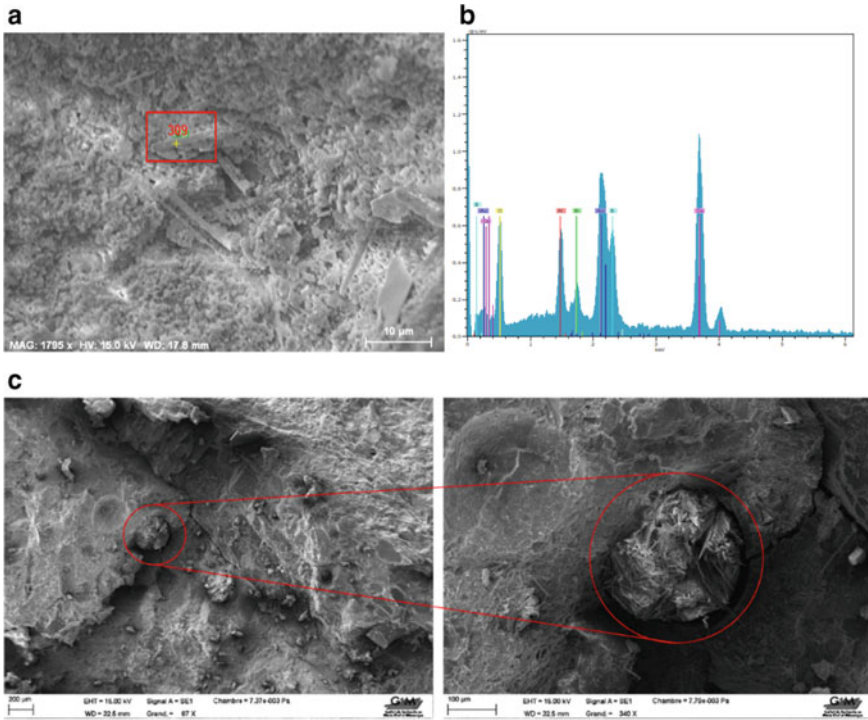
In the analyses performed with SEM, some specific parts that indicated the presence of delayed ettringite formation were chosen. The first point was 309, where the morphology indicated that it was an ettringite acycle. Figure 6a shows this part of the sample, with a magnitude of $1795\times$.

Fig. 6 **a** Acycular crystals of ettringite found in the mortar; **b** components such as: sulphur (S), aluminum (Al) and calcium (Ca) in the sample and **c** ettringite crystals completely filling a pore (23×–340×)

The chemical composition obtained by EDX is shown Fig. 6b, where the components such as Sulfur (S), Aluminum (Al) and Calcium (Ca) suggests the presence of delayed ettringite [4, 17]. Figure 6c illustrates ettringite crystals completely filling an existing pore in the concrete. The first magnitude is 23×, being increased to 340×.

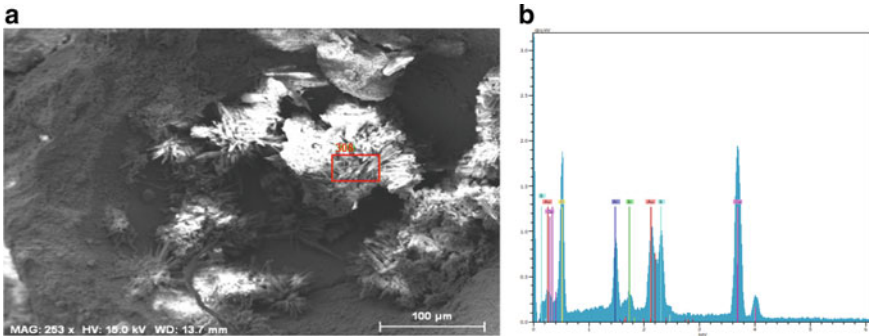
At point 308 (Fig. 7a) analyzed by SEM, it is possible to observe ettringite crystals developed and deposited in a pore and the corresponding chemical composition is presented in Fig. 7b, with the presence of Sulfur (S), Aluminum (Al) and Calcium (Ca), aspect that confirms that it is delayed ettringite [4].

Fig. 7 a Ettringite crystals deposited in a pore; b chemical composition of the crystals

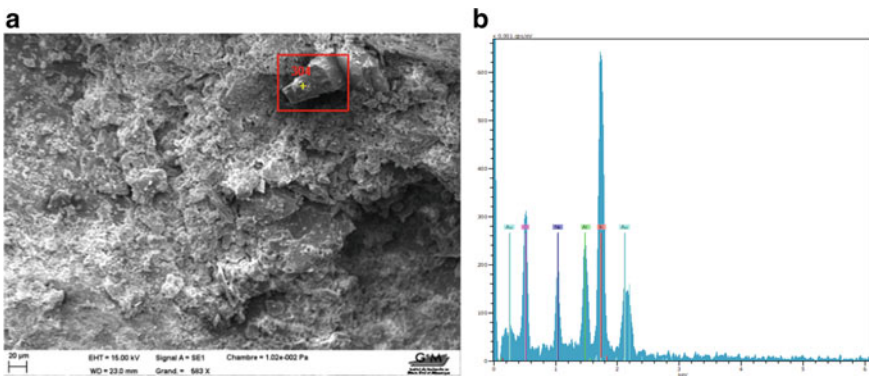
This particle (point 304—Fig. 8a) analyzed showed in its chemical composition Aluminum (Al), silicon (Si) and sodium (Na), indicating that there are components of delayed ettringite formation and crystalline products of alkaline reaction [4] acting together. Figure 8b illustrates the composition (Al, Si and Na) of this point analyzed.

Fig. 8 a Aggregate particle with crystalline products of the alkali-silica reaction; b crystalline product of alkaline silica reaction

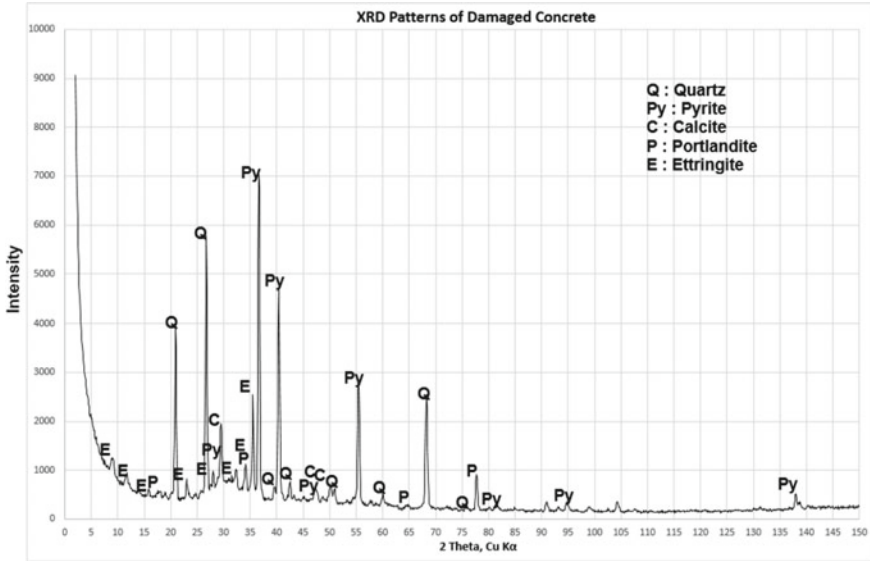
In the analyses with EDX it was possible to observe a large amount of sulfur (S), aluminum (Al) and calcium (Ca), chemical elements predominantly found in crystals of ettringite [4]. The XRD analyses also proved the presence of ettringite and pyrite (sulphate) internally. These internal compounds associated with a high heat of hydration may have caused the formation of delayed ettringite. Figure 9 shows the patterns of concrete damaged by internal expansion reactions.

The highest peaks are from pyrite, followed by quartz and ettringite. They are similar to those found by [4, 9] in cases of dams affected by delayed ettringite and alkali-silica reaction, respectively. The diffraction angles that showed strong reflection were: 2 theta of 37°, 2 theta of 41° and 2 theta of 55°, with high intensities, and refer to Pirita or Sulfate. The ettringite with greater intensity is found in 2 theta

Fig. 9 Presence of pyrite (sulphate), sodium hydroxide, calcium carbonate and silicon dioxide

of 36°, corresponding to the crystals present in all the concrete, predominantly of the pores and voids.

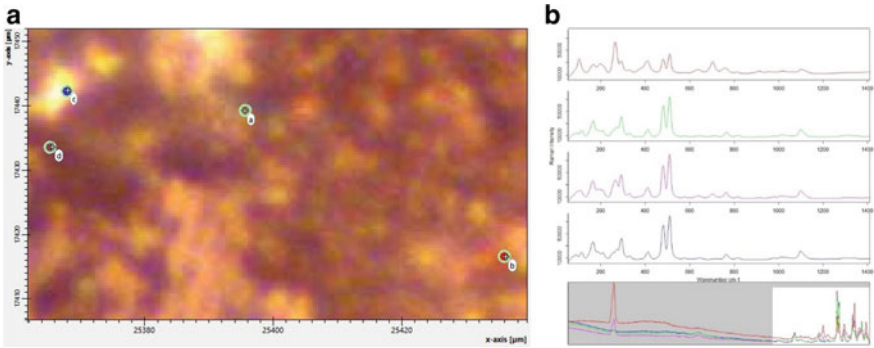
Figure 10a represents the coarse aggregate region of the RA-02 sample in expanded resolution. Four points (a, b, c and d) were chosen to be analyzed by Raman spectroscopy.

Figure 10b illustrates the Raman spectra of the crystalline products found in different locations of the same analyzed aggregate. The Raman spectra were found between two wide bands, in the range of 100–600 cm⁻¹ (low frequency region), indicating the amorphous nature of the gel. The wave numbers identified (see Fig. 10b) were similar to those found by the researchers for the aggregates that contained reactive mineral [17, 18]. When analyzing the edges of the aggregate, the bands of the crystalline product do not result in peaks, indicating only noises, a similar behavior found in [19]. The colour of the dots corresponds to the colour of the spectra, the corresponding sequence is: b, a, d and c.

Fig. 10 **a** Points (a, b, c, d) where the Raman analysis was performed; **b** Raman spectra of the crystalline products at the four points analyzed in the RA-02 sample

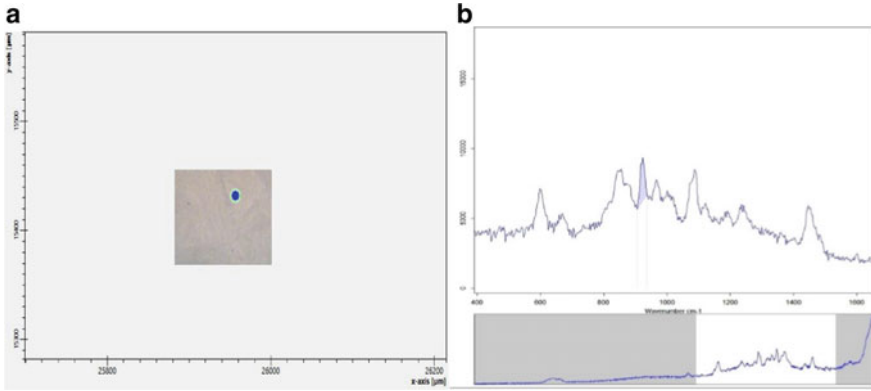
Figure 12a shows the point from which this spectra was obtained and the Fig. 12b shows the spectrum of the crystalline product located inside a pore in the RA-05 sample. There are different peaks, the largest is in the range of 800–1000 cm^{-1} . In

Fig. 12 **a** Crystalline product analyzed by Raman spectroscopy; **b** Raman spectra values found in the ASR products inside a pore

the wavenumber 600 cm^{-1} there is a peak, similar to what was found by [17] as a peak of the alkali-silica reaction product.
