# Conserving Stone Heritage

Traditional and Innovative Materials  
and Techniques

## Preliminary Investigations, Condition Assessment, and Mapping of the Deterioration Patterns

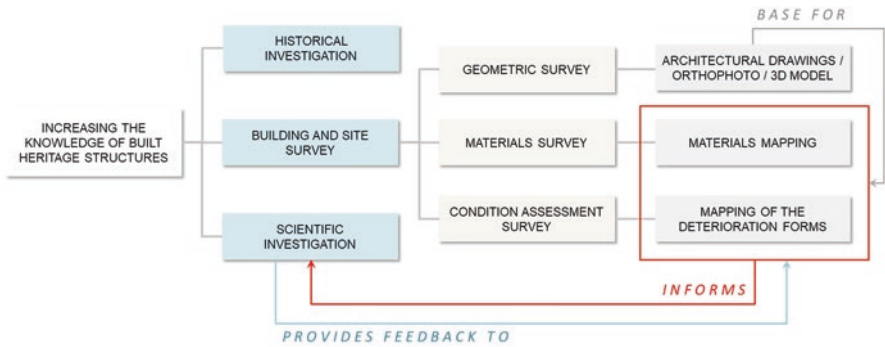
**Fig. 1.2** Relationships and outputs (right column) of the condition assessment within the overall process aiming to increase the level of knowledge of the built heritage structures. (Elaborated from Ref. [18])

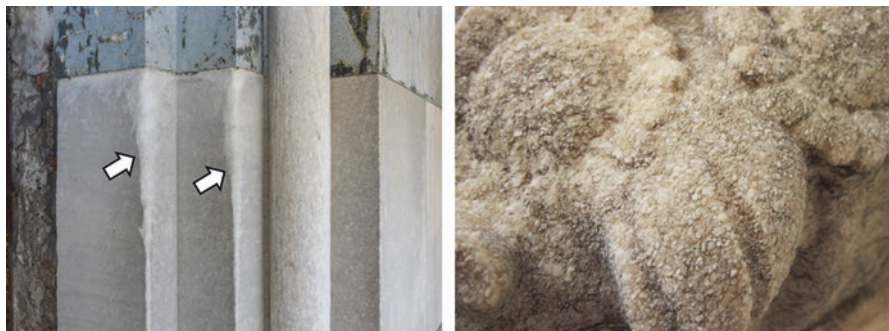
**Fig. 1.4** Left, rounding along the edges of blocks of fine-grained Crevoladossola marble (dolomitic marble, Monza Cathedral, Italy) due to the erosive effect of water runoff. Right, roughening of the sculpted decorative element of Candoglia marble (medium- to coarse-grained calcitic marble, Milan Cathedral, Italy) due to the combined action of rain and thermal dilation

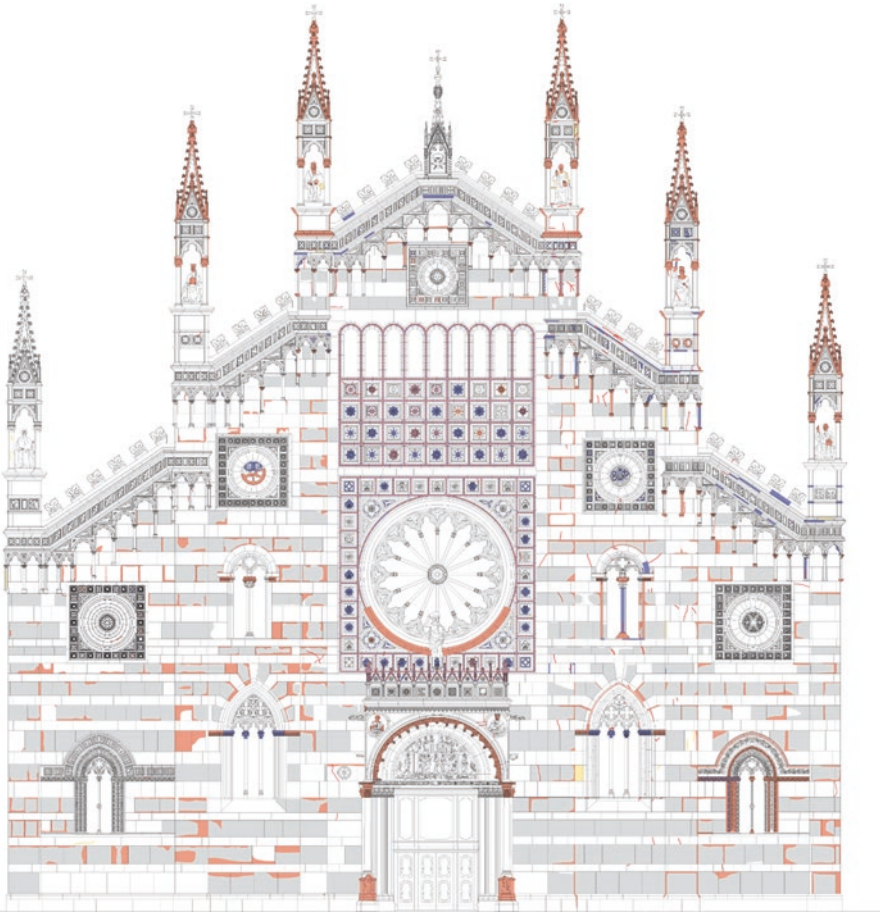
**Fig. 1.11** Mapping of the deterioration patterns, showing the preferential distribution of the discoloration pattern on the with marble rows of the cladding (see Fig. 1.9 for reference) and its increasing extent towards the lower sector of the façade. Color key: discoloration, grey areas; erosion, orange areas; differential erosion, yellow areas; crack, purple areas; fracture, red lines. Original scale 1:50

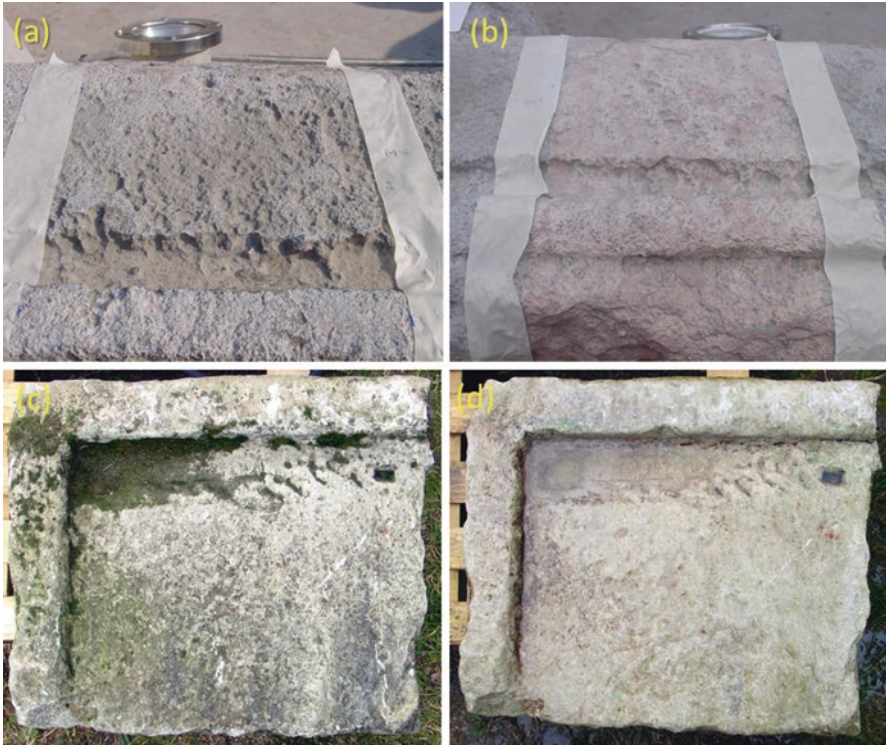
**Fig. 2.3** (a) Deposit on a fountain of the organogenic limestone Rosso di Verona; (b) after micro-sandblasting, silica microparticles 100  $\mu\text{m}$ , 1 bar pressure, and 1 mm of nozzle diameter; (c) Biocolonization on an Istria stone archaeological find; (d) after cleaning with cryosandblasting (dry ice pellets) at 10 bar pressure, © Archive Arcadia Ricerche Srl (Italy)

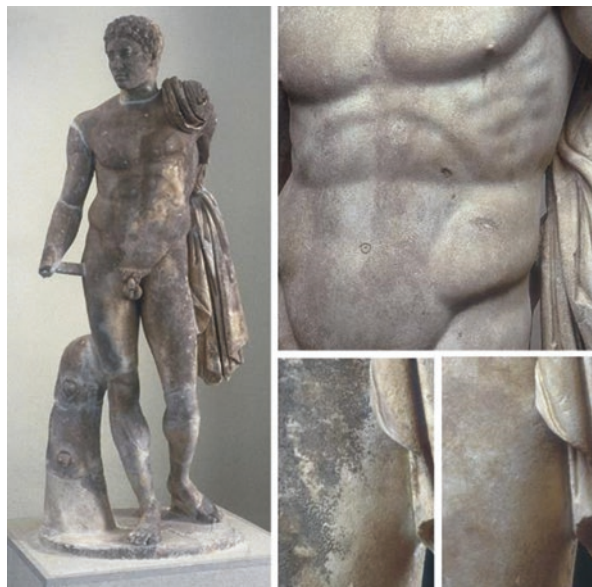
**Fig. 3.7** Hermes sculpture before cleaning (left) and details of the surfaces cleaned with 1064 nm QS- Nd:YAG laser at  $F = 0.8\text{--}1.6 \text{ J/cm}^2$ . © Lithou Sintirissis Conservation Associates, photos by S. Mavrommatis

Hermes is a life-size Roman (first century AD) marble statue, excavated in 37 fragments in Ancient Messene in the Peloponnese, Greece. Its appearance after conservation undermined legibility and appearance, so cleaning of the inorganic encrustations was proposed. Prior to being the first statue to be laser-cleaned *in situ* in Greece, cleaning trials were undertaken in order to compare the result of most common conventional techniques (ultrasound pick and micro-air abrasive) on a marble fragment from the same excavation, characterised by a thick dark brown crust, similar in texture and composition to the one on the Hermes statue. The cleaning results were evaluated by means of optical microscopy and spectral imaging, for different types of crust and substrate condition, as well as their performance efficiency, the degree of control, and their complexity in handling [85]. The sculpture, which is currently exhibited in the Archaeological Museum of ancient Messene, was laser cleaned on February 2001 *in situ* by “Lithou Sintirissis Conservation Associates”, using a QS Nd:YAG system (Lynton Lasers) on damp surfaces. F range was 0.8–1.6 J/cm<sup>2</sup> (Fig. 3.7).

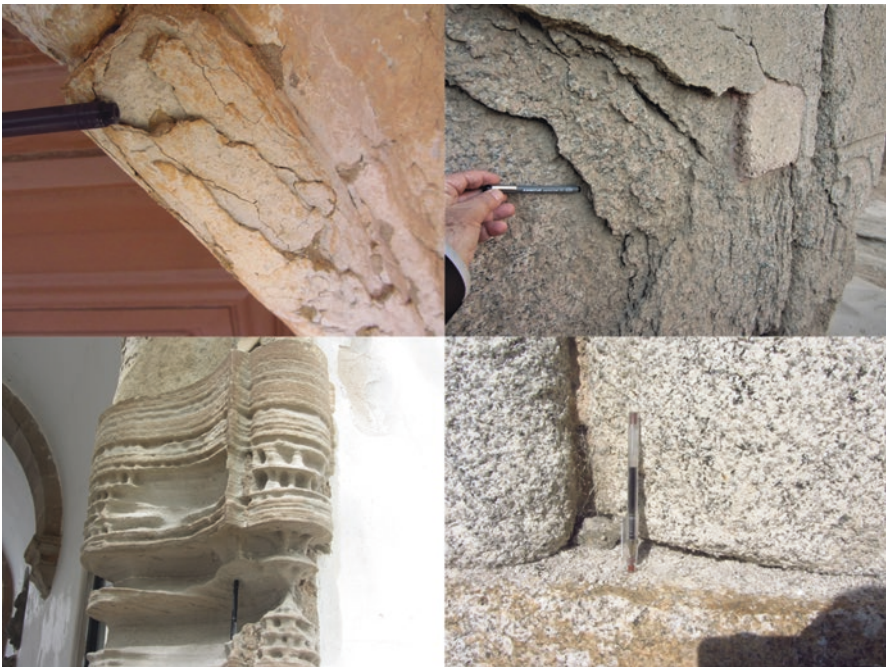
**Fig. 4.1** Different deterioration patterns will need different treatment approaches. Thick scales, plaques and chips (top) are individually addressable, while powdering and granular disintegration (bottom) need to be addressed with a more encompassing treatment process, © José Delgado Rodrigues

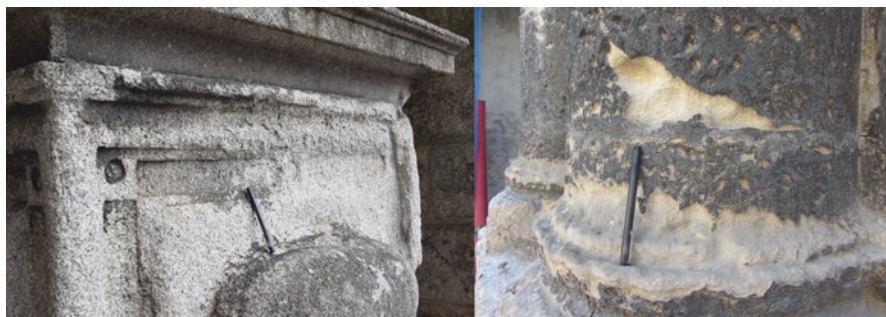
**Fig. 4.2** Significant mass losses can occur in localised areas that require consolidation, and the approach to follow is primarily specific to each situation. Examples of granular disintegration in granite from S. Francisco church (Porto, Portugal), and powdering in a soft limestone from Avignon (France), ©José Delgado Rodrigues

Small variations in the composition of the stone, in the exposure situations, and in the environmental factors make each situation unique (Fig. 4.2) and it should always be remembered that **my case is not your case**.

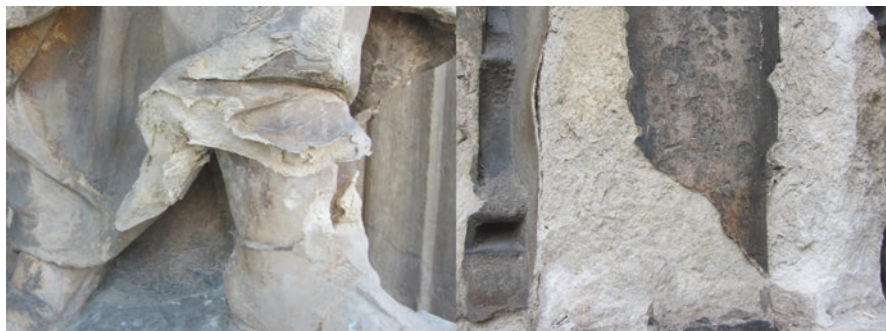
**Fig. 4.3** Incompatible performance of treated limestone showing a thin hardened layer detaching from the powdery underlying stone. The strengthening of the consolidated layer was still effective, but its highly different physical properties led to a severe incompatible behaviour, ©José Delgado Rodrigues

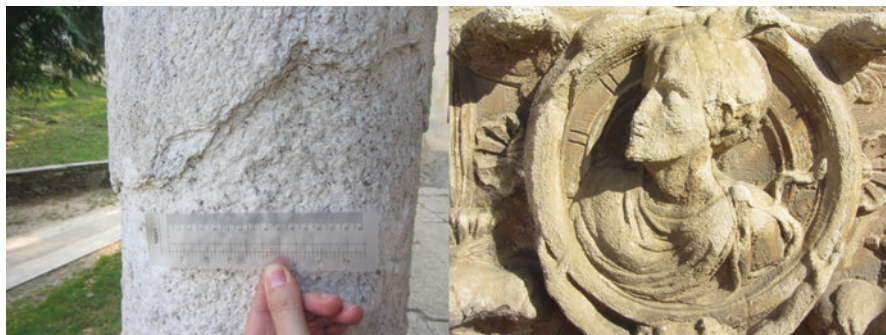
**Fig. 4.4** Different functions require distinct treatment approaches. A load bearing column (left), deeply decayed and with significant mass losses may require a strong consolidation action, while a delicate decorated surface (right) may just need a gentle consolidation action, proper maintenance, and regular monitoring, ©José Delgado Rodrigues

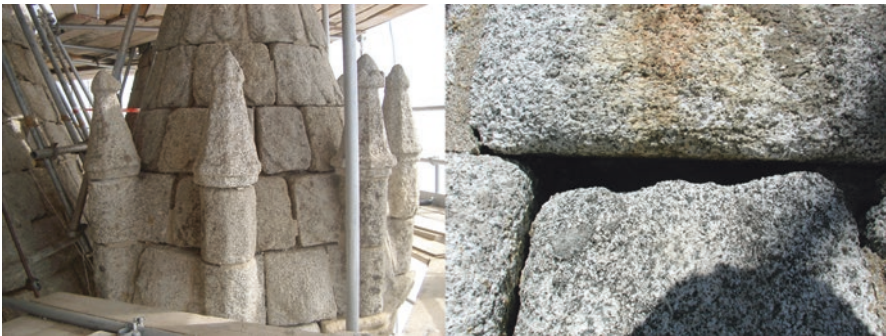
**Fig. 4.6** Lantern of Evora Cathedral. Sand disintegration of granite and extensive deterioration of joints were the main problems to address, ©José Delgado Rodrigues

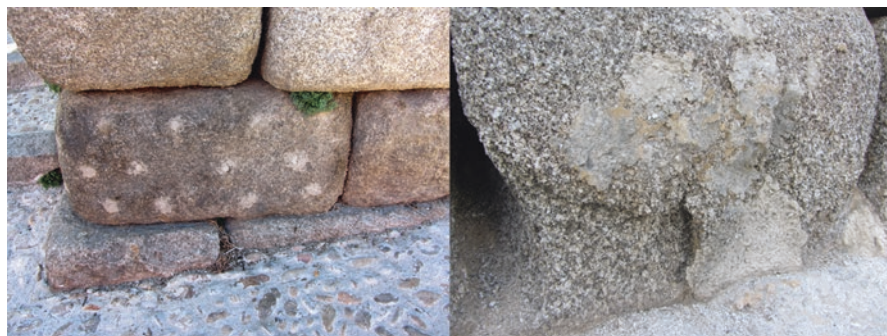
**Fig. 4.7** Segovia Aqueduct (Spain). The deep injection of epoxy resins in a fairly sound block (left) was useless, while the similar injection in the heavily decayed block (right) has left the surface unconsolidated and subject to active sand disintegration and significant mass loss, ©José Delgado Rodrigues

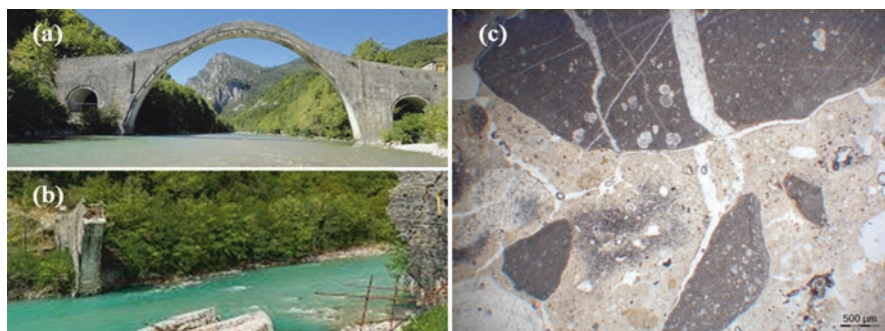
**Fig. 6.5** Plaka bridge in Epirus (Greece): (a) before its collapse, (b) after its collapse in 2015; (c) presence of pozzolanic material throughout the mortar, as detected through polarized optical microscopy, dictated the design of a lime-pozzolan restoration mortar. (Adapted from [90])

Microscopical investigation can assist in revealing the nature of the mortar, identify decay patterns and products, and provide information regarding raw materials used for the production of the mortar [75, 76]. If, for example, pozzolanic material is identified in a historical mortar (Fig. 6.5), the use of a pozzolanic additive in the restoration mortar is suggested [90].

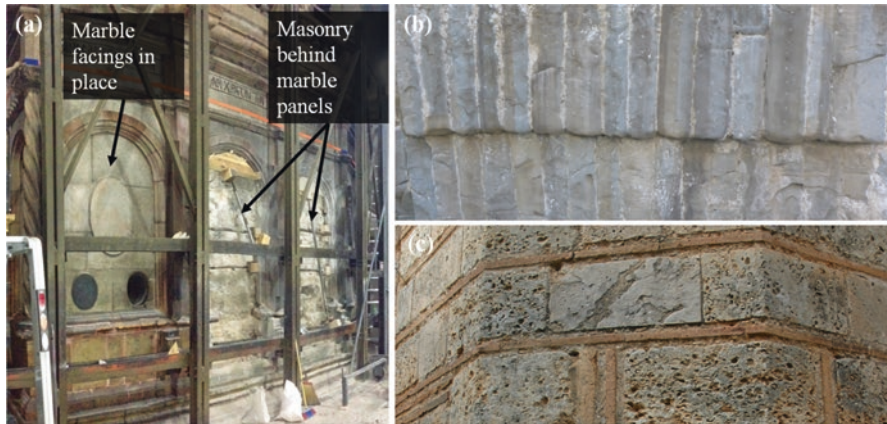
**Fig. 6.11** (a) Thick marble facings cover the historical masonry of the Holy Aedicule in Jerusalem (Israel), prohibiting CO<sub>2</sub> diffusion to the internal masonry; (b) narrow mortar joint of the Plaka Bridge in Epirus (Greece) (2–10 mm) allow the use only of fine sand in the restoration mortar; (c) thick byzantine mortar joint (1.5–2.5 cm) at the Kaisariani Monastery in Athens (Greece) allows for the use of coarser aggregates in the restoration mortar (up to 8 mm)

- In some cases, carbonation of the mortars applied in the interior layers may be inhibited due to low diffusion of  $\text{CO}_2$  from the external layers of a structure (Figure 6.11a) [91]. In this case, calcium hydroxide of the mortar must be consumed as early as possible, and the use of a pozzolanic additive is advised for this purpose, in order for the mortar to harden mostly through hydration, rather than carbonation.

- When the mortar is used as joint mortar, the width of the structure's joint must be taken into account (Figure 6.11b, c). For example, in typical Byzantine thick joint masonries, the mortar may be produced with larger aggregates [109]. In any case, the width of the joint limits the size of the used aggregate, as the diameter of the aggregate's largest grain must be less than 1/2 the width of the joint [110].

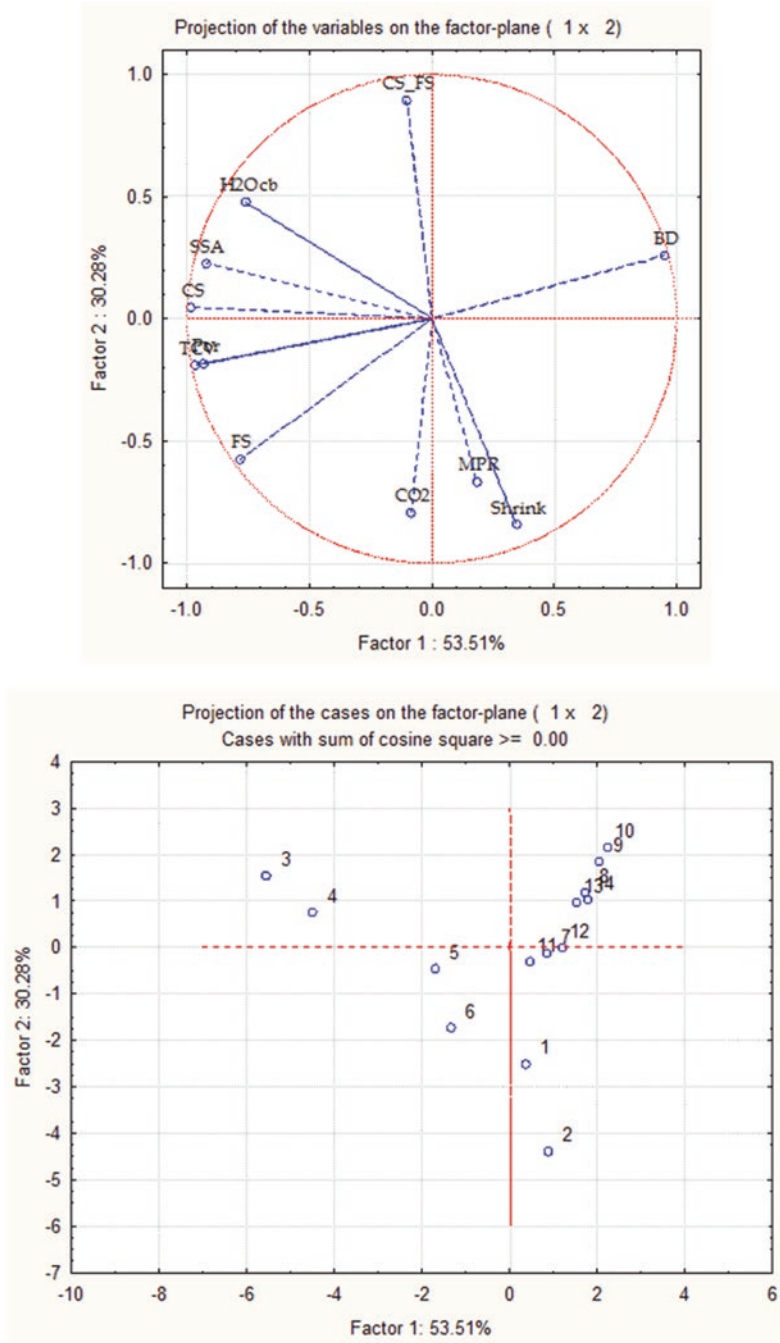
**Fig. 6.14** Projection of the variables on the plane of principal components/factors 1 and 2 (top); graphical representation of the PCA scores of the examined restoration mortars (bottom)

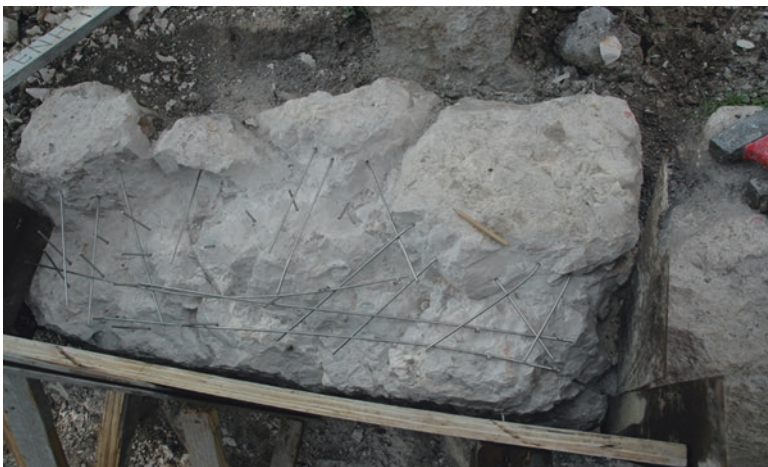
**Fig. 7.3** Stainless steel rods embedded in the stone body before repairing, from [26]

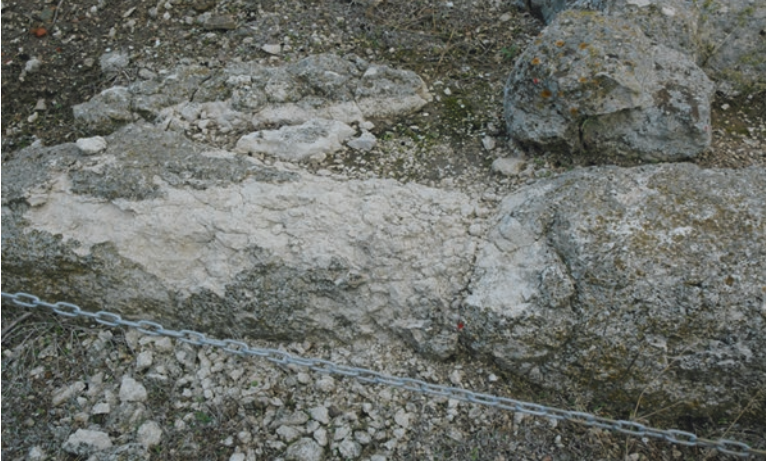
**Fig. 7.6** Compact and deteriorated stone units from Pella Agora (Greece)

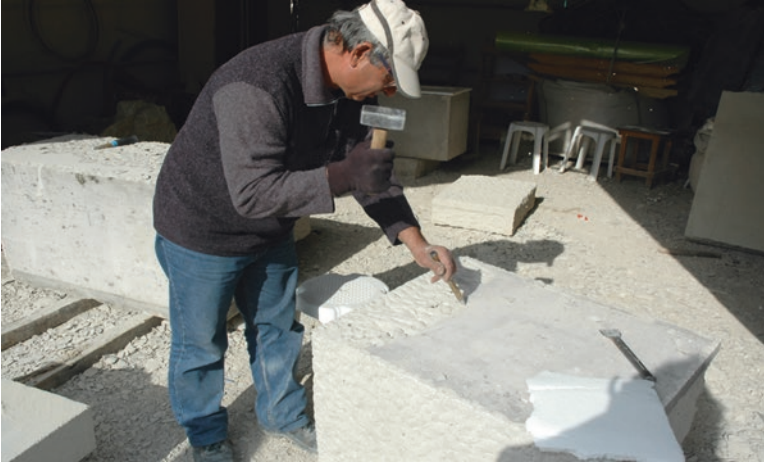
**Fig. 7.7** Grooving the artificial stone with chisel

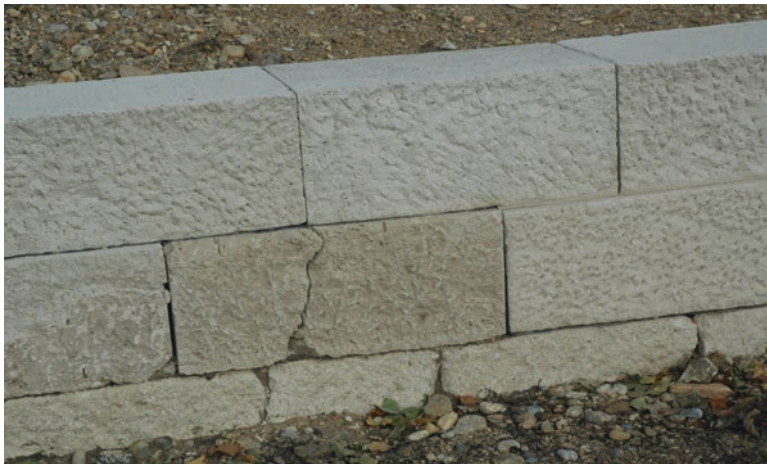
**Fig. 7.8** A large artificial stone with severe cracking after 2 years from its manufacture

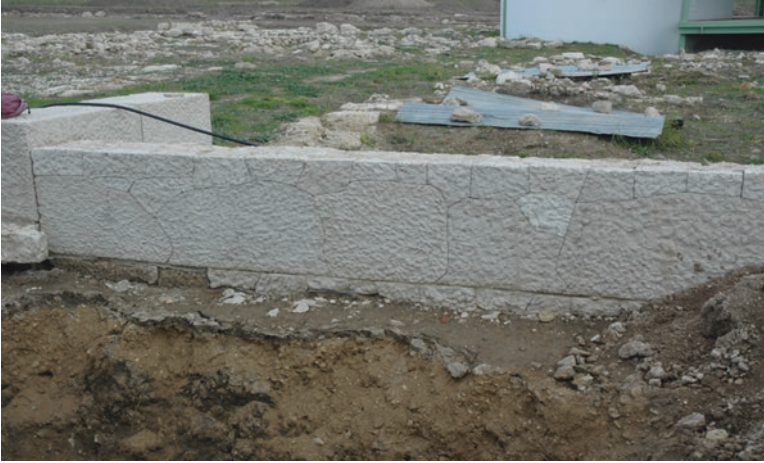
**Fig. 7.9** Thin cracks in the new artificial stone

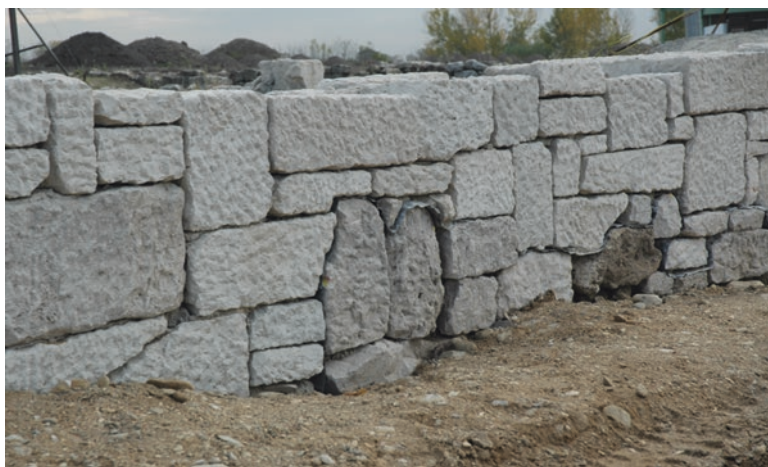
**Fig. 7.10** A reconstructed part of wall of the Agora in Pella, with greatly reduced cracking

A system of checking the quality of manufactured mortar mixtures on site was also suggested, in order to meet the target strength. The cracking tendency was significantly reduced. The reconstructed parts of the walls are shown in Fig. 7.10.

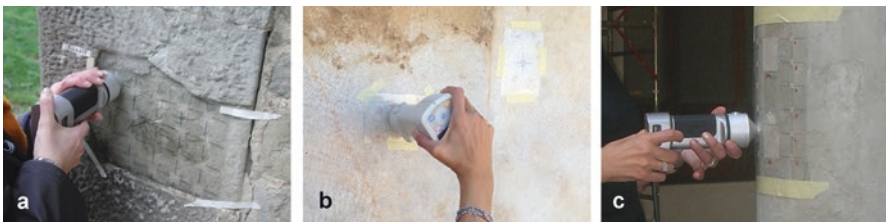
**Fig. 8.4** Colorimetric measures on different materials (sandstones **a** and **c**, and marble **b**). For each case a mask for repositioning the instrument was prepared

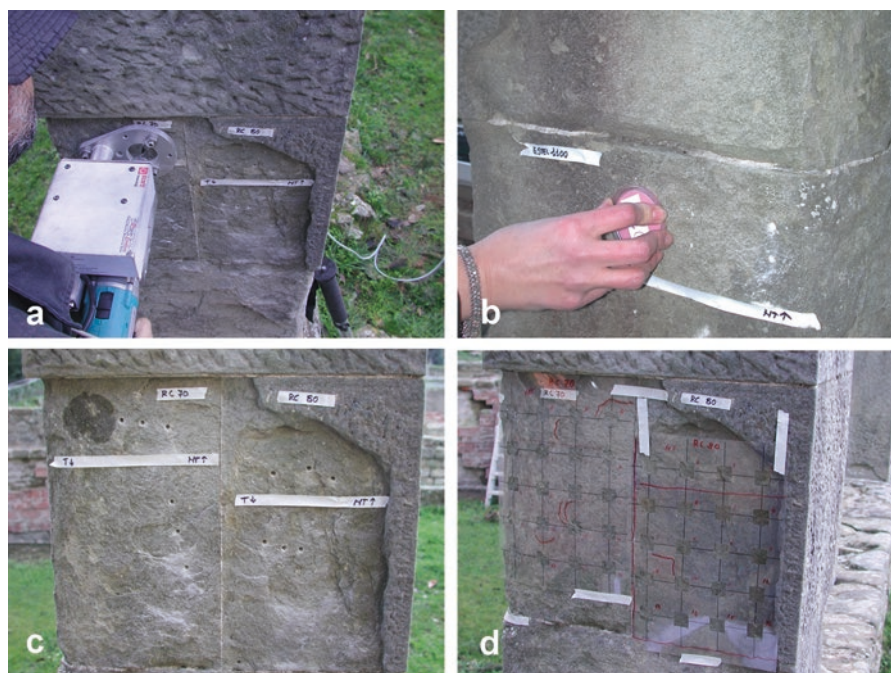
**Fig. 8.6** Archeological site of Fiesole (Florence, Italy). (a) DRMS system; (b) contact sponge test; (c) the holes drilled in the treated (below) and not treated (above) stones and the trace left by the sponge (just after sponge removal); and (d) masks for the colour measurements

diagram of drilling resistance as a function of the depth of the hole. The DRMS system was applied to assess the performance of both consolidants and protectives in the archeological area of Fiesole, near Florence, in 2004. In addition to DRMS measurements, colour measurements and water uptake, by sponge method, were performed [181]. In this case, the material was sandstone and, since the state of conservation of the stones was very different, it was decided to ideally divide each block in two and leave one part untreated so that the data before and after treatment could be better compared (Fig. 8.6).

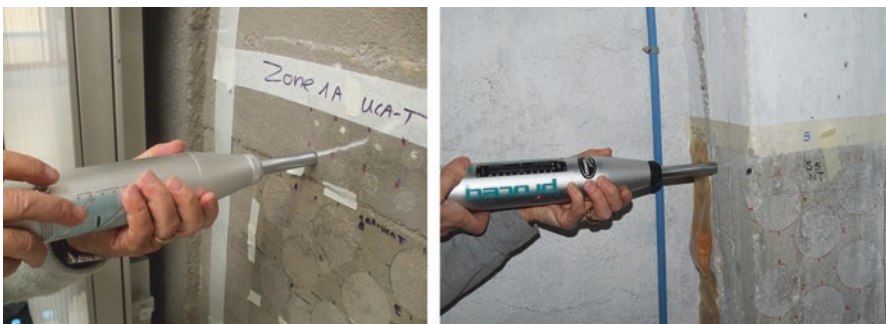
**Fig. 8.8** Durometer (Rebound hammer). (Photo by S. Rescic – ISPC-CNR)

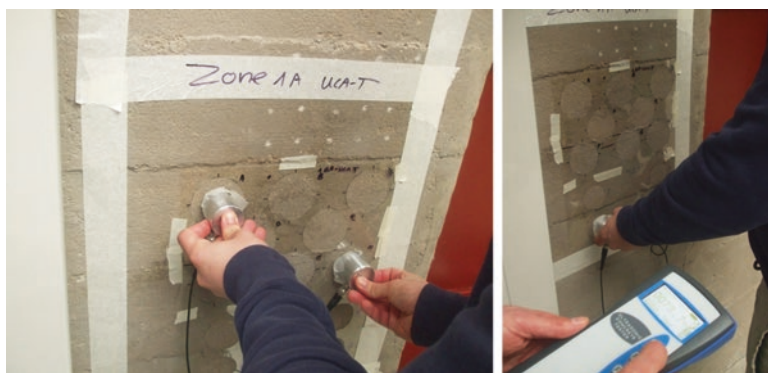
Fig. 8.9 UPV applied *in situ* with a portable device. (Photo by O. Cuzman – ISPC-CNR)

related to a decrease of porosity (and therefore, presumably to consolidation), to changes in fissuring and microcracks, and consequently, a decrease of the same after consolidation. Portable ultrasound devices are also available, which allow measurements to be made directly *in situ* (Fig. 8.9).

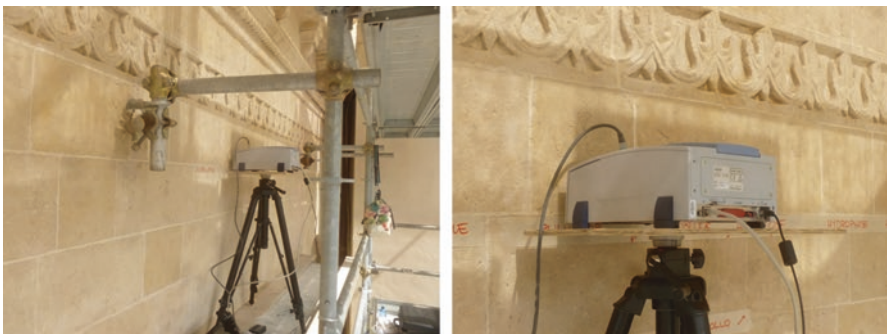
**Fig. 8.11** Matera Cathedral (Italy). Total Reflection FTIR instrument positioned on scaffolding to assess the performances of different protective products [252]

During the last years, many scholars proposed other methodologies in order to study the behavior of protective treatments during experimentation, most of which are unfortunately only feasible in laboratory. Techniques based on spectroscopy are used by many scholars to verify the effective presence of the applied products on the treated surface. As already introduced in Sect. 8.3, FTIR spectroscopy [63] is widely used to analyze treated stone specimens [235, 236, 238, 244] and samples taken from the monuments. In the last decades portable instruments have also been made available on the market for *in situ* analyses, avoiding sampling [64, 65]. FTIR analyses on treated stone surfaces becomes particularly interesting when the applied product is an organic polymer (like siloxanes, fluoroelastomers, acrylates, and so on), and it is necessary verify its presence and its durability over time (Fig. 8.11).
