Chapter 1

Preliminary Investigations, Condition Assessment, and Mapping of the Deterioration Patterns

Davide Gulotta and Lucia Toniolo

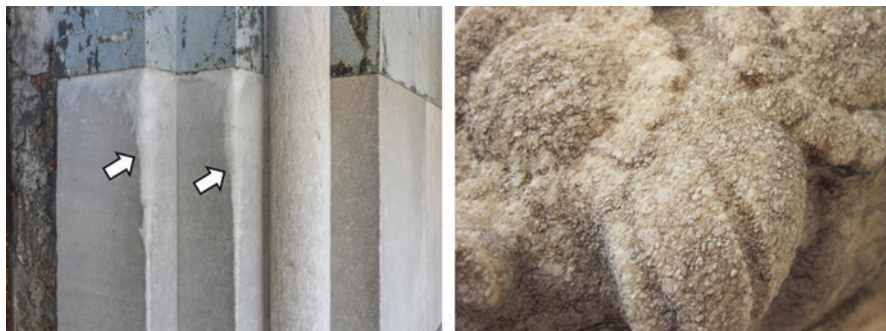
Fig. 1.4 Left, rounding along the edges of blocks of fine-grained Crevoladossola marble (dolomitic marble, Monza Cathedral, Italy) due to the erosive effect of water runoff. Right, roughening of the sculpted decorative element of Candoglia marble (medium- to coarse-grained calcitic marble, Milan Cathedral, Italy) due to the combined action of rain and thermal dilation

To highlight further the potential of the ICOMOS glossary, it is worth exploring in detail the term *erosion*, corresponding to one of the most common patterns affecting stone surfaces exposed outdoors and belonging to the *features induced by material loss* family. This pattern is defined quite broadly as the “*loss of original surface, leading to smoothed shapes.*” Such a definition clearly focuses on the ultimate effect on the stone substrate rather than on the mechanisms responsible for it. It can describe a range of macroscopically altered surface conditions as a result of natural or anthropogenic actions, as well as by the synergic effect of both of them. Depending on the nature of the substrate, geometric features, and surface finishing, this pattern can be observed either as a loss of material from border areas, edges, and sculpted details, as in the case of *rounding*, or as an increase of the surface irregularity resulting in *roughening*. The presence of these two sub-types allows for a detailed identification that takes into account some peculiar substrate characteristics. *Rounding* is typically associated with stone suffering from granular disintegration, whereas *roughening* is due to the removal of superficial grains or clusters of particles, and it is therefore emphasized in medium- to coarse-grained substrates. Examples of both subtypes are reported in Fig. 1.4.

The third sub-type within the *erosion* term is *differential erosion*. It describes deterioration patterns observed as a non-homogenous loss of material from the surface due to marked compositional or microstructural variability of the substrate. Therefore, *differential erosion* is typically encountered on sedimentary stones characterized by a layered or composite-like structure (e.g., conglomerates), and mineralogically heterogeneous volcanic stones. The additional sub-division into the

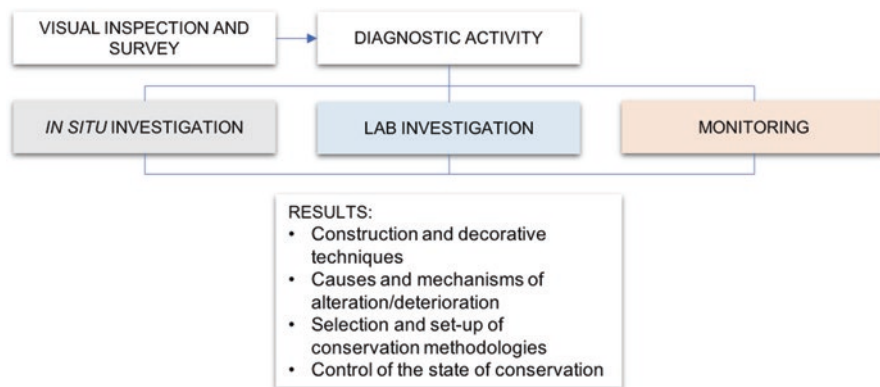
Fig. 1.5 Diagnostic approach for built heritage: three different levels of investigation can be exploited to study stone surfaces

As reported in Fig. 1.5, the diagnostic approach [1] can be composed of three different levels of investigation: *in situ*, when the equipment can be used directly on the built surfaces in a non-invasive or micro-invasive way; in the laboratory, with equipment that requires samples from the stone surfaces; and “monitoring”, using non-invasive or micro-invasive equipment, generally *in situ*, for repeated sets of measurements at established time intervals.

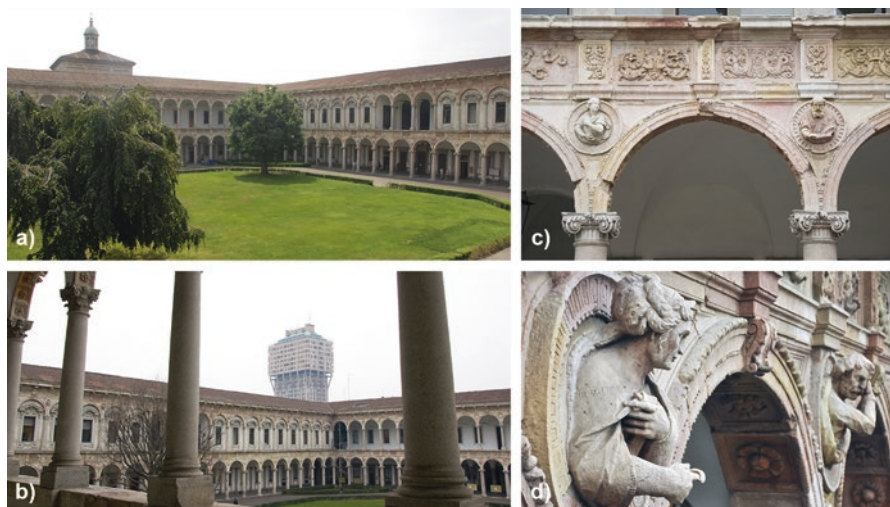
Fig. 1.6 General views of the courtyard showing the NW and NE-facing façades (a), and the NE and SE-facing ones (b) from the upper loggias; (c) the sculpted apparatus made of Angera stone decorating the lower level; (d) detail of the high-relief sculpted figures emerging from the spandrels

the sober volumes of the granitic columns. Floreal tiles cover the intrados of the arches, highly detailed bas-reliefs decorate the continuous parapet between the two levels, and high-reliefs with human figures emerge from the spandrels (Fig. 1.6c–d). Except for the columns and capitals, all the sculpted elements are made of *Angera stone*, a local dolostone with a typical color that varies, even within the same block or element, between white, yellow, and pink-orange hues [50]. The *Angera stone* is also a rather soft and porous lithotype, which makes it particularly suitable for sculpted and carved decoration. On the other hand, its characteristic microstructure and mineralogical composition are responsible for its generally low durability. The exposure to urban and highly polluted conditions, in particular, increases the stone reactivity, thus promoting erosive, corrosive, and sulfation processes [51].

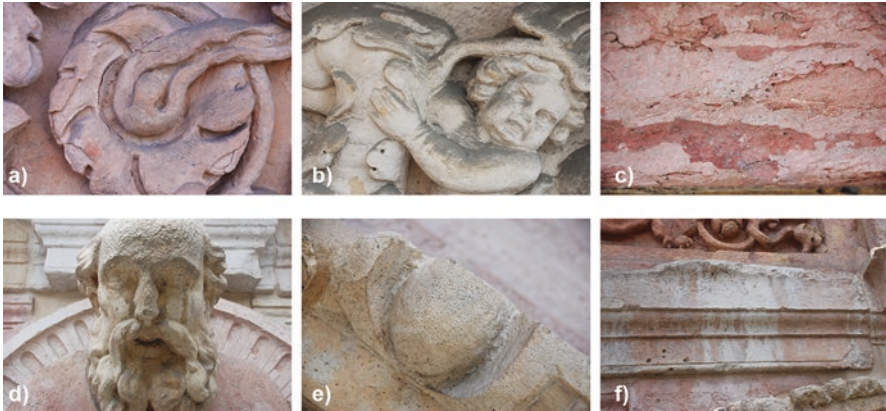
Fig. 1.7 Photographic documentation of characteristic deterioration patterns in sheltered conditions (a, crust; b, deposit; c, exfoliation) and in areas subjected to the rain runoff (d, erosion and encrustation; e, pitting; f, bleaching)

The condition survey was meant to provide the baseline data for future monitoring by non-expert personnel. Therefore, the mapping was integrated by a site-specific atlas of the deterioration forms, structured as a series of single-paged, two-sided working sheets for easy onsite consultation during the periodic surveys. For each deterioration pattern, the atlas provided the general standard definition, a description of the specific features characterizing their occurrence on the four sides of the courtyard, and explanatory notes for the identification, such as possible relationships with correlated damages.

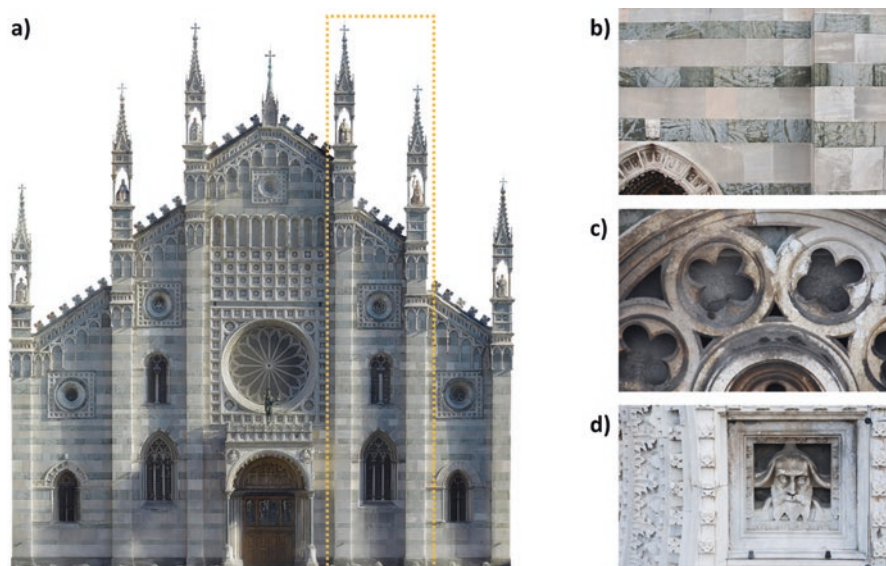
Fig. 1.9 (a) Orthophotographic documentation of the façade with the location of the pilot site area (yellow frame) and preliminary documentation of the weathering effects with aerial work platform: (b) diffused darkening of the stone cladding, (c) areas of crust formation, disintegration and loss of material, (d) detail of the intense soiling of the sculpted decorative elements framing the rose-window

The preliminary assessment was conducted using an aerial work platform, which allowed for the rapid exploration of the stone surfaces of the whole façade up to the spire level, located roughly 36 meters above ground level. The information acquired during this phase, supported by the photographic documentation, provided the baseline data for the first identification of the weathering effects, their location and relationship with the architectural surfaces, and the areas displaying particularly critical conditions (Fig. 1.9b–d).

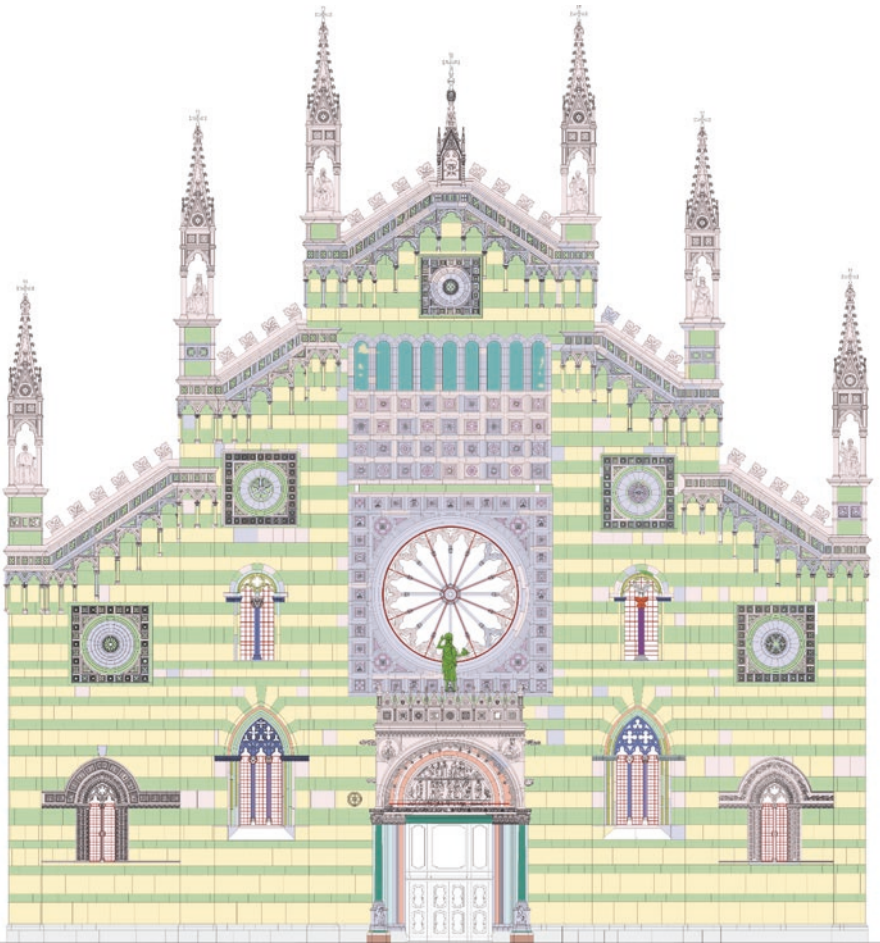
Fig. 1.10 Lithological mapping, showing the consistent usage of dolomitic marble and serpentinite for the cladding (yellow and green areas, respectively), and *Candoglia* marble for the spires and top elements (pink areas). Original scale 1:50

local calcitic, medium- to coarse-grained marble) occasionally used for replacements (Fig. 1.10). Similarly, the dark-colored rows are made of a single type of dark-green serpentinite (*Oira stone*). Additional correlations were also identified with the building evolution, such as the prevailing use of *Candoglia* marble for the spires and top decorative elements, which all belong to the latest construction phase. Such correlations proved extremely important during the scale-up of the lithological mapping from the pilot area to the whole site, providing an additional set of information to support, and confirm the photographic- and photogrammetric-based identification of the materials used at the scale of the façade.

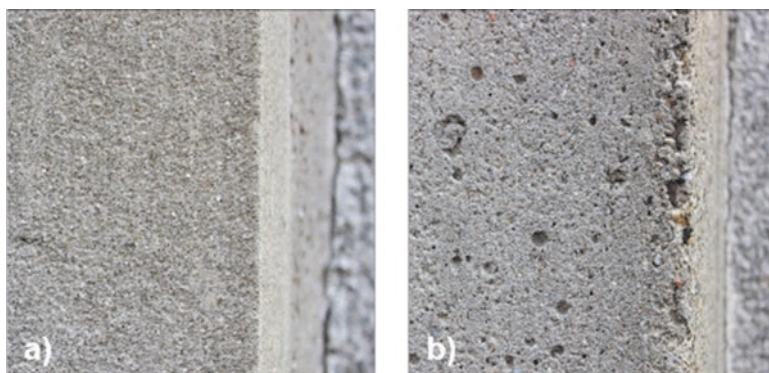
Fig. 1.13 New concrete repairs along the vertical pillars of the structure visible on the façade: comparison between the original compact concrete (a) and the new integration concrete (b)

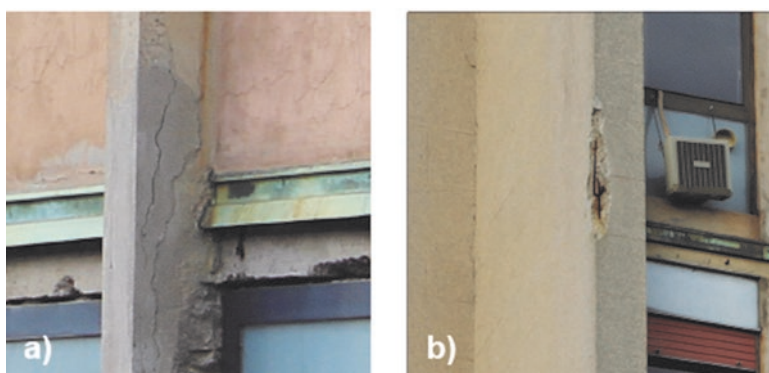
Fig. 1.14 Concrete integration patches along the vertical pillars with new formation cracks (a); areas along the pillars with exposed corroded steel rebar (b)

These elements show a typical general erosion of the surface due to the rainfall, and diffused detachment and loss of material that can be defined “bursting” due to corrosion and expansion of the steel rebars inside the concrete [26]. In some areas, these lacunas have been integrated with cement mortar patching that looks different (Fig. 1.12, grey areas in the light yellow vertical pillars), and are quite diffused along the pillars, both in the east elevation and in the lower part of the west façade. These patch repairs (Fig. 1.13 shows a comparison of the original and integration concrete where the difference in the homogeneity of the two materials is clearly visible) demonstrate their failure with diffused new cracks, detachment and bursting (Fig. 1.14a); in many areas, the corroded rebar is exposed because of the spalling of the concrete covering due to the expansion of corrosion products (Fig. 1.14b).

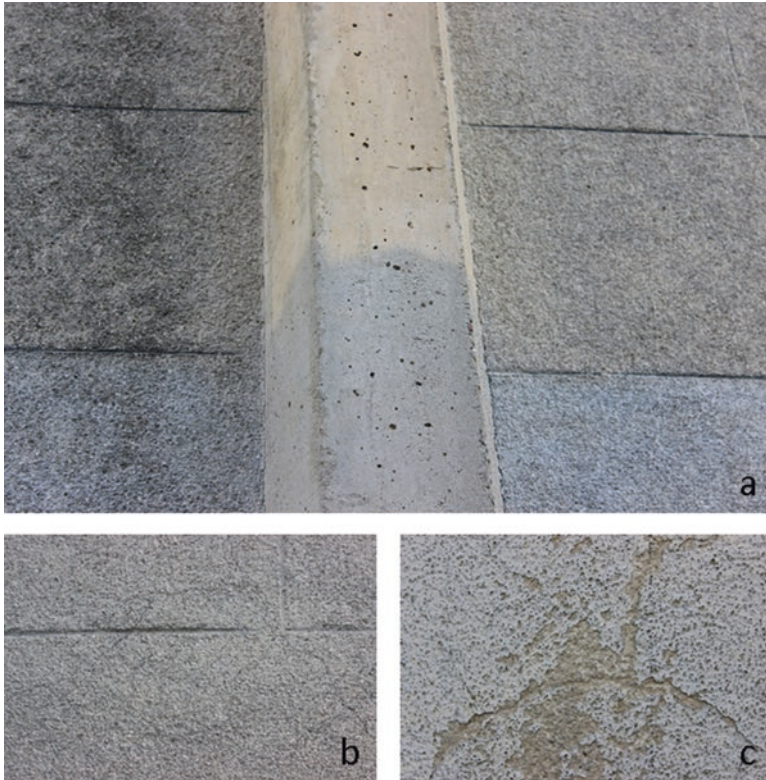
Fig. 1.15 “Graniglia martellinata”: (a) grey hammered cement grit plaster applied around the concrete pillar; (b) evident white marble clasts, intentional incision and a network of hair-cracks; (c) light grey painting layer over the plaster

of artificial stone, a mortar mix using cement as the binder agent and mixed marble fragments as aggregate; the surface was hammered after hardening and smoothing, and underlined with incisions that simulate stone slabs. This surface is in a very good state of conservation and affected by minor alterations: deposit and soiling, mild surface erosion, formation of few micro-cracks, and both erosion and exfoliation of the paint layer applied, most likely, in recent times (Fig. 1.15). The application of this good quality plastering (resembling a stone cladding) proved to be very durable.
