Chapter 9

R&D Field Applications

Margarete Kalin-Seidenfaden

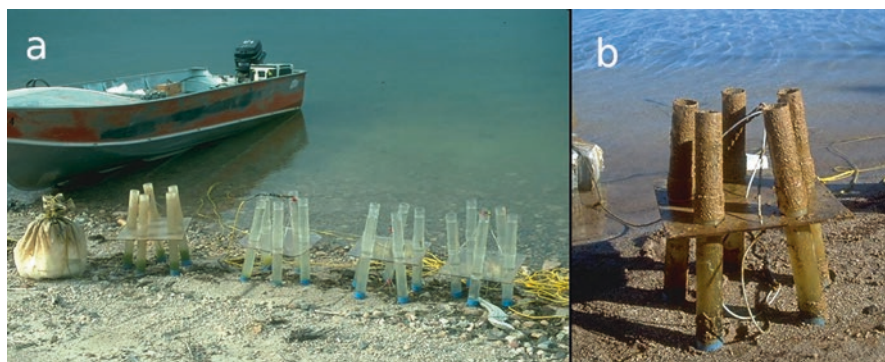
Fig. 9.1 Sediment traps used to collect and analyze particulates. (a) The traps on the left were installed at depths between 3 and 45 m. The traps closest to the boat had a fine layer of clay which was not visible on any of the following traps. (b) Photograph of the 3 m depth traps one year after flooding, showing the high quantity of suspended solids (Boojum Research, 1994; Cao & Kalin, 1999; Kalin et al., 2001). (Photographs by Boojum Research)

A mined-out uranium pit in northern Saskatchewan was force-flooded from an adjacent fishing lake. Once filled, the lake would hold 5 million m³, with the only influxes coming from precipitation. With environmental approval, the barrier between the pit lake and an adjacent fishing lake would be removed. The arsenic and nickel concentrations of 0.22 mg.L⁻¹ and 0.26 mg.L⁻¹, respectively, were low, but exceeded regulatory limits. Before the lake and the pit water could be combined, the arsenic and nickel concentrations had to be lowered. Reductions in these low concentrations were not only difficult to achieve with chemical treatment, but also expensive. If biological polishing could be used to reduce the concentration further, chemical treatment costs could be avoided. The company decided to fund a detailed investigation using biological polishing to remove the nickel and arsenic (Fig. 9.1).

Four sets of sedimentation traps were placed at various depths to collect suspended solids. The traps suspended at 3 m (close to the extinction of light) collected particulates and algae, which were subjected to SIMS microscopy (Secondary-Ion Mass Spectroscopy). This method examines the surface of materials to a depth of 1 to 2 nanometers. From the data generated by SIMS, a schematic was constructed (Fig. 9.2).

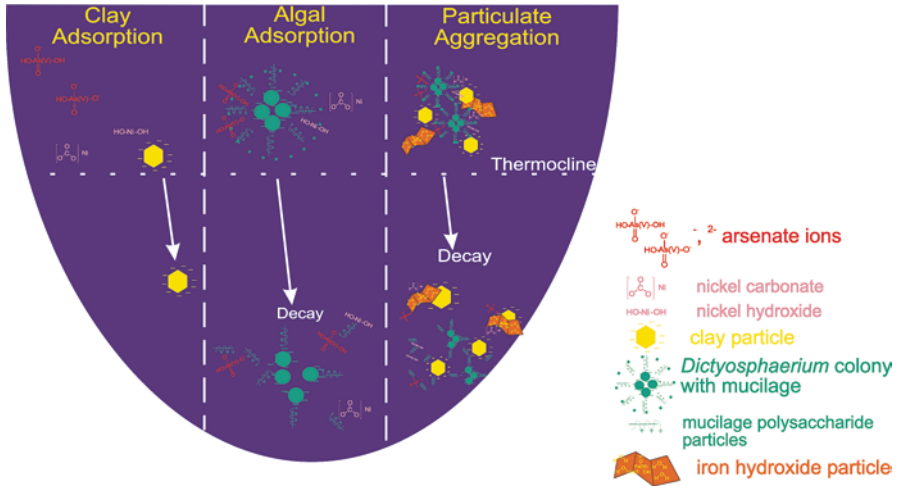
Fig. 9.2 Schematic of particle aggregation based on SIMS microscopy, depicting algae as flocculating agents. The green circles and spirals are algal cells and EPS molecules, reddish brown shapes symbolize iron hydroxide, yellowish shapes are clay particles, pink shapes are nickel hydroxide, and violet crosses represent arsenic.

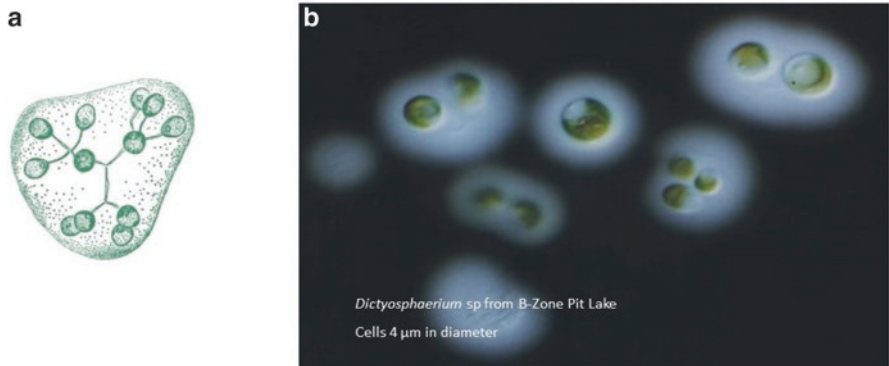
Fig. 9.3 (a) Drawing of a colony of *Dictyosphaerium*, showing the ‘connected’ nature of the algal cells. (b) Photograph of the sheath, likely an EPS compound (Boojum Research, 1994, 1997). (Photograph by Boojum Research)

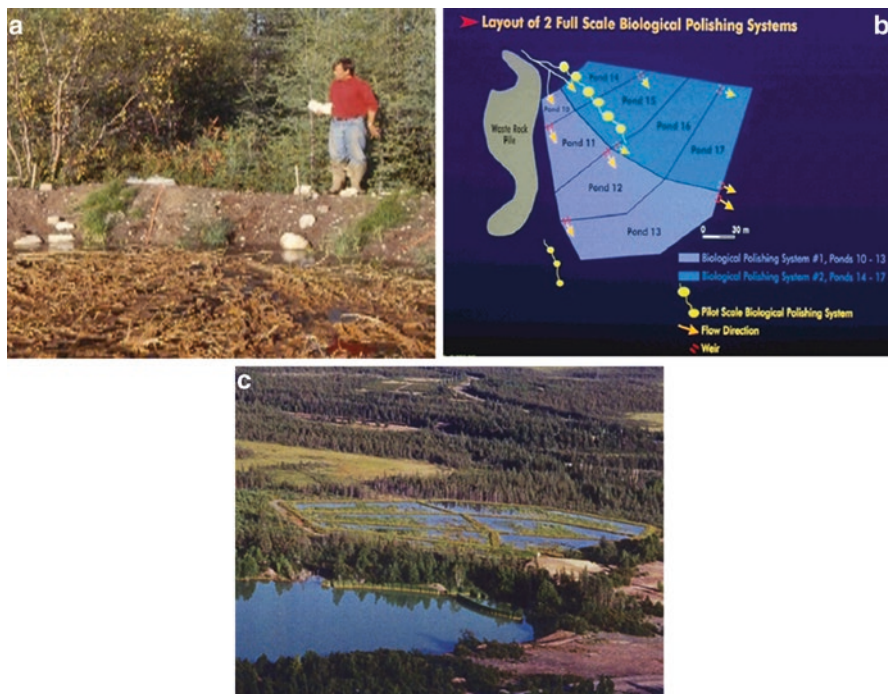
Fig. 9.4 (a) Martin Smith, a Boojum researcher, working on one of the pilot ponds. Note brush in the pond, used as a substrate for periphyton growth. (b) A schematic showing the pilot-scale ponds in yellow, and the scale-up in blue. The series of 6 yellow circles extending through pools 14 and 15 were the pilot ponds which served as design criteria for the scale up. First to be scaled up were pools 10–13 (in lighter blue), followed later by pools 14–17 (darker blue). Yellow arrows denote direction of flow. The three yellow circles in the lower left were ARUM test cells treating the drainage from the waste rock pile. Organics were added to a completely rust-covered sphagnum bog. (c) Aerial photograph of the OEP and polishing ponds in the meadow below the OEP. All photographs by Boojum Research.

One of the goals of the project was to lower the concentrations of zinc that flowed into the Buchans River from the OEP. Since there was a large meadow downstream from the OEP, Boojum decided to use biological polishing to treat the effluent. A series of 6 small ponds were constructed and filled with cut brush as substrate for periphyton growth (Fig. 9.4).

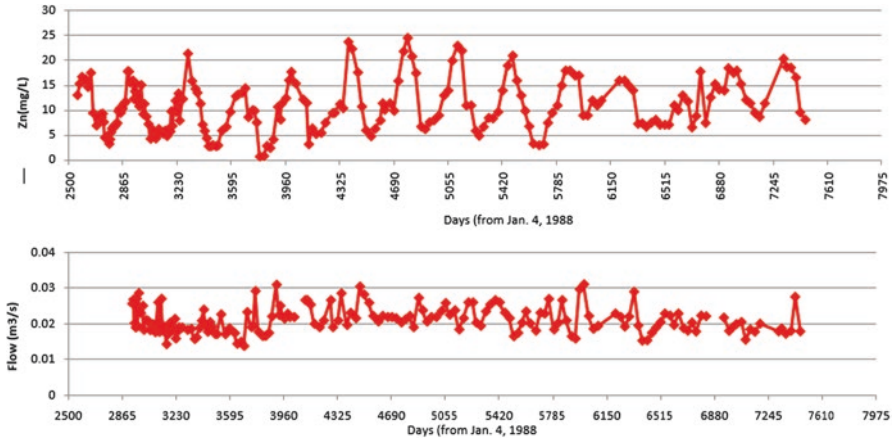
Fig. 9.5 Flow and zinc removal from biological polishing ponds at Buchans, Newfoundland over a period of 13 years. (Data provided by the Newfoundland Ministry of Environment)

These pilot, biological polishing ponds were shallow, and froze during the winter. Later, these 6 pilot ponds were expanded to cover the entire meadow. The scaled-up ponds worked only in the summer dropping the zinc concentration to 5 mg.L⁻¹ or below. Winter removal rates were essentially absent. Winter results were attributed to ice which covered the OEP, preventing oxidation and particle formation. Since the iron could not oxidize, iron and zinc did not precipitate, hence no zinc removal. Periphyton on the cut brush collected the iron/zinc particles in the summer reducing zinc and iron concentrations (Fig. 9.5).

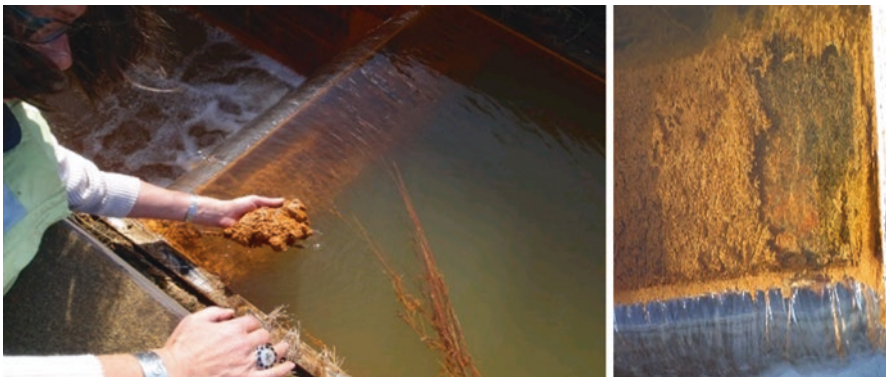
Fig. 9.6 Two photographs of periphyton heavily-caked with oxidized iron at each weir within the pond system and at its edges. (Photograph taken in 2009 by Boojum Research)

The two scaled-up ponds closest to the OEP, ponds 10 and 14, would have to be cleaned out periodically, as they would fill up with precipitate quite rapidly (see Fig. 9.6). But, before the ponds could fill with precipitate, the project came to an abrupt halt, when the mine manager passed away suddenly in 1995. Shortly after, the responsibility for the site changed hands and a consultancy took over management. Boojum obtained system monitoring data from the Newfoundland government in 2007, when Boojum representatives visited the site. Upon reviewing the site, they were stunned, as the alder cuttings, serving as substrates for the periphyton had been removed. The locals, who had worked with Boojum in the past reported that the consultancy had requested that all brush be cleaned out of the pools. Shortly thereafter, a truckload of sugar arrived with instructions to the local caretaker to deposit it into the OEP. Sugar dissolves and leaves with the water! It was clear from the government monitoring data, that the ponds had ceased working sometime after

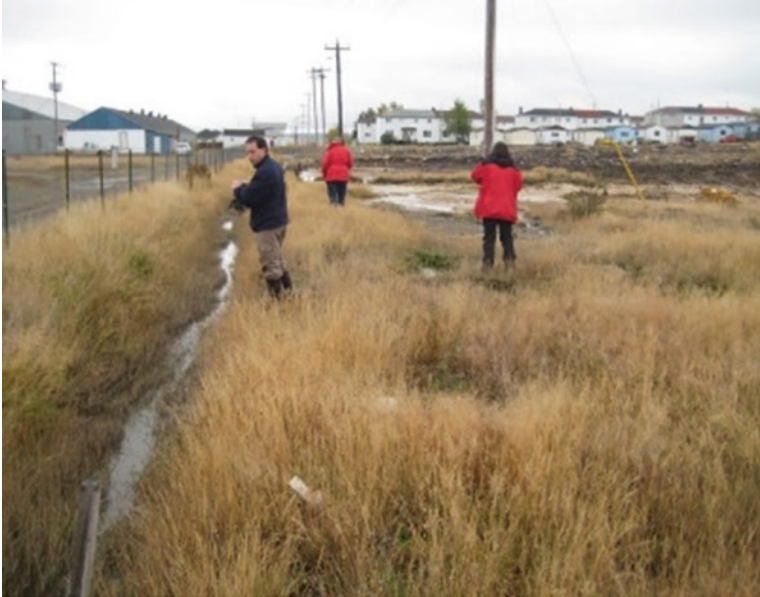
Fig. 9.8 Boojum Research personnel monitoring the grass cover on the tailings concentrate spill in 2009. Photograph by Boojum Research

described in Chap. 8 with tailings. Supernatants were produced and the samples were kept under oxidizing conditions. The experiment was terminated after 1200 days (Kalin, 2004). The most important observations were that, regardless of the mixing ratios, the pH and acidity in the supernatants remained constant or improved compared to controls (Fig. 9.7a). An application of CPMW would produce lower acidity and zinc concentrations being discharged into the river. Shortly before his death, the manager had the local CPMW spread onto the muskeg area with the concentrate spill (Fig. 9.8). The project is described in detail in Kalin (2009).

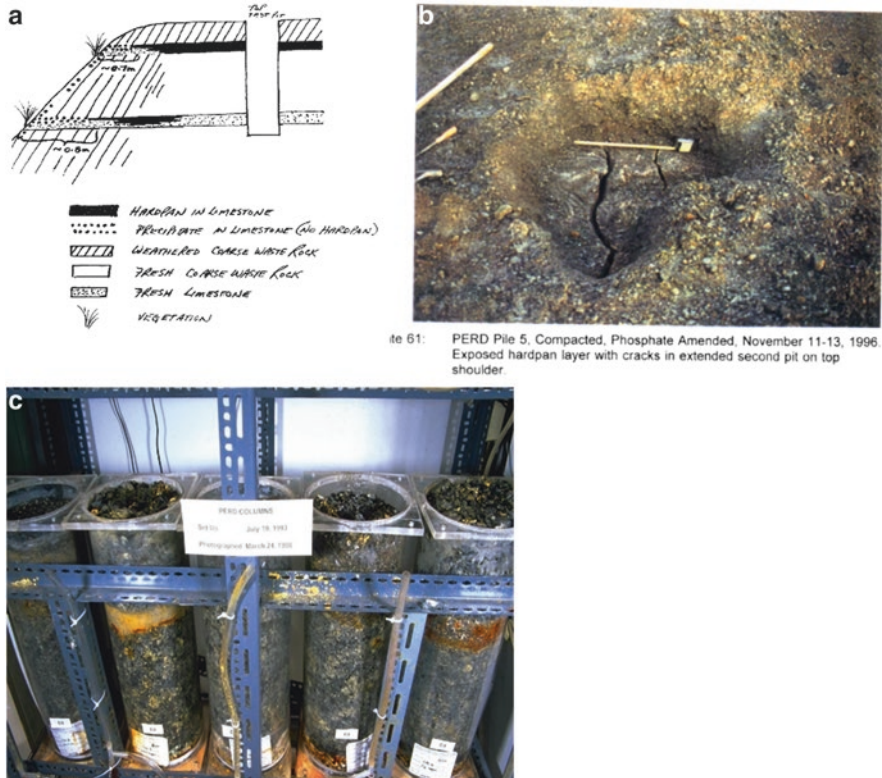
ite 61: PERD Pile 5. Compacted, Phosphate Amended, November 11-13, 1996. Exposed hardpan layer with cracks in extended second pit on top shoulder.

Fig. 9.9 Experiments using CPMW on coal piles in Nova Scotia. (a) Schematic for the application of both CPMW and of differently-compacted limestone, testing construction of coarse coal waste piles. (b) An autopsy of all piles showed the pile containing CPMW produced a hardpan, which reduced infiltration, preventing acidic effluents. Note hardpan layer at bottom of excavated pit with cracks which were described as self-healing, i.e., closed at bottom of crack. (c) Laboratory columns with hardpan formation seen in rust-colored layers set up in the Boojum laboratory. Column photograph by Boojum Research, coal pile photograph and schematic by Fred Baechler

limestone to reduce acid mine drainage. A fifth pile was added, to which CPMW was supplemented in the same configuration as the other 4 piles (Fig. 9.9a). All five piles were heavily instrumented with lysimeters to collect drainage. The work was carried out by an engineering consultancy.

Four piles produced drainage, but the fifth pile, with CPMW, produced no or very little drainage. Instead, the layer of CPMW produced large erosion channels along the sides of the pile. The same consultancy that had set up the test piles was hired by Boojum to perform an autopsy of all test piles (Fig. 9.9b). An extensive hard pan had formed within the CPMW pile, but was not found in any of the piles where limestone was added. The hardpan was extensively documented, and may have been self-sealing (Fig. 9.9b; Baechler, 1997).

Concurrently, Boojum set up laboratory columns which were monitored periodically by adding water and collecting effluent (Fig. 9.9c). The two columns with the yellow or brown stripes produced less and less drainage, eventually plugging. Boojum monitored the collected drainage from the columns for several years, but failed to obtain funding to analyze the drainage and complete the data interpretation. Both the field piles and laboratory columns demonstrated that CPMW could form hardpans, preventing the penetration of precipitation.

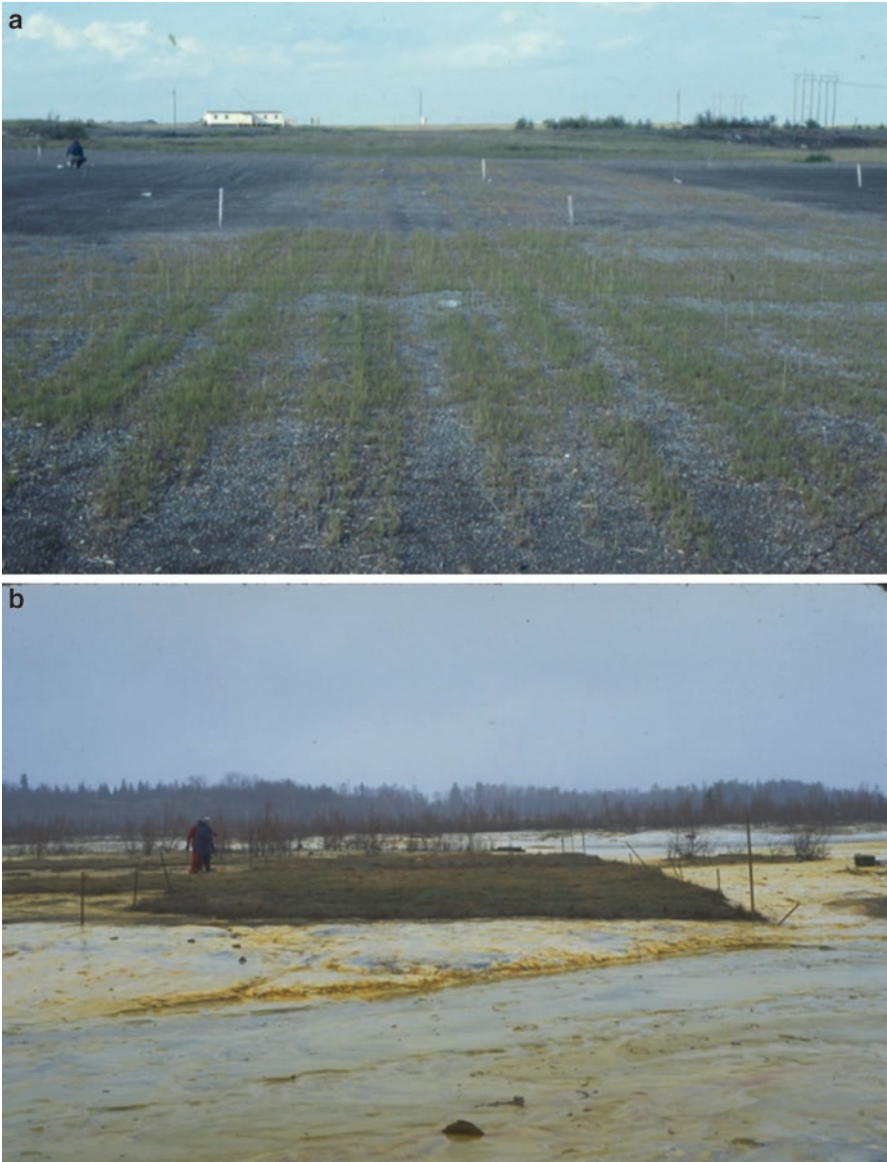
Fig. 9.10 (a) Fresh pyrrhotite tailings in N. Ontario. CPMW was plowed into the tailings in the same fashion as lime would be integrated in tailings for revegetation. Straw was crimped into the surface and the tailings were seeded to control erosion. (b) The plots on abandoned uranium tailings. The control plots are shown in the foreground, while the plots with the highest CPMW and organic applications are in the dark area with a Boojum employee. All plots were seeded with manure and grass seed. (Photographs by Boojum Research)

At a mine site in Sudbury, Ontario. Boojum set up experiments with CPMW plowed into the fresh tailings (Fig. 9.10a). At this site, straw and grass seed were crimped into the tailings. At the aged tailings site (a uranium mine in Elliot Lake, Ontario; Fig. 9.10b), instead of straw, horse manure was crimped with the grass seed. CPMW was tilled into the tailings with a handheld plow. These measures

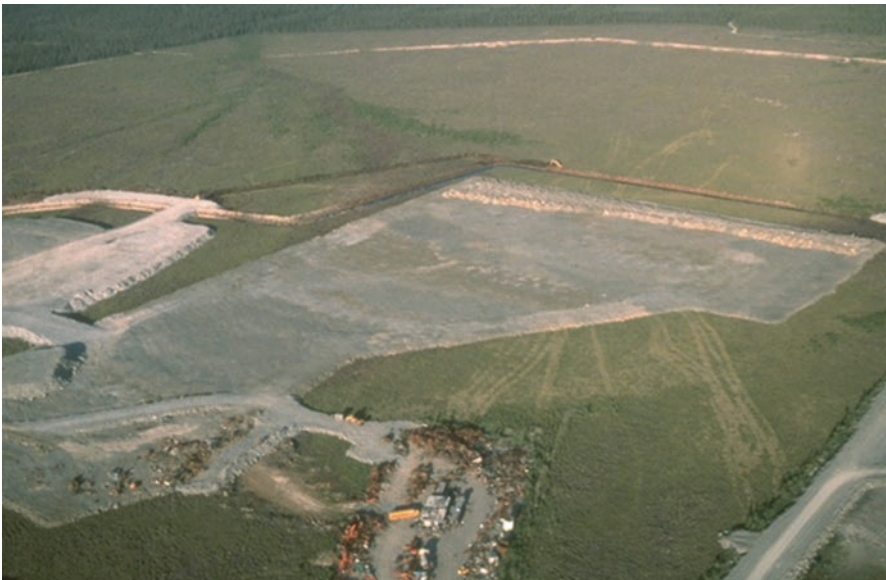
Fig. 9.11 Aerial photograph of an operating zinc mine in Quebec. Iron oxidation is visible as brown stain. The light brown line at the horizon is a ditch that had been dug to intercept the drainage leaving the property of the mine waste management area. (Photograph by Boojum Research)

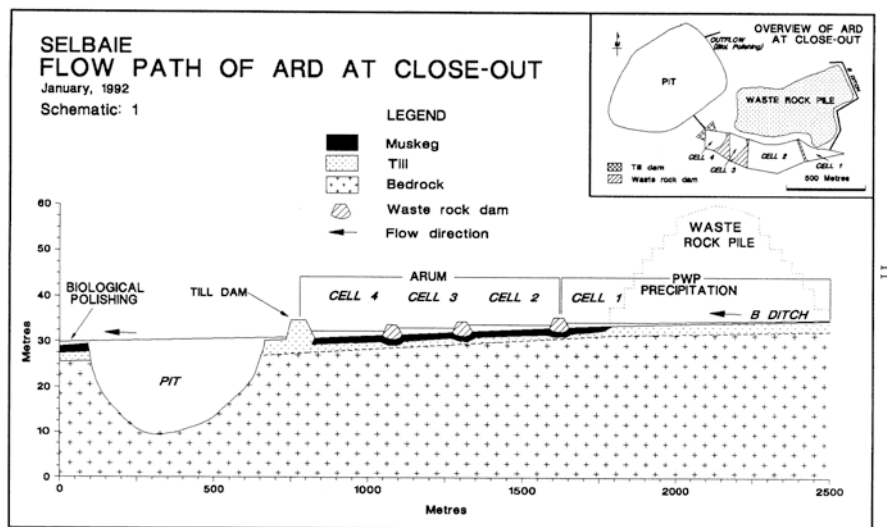
Fig. 9.12 Schematic showing the flow path of ARD and the proposed ARUM cells to treat it

The decommissioning scenario Boojum suggested included adding a layer of granular CPMW to each waste rock lift. Ditches would be filled with haybales, initially to reduce the iron loading to the treatment plant. In time, these ditch treatment cells would be covered with floating, living islands, like those described in Chap. 6. In this proposal, Boojum would build ARUM cells to treat ARD in the perimeter ditch. Effluents would first encounter a cell containing CPMW to precipitate oxidized iron. The effluents would then enter several ARUM cells to remove acidity and metals. Finally, the ‘cleaned’ effluents would be directed to the finished pit. A schematic of the proposed system is shown in Fig. 9.12.

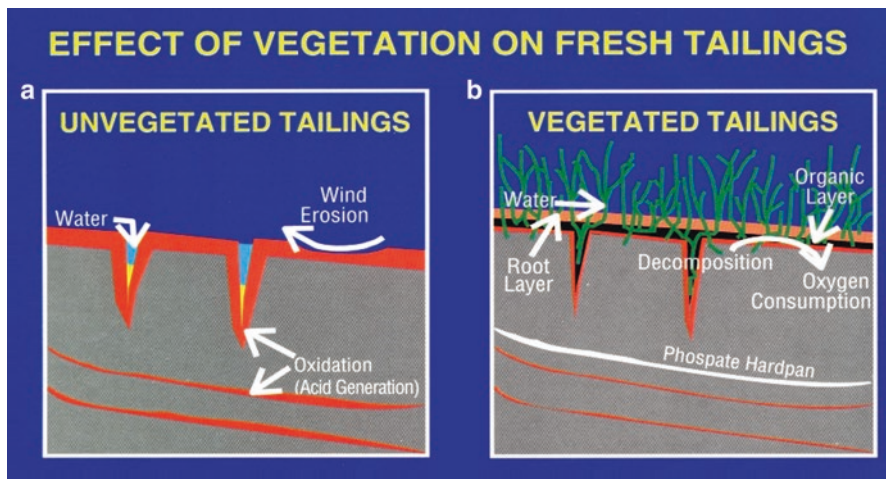
Fig. 9.14 (a) Schematic showing the concept of unvegetated (barren) tailings as they dry. Water and air enter drying cracks oxidizing pyrite in the tailings on the left. (b) Concept of tailings in which a layer of CPMW is added to fresh tailings, but buried to react in the vadose zone, as exemplified in section 9.6. The CPMW (phosphate hardpan) would initiate iron precipitation and, in part, neutralize the acid. Most important, though, would be the presence of heterotrophic microbes which would consume oxygen in the vadose zone

Here, the transport of water through the tailings can be reduced with the formation of a hardpan within 0.5 m depth of the tailings surface (Fig. 9.14). The tailings above the hardpan are tilled with organics and grass seeds, as shown in the schematic shown in Fig. 9.14. Heterotrophic microbes living in the organics would remove oxygen from the upper strata of tailings. The combination of low oxygen and hardpan would restrict water and air access to the tailings, reducing the production of AMD.

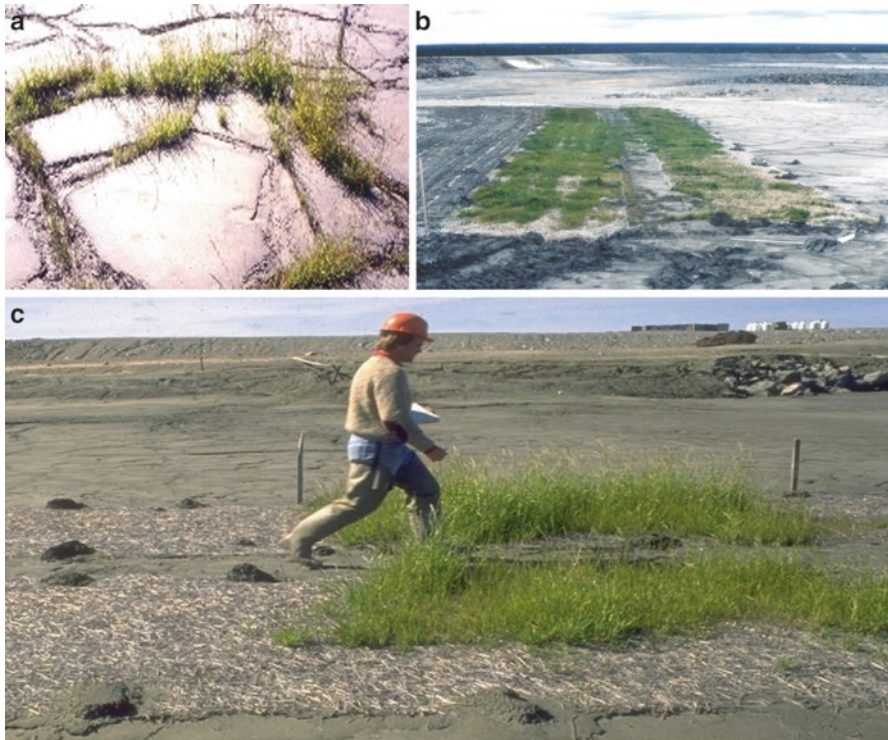
Fig. 9.15 Field experiments to grow grass and vegetation on fresh tailings. (a) Vegetation seeds were added to the fresh tailings spigot line. Results were not satisfactory, as vegetation only grew in the cracks. (b) The more satisfying efforts with straw mats and CPMW. (c) Boojum researcher, Martin Smith, monitoring the grass plots. (Photographs by Boojum Research)

The first experiment on fresh tailings involved adding vegetation seeds to the spigot line. Then, as the tailings were laid down, the seeds would sprout and cover the tailings with vegetation. However, this result did not occur. Tests carried out with this option failed, as growth only occurred in cracks of the drying tailings (Fig. 9.15a).

which existed along the tailings slope (wet, moist, and dry). Verdyol™ strips (4.0×3.75 m) were used to blanket the tailings. They were further divided into areas with different arrays of seeds and CPMW. Water penetrating the tailings should result in development of a low permeability stratum (iron precipitate hardpan) beneath the vegetation layer. This will provide suitable conditions for heterotrophic (oxygen-consuming) bacteria in the root zone of the grass layer, conventionally established (Kalin et al. 1993; Fig. 9.15b). Tailings, shortly after discharge, are not yet totally solid, requiring researchers like Martin Smith to constantly move (Fig. 9.15c).

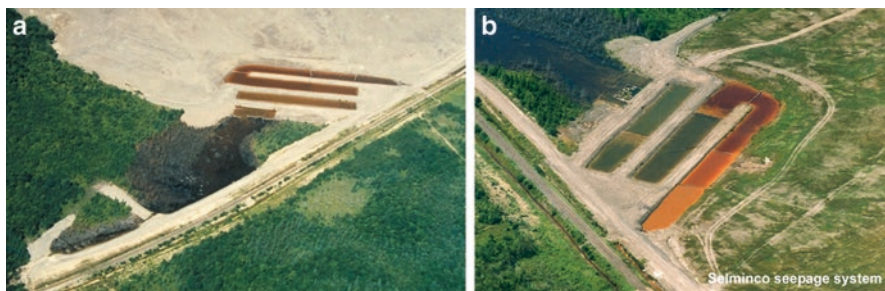
Fig. 9.16 A CPMW, ARUM, and biological polishing treatment system established on a coal tailings dump in Nova Scotia. (a) System shortly after installation. Iron oxidation was occurring throughout the ditch system. (b) System after installation of curtains and CPMW dikes were constructed with the coarse gravel to foster iron oxidation in the first cells only. ARUM cells are shown as clear of iron. (Photographs taken by Fred Baechler)

A coal, tailings dump in Nova Scotia produced acidic effluent, which was impacting the local vegetation (Fig. 9.16). Boojum was tasked with decommissioning the effluent stream. The concept consisted of ditches which were to pretreat the unoxidized iron in the effluent with CPMW. The oxidized iron and other contaminants would then be treated downstream to remove acidity and metals using ARUM (Kalin 1993). Finally, as a last step, biological polishing would remove remaining contaminants. Fig. 9.16a shows the system in the first year after installation. At this point, iron was being oxidized throughout the ditch system, and fouling hay bales installed for ARUM. Installation of curtains in the first ditch (Fig. 9.16b), enhanced the oxidation process, allowing only oxidized iron and contaminants to enter ditches downstream. A test area with ARUM (and floating cattails) was planned once the system was working. The effectiveness was evident in the successively clearer water entering the proposed ARUM area (Fig. 9.16b).

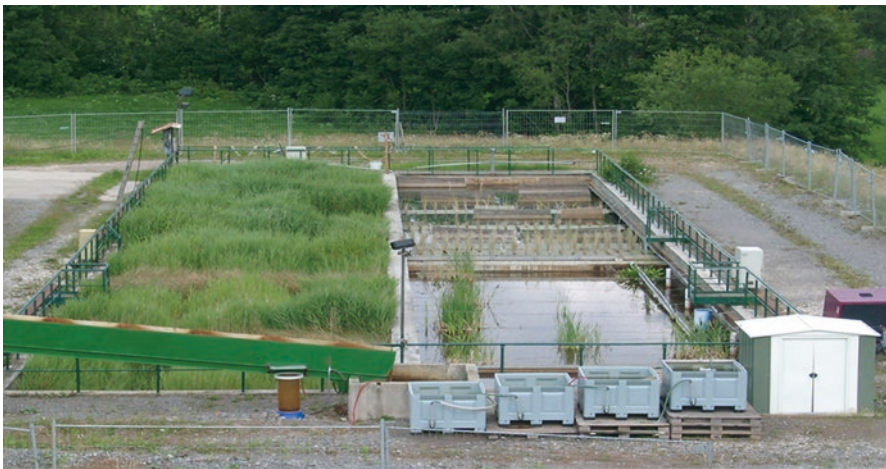
Fig. 9.17 Wisnut-designed mine water treatment system with rooted plants receiving water from the right side for treatment. On the right side, in the open water, Boojum recommended installing curtains for biofilm formation and floating cattail islands to address fine iron particles. In the foreground some cattail islands grew well, but others were plagued leaf lice. The light blue buckets were installed to provide a flow-through system for *Chara*. Growth data were used to derive design criteria for scale-up

side housed a regular wetland with plants rooted in sediment. Iron oxidation was accomplished using cascade ‘waterfall’ on the left side of Fig. 9.17 shown as a green bar. The open water side of the pool was used to collect the iron precipitate. The results were not very satisfactory, and Boojum was asked to implement some of its ecologically engineered tools.

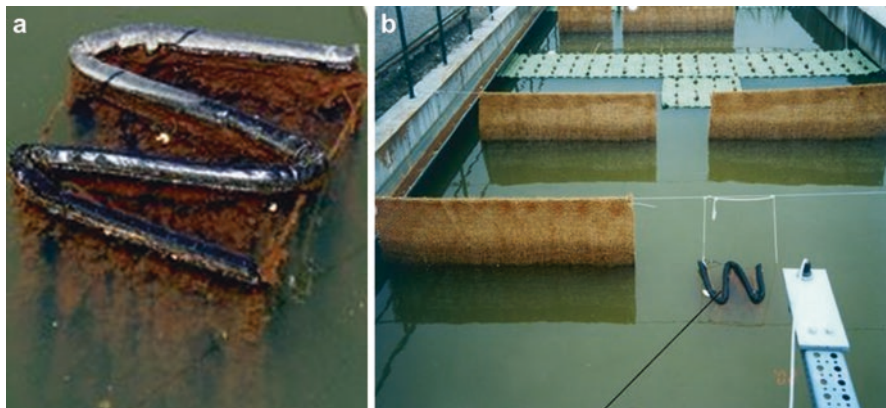
Fig. 9.18 Curtains added to Wismut treatment system to support periphyton and microbial biofilms. (a) Closeup of one of the curtains, showing periphyton with precipitated iron. (b) Placement of the curtains in the Wismut treatment system, surrounding floating islands with cattail seedlings

With iron precipitation in the cascade, arsenic and ^{226}Ra were partially co-precipitated and removed from the circumneutral water. At the recommendation of Boojum, mats or curtains were suspended in the open water part of the pool to grow periphyton and biofilms which were to polish the arsenic, iron and ^{226}Ra . Floating vegetation islands were tested as a means to supply dissolved organic carbon for biofilm development (Figs. 9.18 and 9.19).

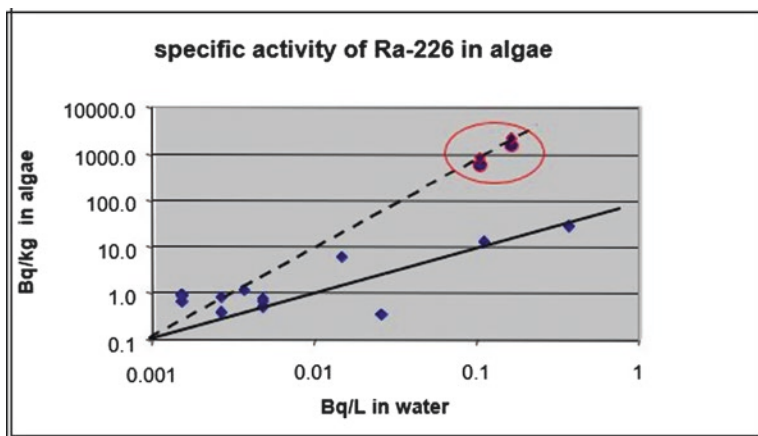
Fig. 9.19 Graph showing the specific activity of ^{226}Ra removal by *Chara* at different radium concentrations. The *Chara* removal line (dotted) is compared to removal rates by other periphyton (solid) from the treatment system. The lines suggest that *Chara* can remove low levels of ^{226}Ra , and it has a higher affinity for radium than other periphyton, even though there are only a few data points to support these conclusions. After 6 months in the containers, *Chara* thalli, starting from an initial concentration of $< 1 \text{ Bq.kg}^{-1}$, had a specific activity of 8700 Bq.kg^{-1} , suggesting that *Chara* at high ^{226}Ra effluent concentrations showed a concentration factor greater than 1000

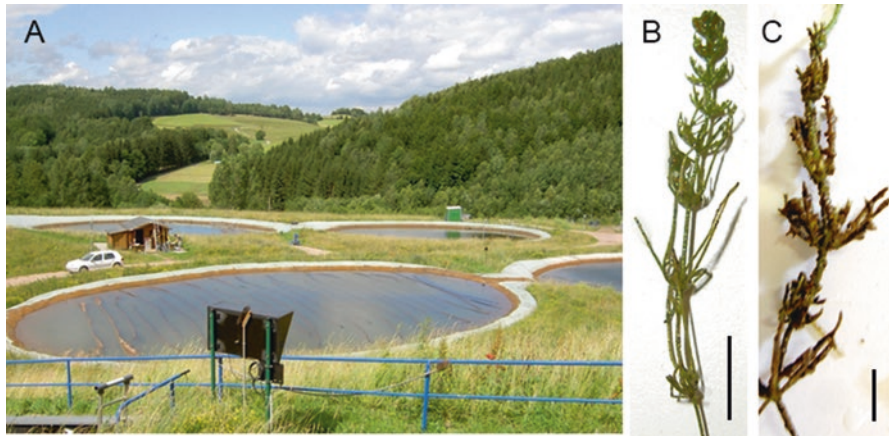
Fig. 9.20 Bioremediation ponds in Pöhla (Boojum and Wismut, GmbH), Germany (a). Scale-up of the pilot test system at Pöhla (b). Non-encrusted *C. vulgaris* from the unpolluted reference site near the bioremediation ponds. (c) Heavily encrusted *C. vulgaris* from the bioremediation pond, scale bar = 1 cm. (Photographs: H. Schubert)

The results from the pilot project looked promising so the system was scaled up (Fig. 9.20a). Shortly after the scale-up, the management of the system was turned

over to a consultancy, which discontinued Boojum’s participation. After Boojum left the project, Prof. Schubert from the University of Rostock, an expert in *Chara* growth, was asked to determine the health of the *Chara* growing in the ponds. He compared the photosynthesis of *C. vulgaris* from an unpolluted reference site (Fig. 9.20b) and from the bioremediation pond (Fig. 9.20c).

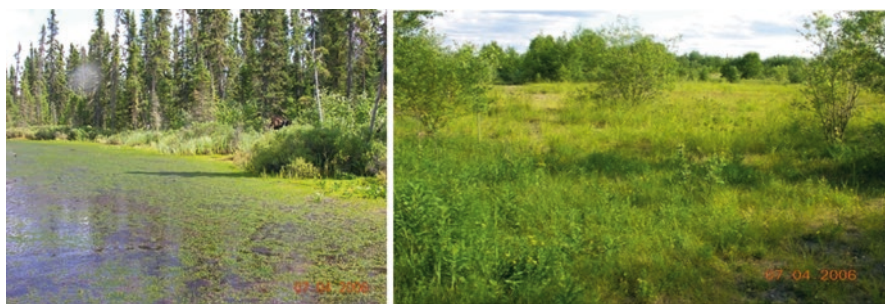
Fig. 9.21 The experimental lake and tailings 4 years after Boojum's departure. The lush green vegetation (both aquatic and terrestrial) is likely due to the application of CPMW to both lake and tailings. (a) Periphyton growth on cut brush in the biological polishing lake. (b) The growth of indigenous vegetation on the tailings after a CPMW addition. (Photographs taken in 2006 by the University of Windsor)

Boojum terminated cooperation with Ministry of Mines and Northern Development in 2002 over disagreements about the ownership of the mine wastes and the associated responsibility. The site was returned to the crown decades ago with the full approval of the regulatory bodies of the time. To close the project, Boojum's client requested that a summary of the contaminant sinks and sources within the mine waste management area be prepared. The largest sink in the waste management area was the contaminated lake, with sediments heavily-laden with iron, zinc and copper. By that time, the ecological measures used on the lake had matured. The underwater meadow which developed from the transplanted moss, was completely covering the sediments. The narrow outflow of the lake, where brush was placed, had begun the process of 'landing in' (Fig. 9.21a).
