# Long-Term Window Evaluation: Comparison of Pavilion Laboratory and Climate Chamber Measurement

**Abstract.** In the pavilion laboratory there are three different windows evaluated since 2011. These windows are suitable for low-energy or passive houses. Two different plastic based windows were modelled and the temperatures were compared to the real measurement with different outdoor temperatures. One of the windows, with the theoretically worst properties was recently removed and another one was mounted into the laboratory. Than the window was tested in the climate chamber. Result is the comparison of temperature courses with simulation of the same winter day as recorded with the weather station. Similar results were obtained and the degradation of thermal properties of the window were confirmed.

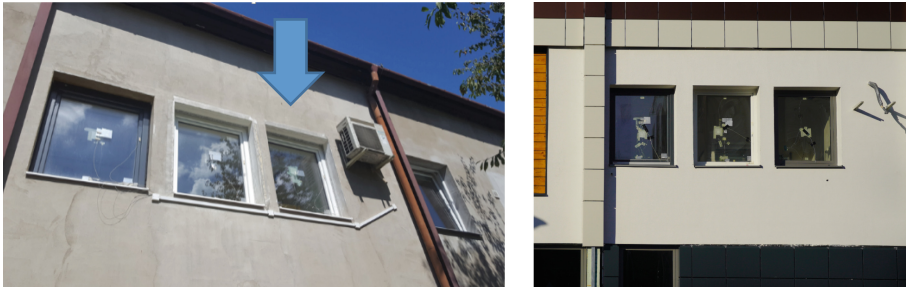
**Fig. 1.** Outer view on the built-in windows before and after façade renovation.

The analyzed window was built into the testing laboratory of the Department since 2011 (Fig. 1). This is a so-called “laboratory of the pavilion type”, which nowadays consists of three different rooms aimed on the nearly zero building envelopes [18, 19].

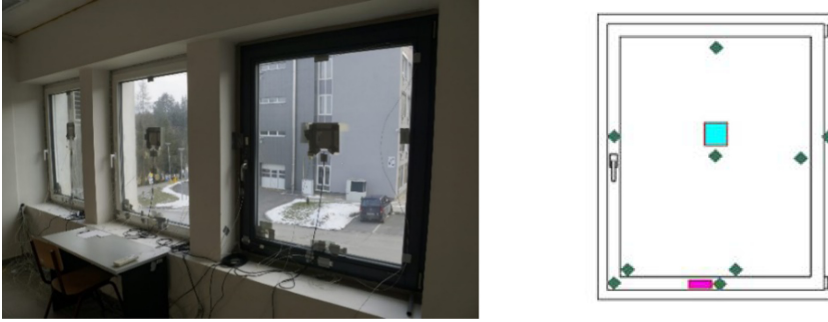
**Fig. 2.** Inside view in the room with test windows. Visible positions of sensors and heat flux plates. Sketch of window with marked position of sensors.

(120 × 120 mm) and half-sized for window sashes and frames) [21]. Monitoring positions are frame, sash and glazing (Fig. 2). The pattern of the positions is the same on all three windows to make the possibility of direct comparison. Totally 57 thermocouples are used, there are 6 positions on each window on both sides. The datalogger and both sensor types are from Ahlborn. For this measurements the recording interval was five minutes.

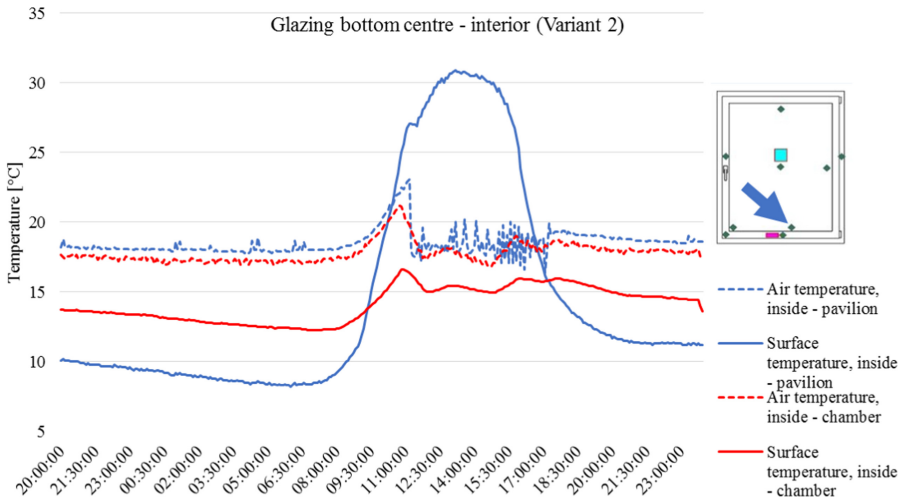
**Fig. 6.** Temperature courses for bottom of glazing. Variant 2 with non-steady indoor temperature. Difference about 4 °C on surface temperatures.

In Fig. 4 there are temperature courses for centre of glazing from the interior side. Temperatures were measured by the HFP. In Figs. 5 and 6 is the comparison of different indoor temperature. In the first case is steady – constant indoor air temperature used with hotbox in climate chamber. In second figure, non-steady temperature is used as boundary condition in chamber. Figures 7 and 8 showed temperature courses for another positions

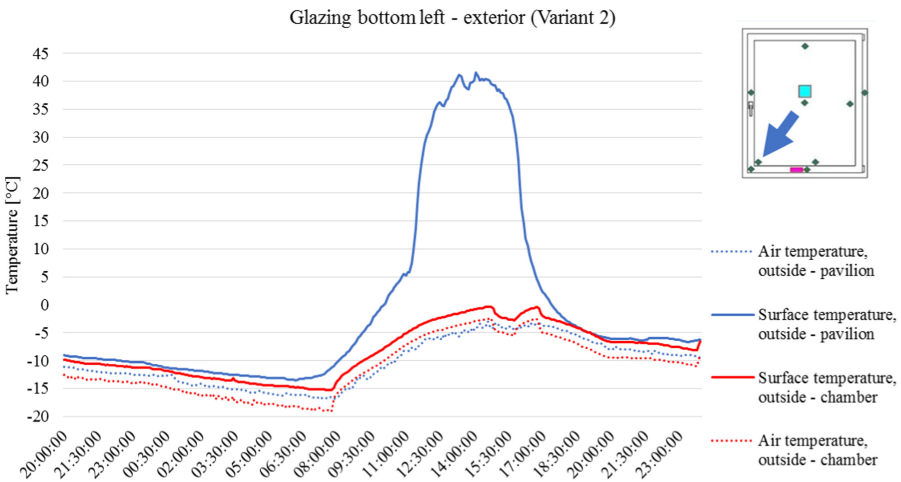
**Fig. 10.** Temperature courses for left bottom corner of the glazing. Difference about 1.3 °C on surface temperatures.

from indoor side. Figures 9 and 10 showed courses from the exterior for same position as Figs. 4 and 7 for interior.
