Experimental Study on MOC Cement Based Micro Concrete for Repairing of Wide Cracks in Concrete Pavement Slabs

Avanish Singh, Rakesh Kumar, and Pankaj Goel

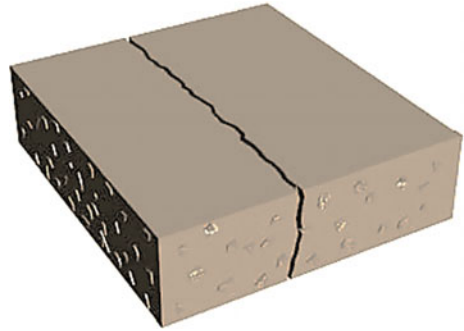
Fig. 1 Typical view of cracked concrete slab

tensile, or shear cracks in concrete. Cracks may not affect the appearance only but also causes the loss of structural integrity and functional characteristics of the pavement by making the surface rough. Repair of deteriorated concrete pavement is essential to restore structural capacity and assure serviceability and safety of road users (Fig. 1).

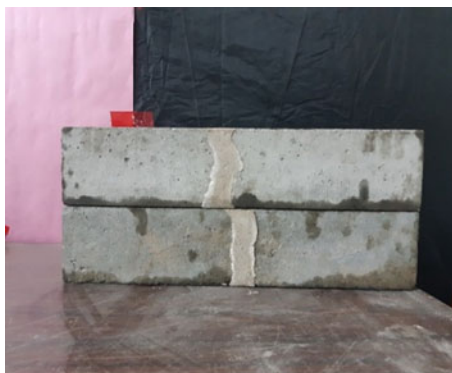
Fig. 2 Repaired broken beams of substrate concrete

If repair is required to restore structural integrity for cracks with surface widths of 25 mm and extending downward from nearly horizontal surfaces, they should be repaired by micro concrete filling incorporating a long pot-life material. First of all, the cracked surfaces should be cleaned. Contaminants such as oil, grease, dirt, or fine particles of concrete prevent bonding and diminish the effectiveness of repairs. Preferably, contamination should be removed by vacuuming or flushing with water (water blasting) or other especially effective cleaning solutions (air blasting). Then MOC based micro concrete should be filled in the crack and compacted by tamping rod and left in the atmosphere for curing for 24 h (Fig. 2).

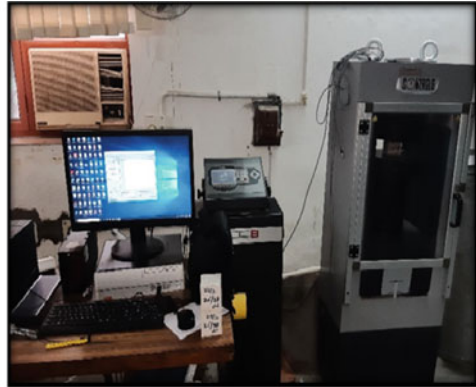
Fig. 4 Testing of flexure strength of substrate concrete under 4-point loading

The design of concrete pavement is based on the flexural strength of concrete. The flexural strength of concrete is determined by the use of beam specimen under 4-point loading standard test procedure. The beam specimen with the dimension $100 \times 100 \times 500$ mm were cast from concrete mix. The beams were demolded after 24 h of casting and cured for 28 days.

The compressive strength and flexure strength of substrate concrete after 28 days of curing are presented in Table 3. The broken beams tested for flexure strength were cut 1 in. from the longer portion to ensure a required gap between the two pieces of the tested beam. Repaired beams were air-cured for 1 day, 3 days, and 7 days, then tested for the flexure strength, and the results are presented in Table 4 (Figs. 3 and 4).

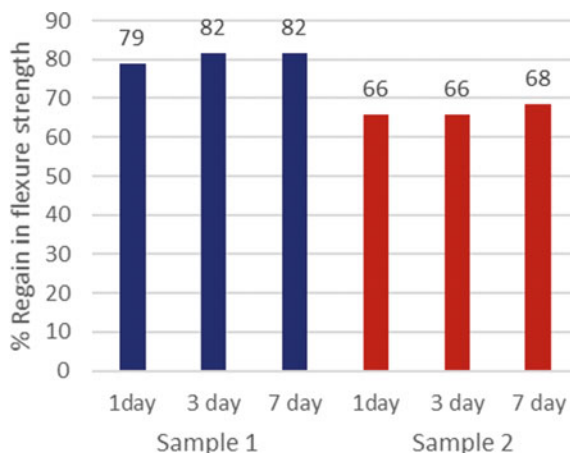
Fig. 5 Percentage regain in flexure strength of M30 grade repaired concrete beams

Beams repair by sample 1 (MOC based micro concrete having MgO: Sand is 1:2) shown an appreciable amount of regain in flexure strength. It is also evident from the results that the flexure strength of repaired beams is almost constant with the age. For M30 grade 82% and for M40 grade 67% flexure strength was regained by broken beams. Similarly, beams repair by sample 2 (MOC based micro concrete having MgO: Sand is 1:3) also shown a considerable amount of regain in flexure strength. For M30 grade 68% and for M40 grade 58% flexure strength was regained. Figures 5 and 6 shows the % regain in the flexure strength of M30 and M40 grade beams repaired by MOC-based micro concrete. Figure 7 shows the failure of repaired beams. It is clear that all the beams are failed in bond. That is why flexure strength is not increasing with the age.

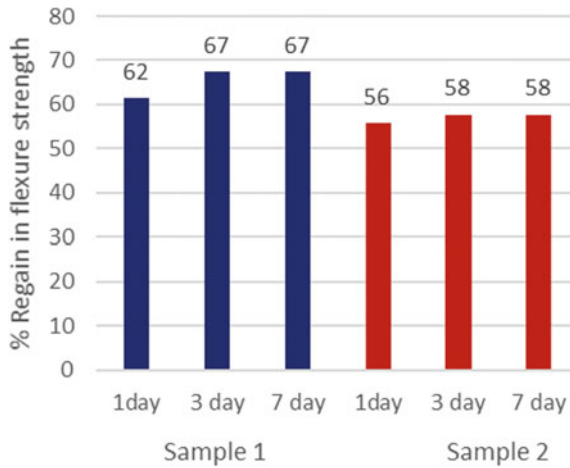
Fig. 6 Percentage regain in flexure strength of M40 grade repaired concrete beams

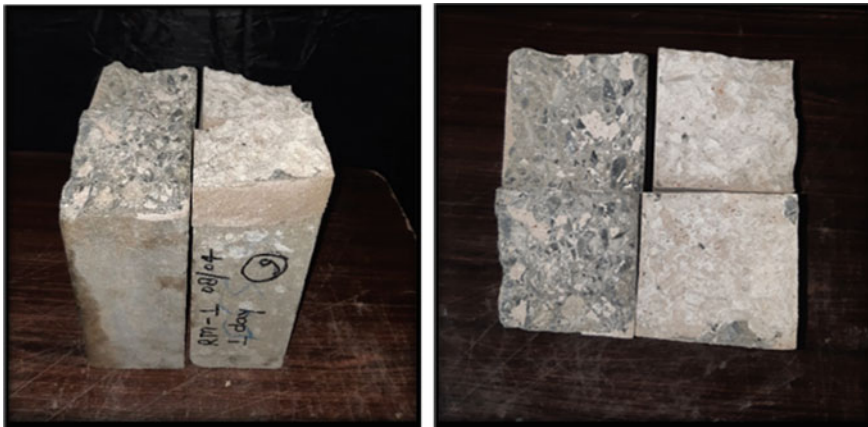
Fig. 7 Typical view of failure in repaired beams of substrate concrete
