# Maintenance and Structural Check of an All FRP Pultruded Construction

**Abstract.** The proposed research focused on the maintenance and structural check of the first all FRP (Fiber reinforced polymer) pultruded construction built in Italy in the 2018. The proposed steps have been mainly in the frame of the joint's efficiency evaluation from the local point of view, and in that of visual inspection from a general point of view. By the way, the joint made by bolts are the more potential weak part in these type of constructions. The construction – all FRP made unless steel bolt – has been the consequence of a specific call and is built in the Iuav University Campus in Venice. The structural check is developed through cyclic in situ analysis of the joint bolted efficiency, specifically by means moment toque value applied evaluation and visual damage detection also considering closed formulas already available both for all FRP bolted joints and similar ones as well as connections made by steel and wood. Bolt monitoring is managed by means of a controlled tightening torque wrench which is used to detect the tightening torque for each bolt in the structure. To calculate the friction c

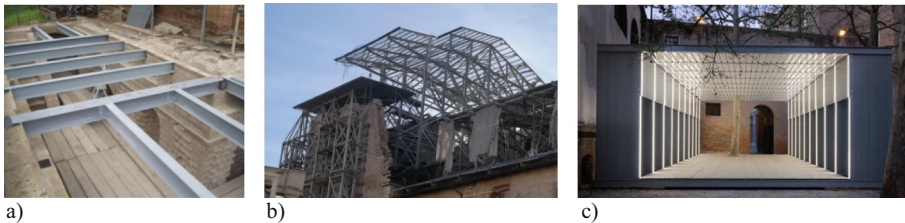
**Fig. 1.** Examples of FRP structures, a) temporary walkway, b) post-earthquake coverage, c) Glass-House.

In the figures below it is possible to see the use of profiles for a walkway inside an archaeological park. The same profiles can also be used for temporary coverage on the post-earthquake construction site. The last image shows the Glass House, a project created in collaboration with the IUAV and made interaction with FRP pultruded (Sciarretta et al. 2018) (Fig. 1a,1b,1c).

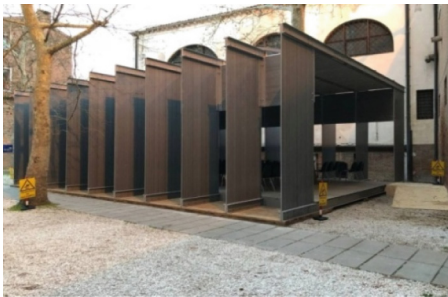
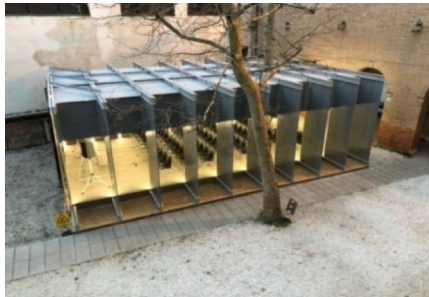
**Fig. 4.** Glass house, a) side view, b) view from top.

At floor level, the stiffener structure is made of two C profiles with dimensions  $2000 \text{ mm} \times 600 \text{ mm} \times 100 \text{ mm}$  fixed to the vertical panels. These profiles are the support surface of the paving slabs. To increase the stiffness orthogonal to the slabs, there are connections made up of 2 C profiles with dimensions of  $2000 \text{ mm} \times 600 \text{ mm} \times 100 \text{ mm}$  near each slab between the various portals. The roof also consists of two profiles C  $2000 \text{ mm} \times 600 \text{ mm} \times 100 \text{ mm}$  similar to those indicated on the flooring, on which the panels that have the function of covering are fixed. The bracing of the structure is made with angular profiles  $1000 \text{ mm} \times 1000 \text{ mm} \times 80 \text{ mm}$ , fixed to the upper wings of the pavilion (Fig. 4a,4b).

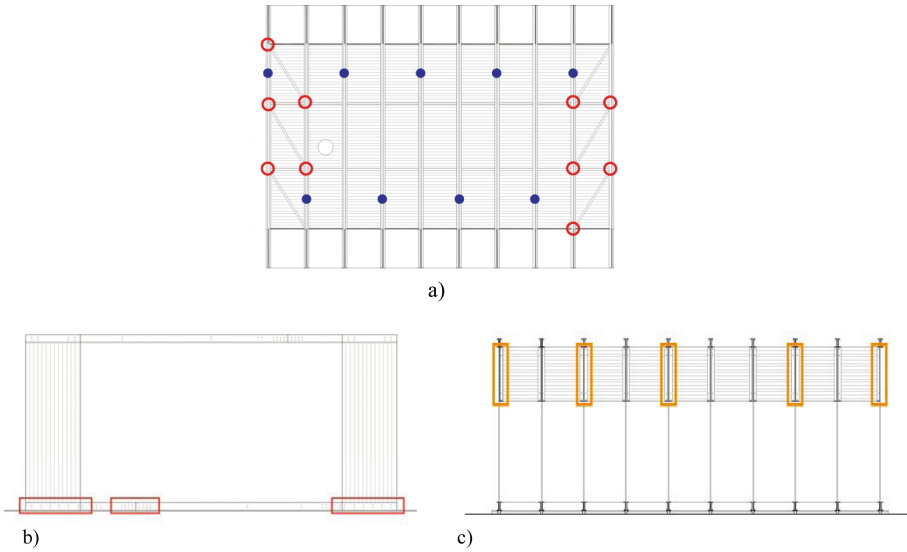
The values of the torque loss were the result of an average of the measurements found on all the bolts monitored inside the pavilion. In the image below are highlighted in blue and orange the connections of type B and E that result to have lost 10% of the tightening torque, in red the typology C that turns out to have lost 8% of the tightening torque (Figs. 10a,10b).

**Fig. 10.** Glass House a) planimetry of covers with B and C connections, b) later view with node A, c) prospect with node E and D.
