RC Columns Upgrade: Opportunities Given by FRP and Potential of FRCC Systems

Abstract. Fiber Reinforced Polymer (FRP) composites have been widely used in past decades for the seismic upgrading of sub-standard reinforced concrete (RC) members and their effectiveness as a suitable strengthening technique for such kind of structural components has largely been proved. However, some concerns still arise with the effectiveness of such composite materials at high temperature, such as in the case of fire exposure. Furthermore, the use of FRPs requires a minimum quality for the concrete substrate to avoid undesirable premature failure mechanisms. Usually, the replacement of the poor quality or damaged concrete cover of existing members with a new one is needed before the strengthening intervention. Current research is now moving towards the adoption of inorganic composite materials, such as Fiber Reinforced Cementitious Composite (FRCC), for repairing existing RC buildings and infrastructures as a replacement of the original concrete cover, due to its good durability properties and resistance to high temperature. The present study discusses the possibility of adopting such FRCC jacketing

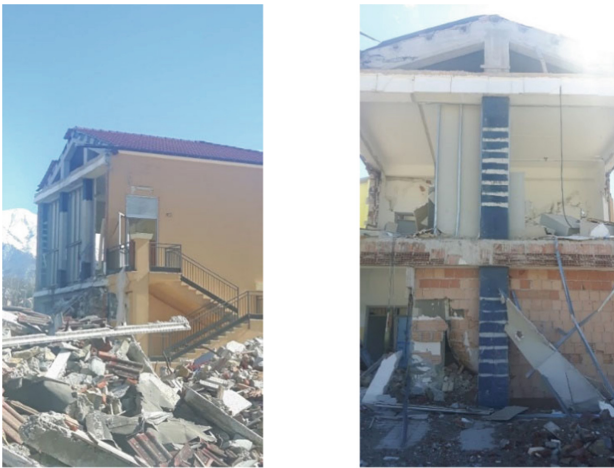
The L'Aquila earthquake (2009) confirmed the high occurrence of columns brittle failure due to shear, especially in the case of short members (Del Zoppo et al. 2017). Indeed, among 284 heavily damaged RC buildings that were demolished after the earthquake, 56 (i.e., 20%) experienced the shear failure or one or more columns, sometimes followed by the loss of axial load capacity. After the Central Italy earthquake (2016), it was observed that the FRP external jacketing was perfectly able to provide enough resistance to carry on the seismic-induced actions on vertical members without failure, see Fig. 1.

Fig. 1. Field survey after the Central Italy earthquake (2016).

The experimental results presented in (Del Zoppo et al. 2017) and the recent Central Italy earthquake (2016) have proven the effectiveness of FRP techniques for increasing the shear capacity of existing RC members and preventing their brittle failures. The experimental campaign carried by the authors on short RC columns with square cross-section, representative of existing RC members, and strengthened with Carbon FRP provided an in deep knowledge about the effectiveness of such systems to avoid brittle failures. Results from Del Zoppo et al. 2017 show that in the case of short columns characterized by a poor-quality concrete (15 MPa on average), FRP jacketing with axial stiffness, $E_f \rho_f$, lower or equal to 0.31 GPa provides an enhancement of lateral capacity from 56% to 67% with respect to the original shear capacity of the short RC columns. However, the external reinforcement is not able to avoid the shear failure of the member. Conversely, an external reinforcement ratio of 0.34 GPa is able to prevent the brittle failure of the poor-quality concrete members, allowing the development of plastic deformations with ultimate drift ratios greater than 7%. Columns characterized by medium

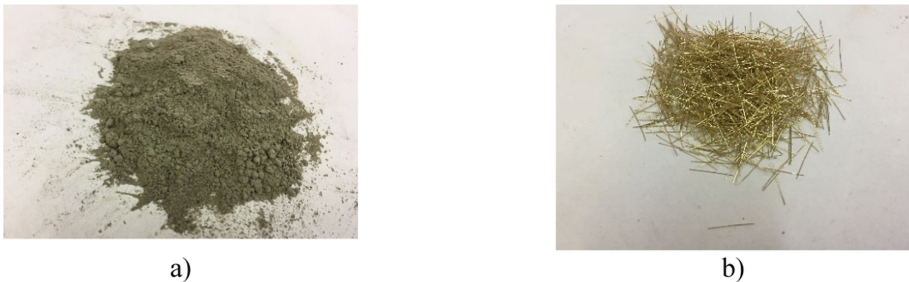
The FRCC material adopted for this experimental program is characterized by a high-strength cement-based mortar with very small aggregates (maximum size 2.5 mm) and plain short stainless-steel fibres (fibre diameter 0.21 mm, fibre length 13 mm), see Fig. 2. The fibres weight ratio is lower than 2%, in order to allow the workability of the composite system and to reduce the costs. This low volumetric ratio, typical of fibre reinforced cements, provides a strain-softening behaviour in tension after the opening of the first crack in the matrix.

Fig. 2. FRCC, a) matrix, b) steel fibres.

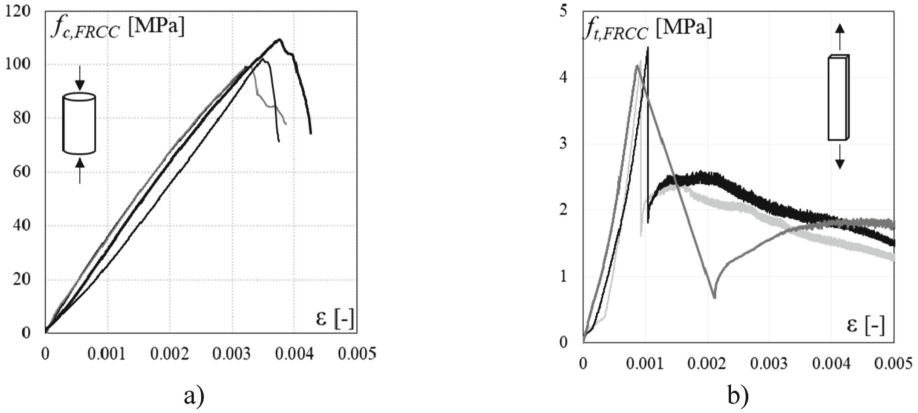
To characterize the mechanical properties of the adopted FRCC material, compressive tests on cylindrical specimens (diameter 100 mm, height 200 mm) and direct tensile tests on dog-bone coupon tests (width 40 mm, length 150 mm, thickness 10 mm) are performed under displacement control. The average mechanical properties derived from experimental tests on FRCC materials are herein summarized: average compressive strength $f_{c,FRCC}$ of 104.3 MPa, elastic modulus of 31.3 GPa, ultimate compressive strain ϵ_{cu} equal to 4% and average tensile strength $f_{t,FRCC}$ of 4.3 MPa. Stress-strain curves for the FRCC material in both compression and tension are depicted in Fig. 3a and b, respectively.

Fig. 3. Mechanical properties of FRCC, a) compressive behaviour, b) tensile behavior.

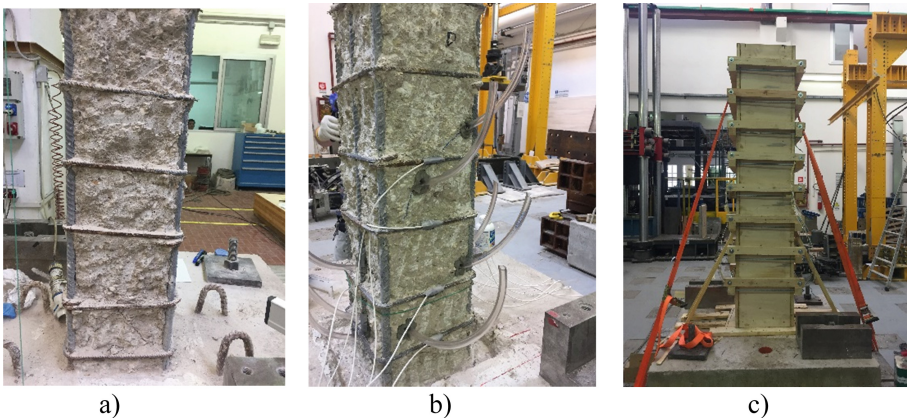
The jacketing procedure relies on different steps: after the complete removal of the original concrete cover (Fig. 4a), the concrete surface is wetted up to complete saturation; if needed, the specimen is repaired with epoxy-resin injections (see Fig. 4b) to close the eventual flexural and shear cracks in the concrete core. The epoxy-resin injections should be cured for 24 h before casting the FRCC jacket. Then, a wooden formwork is built around the column in order to allow fresh FRCC pouring (see Fig. 4c). Given the highly performing bond properties of FRCC material herein adopted, no bonding agent or primer are needed at the FRCC-inner concrete interface.

Fig. 4. FRCC jacketing procedure, a) concrete cover removal, b) repair with epoxy-resin injection (if necessary), c) casting of the new FRCC cover.

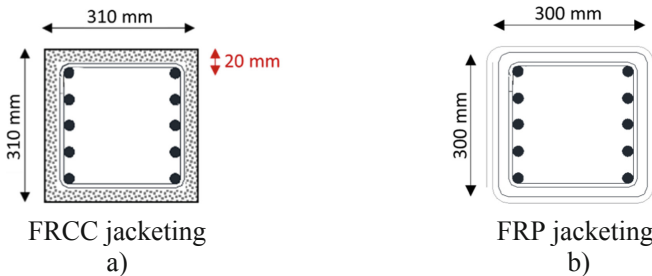
In the case of axial load ratio $\nu = 0.1$, the test results for FRCC jacketing are also compared with the results obtained by using the FRP jacketing on a specimen with same geometrical and mechanical characteristics (Del Zoppo et al. 2017). The discontinuous FRP jacketing consisted in applying one-ply strips of Carbon FRP (unit weight 600 g/m^2), width 100 mm and spacing 165 mm, covering the entire length of the column. Both retrofit configurations are shown in Fig. 5.

Fig. 5. Specimens configuration: FRCC jacketed (a) and FRP jacketed (b)

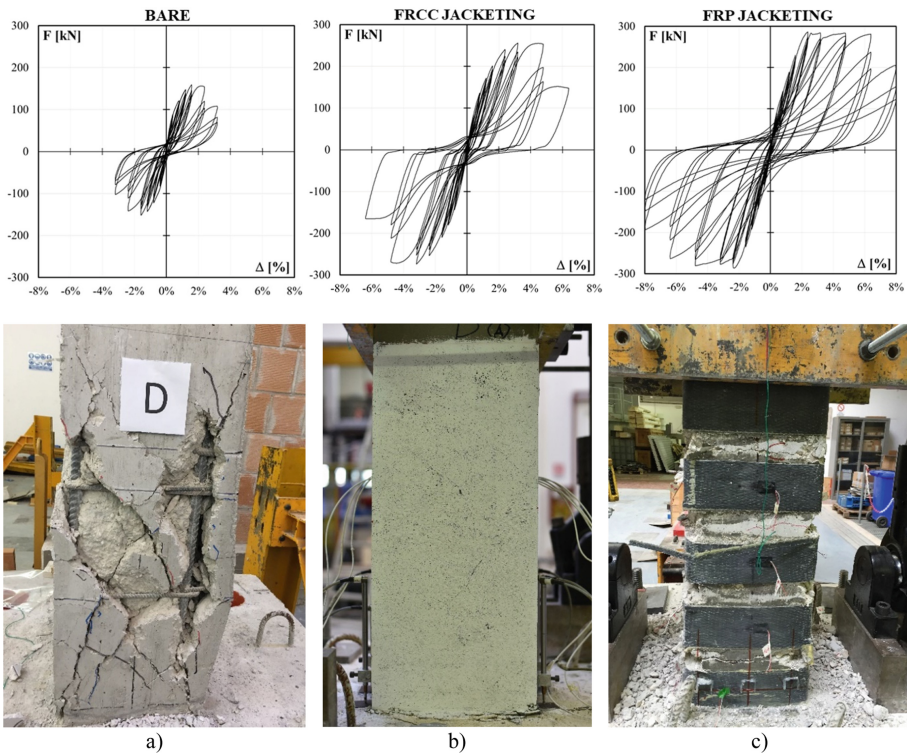
The bare column subjected to an axial load ratio $\nu = 0.1$ and to cyclic lateral loads exhibited a brittle failure governed by the shear failure before the achievement of the flexural yielding of internal steel reinforcement, as shown in Fig. 6a, where the cyclic force-drift ($F-\Delta$) relationship is reported. Figure 6a also reports the damage pattern at

failure for the bare specimen (for a drift ratio of 3.2%), where the development of large diagonal cracks for the entire shear span of the member is clearly visible. Vertical cracks along the longitudinal reinforcement are also detected, due to a probable loss of bond between steel bars and surrounding concrete.

The force-drift relationship derived for the specimen jacketed with FRCC is depicted in Fig. 6b. In this case, the specimen achieved the flexural capacity (with flexural yielding of internal steel reinforcement) and experienced a ductile behaviour up to a drift ratio of 4.2%. During the test, the specimen experienced a very low damage, as visible in Fig. 6b representing the crack pattern at the end of the test. The FRCC jacket showed a few hairline cracks and the major deformation were achieved at the interface between the column base and the foundation block.

A similar performance, in terms of force-drift capacity curve, was experienced by the specimen jacketed with discontinuous CFRP strips (see Fig. 6c). Indeed, also in this case the specimen achieved the flexural capacity, associated with the yielding of longitudinal reinforcement, and experienced a ductile behaviour with ultimate drift ratio greater than 6%. The failure was partly governed by the local rupture of the FRP fibres and partly related to the high deterioration of unconfined concrete between consecutive FRP strips, as visible from Fig. 6c at a drift ratio of 8%.

Fig. 6. Specimens force-drift relationship and damage at failure: a) bare; b) FRCC jacketed; c) FRP jacketed.

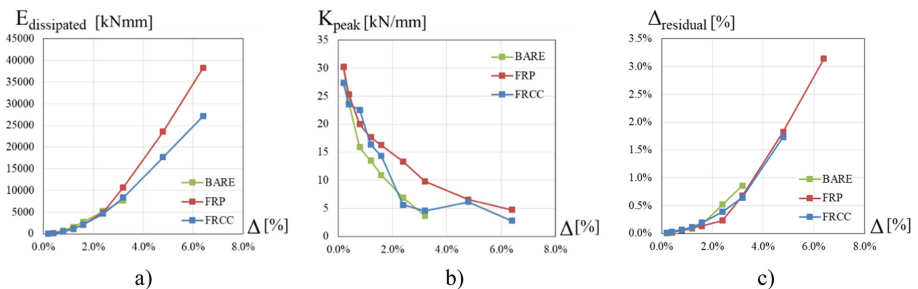
To further investigate on the potential of FRCC jacketing for the seismic retrofit of existing short RC columns, the behaviour of the specimens has been compared in terms of energy dissipation, $E_{dissipated}$, peak-to-peak lateral stiffness, K_{peak} , and residual drift ratio at the end of each complete cycle (i.e., after the three repetitions for the imposed drift), $\Delta_{residual}$, in Fig. 7.

In terms of energy dissipation (Fig. 7a), the FRCC jacketed specimen experienced a slightly higher energy dissipation capacity with respect to the bare specimen up to a drift ratio of 3.2% and then achieved a quite good energy dissipation, with a cumulative dissipated energy of 2700 kNmm at failure. Conversely, the FRP jacketed specimen showed a greater energy dissipation capacity with respect to bare and FRCC jacketed specimens after a drift ratio of 2.4%. At failure, the FRP jacketed specimen reached an energy dissipation of 3800 kNmm. This is also visible from the comparison between capacity curves in Fig. 6b–c, where the pinching phenomenon is more visible in the FRCC jacketed column (Fig. 7b). This difference is probably related to the global behaviour of the specimens. Indeed, the FRCC jacketed specimen experienced a rocking behaviour, with damage concentrated mainly at the base cross-section. Conversely, the FRP jacketed specimen showed flexural deformations for its entire length.

The peak-to-peak stiffness was measured at the first cycle for each imposed drift ratio. The initial flexural stiffness is almost the same for all specimens, as the cross-section was not enlarged with both the jacketing techniques (Fig. 7b). The lateral stiffness reduction for increasing drift demand was lower in both jacketed specimens with respect to the bare one, up to a drift ratio of 1.8%. Then, a sudden reduction of lateral stiffness was observed for the FRCC jacketed specimen, probably related to the beginning of the rocking behaviour. Conversely, specimen jacketed with FRP showed a softer reduction of lateral stiffness for increasing drift demand.

Finally, in terms of residual drift ratio at the end of each imposed cycle, both FRP and FRCC jacketed specimens experienced a slightly lower residual drift with respect to the bare column. The behaviour of the two jacketed specimens was very similar in terms of residual drift ratio (see Fig. 7c).

Fig. 7. a) Energy dissipation; b) Lateral stiffness; c) residual drift ratio.

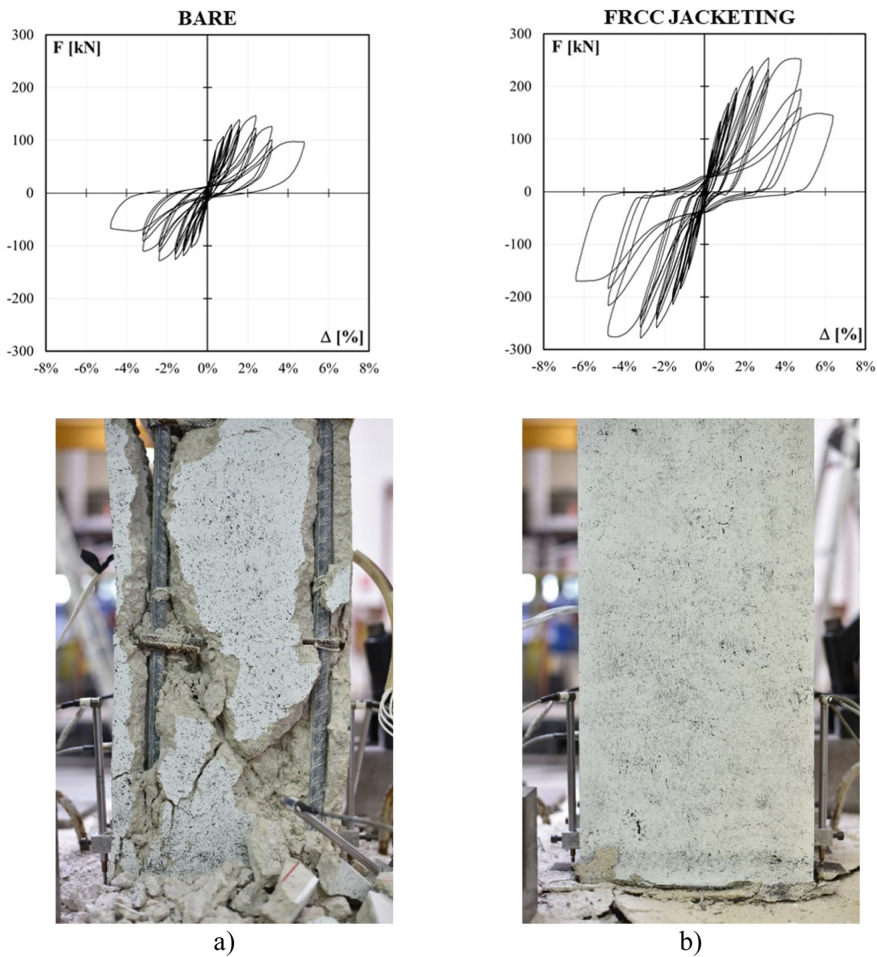
The force-drift relationship derived for the bare and FRCC jacketed specimens under axial load ratio 0.2 are depicted in Fig. 8 along with the damage pattern at failure.

Also in this case, the bare specimen achieved a brittle failure before the yielding of internal steel bars (Fig. 8a). The failure mode was governed by the loss of bond between steel reinforcement and surrounding concrete associated with the shear resisting mechanism. Conversely, the specimen jacketed with FRCC experienced a ductile behaviour, with the flexural yielding and the ultimate drift ratio greater than 4% (Fig. 7b). The damage pattern at failure of FRCC jacketed specimen was very similar to that observed under axial load ratio 0.1, with very few hairlines cracks of the jacket and major damage located at the interface between the column and the foundation block.

Fig. 8. Specimens force-drift relationship and damage at failure: a) bare; b) FRCC jacketed.

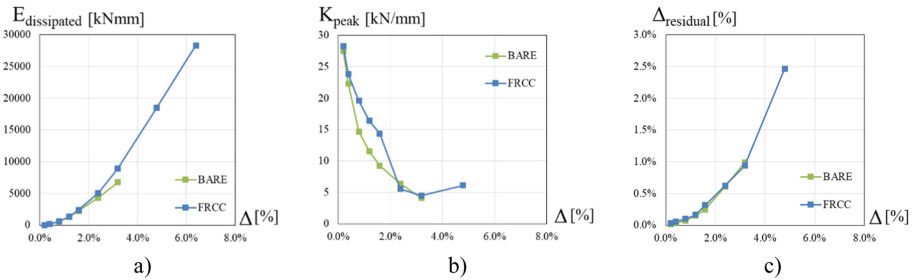
In terms energy dissipation capacity, reduction of peak-to-peak lateral stiffness and residual drift, the same considerations made for the specimens under axial load ratio 0.1 apply to the case of specimens under axial load ratio 0.1. The FRCC jacketed specimen exhibited a higher energy dissipation capacity and a softer lateral stiffness reduction up to an imposed drift ratio of 1.8%. Then, a drop of the lateral stiffness was observed, confirming the beginning of a rocking mechanism. In terms of residual drift ratio, significant differences between bare and jacketed specimens were not clearly visible (Fig. 9).

Fig. 9. a) Energy dissipation; b) Lateral stiffness; c) residual drift ratio.
