# Chapter 19

## Environmental Change and Cultural Continuity: Extraordinary Achievements of the Rapanui Society after Deforestation

Andreas Mieth, Annette Kühlem, Burkhard Vogt, and Hans-Rudolf Bork

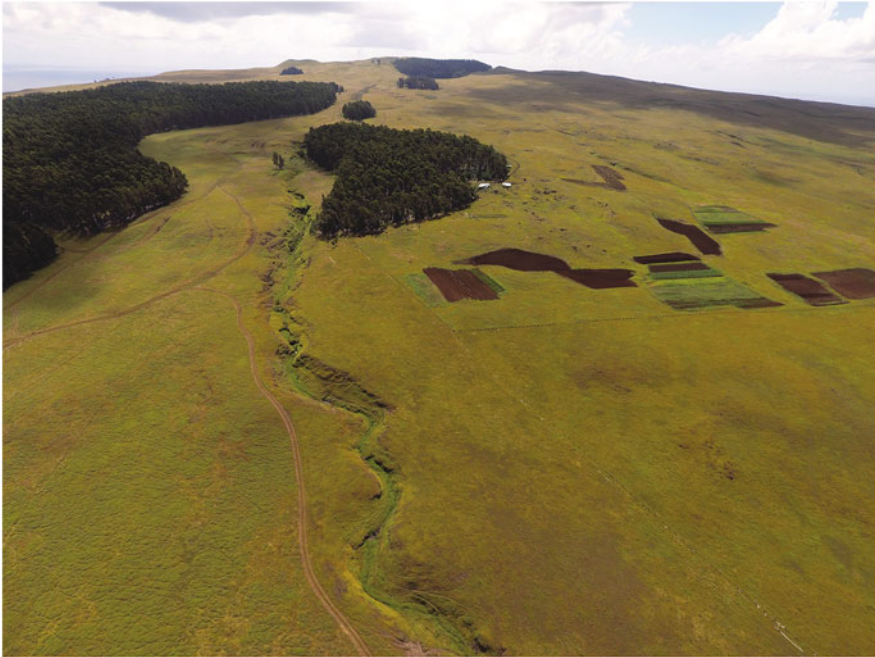
**Fig. 19.1** Aerial view of the Quebrada Vaipú on the southern flank of the Terevaka volcano (drone image: Christian Hartl-Reiter, DAI)

Nowadays the Quebrada Vaipú is the only seasonal stream on Rapa Nui that carries a significant amount of water every year. It runs down the southern flank of the Terevaka volcano from the Rano Aroi crater lake to the shore at O Pipiri (Fig. 19.1). Its upper course lies within a mostly collapsed lava tube; in a limited area the roof of this tube is still intact and the water runs underground. Today the stream only carries running water after strong or prolonged rainfall. That this unique water course once held a great importance to the Rapanui is attested to by many hydraulic installations along the course of the creek.

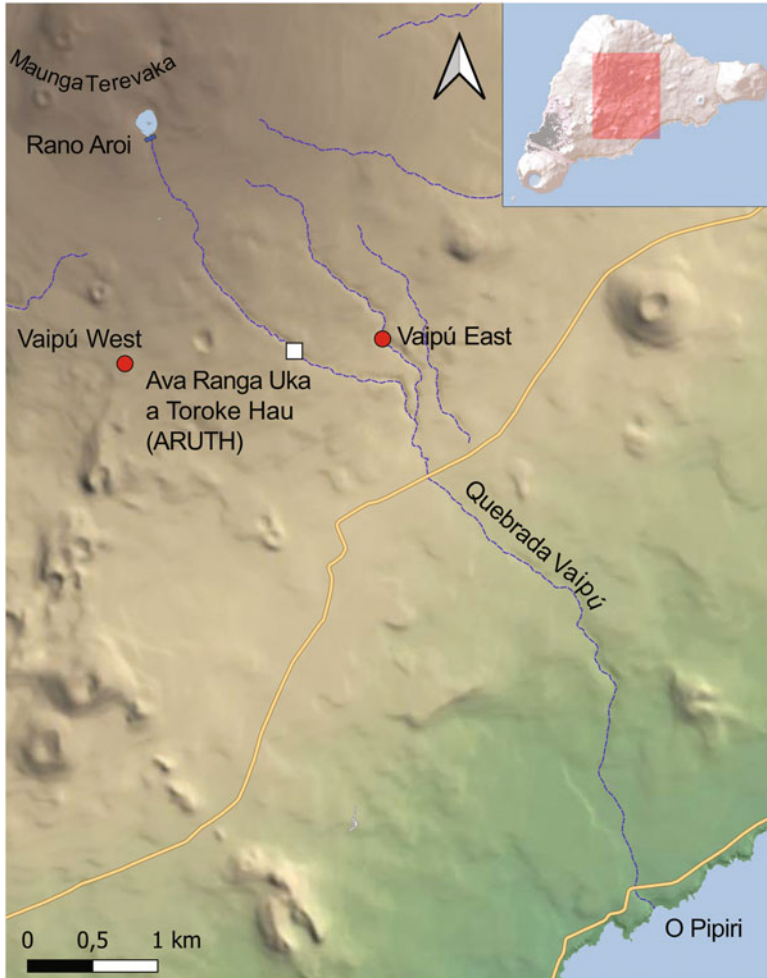
**Fig. 19.3** Study sites on the southeastern flank of the Terevaka volcano (graphic: Christian Hartl-Reiter, DAI)

It is noteworthy that settlement structures in the vicinity of the Quebrada Vaipú are not more frequent than the general site distribution on the island as demonstrated by a large-scale survey in the late 1970s and early 1980s (cf. Cristino et al. 1981). DiNapoli et al. 2019 showed a strong correlation between the location of nearshore water sources and the location of *ahu* and settlements. Since inland access to freshwater is an even rarer commodity, one would also expect a concentration of settlement structures along the course of the only significant seasonal stream. The fact that this is not the case points towards a limited, regulated, and/or sanctioned access to the water in the Quebrada Vaipú. The most elaborate architectural framework for this water management was found at the site of Ava Ranga Uka A Toroke Hau in the very center of the island (Fig. 19.3).

Trench T7 runs parallel to the Quebrada Vaipú at the western bank of the stream through the former southern embankment of ARUTH (cf. Fig. 19.3). The profile shows the complex stratigraphy of the spacious southern terrace complex of ARUTH. Like in the central area (T4) a sequence of different construction and use phases could be documented (Figs. 19.12, 19.13, 19.14). At the base of T7 there is a body of loose rock debris (Fig. 19.12: Layer 1), the surface of which is covered with a pavement made of slightly weathered small yellowish volcanic rocks (Pavement 1). It is the man-made, water-permeable, former outer wall of the earliest documented terrace at ARUTH. The noticeably yellowish volcanic rocks that had been selected for the pavement possibly had a ritual display function. Above the surface of this earliest terrace lies another anthropogenically deposited layer (Fig. 19.12: Layer 2). It consists of up to 0.45 m of rock debris intermixed with a brown humus fine soil. The surface of this layer is covered by a rough stone pavement (Pavement 2). Layer 3 consists of up to 0.2 m of anthropogenically deposited rock debris intermixed with a brown humus fine soil.

The pigment pits found at Vaipú East are not the only ones on Rapa Nui. The authors also found pits filled with reddish pigments on a ridge about 1300 m west of the Quebrada Vaipú (Vaipú West, Fig. 19.3) as well as in connection with the monumental installations of ARUTH, where they were embedded in the terrace complexes and anthropogenic layers. Further pigment pits were discovered downstream of the monuments of ARUTH. There as at Vaipú East they are embedded in fluvial sediments (Vogt et al. 2018; Out et al. 2020). It is obvious that pigment production and use in the Vaipú area was not only spatially but also culturally and ritually related to the ARUTH installations and was part of the flourishing cultural manifestations of this particular site.

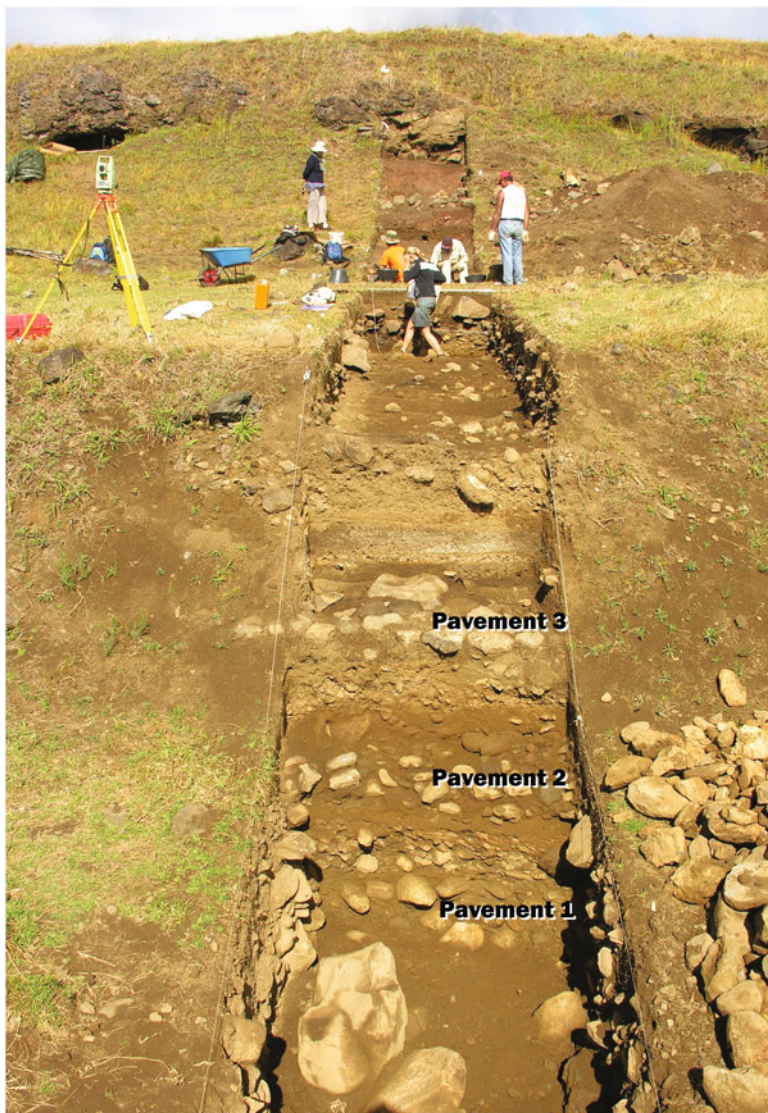
**Fig. 19.5** Embankment profile showing the succession of pavements and compacted layers of trench T4 (photo: Burkhard Vogt)

In the central area of the site (Fig. 19.4, T4) it was possible to identify different phases of site use. The stratigraphy consists of up to 6 m of cultural deposits with different use-surfaces (Fig. 19.5). The body of layers forms an artificial platform on

the western bank of the Quebrada. The eastern edge of this platform was eroded by the stream during an extreme runoff event (see below). The resulting embankment profile shows a succession of three pavements that are separated by compacted layers (cf. Kühlem 2016, Kühlem et al. 2014; Fig. 19.5).

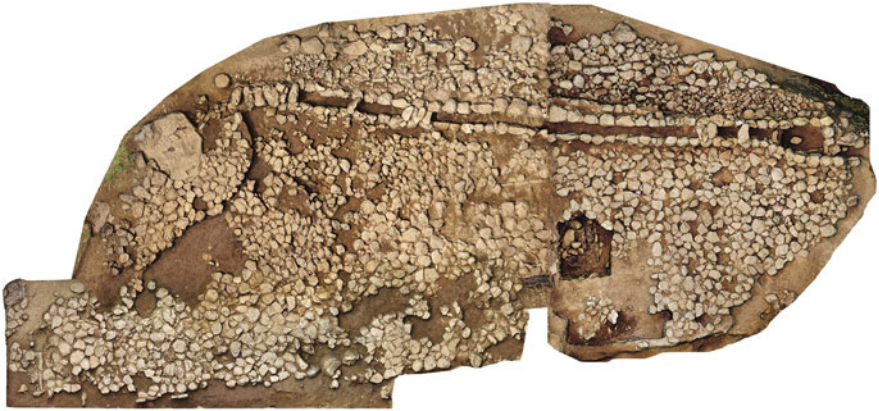
**Fig. 19.6** Orthophoto of T4 with partially covered canal and stone-rimmed palm tree planting pits (photo/graphic: Christian Hartl-Reiter, DAI)

The above-mentioned Pavement 3 that spans the entire widening of the valley is the lowest level of large-scale surface excavation that was reached to date (Fig. 19.6). It corresponds to the uppermost pavement in the embankment profile. Even though the direct connection between this pavement and the paved areas around the megalithic basin T1 is disturbed, the stratigraphic context and the height of the pavement slabs indicate that Pavement 3 of T4 merges with the pavement around the basin.

The eastern water canal (see above; Fig. 19.6) was also still in use after the pavement level had been sealed off by the compacted soil. Some areas of the canal are covered with flat stone slabs, probably to prevent evaporation and/or pollution of the water while the canal still ran at the surface. When Pavement 3 was covered the canal ran underground. In some places along the canal, small shafts were dug into the overlying compacted layer, presumably to clean the canal or to remove blockages. Despite the fact that the pavement and all the installations within were sealed off by the anthropogenic layers there are a few features from the level of Pavement 3 that were still in use.

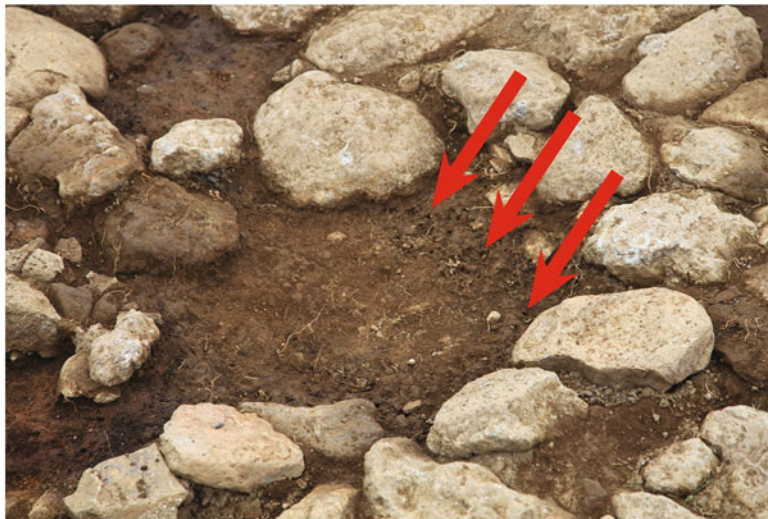
**Fig. 19.7** Stone-rimmed palm tree planting pit with root imprints (marked by arrows) (photo: Annette Kühlem)

There are several noteworthy features within the excavated paved area of T4. A number of circular stone-rimmed pits were found amidst the pavement slabs (Fig. 19.7). In ten of them, *in situ* palm root imprints were visible, demonstrating that a small grove of the now-extinct palm species grew in the central area of ARUTH and the trees were integrated into the paved area. In some of the pits the root clusters were over 1 m in diameter. The assumed closest genetic relative of the extinct Rapa Nui palm, the *Jubaea chilensis*, grows mainly in diameter for the first 20 years, before growing tall (Guzmán et al. 2017). Also, the roots at the base of the trunk tend to be wider than the trunk itself. If this was also the case for the palm trees in the central area of ARUTH, then they need not have been large and mature specimens. The radiocarbon dates for the succession of layers in T4 show that the palm trees most probably did not have time to grow to their full height between the time when they were planted to when the area was altered again (see below).

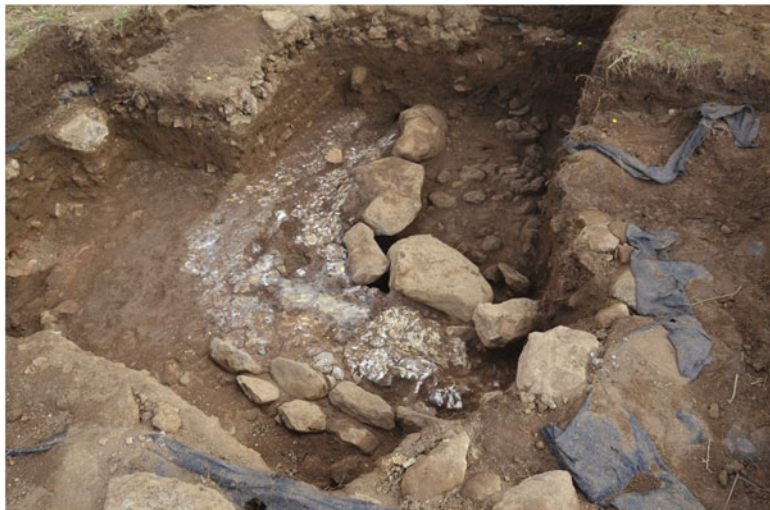
**Fig. 19.9** Earliest documented megalithic basin with white sealant around the rim (photo: Annette Kühlem)

below Pavement 3 the rim of an earlier megalithic basin was found (Fig. 19.9). A layer of whitish clay, analogue to that had been found at the base of basin T1, had been applied around the massive stone blocks that make up the walls. Here again, it seems like this material was used as a sealant as it was also smeared into the cracks between the large boulders. The basin has a maximum depth of 1.6 m and the one excavated block in the western wall measures 1.3 m x > 1.4 m. The basin tapers downwards and has a paved floor. Whether this paved floor corresponds to one of the lower pavements that are visible in the embankment profile cannot be said with certainty at this point. The complete dimensions will only be known after further excavations but even at this stage the basin is evidence for megalithic hydraulic architecture in the early phases of the site use.

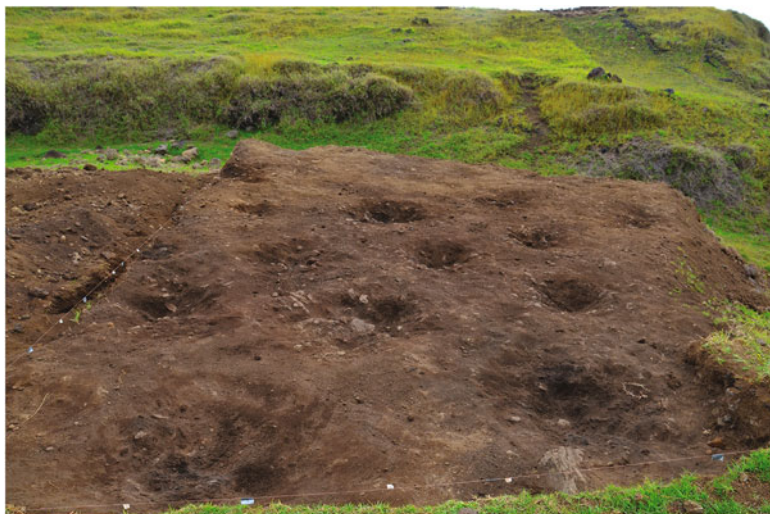
**Fig. 19.11** Series of later horticultural planting pits in the upper layer of T4 after the catastrophic rain event (photo: Annette Kühlem)

The flood event and the resulting covering of the central area of the site with a thick layer of sediment seem to have brought about a functional and cultural change at the site of ARUTH. The lower levels with the succession of pavements, water basins, canals, and the palm tree grove point to a ritual significance, while the garden pits in the upper levels show a more profane use of the site for horticulture.

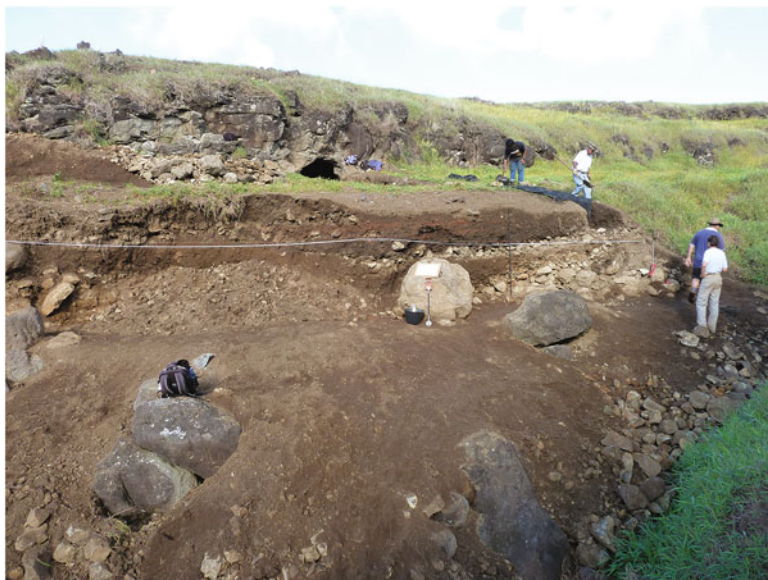
**Fig. 19.13** View of the southern part of the site ARUTH with profile T7 and the cave in the steep cliff (photo: Hans-Rudolf Bork)

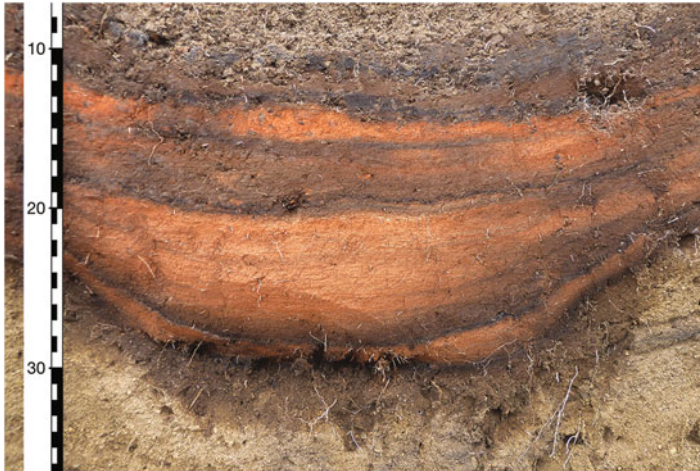
**Fig. 19.16** Pit filled with reddish pigments from a section in Vaipú East (photo: Andreas Mieth)

minerals hematite and maghemite in very fine and homogeneous grain sizes. The geochemical composition and physical properties of the minerals in the pit fill differ significantly from those of the sediments in which the pits are embedded. Dark brownish to blackish layers embedded in the reddish fill contain concentrations of miniscule flakes of charred plant material. Larger, taxonomically identifiable charcoal fragments were not found. Furthermore, the pit fill deposits contained thin, whitish to light gray layers, which contain a high concentration of phytoliths. The composition of the phytoliths was studied in detail for both the pit fill deposits and the surrounding sediments. While the fluvial sediments are rich in palm phytoliths, the pit fill contains very few phytoliths of palms. Instead, high numbers of grass
