Assessment of Masonry Bridges with the Help of Combined NDT Methods

Keywords: Masonry arch bridges · Non-destructive testing · Assessment

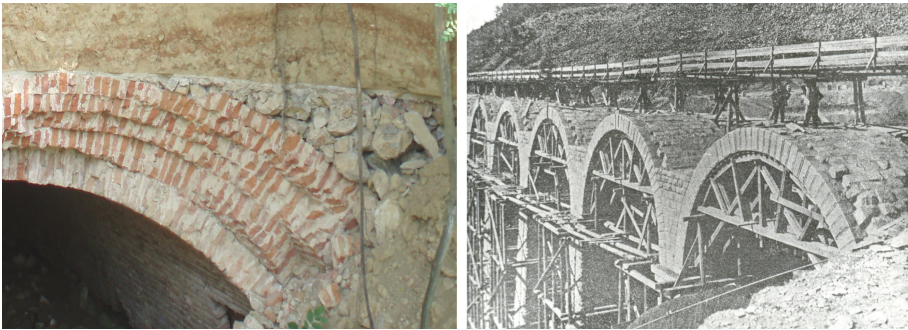
Fig. 2. Left: Stone backing of brickwork arch (bridge under demolition, Hungary), Right: Haunching between piers (bridge under construction, Hungary)

The geometry of a masonry arch bridge is not so simple as it appears at first glance. They rarely have accurate or sometimes any drawings at all of their construction or early repair details. The internal structure of arch bridges may be unknown from external appearance and may include features such as haunching at the supports, internal spandrel walls, ribs or the presence of a saddle over the arch barrel. The thickness of the barrel may be greater at the springing than at the crown that might not be visible at the edge of the barrel. The arch barrel thickness across a width may be reduced locally under the external spandrel walls or increased under the track. The material and geometry of backing or haunching and the way they are connected to the arch are often unknown and are rarely visible (see example in Fig. 2). Most masonry arches have a semi-circular arch shape, although compacted backfill and the presence of backing or haunching can reduce the working span and modify the shape of the actual load bearing arch. Piers

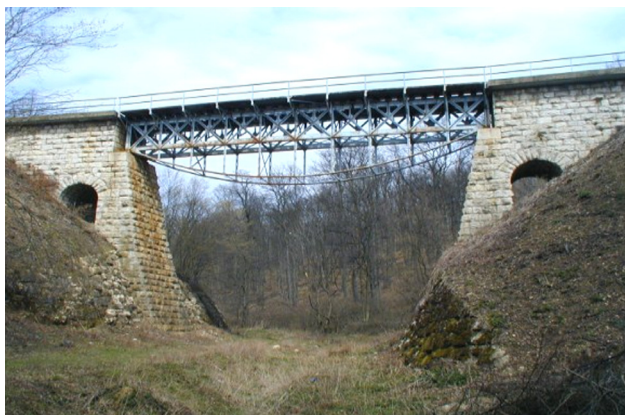
Fig. 3. The Rátót viaduct with stone masonry abutments

Non-destructive tests were carried out on the masonry abutments of the Rátót viaduct in Hungary using ground penetrating radar (GPR), seismic method and infrared thermography. Calibratory investigations were made with boroscopy in order to confirm and interpret data obtained by the NDT measurements. The viaduct was constructed in 1896 and consists of wrought iron truss superstructure with stone masonry abutments (Fig. 3). The viaduct is still in service but its reconstruction in the near future is considered necessary. The abutments are approx. 15 m high and 5 m wide. Originally, both abutments contained three internal arches from which only one arch at each abutment have remained visible. The others cannot be observed from outside the structure because

they are fully covered by earth. According to the drawing the internal arch at the bottom of the abutment is 4,50 m wide while those at the top are 2,40 m wide. The abutments were constructed from large size stone blocks. There was no information on the internal structure of the abutments although it was presumed that there were loose rubble stones behind the outer stone layer.

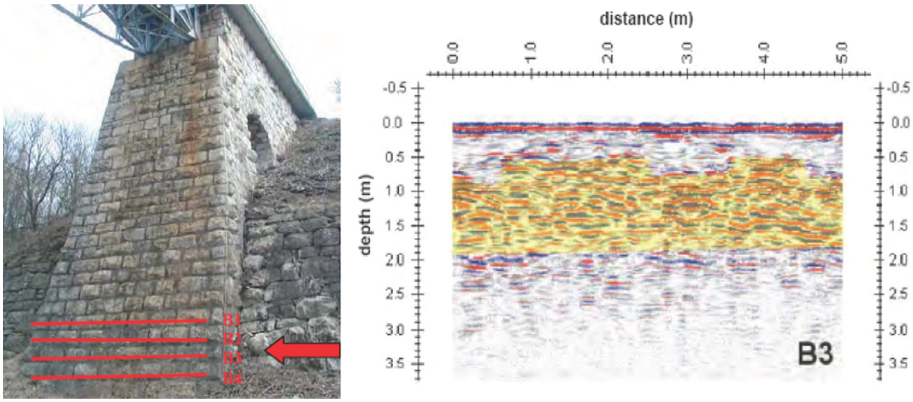
Figure 4 shows the horizontal test profiles on the abutment front wall and demonstrates an example of the radar test results. The first part of the demonstrated profile is exempt from anomalies except for the waves travelling directly from the transmitter to receiver. Until the yellow zone no significant reflections were perceivable within the outer part of the stone wall, which means that the outer stone layer is more or less homogenous. The thickness of this layer is about 50 cm but varies from stone to stone. Distinctively, the first and the last row of the rubble stone layer were constructed from thicker stones. The thickness variation of the abutment wall can clearly be seen on the radargram, but individual stones cannot be distinguished with the given resolution. The yellow zone represents the area behind the outer stone layer where strong reflections can be observed. The reflection from the boundary means that this area was built of a different material. The reflections within the area mean that this building material is highly inhomogeneous. There are profiles where the anomalies are more significant at the same depth than on other profiles. This suggests that the area behind the outer stone layer was filled with loose gravel stones rather than being a standard masonry. At the end of the yellow band, around a depth of 2 m, the profile reveals a weak anomaly. Beyond the yellow band, no significant reflections could be recorded.

Fig. 4. Radar survey of the front wall of the stone abutment

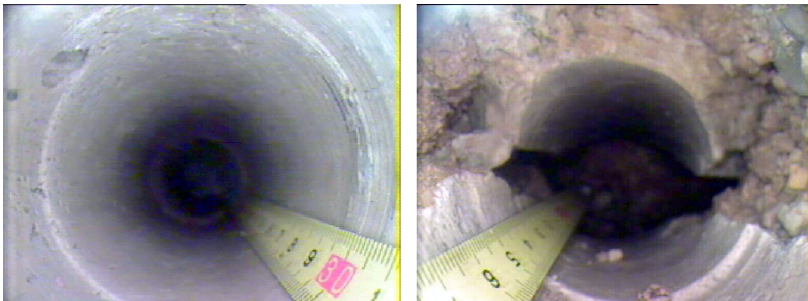
Fig. 7. Boroscopy images. (Left) solid stone material (right) rubble stone material

Calibratory survey was carried out with the use of a boroscopy camera that was inserted into boreholes drilled in representative parts of the abutment. Digital recordings were made during the operation that allowed a detailed study of the internal parts of the structure in the boreholes. The objective of the survey was to help interpret the results of the radar measurements. The cores taken out from the drillings were utilised for testing the physical and mechanical properties of the stonework. In Fig. 7 the boroscopy images demonstrates the solid part (outer stone layer) and the internal gravel stone filling of the abutment wall at 50 cm depth measured from the surface.

These findings confirm the results of the radar survey. According to these measurements the outer stone layer is about 50 cm thick both at the abutment front wall and at the internal arch. More loose material was found behind the stone layer of the abutment front walls. Gravels behind the internal arch barrel are well embedded in mortar. These observations are in line with the range of reflections perceived by the radar survey.
