# Fiber Optic Sensors to Perform Structural Health Monitoring of Concrete Structures Affected by Internal Swelling Reactions

**Abstract** Structural Health Monitoring (SHM) on concrete structures is an important issue in controlling its performance during its service life. Data obtained using this technology can provide valuable information for decision making about the needs for corrective interventions that can ensure the integrity and safety of concrete structures. When concrete structures exhibit internal expansions due to the several types of swelling reactions a strong surface mapping cracking process appears that can significantly affect its durability and performance. The paper presents the state-of-art of the use of fiber optics sensor to monitoring concrete structures with focus in the researches related with its use. Background of the theory regarding fiber optics sensors and advantages and limitations are also discussed.

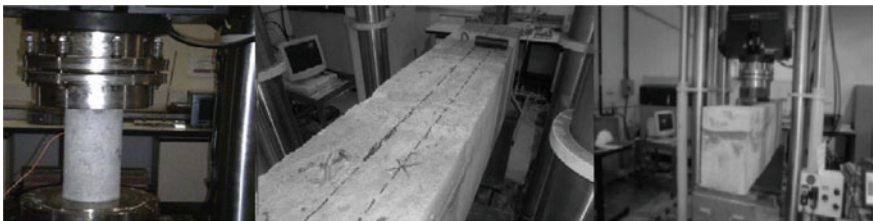
**Fig. 7** Cylindrical specimen and beams during tests (Yehia et al. 2014)

In Fig. 7, it is possible to observe the performance of tests with cylindrical samples and concrete beams, and in the Figs. 8, 9 and 10, it is possible to see the results provided by the sensors, for each test performed on the concrete samples, as a function of time.

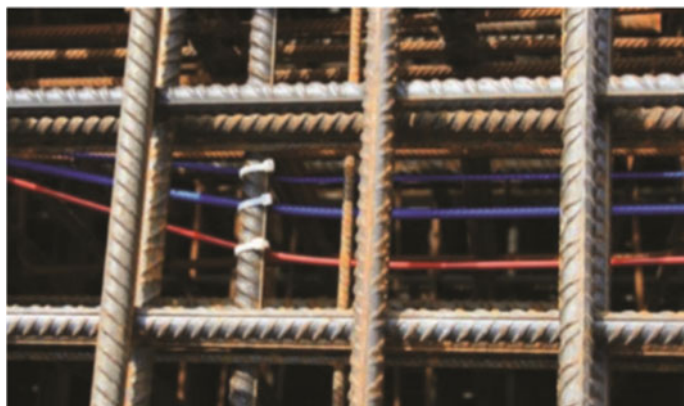
**Fig. 15** Three different sensor cables attached to the reinforcement (Horch et al. 2015)

of 20 m. As the structural element was 32 m. Altogether, 12 fibers were used coupled to the reinforcement (see Fig. 15), 8 for strain measurement (blue cables) and 4 for temperature (red cables). Regarding the 8 sensors, 4 had cables with a diameter of 3.2 mm and 4 with a diameter of 7.2 mm, in order to also compare the influence of the size of the cables in obtaining the results. The system is described in the Fig. 16.

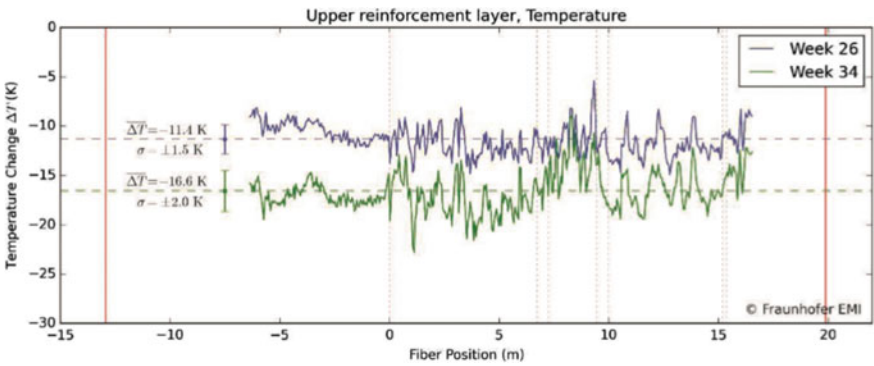
On the other hand, the temperature values oscillate around a constant average value throughout the foundation slab. The two horizontal lines in Fig. 17 show these average values. The author used these means to compensate for thermal expansion, so a constant stress displacement is calculated from the average temperature and subtracted from the measured strain values.

**Fig. 17** Results of temperature measurements. The horizontal lines show the average of the temperature curves. The solid red lines indicate the dimensions of the foundation slab. Position 0 is the position where the fibers leave the slab. The dotted gray lines mark vertical sections of the sensor cable (Horch et al. 2015)

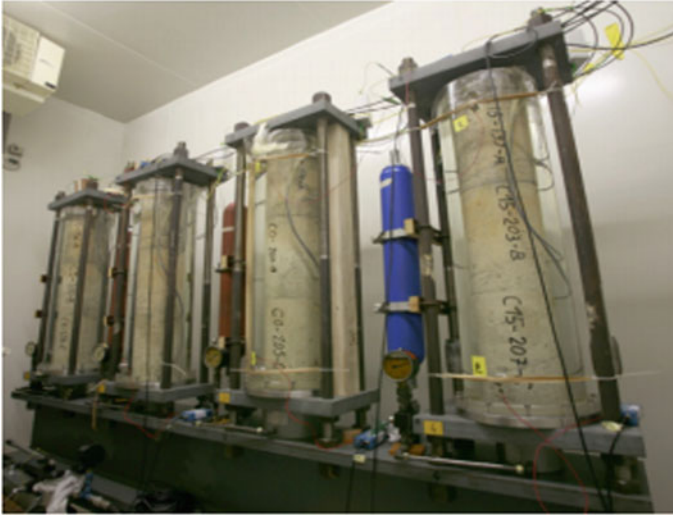
**Fig. 19** Samples in the loading frame (Horch et al. 2015)

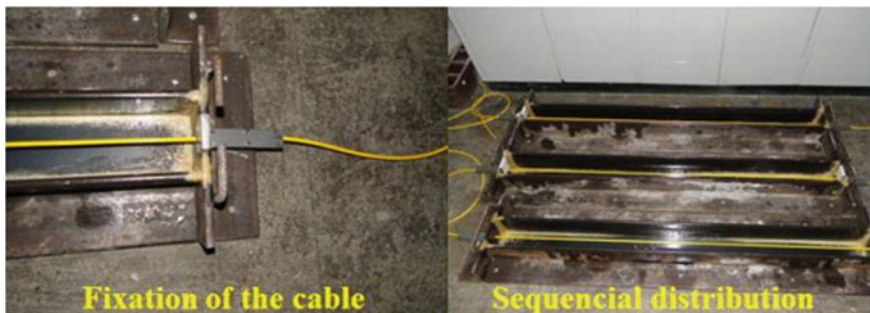
The forms were filled with mortar carefully to avoid damage to the sensors. Demolding occurred after 7 days. To perform external measurements, metal pins were fixed on the lateral surface of each sample. Each group of pins was fixed at least 50 cm apart. External measurements were made to compare with internal optical fiber measurements (Rocha et al. 2013).

**Fig. 22** Installation of the sensors in the molds (Rocha et al. 2013)

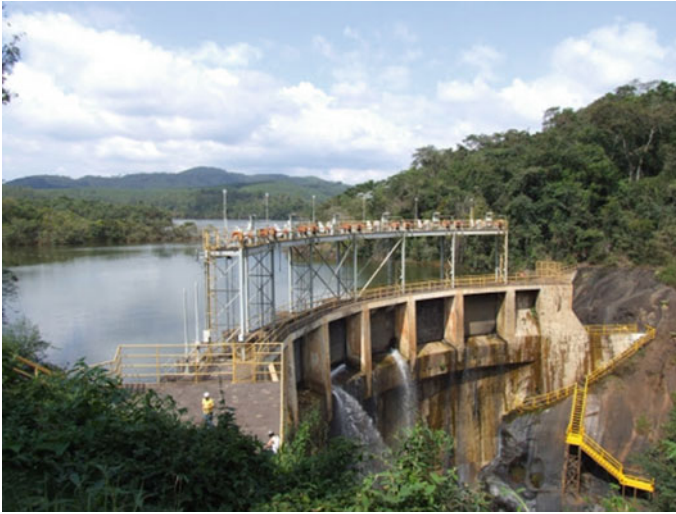
**Fig. 25** Peti Dam (Rocha et al. 2013)

According to the authors (Rocha et al. 2013), the first part of the experiment, carried out in the laboratory, served as a basis for understanding the measurement system that incorporates FOSs and only after the laboratory tests, the study began in a real structure. The structure in question is the Peti dam (see Fig. 25) that is located in the state of Minas Gerais, Brazil and was built between 1941 and 1945.

Unlike the studies previously presented in this work, in the case in question the installation of optical fiber sensors was done after the element already built. In this dam, structural abnormalities have been observed due to the reaction of the alkaline aggregate (AAR) since 1972. Eight preexisting vertical wells, with different depths, were instrumented with fiber optic sensors, with a depth of 3 to 30 m, distributed along the dam. One limitation encountered was the possibility of installing only in one direction. The column regions and the central section were instrumented, with a greater number of sensors on the left column, where greater degradation was reported. In this particular region, the DTSS and FBG sensors were applied. A schematic distribution of the DTSS cable is shown in the Fig. 26. The FBG sensors were installed on the left column next to the DTSS sensors in holes F5 and SR1.

Rocha et al. (2013) was observed that the Peti Dam is still showing evidence of a slow and continuous expansion due to the AAR. The installation of DTSS and FBG sensors in this structure offers a great opportunity for validating the use of optical fiber sensors for evaluation of expansions due to internal expansion reactions. Data readings can be taken in a few hours and are taken from a single point for the entire

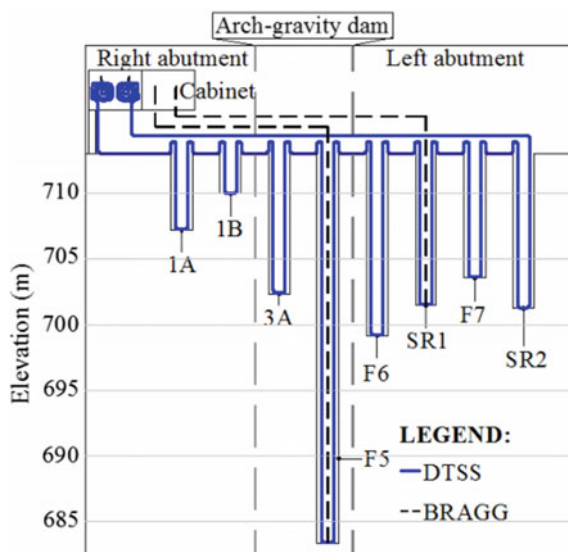
**Fig. 26** Distribution of fiber optic sensors (Rocha et al. 2013)
