Radiographic Workup of the Failed ACLR

Ajay C. Kanakamedala, Aaron M. Gipsman,
Michael J. Alaia, and Erin F. Alaia

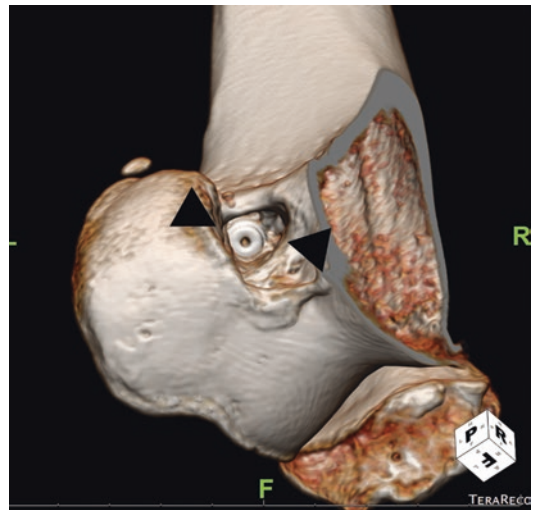
Fig. 2.4 Utility of 3D CT in the evaluation of the ACL graft tunnel. A 3D reconstructed CT image with medial femoral condyle subtraction demonstrates the aperture of the femoral tunnel (arrowheads), which appears widened, with gapping between the tunnel wall and the femoral interference screw

It is worth noting that, while plain radiographs can provide valuable information, multiple studies have shown poor inter-rater reliability and validity with the use of plain radiographs for the evaluation of tunnel placement when compared to MR and CT imaging. Moreover, it is often difficult to even identify bony tunnels on plain radiograph. Some authors recommend routinely obtaining CT imaging for the most accurate identification of prior tunnel position whenever precise measurements are needed [13]. Three-dimensional CT reconstructions can also be extremely helpful, as they can directly examine the aperture on both the femur and the tibia, especially when the medial femoral condyle is subtracted, as this allows a direct en face view of the lateral femoral condyle wall and the tibial plafond (Fig. 2.4).

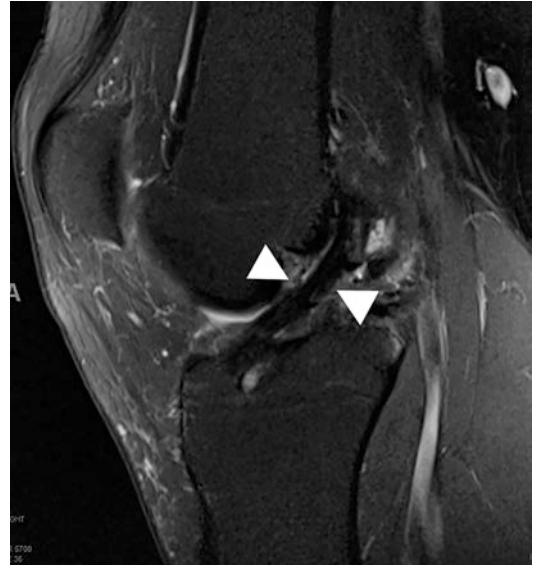
Fig. 2.6 Normal ACL graft. The normal ACL graft is homogeneously low in signal on fluid-sensitive images, with graft fibers intact and taut, and parallel to Blumensaat's line

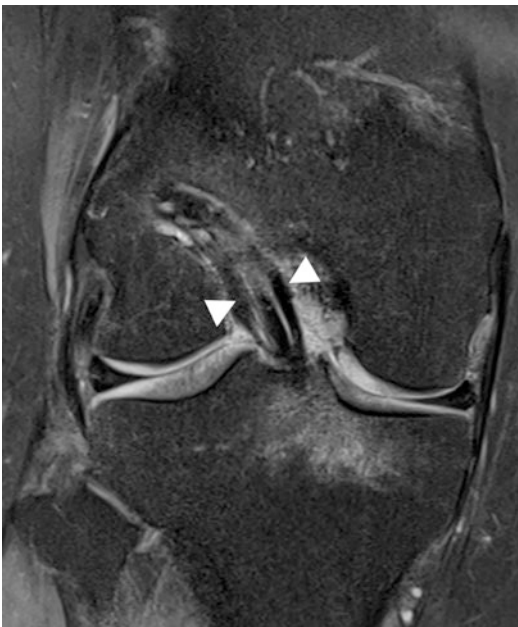
Fig. 2.7 Normal ligamentization of an ACL graft. Coronal MRI image shows thin longitudinal fluid signal along intact fibers of the ACL graft (arrowheads), representing the normal process of ligamentization in this patient 3 months following ACL reconstruction

phase will manifest on MRI as focal areas of intermediate signal within the graft that should not be misinterpreted as pathologic (Fig. 2.7). This signal intensity tends to slowly decrease as the graft matures [16]. While numerous studies have found varying timelines for ligamentization, some have reported that ligamentization may persist for up to 4 years following graft reconstruction [9].

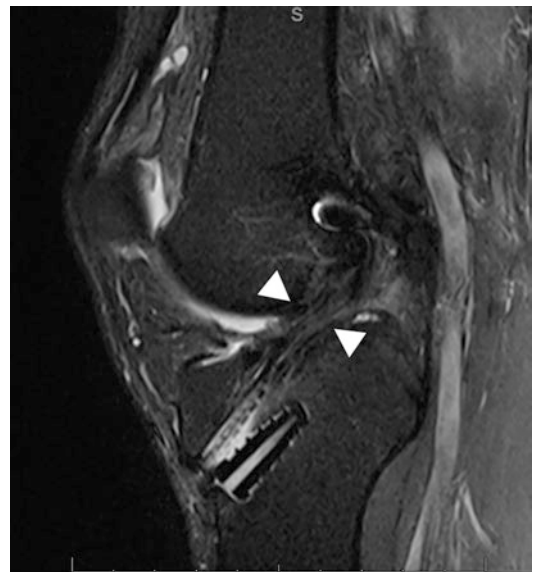
Fig. 2.8 Roof impingement following ACL reconstruction. Sagittal MRI image shows evidence of roof impingement, with anterior graft fibers (arrowheads) mildly frayed and kinked along the undersurface of the intercondylar notch. The tibial tunnel has an anterior position relative to where Blumensaat's line intersects the tibia, predisposing to roof impingement
