# Are the Badlands of Tapi Basin in Deccan Trap Region of India “Vanishing Landscape?” Badland Dynamics: Past, Present and Future!

Veena Joshi and Shreeya Kulkarni

## Abstract

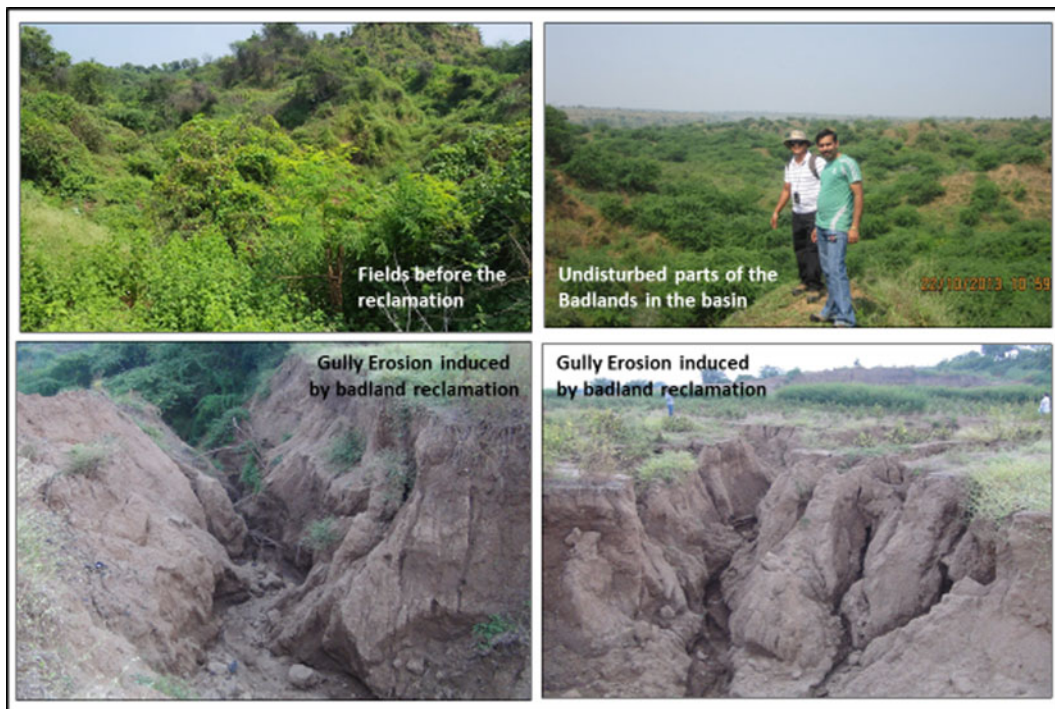
**Fig. 10.2** The field pictures of the undisturbed parts of the badlands and gully erosion after the clearance of the vegetation and levelling the land for agriculture, within the same watershed

Figure 10.2 depicts the undisturbed parts of the Tapi Badlands, as well as, freshly activated gullies in a field, which was taken in 2013. Figure 10.3 displays the same spot in 2017, where it is seen that all those previous active gullies were filled up and brought under cultivation.

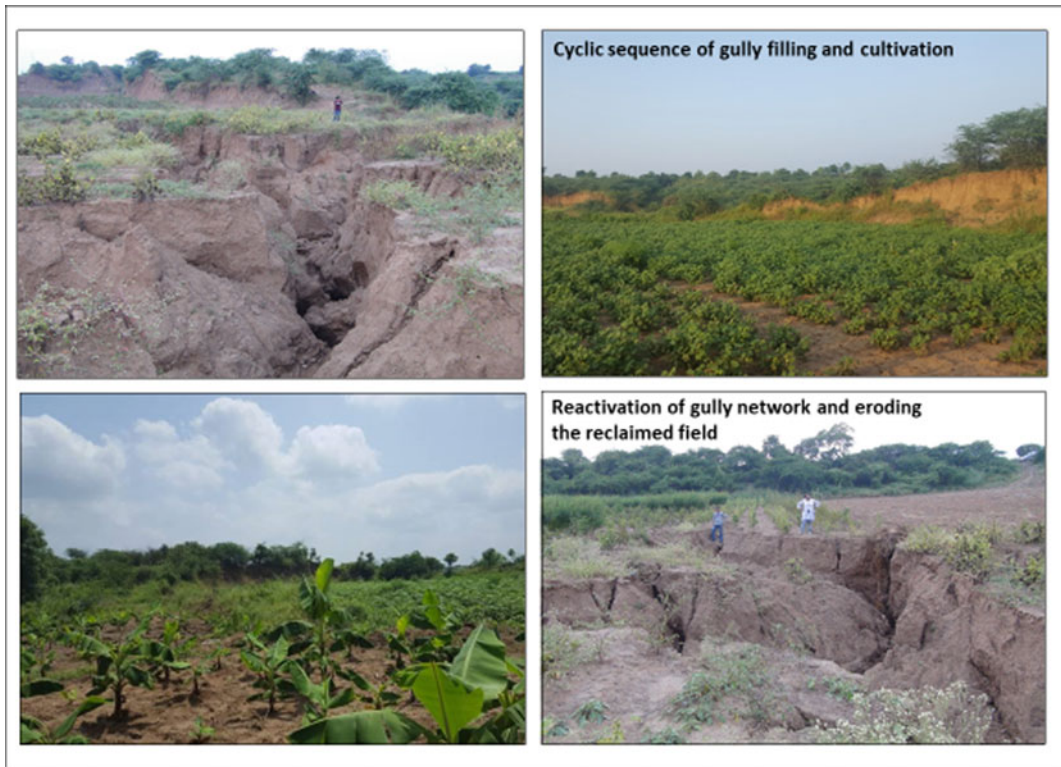
**Fig. 10.3** Scenarios after the badland reclamation are evident in these field pictures. Filling the gullies for cultivation, followed by reactivation of the gully network has been captured in the pictures

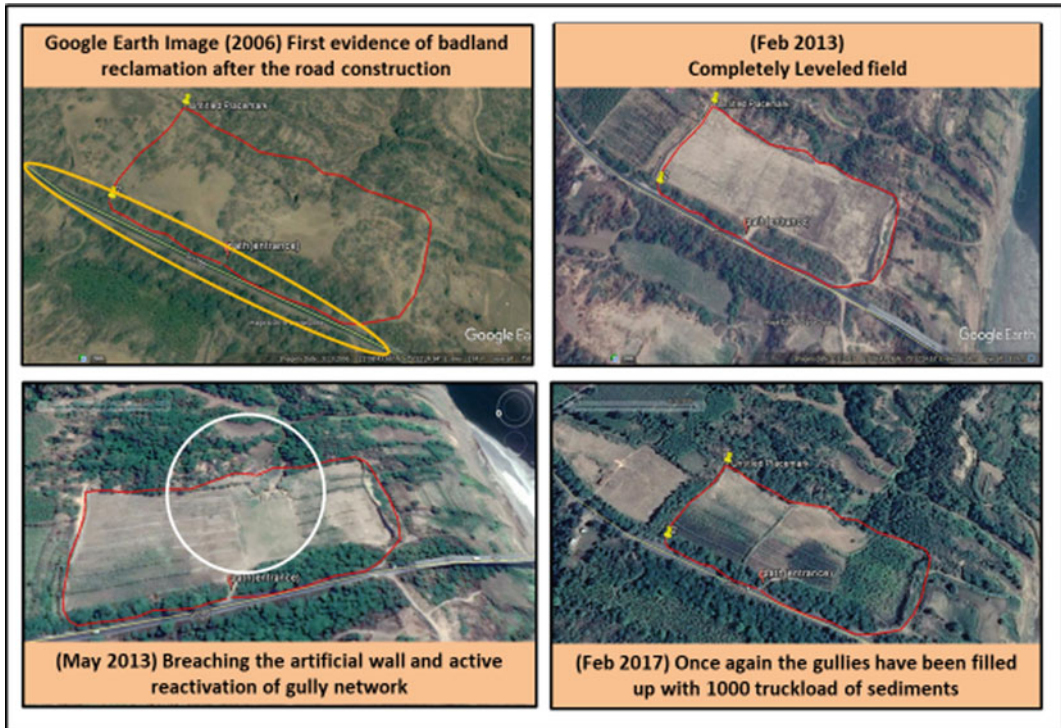
**Fig. 10.4** Google Earth images from 2006 till 2016, depicting stages of badland reclamation and gully reactivation in the area (a Yellow polygon depicts a road being constructed making the badland watersheds

accessible. The reclaimed field is right across the head of an active tributary gully of Tapi River, b increase in the reclaimed areas, c reactivation of the previous gully after a heavy storm and d refilling of the gullies)

Google Earth images and the DEMs along with the field photographs reveal that the AOI is undergoing a rapid change. There is a steady increase in the reclamation of badland areas and consequences of gully reactivation from 2005 till the present. The biggest change was observed in 2013 when some heavy spells destroyed the artificial wall across the gully and caused widespread gully erosion. Photographs taken from the field in 2013 provided a good evidence of the severity of gully erosion in the area. The gullies were finally filled in 2016 and brought under cultivation once again.

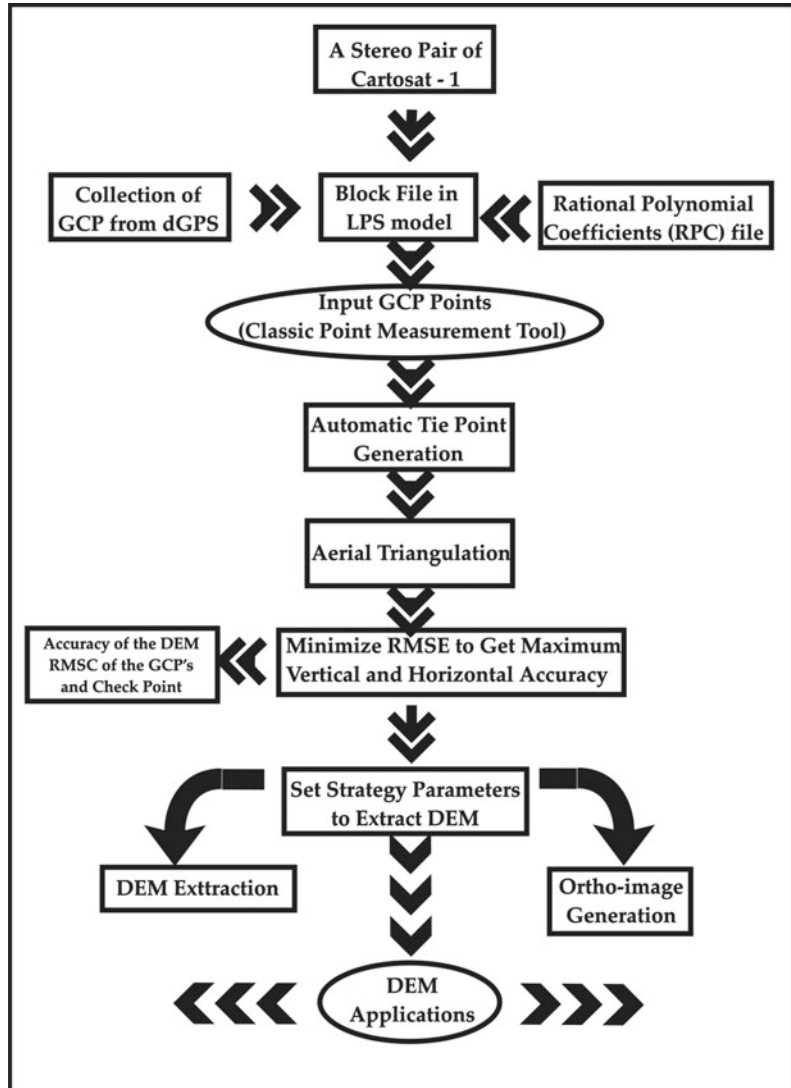
**Fig. 10.5** Flow chart demonstrating steps of the generation of DEM from Cartosat I images, in Leica Photogrammetry Suit 9.2 and Arc GIS 10

- In order to detect the changes in the morphometry resulting from excessive periodic land reclamation, DEMs of three time periods, such as, 2005, 2010 and 2015 were self-generated from IRS (Indian Remote Sensing) Cartosat I stereo images. Leica Photogrammetry suit (Version 9.2) and Arc GIS 10 were used to create the three DEMs. To study the micro-relief of the field, a detailed survey was conducted using dGPS (differential Global Positioning System) to create DEM of the present field morphology at 5 cm resolution.

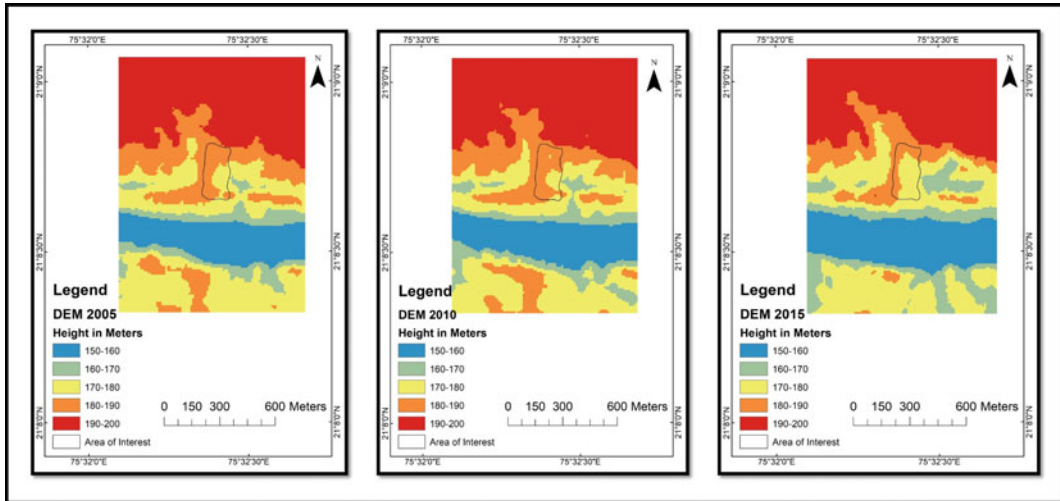
**Fig. 10.6** DEMs of 2005, 2010 and 2015, with 10 m resolution

Under the natural conditions, major changes in the hillslope morphology within a time span of 10 years are not expected. But such changes can be possible in an area that is actively interfered by human activities, as in the present study area. Figure 10.5 depicts the flowchart showing the methodology to generate DEM from IRS Cartosat I images and Fig. 10.6 displays the DEMs of the three time periods created at 10 m resolution. The three DEMs were used to assess the changes in the hillslope morphology from 2005 to 2010 and 2015. All the 3 DEMs (12 Dec 2005, 12 Dec 2010, and 10 May 2015) show noteworthy differences in the elevation as well as in the slope.

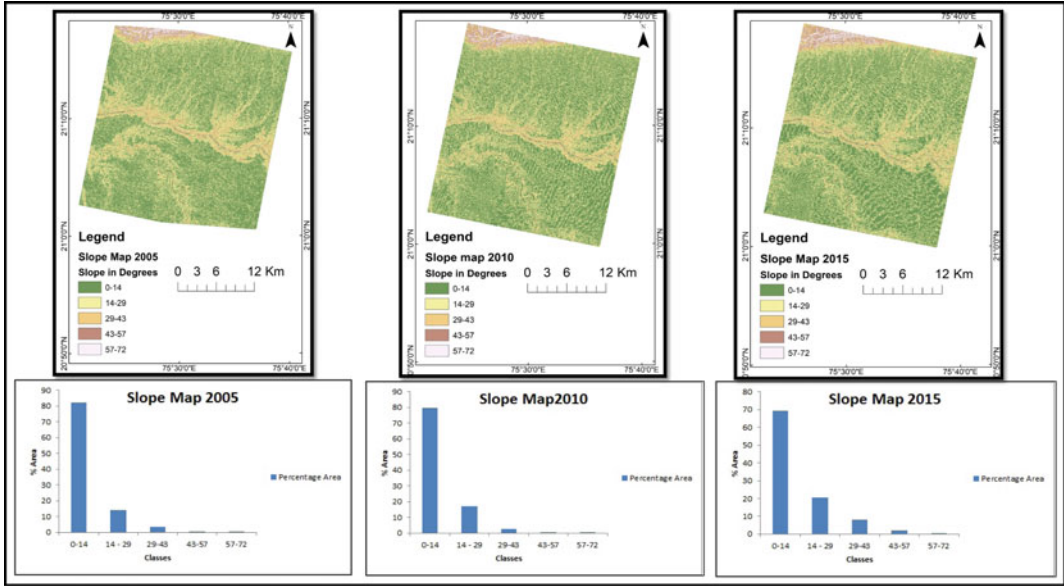
Fig. 10.8 Slope maps and their categories, for the three time periods (2005, 2010 and 2015)

Slope of the area also revealed noticeable changes. Area under  $14^{\circ}$ – $29^{\circ}$  category increased significantly (5% in five years) from 2005 to 2010 (Fig. 10.8). Area under  $14^{\circ}$ – $29^{\circ}$  and  $29^{\circ}$ – $43^{\circ}$  categories also increased noticeably (10%, in five years) from 2010 to 2015. Category  $0^{\circ}$ – $14^{\circ}$  decreased in the area by 10%. Slope category  $43^{\circ}$ – $57^{\circ}$  was absent from 2005 and 2010 DEMs but they start appearing in 2015 DEM. Overall assessment of the slope is that they are visibly changing.

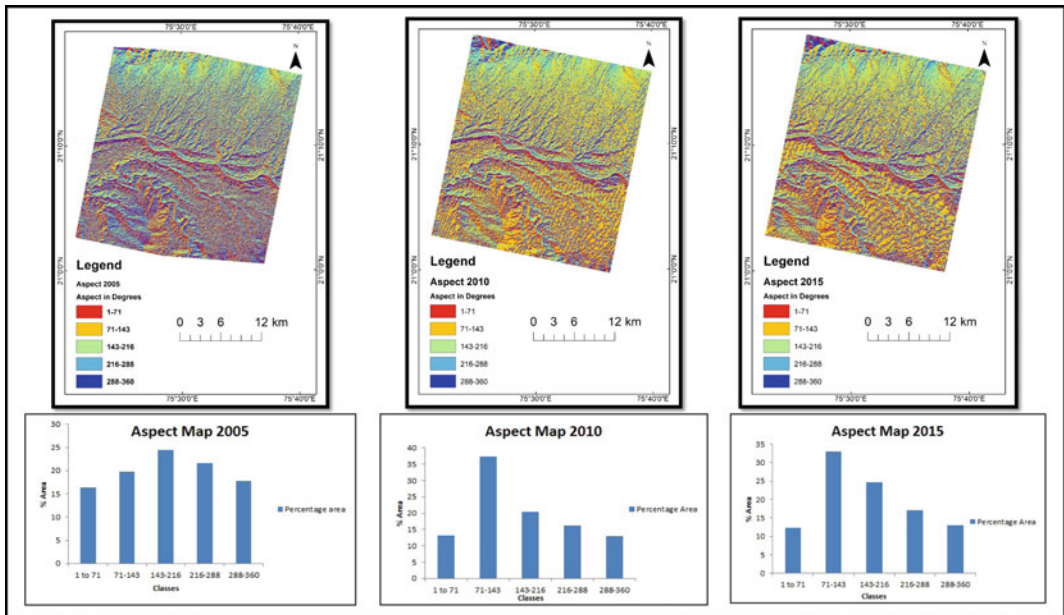
Fig. 10.9 Aspect maps and their categories, for the three time periods (2005, 2010 and 2015)

There are a lot of changes in the aspect map also as can be seen in Fig. 10.9. Slope orientation has considerably modified from 2005 to 2010 but the change is not significant between 2010 and 2015. These categories were chosen based on the observation of the main slope aspects of the badland

terrain in the area. Significant changes in the area can be observed in all the categories. Maximum change can be observed in the category of 71–143 with 15% increase in the area between 2005 and 2010. Category 145–216 and 216–283 decreased by 5% each in the area in the same time. Though the change is slight, pattern remained more or less the same between 2010 and 2015. All the three parameters indicate remarkable changes between 2005 and 2010, implying a major remodelling during this time. Such dramatic changes within such a short time can validate the significant impact of human interference in the region.

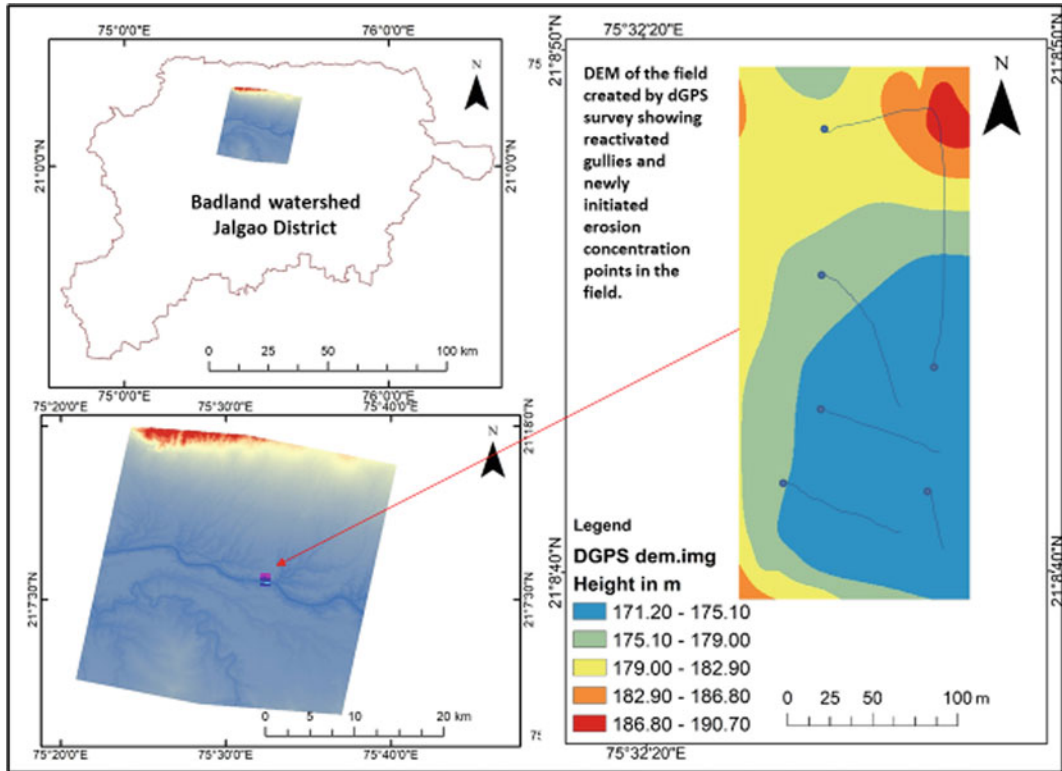
**Fig. 10.10** DEM of the field under review created by field survey using dGPS with resolution of 5 cm. Many erosion concentration points can be seen on the DEM, which are following the original gully network

During the recent field visit to this area, reactivation of the gullies and the erosion concentration points were observed all over and also documented in the DEM generated from a field survey. Blocking the gullies and filling them offer just a temporary solution but the energy of the landscape is not diminished. Rainwater will flow with the same vigour and find its way to the river, eroding all the way. It is very clearly seen in the field that several minor rills and two major ones have already formed on the field. With time, it will deepen and once again the old network of gullies will be reactivated, unless a well-engineered diversion is created.

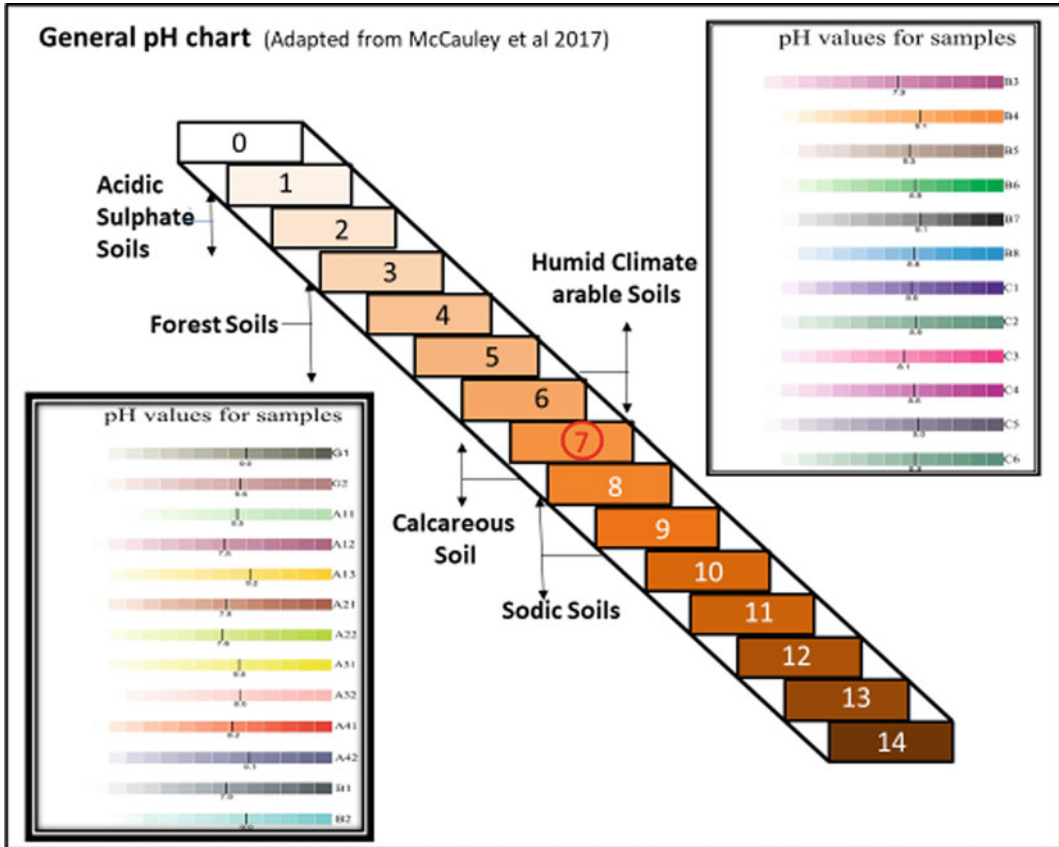
**Fig. 10.11** General pH chart in the center (adapted from McCauley et al. 2017) and the pH of the samples from the field. The diagram shows the relation between pH and sodicity of the sediments

category of moderately sodic class. An association of pH with the general sodicity of the sediments has been depicted in Fig. 10.11 that indicates that samples having pH value between 8 and 10 are sodic in nature. ESP values for the samples indicate that they can be put under the category of moderate to highly erodible category. The pH of 25 samples from the area shows the value between 7 and 9, that also supports the observation.

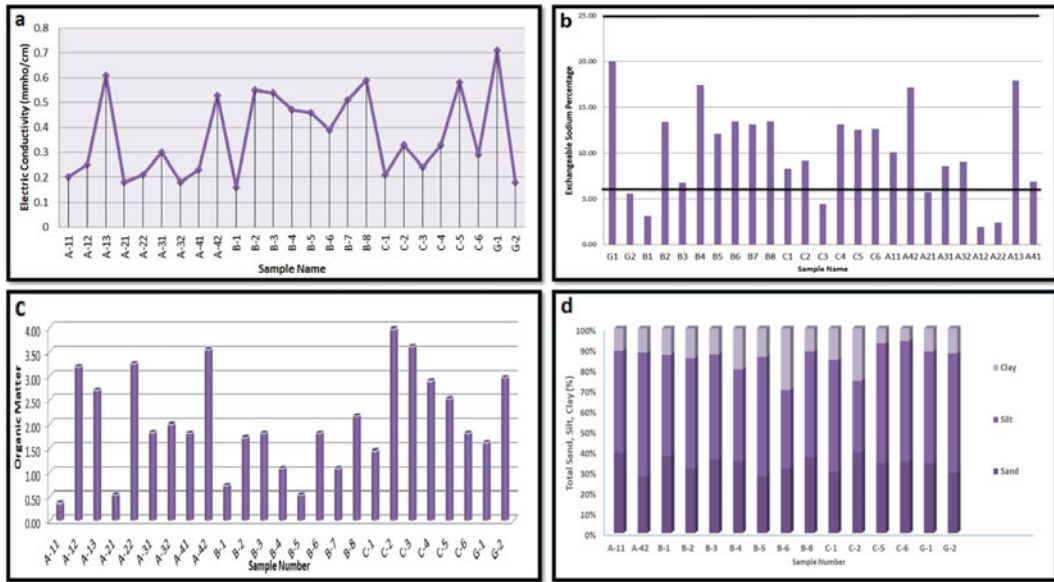
**Fig. 10.12** The diagram depicts the results of four sediment parameters of the area (a electric conductivity, b exchangeable sodium percentage, c percentage organic matter, d sediment textural classes

Most of the samples ESP range in the value between 5 and 15% (Fig. 10.12). The average

Textural analysis of the fifteen samples was carried out by using sieving for the coarse sands and sedigraph for silt and clay. It is evident from Fig. 10.12 that silt content is higher than sand and clay in all the samples. Sand allows water to transmit through and hence soil containing higher percentage of sand is not erodible. Clay has the property of forming compact layer as well

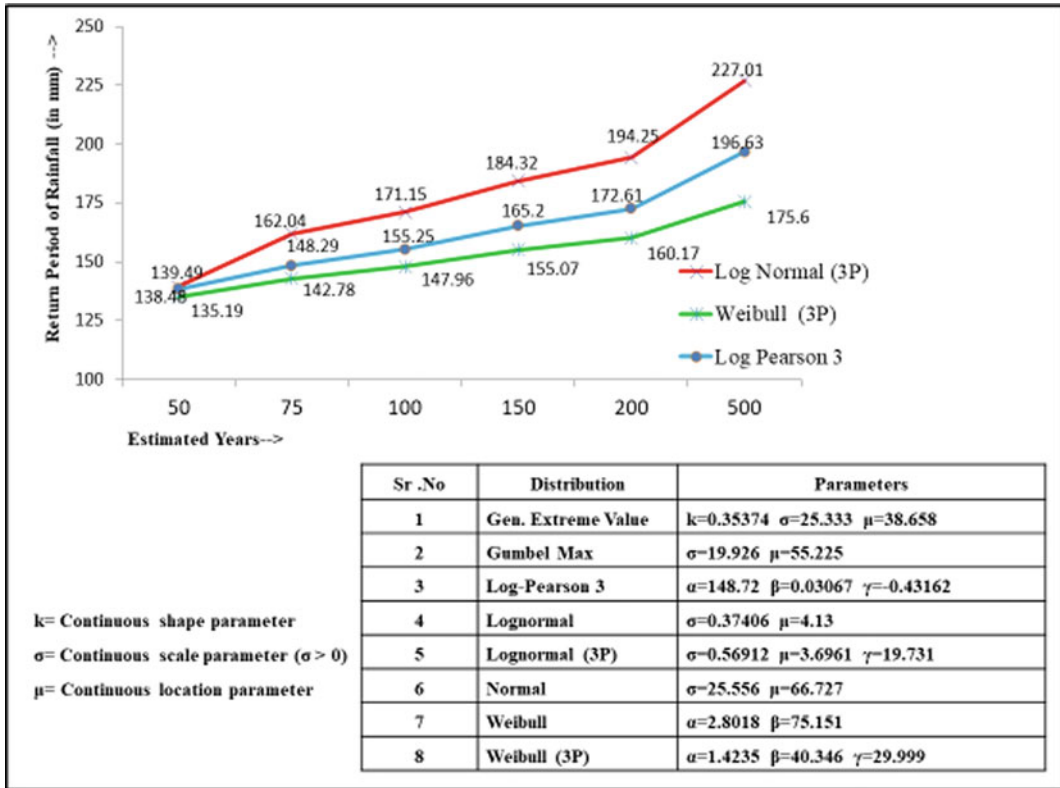
**Fig. 10.13** Estimated return period of the rainfall for 500 years, for the three top ranking techniques, such as, Lognormal (3P), Weibull (3P) and Log Pearson 3 (based on Anderson–Darling goodness-of-fit test). Inset is the parameters of the eight statistical techniques used for the trial statistics in Anderson–Darling goodness-of-fit test

142 mm/day after Log-Pearson 3. The five-hundred-year estimate goes up to 227 mm/day.

The data presented above implies that the chances of a rain event of 227 mm/day occurring in this region are once in 500 years or an event of 194 mm/day is 200 years. If it happens, it will create catastrophe in these fields and everything will get eliminated. Effect will be even more pronounced when the land is disturbed and loosened by the cultivation of crops. Figure 10.2 clearly showed that when undisturbed, these badland slopes are stabilized by vegetation reducing vulnerability. The real threat is when the watershed is disturbed, that progresses towards positive feedback of the system.
