The Right Key

Four Spacewalks to Repair the Alpha Magnetic Spectrometer on the International Space Station

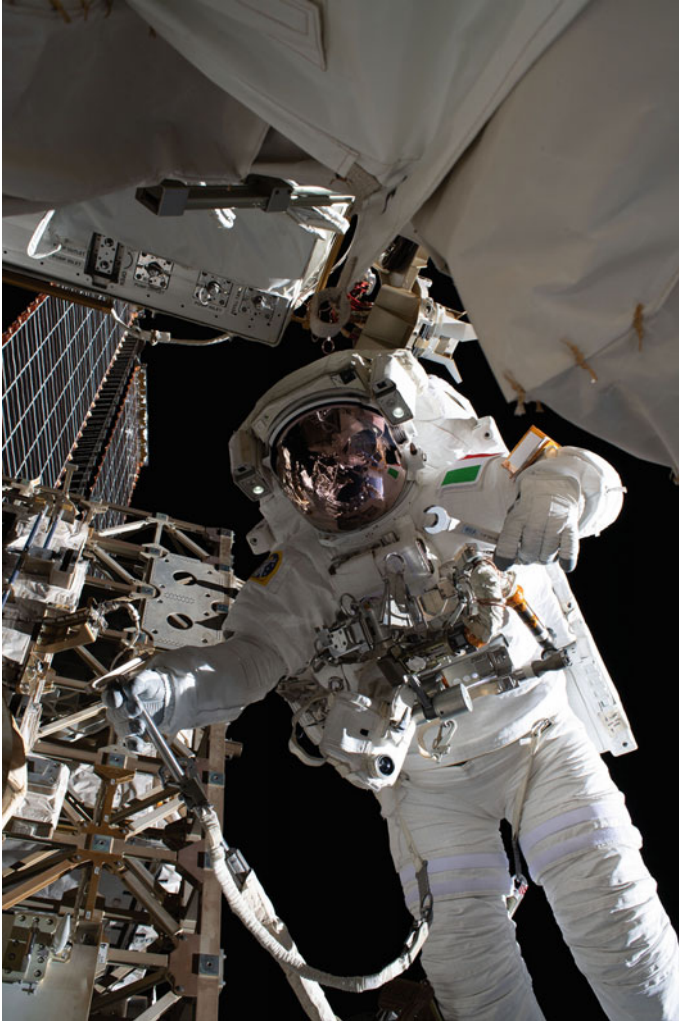
Fig. 6 Luca Parmitano outside the ISS with the wrench and tools in his hand (Photo credit NASA)

While the giant image of Luca Parmitano holding that 7/8” wrench in his hand occupies the giant screen, an explosion of relief, (Fig. 6) gratitude and pure joy pervaded every face in the AMS POCC at CERN. A relieved and as joyful as rarely can be seen (Fig. 7) Sam Ting declared: “*William Gerstenmeier, head of human spaceflight at NASA, thought this it was such a complex thing to do, because it was totally unprecedented. But NASA has to learn to do new things in space, because if they want to have a base on the Moon, or go to Mars, for instance, you need this type of things. We are very grateful to the astronauts who accomplished a fantastic feat, an almost impossible mission.*”

Thanks to that “SIMPLE 7/8” wrench, Parmitano was able to solve a problem that had not occurred during the training in the labs. The astronaut considers the image of him holding “**the right key**” as the symbol of the entire AMS spacewalk programme. “*I liked that photo immediately, because it showed that complex problems are often solved with the ingenuity of the simplest tools such as a lever, first used by Archimedes and represented by that wrench, which allowed us to repair such complex equipment as AMS-02 in this case.*”
