Implants

L. Chow, B. Li (eds.), *Absolute Breast Imaging Review*,
https://doi.org/10.1007/978-3-031-08274-0_9

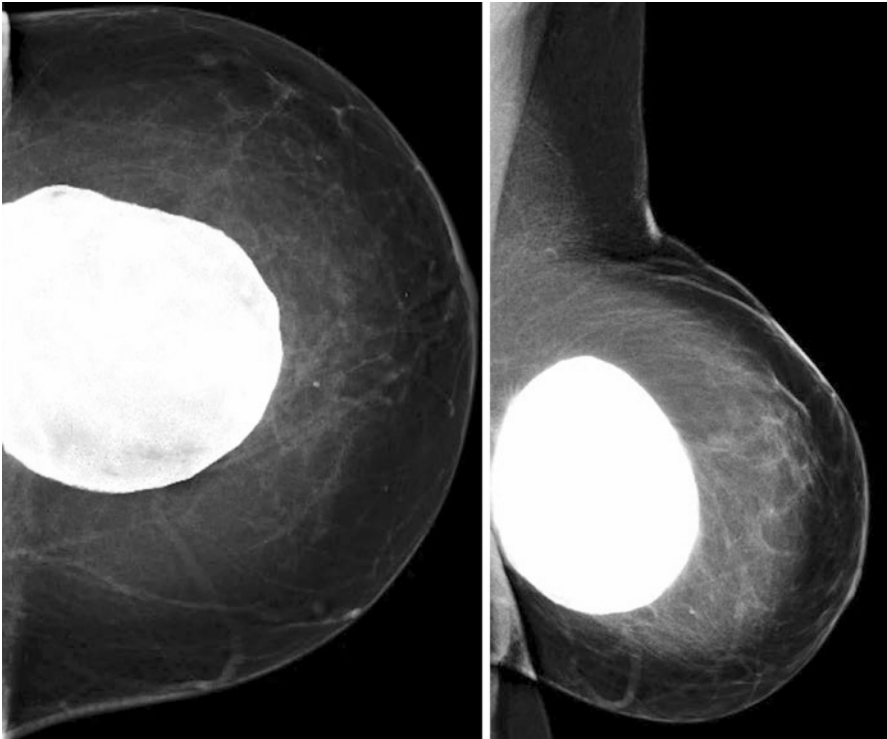
- 4a. A 53-year-old female with history of implants presents with left breast pain, firmness, and change in shape. CC and MLO views of the left breast are shown. What is the most likely diagnosis?

The left implant appears rounded and spherical rather than oval in shape, indicating capsular contraction. Another finding include contour irregularity. Capsular contraction is one of the most common complications after breast augmentation. It refers to a tightening of the fibrous capsule surrounding the breast implant, most commonly occurring within months after implantation but can occur at any time [5].

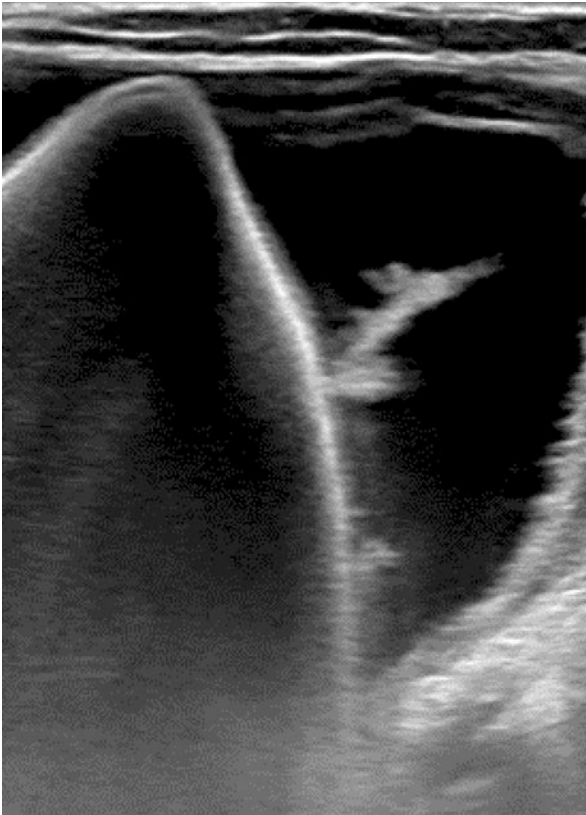
- 12a. A 55-year-old woman with a remote history of bilateral breast augmentation presents with asymmetric swelling and pain of her right breast. Mammogram was negative. What is the next best step?
- (a) Nothing.
 - (b) Ultrasound.
 - (c) MRI.
 - (d) Surgical consultation.
- 12b. An ultrasound was performed. What is the differential diagnosis for this peri-implant fluid collection?

A late seroma associated with a breast implant is defined as a periprosthetic fluid collection occurring more than 1 year after the breast augmentation or reconstruction procedure. This complication is rare and usually benign. The symptoms can be indistinguishable from those of Breast Implant-Associated Anaplastic Large Cell Lymphoma (BIA-ALCL). At a median age of 10 years after implant placement, the typical presenting features are sudden onset of breast swelling from peri-implant effusion and less likely a mass [7].

The initial assessment of late onset enlargement of the breast in the setting of breast implants should include a clinical history querying recent trauma or infection. An initial screening with breast ultrasound should be performed to assess for implant integrity, the presence of effusion, the presence of a mass and axillary lymph nodes. If an effusion is present, fluid aspiration is indicated in an attempt to relieve the patient's symptoms and to exclude breast implant-associated anaplastic large cell lymphoma (BIA-ALCL). At least 50 ml of effusion fluid should be analyzed for cytologic analysis and immunophenotyping, culture, cell count, and protein. In contrast, 5–10 ml of fluid surrounding an implant in an asymptomatic patient is usually normal and generally does not require further investigation. Surgery (en-bloc capsulectomy) followed by chemotherapy and radiation are typically the next steps in management [7]. In this case, cytology revealed a breast implant-associated anaplastic large cell lymphoma.

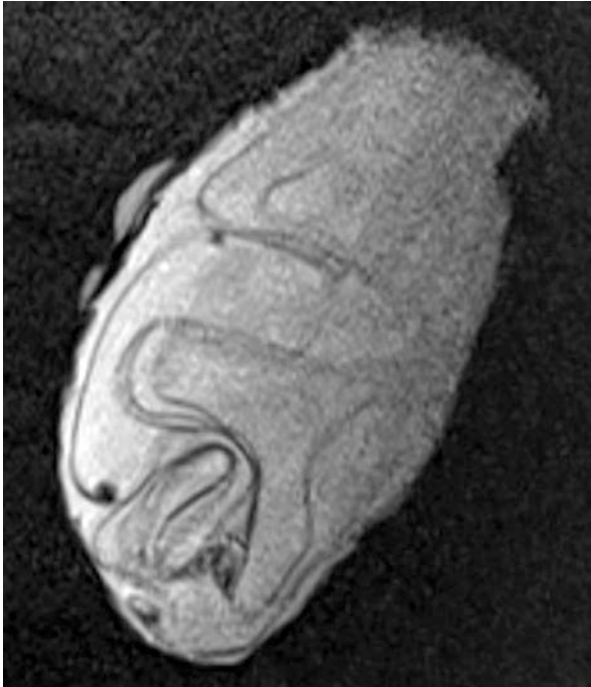
16. A 70-year-old female is seen for callback from screening. Silicone-sensitive sequence image of the breast is provided. What is the diagnosis?

The irregular contour of the right breast implant and presence of silicone outside the implant capsule (red arrow) indicate extracapsular silicone rupture of the implant. Free silicone injections and breast lymphoma have an alternate

appearance. Linguine sign is also seen which is indicative of intracapsular rupture.
