# A Brief History of Nuclear Reactor Accidents

From Leipzig  
to Fukushima

Serge Marguet  
SINETICS, Bureau O2 EF:05  
Electricite De France, Recherche et D ev  
Palaiseau, France

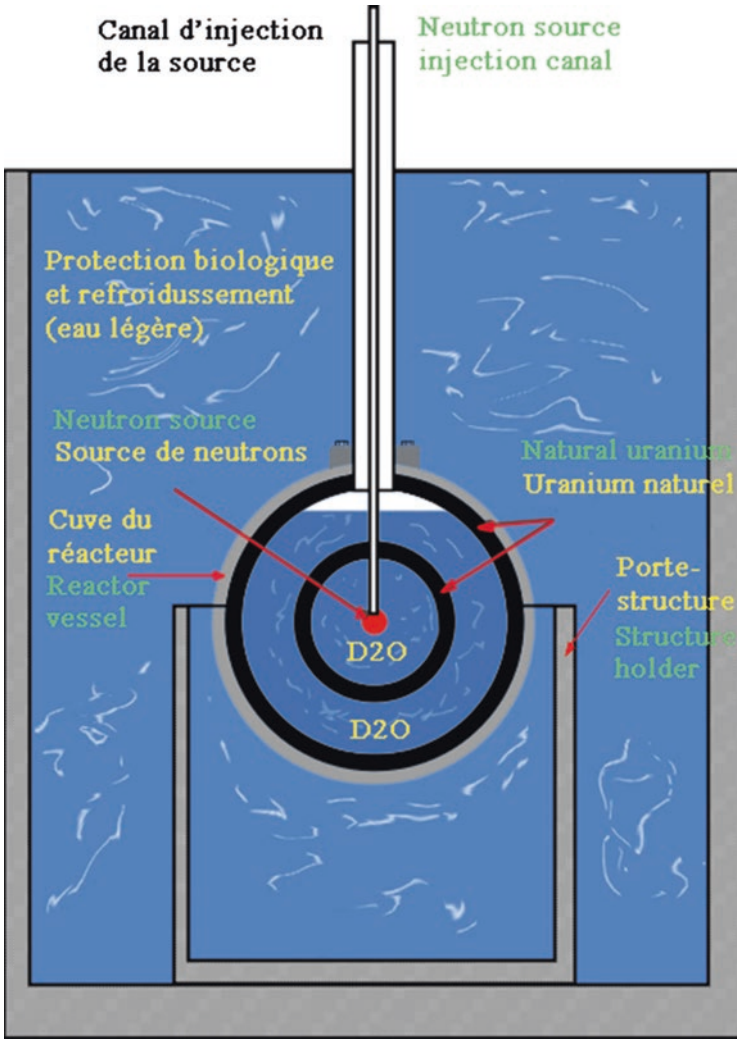
**Fig. 2** Leipzig reactor of 1942 (L-IV with metallic uranium). It was necessary to leave a little vacuum in the vessel to take into account the thermal expansion of the heavy water during the heat-up. One of the realistic causes of the explosion of June 23, 1942, is that this void would have been filled with air at dismantling, reacting explosively with the uranium at high temperature, especially in the form of powder, and especially if the uranium had been hydrated during the 20 days of operation. It is known that uranium hydrides are particularly pyrophoric. It should be noted that no system for

The Leipzig research group was led by Heisenberg until 1942. Heisenberg then withdrew from practical experiments and left the execution of the L-III and L-IV experiments (Fig. 2) mainly to his colleagues under the direction of

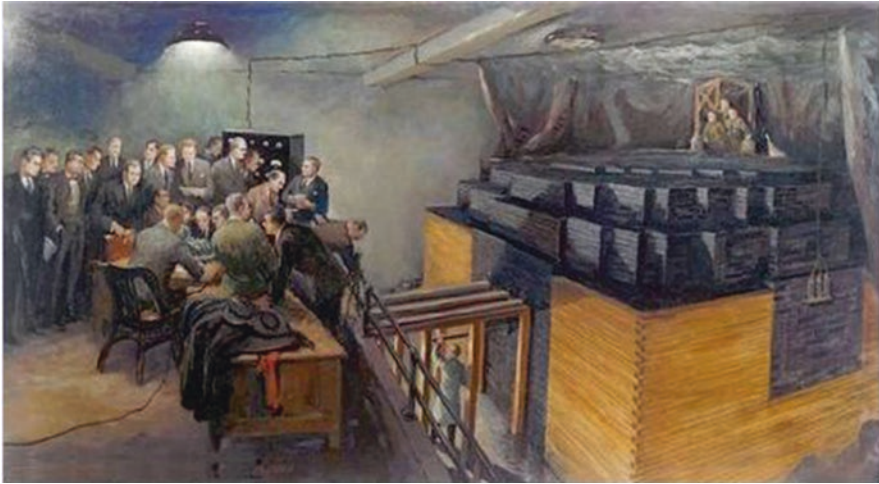
**Photo 8** The famous CP-1 pile of Fermi (*pile* in English means stack. The word is also used in French, although the usual meaning is *battery*). As there are practically no photos of the pile itself and of this historical event, only this painting allows us to understand the excitement preceding the divergence of December 2, 1942. At the top of the pile is the wooden frame under which the shutdown control rod is suspended (Painting by Gary Sheahan (Joseph "Gary" Sheahan (1893–1978) was born in Winnetka, Illinois. He studied at the University of Notre Dame and the Chicago School of Art before joining the *Chicago Tribune* as an illustrator in 1922. He is best known for his World War II paintings, having participated in the D-Day landings.))

From the first Fermi pile in 1942 (Photo 8), there was concern about the safety of the reactor and a redundancy of reactor shutdown resources was planned. First of all, a scientist, Norman Hilberry, nicknamed afterward “*the Axe man*”,<sup>22</sup> armed with an axe, stands over the pile, ready to cut the rope holding a cadmium-coated shutdown control rod, a powerful neutron

absorber, which will then fall by gravity into the core. The image is so striking that at the end, the word SCRAM, widely used in the nuclear industry to signify the shutdown, has been associated a posteriori<sup>23</sup> with the significance *Safety Cute Rope Axe Man* or *Safety Control Rod Axe Man*. A second operator, the physicist Wallace Koehler, is always standing over the pile, armed with a tub full of a cadmium sulfate solution, ready to spray it in the reactor. Cadmium is indeed one of the most powerful absorbers of slow neutrons. We find here the current principles of redundancy in safety systems. The pile is controlled by a horizontal cadmium control rod handled by hand by the operator George Weil, and Enrico Fermi supervises the neutron flux measuring devices.

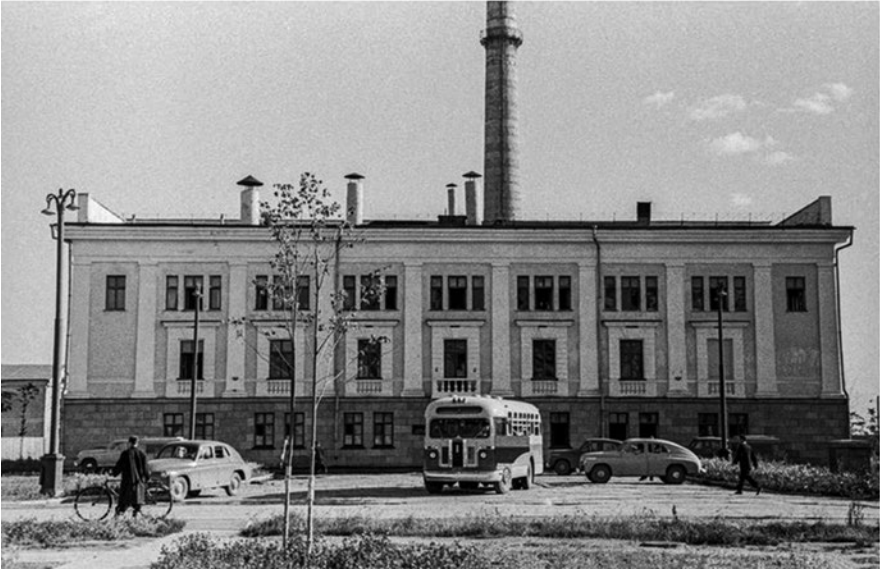
**Photo 10** The building containing the Obninsk reactor (August 1955), in the Kaluga region. The first power reactor in the world. The construction of the plant began on January 1, 1951, and the reactor diverged on June 27, 1954, to shut down on April 29, 2002

From this pioneering work, the development of nuclear reactor technology was to be rapid and awareness of the risk of accidents was to develop at the same time as physicists' understanding of reactor behavior. The first industrial-scale piles were built at Hanford (USA) to produce plutonium for the American military program. On June 27, 1954, the Russian plant in Obninsk (5 Mega Watt electric or MWe, 30 MWthermal or MWth) produced the first industrial production of nuclear electricity on the city's grid. This reactor (Fig. 6, Photos 10 and 11) was conceived by the very discreet "*Laboratory n°2*," in fact a secret institute in charge of conceiving the atomic bomb, and which will become in 1960 the Kurchatov Institute, named after its first director Igor Kurchatov.<sup>25</sup> The reactor was permanently shut down on April 29, 2002 to become an Atom Museum.

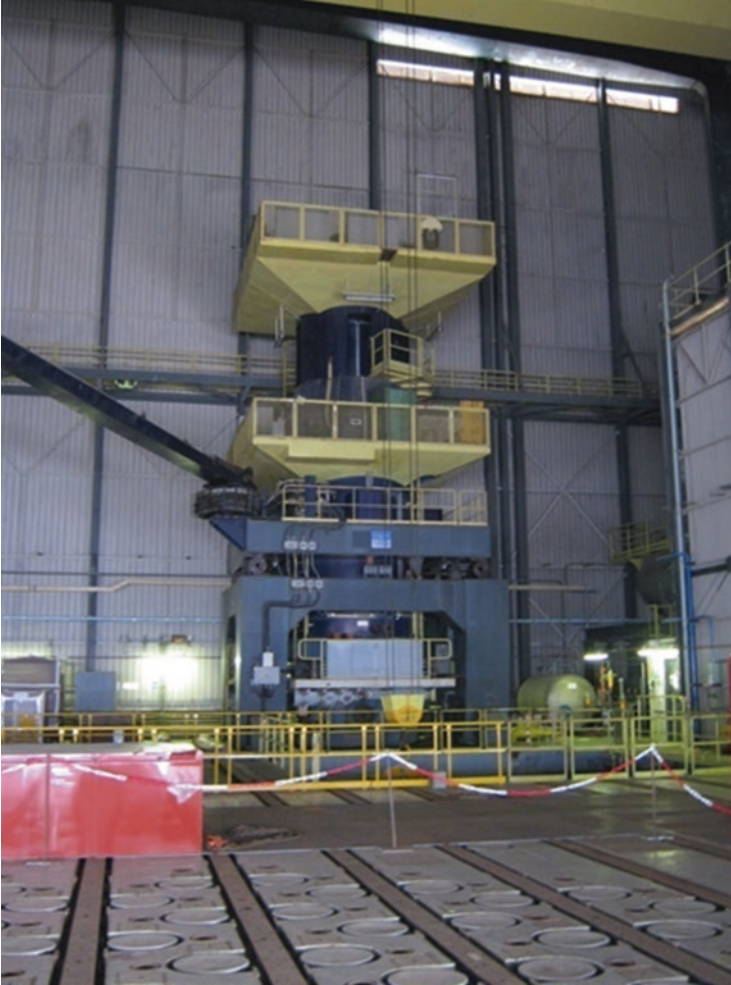
**Photo 1.3** Natural uranium graphite gas reactor (first French reactor type). The Saint Laurent-A loading platform and the Main Fuel Handling Device. The rails of the fuel loading machine and the tulip-shaped plug closed next to a CO<sub>2</sub> channel can be seen (photo: Bouchacourt-Foissote-Valdenaire)

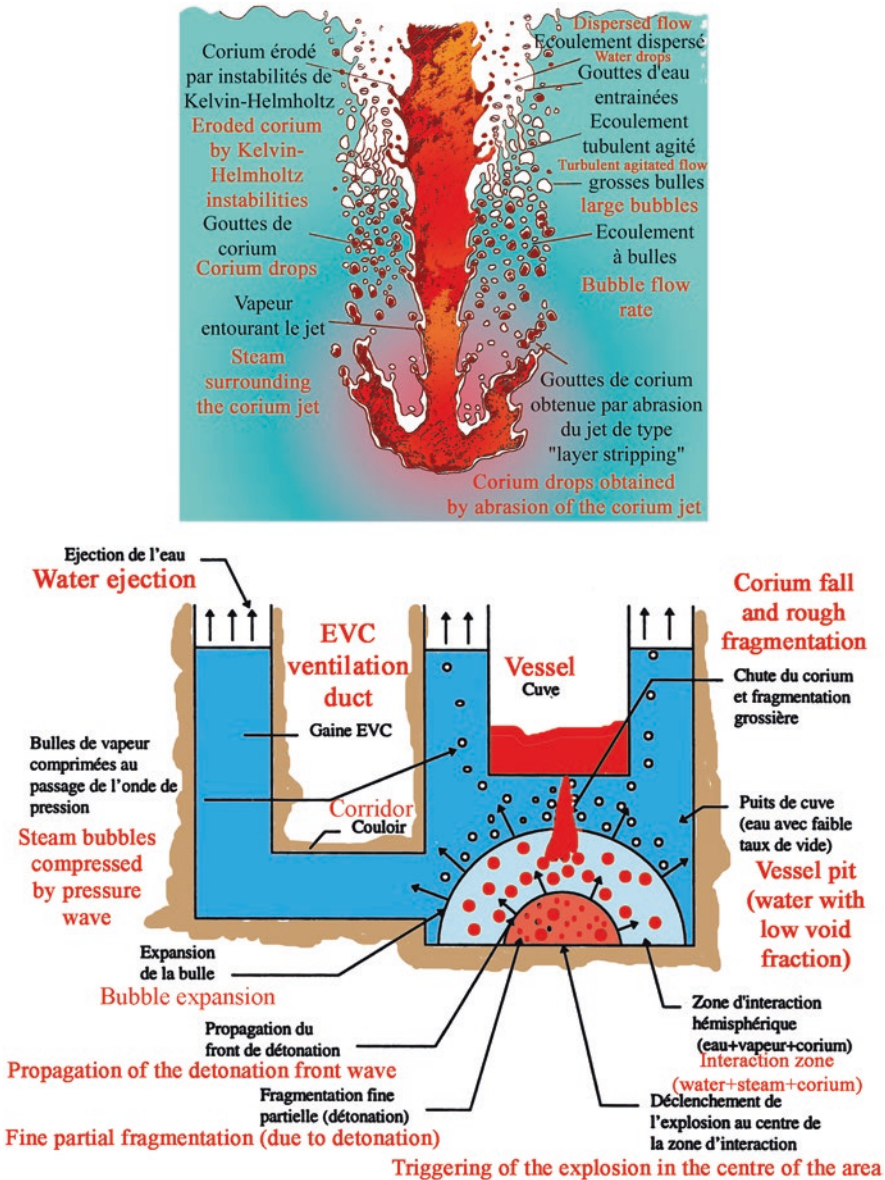
Fig. 1.4 Fragmentation of a jet of corium falling into water and risk of steam explosion which sets in motion by piston effect the columns of water around the vessel and in the EVC duct of access to the pit, hence a possible water hammer

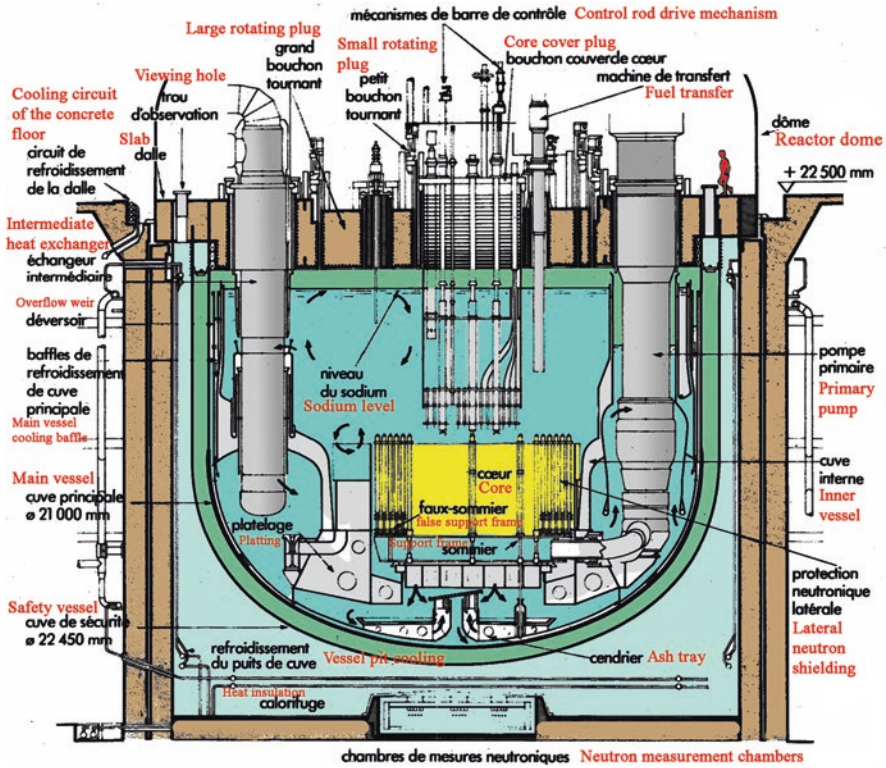
Fig. 1.5 View of the SUPERPHENIX reactor vessel: the sodium-sodium heat exchangers extract heat from the reactor. A safety vessel encloses the primary circuit to collect any leakage. A rotating plug allows the assemblies to be handled without having to open the reactor, whose sodium remains protected from the air by a mattress of argon gas

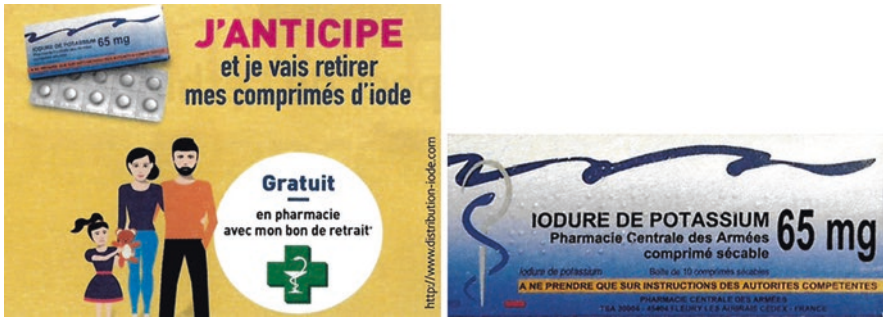
Photo 1.4 Iodine tablets distribution cycle and packaging box

There is an effective way to avoid radioactive iodine contamination independently of the evacuation. That is to use the thyroid's appetite for iodine by administering a stable iodine tablet to the subject. In the event of an accident, radioactive iodine is inhaled or ingested and will concentrate in the thyroid. In case of inhalation, part of it is expectorated during exhalation, the other part enters the lungs and the blood, and finally is absorbed by the body. If ingested, iodine enters the bloodstream in about 2 hours, but some is eliminated through the natural way. In an adult, it is estimated that about 30% of this iodine incorporated in the blood is fixed by the thyroid. The radioactive iodine fixed by the thyroid will then kill cells or damage their DNA by the emission of electrons due to the radioactivity, causing cancers in the long term. The idea of the stable iodine tablet is to saturate the thyroid with stable iodine before the subject is exposed to radioactive iodine, as the thyroid can only absorb a certain amount, after which the thyroid inactivates specific iodine transporters in the same way that a full stomach signals satiety to the brain. Taking stable iodine protects for at least 24 hours, providing a respite for the evacuation of people. Iodine 127 comes in the form of potassium iodide KI tablets produced in France by the *Pharmacie Centrale des Armées*. These tablets will be distributed to the populations concerned in the event of an accident. People who live within 10 to 20 km of a French nuclear plant can have pre-positioned tablets at home by picking them up free of charge at their nearest pharmacy. This provision allows them to be taken as soon as an accident involving a radioactive release is announced. The tablets are dosed at 65 mg and can be broken into four parts to respect the dose to be taken according to age (two tablets above 12 years, one tablet between 3 and 12 years, half a tablet from 1 month to 3 years, and a quarter tablet below 1 month for babies). The protection acts from 24 to 48 hours. The IRSN (the French Technical Support of the Safety Authorities) is considering the possibility of treatments including several doses over 7 days, except for pregnant women because fetuses are very sensitive to iodine. Consideration is being given to the possibility of overdosing, as it is to be expected that some people, too curious or too anxious, will take all the tablets at once (Photo 1.4).

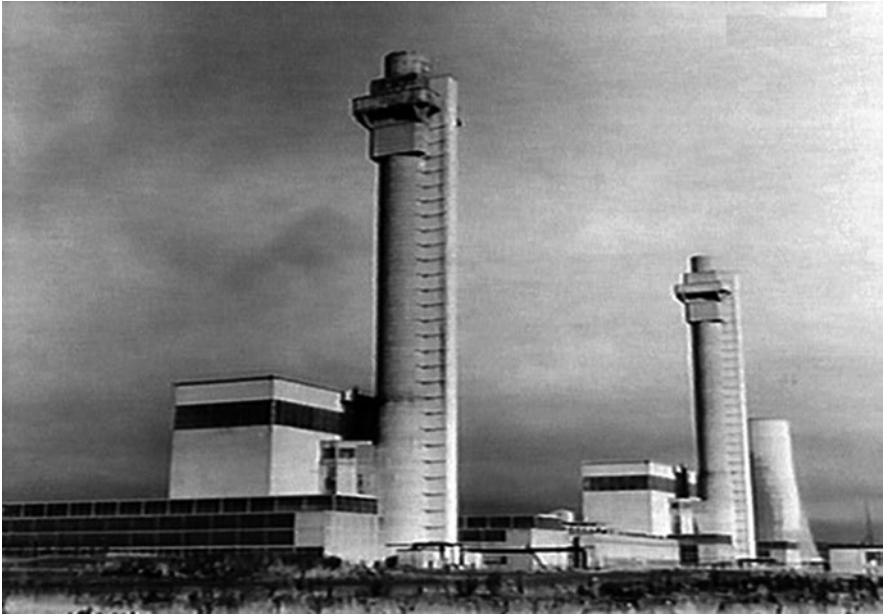
**Photo 2.1** An ominous-looking photo (cloudy sky? low angle shot?) of the two military reactors at Windscale. One notices the filters placed abnormally at the top of the chimneys

The first major reactor accident occurred in 1957 on the first British military reactor at Windscale (Photo 2.1). Beginning in 1947, the British built a set of two graphite-moderated, air-cooled piles to produce weapons-grade plutonium. Windscale was located in the county of Cumberland, in the northwest of England, on the coast of the Irish Sea. This region was rather poor and sparsely populated, with barely 70 inhabitants per square kilometer at the time. Population therefore welcomed the arrival of an industrial complex that

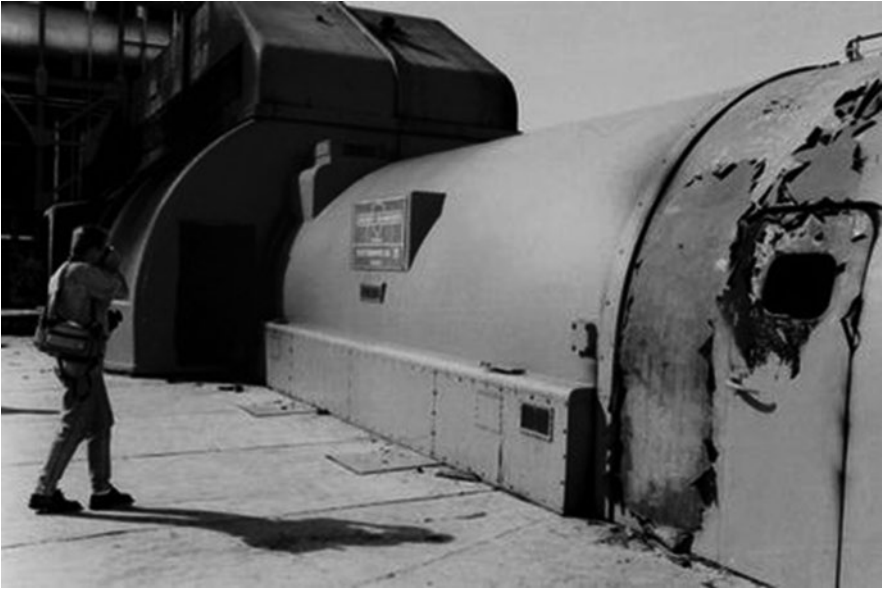
**Photo 2.8** Photo taken outside (shadow of the photographer) probably showing a fan motor cowling damaged by the fire (photo J.L. Sellart)

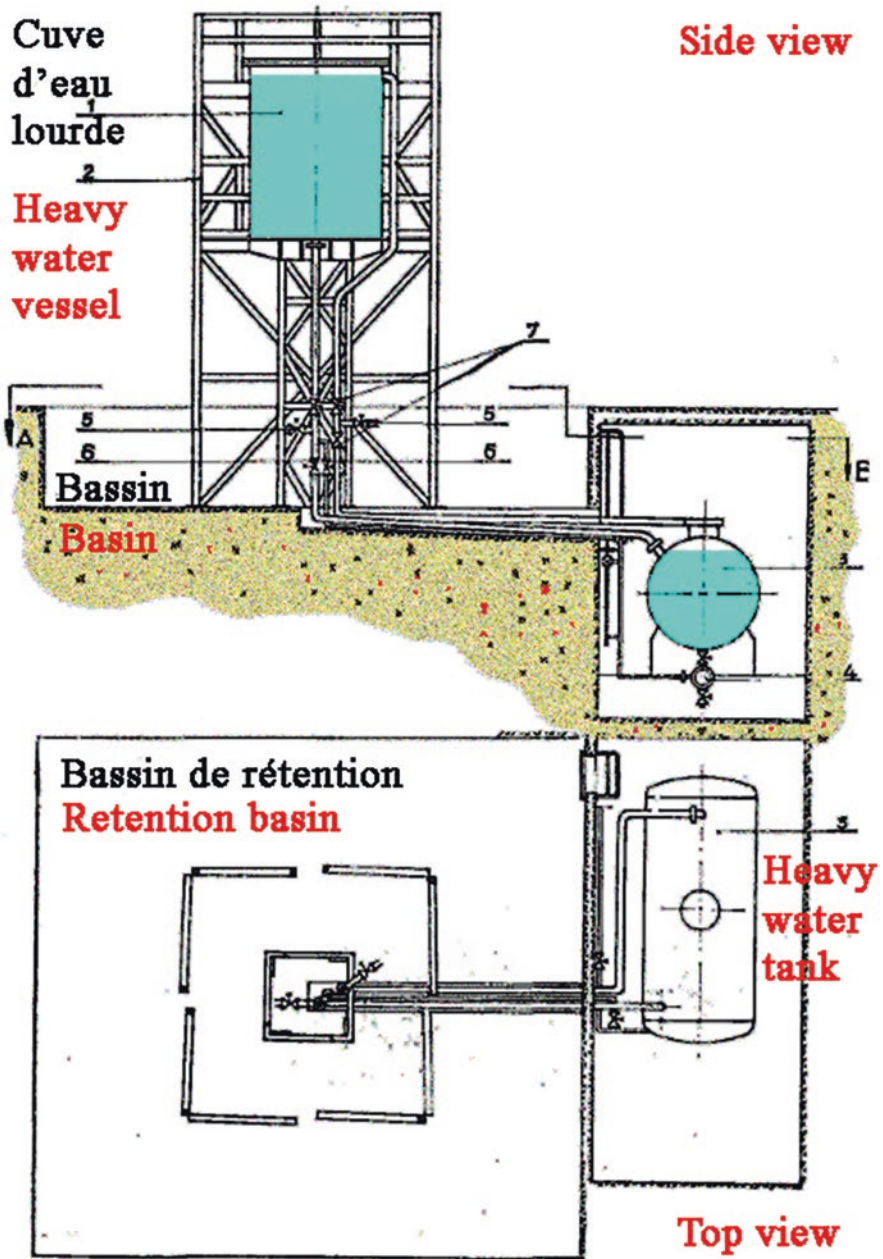
Fig. 2.7 View of the RB installation. 1: Reactor vessel, 2: Supporting structure, 3: Heavy water filling tank, adapted from (D. Popovič, S. Takač, H. Markovič, N. Raišič, Z. Zdravkovič, j. Radanovič: *Zero Energy Reactor « RB »*, Bulletin of the Institute of Nuclear Sciences "Boris Kidrič," Vol. 9, N°168, March 1959, Laboratory of Physics)

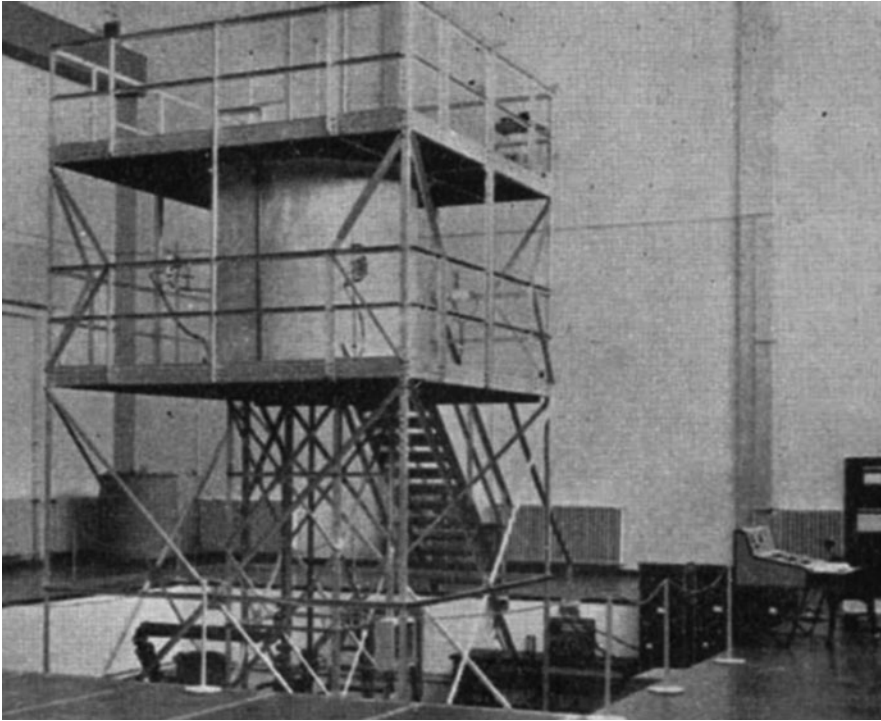
**Photo 2.13** Photo of the RB reactor in 1958. One can recognize the vessel placed on its support, itself placed in the pond with white walls in unevenness compared to the service desk. The control consoles are visible on the right of the picture, a few meters away from the building, without any particular biological protection

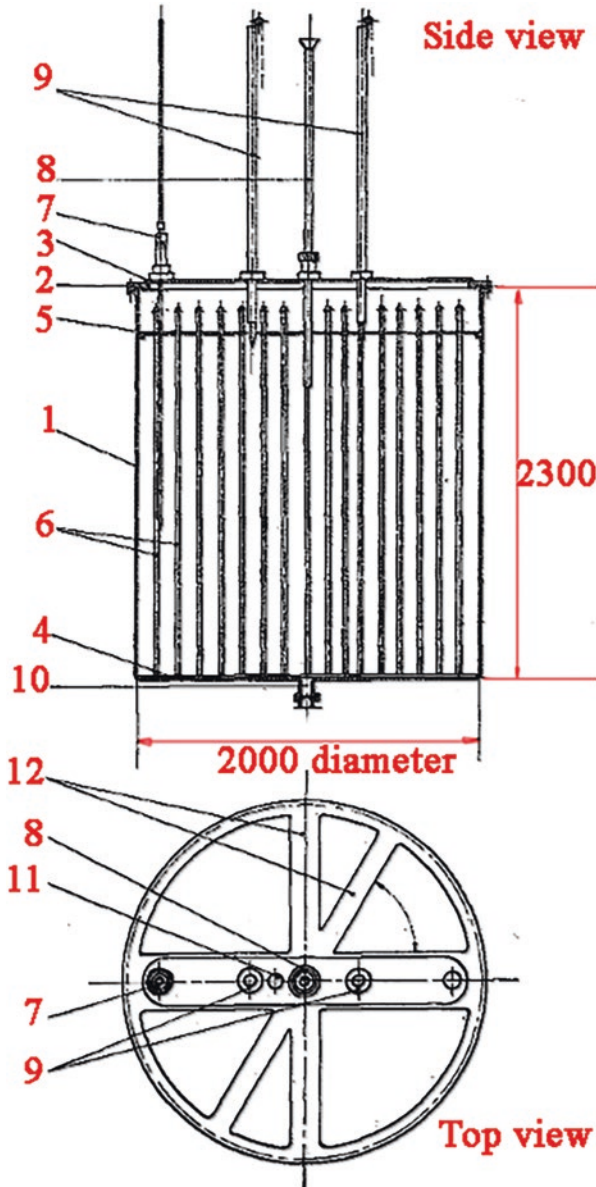
**Fig. 2.8** Schematic of the RB reactor. 1: Aluminum reactor vessel (10 mm), 2: Aluminum vessel cover (7 cm), 3: Instrumentation channel cover, 4: Lower fuel rod grid, 5: Upper fuel rod grid, 6: Uranium rods, 7: Heavy water level measurement, 8: System for injecting the 500 *milliCurie* (Radium-Beryllium) neutron source per reaction ( $\alpha, n$ ), 9: Two neutron safety absorber rods, 10: Bottom of the vessel with the heavy water inlet and outlet, 11: Two sight glasses, 12: Radial ribs as stiffener

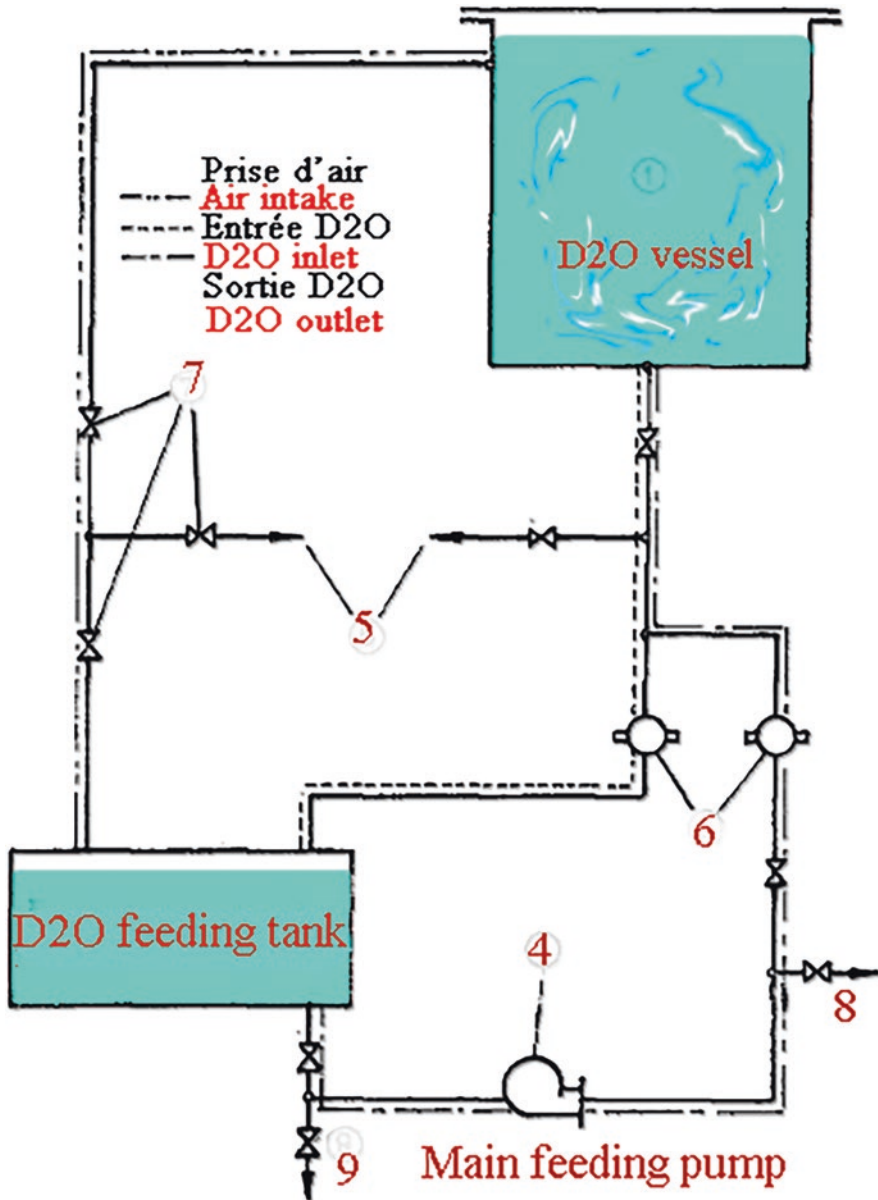
**Fig. 2.9** The filling circuit of the RB reactor. This circuit does not even contain a heat exchanger since the pile is not supposed to produce energy. As heavy water is very expensive, it is carefully collected in a tank when the reactor vessel is emptied. The circulation of dry air prevents the heavy water from becoming loaded with moisture, which would lower its deuterium content

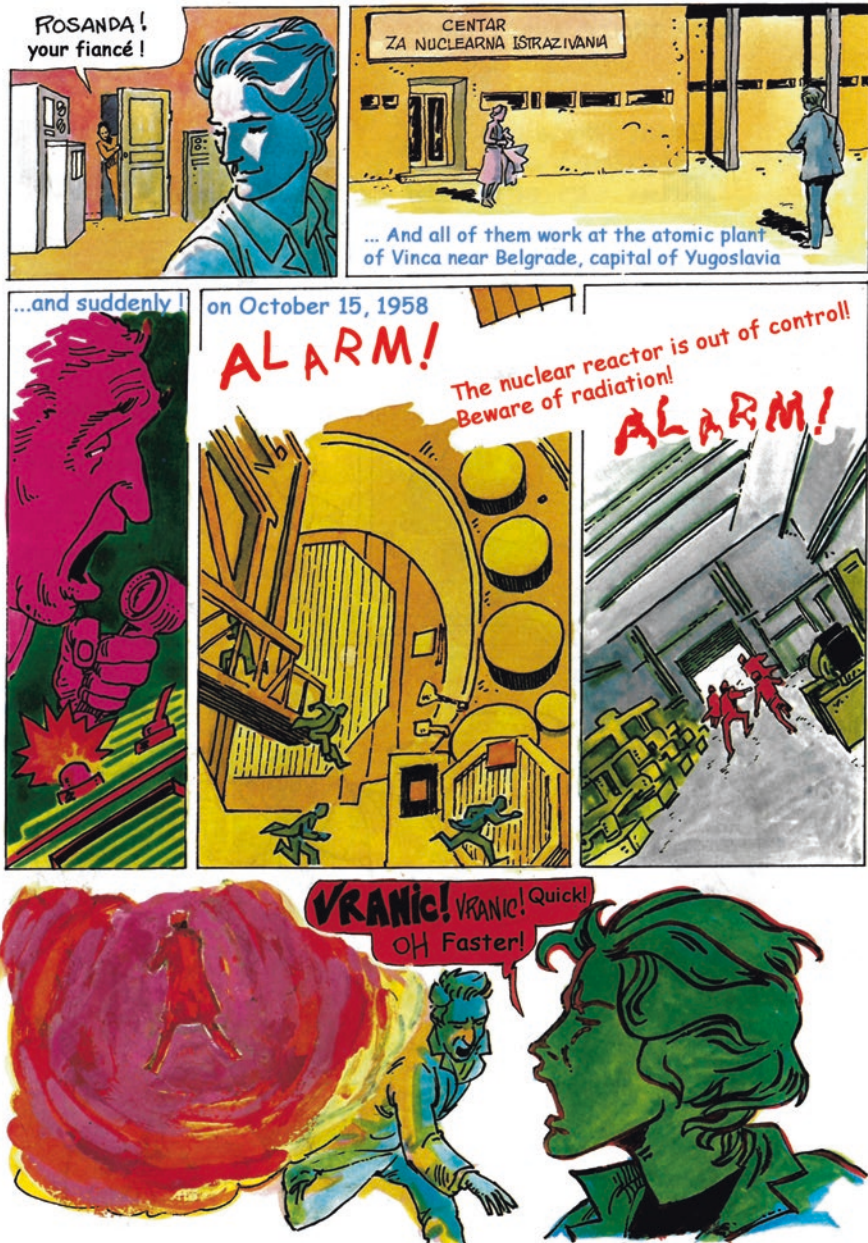
Fig. 2.12 Due to lack of information, the artists, although talented, describe rather the explosion of a power reactor than a modest experimental reactor. A fireball (!) surrounds the operator Vranic

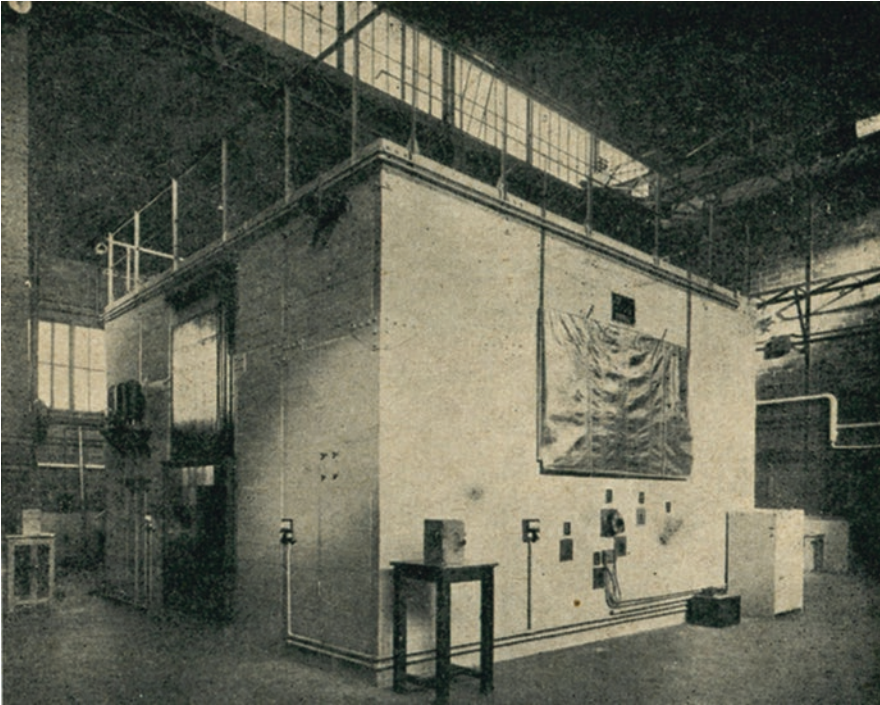
**Photo 2.21** The Zoé pile inside its hall. The vessel is trapped in the concrete block seen in the photo. Nothing to do with the lack of biological protection of the Vinča assembly (photo CEA)

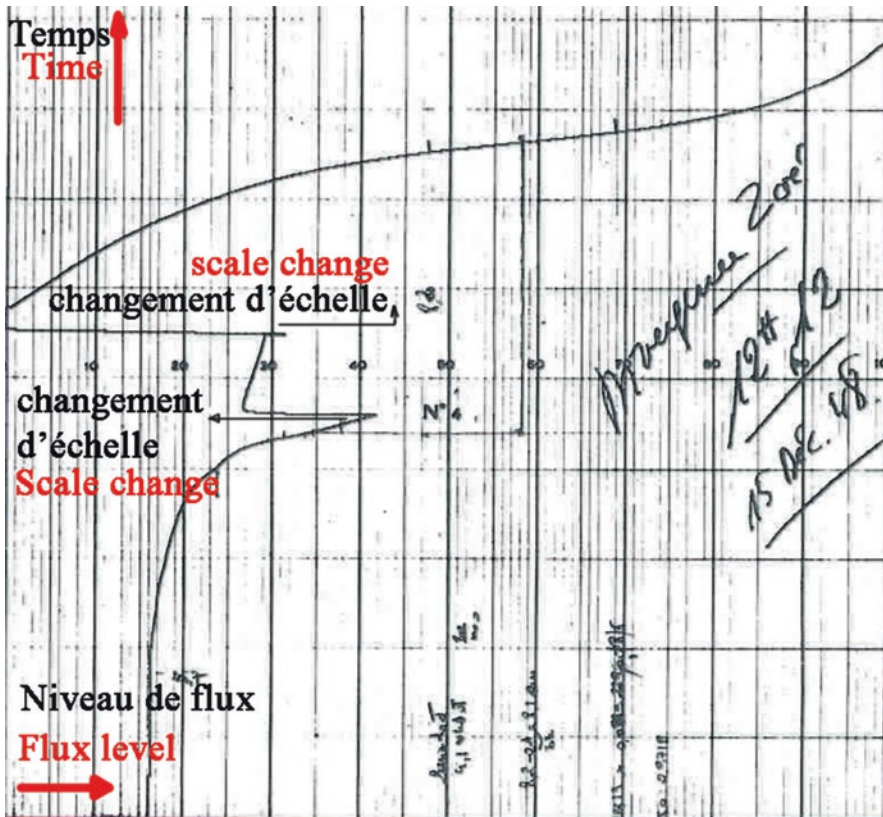
**Photo 2.23** The listing of the historical divergence of Zoé on December 15, 1948, 12 h12, signed by the operator Jacky Weil. As the neutron steam flux increases strongly during the divergence, the scale of the counter has been changed so that the signal remains on the graph paper. The scale changes cause a sudden apparent decrease of the signal while the measured neutron flux level increases continuously from the bottom of the image to the top. The comments about the calibration and scale changes were added by me

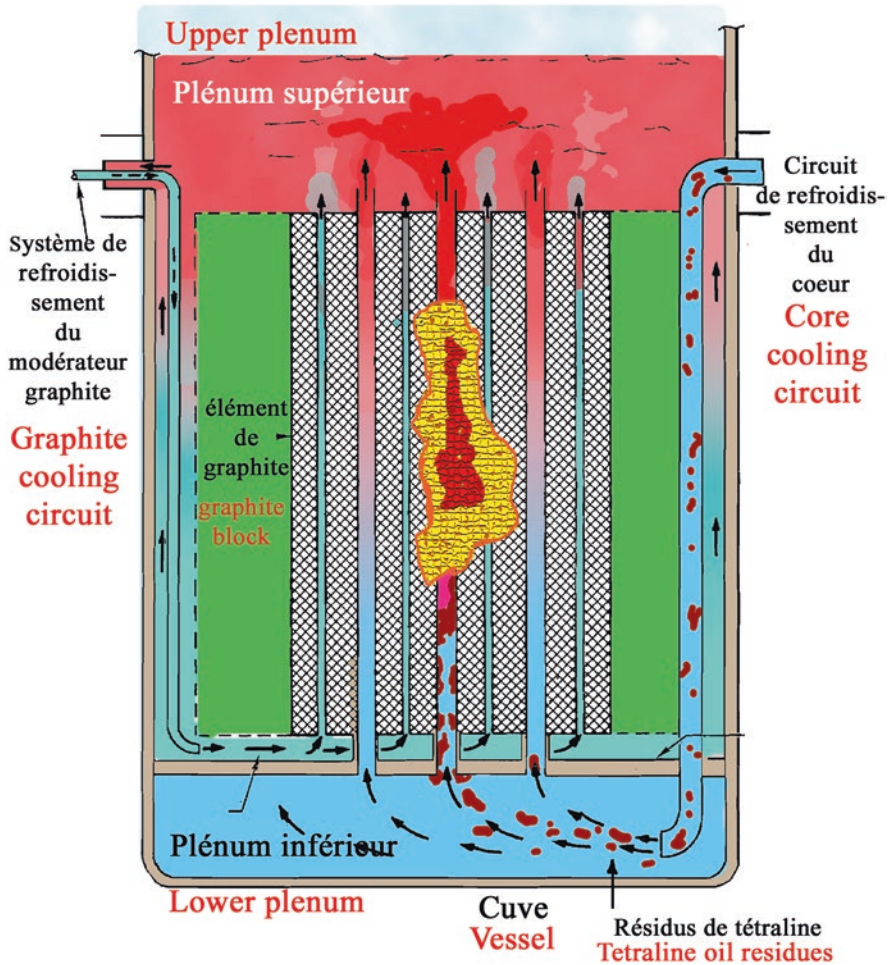
**Fig. 2.21** Accident at Santa-Susana Field (California, USA, July 13, 1959). The clogging of a cooling channel due to coagulated residues of oil used for cooling and isolation of the pumps and seeping into the primary circuit, caused the melting of about 30% of the reactor core (13 fuel elements out of 43). Curiously enough, the accident was not discovered until the end of the test cycle on July 26, 1959, despite a significant release of radioactive fission gas. The radioactive releases were estimated to be about 300 times the dose released during the TMI-2 accident

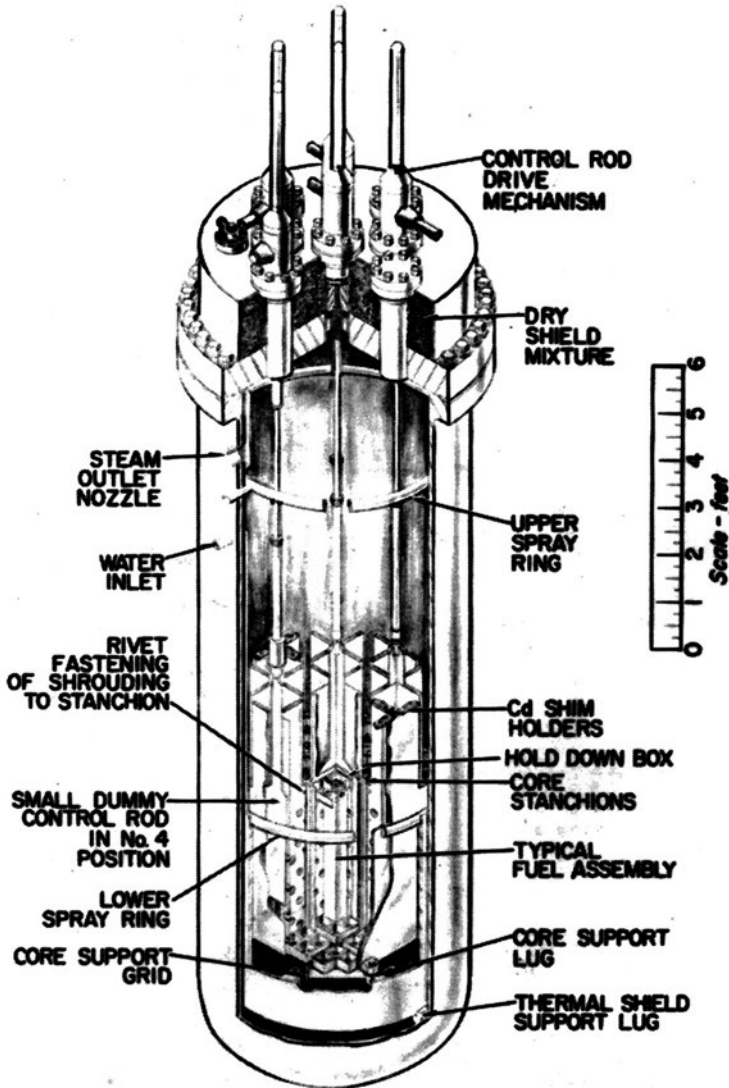
Fig. 2.24 The vessel and core of SL-1, according to ([Tardiff, 1962]: A.N. Tardiff: *Some aspects of the WTR and SL-1 accidents*, Reactor safety and hazards evaluation techniques, proceedings of the symposium, Vienna, 14-18 May 1962, IAEA STI/PUB/57, pp. 43-88 (1962))

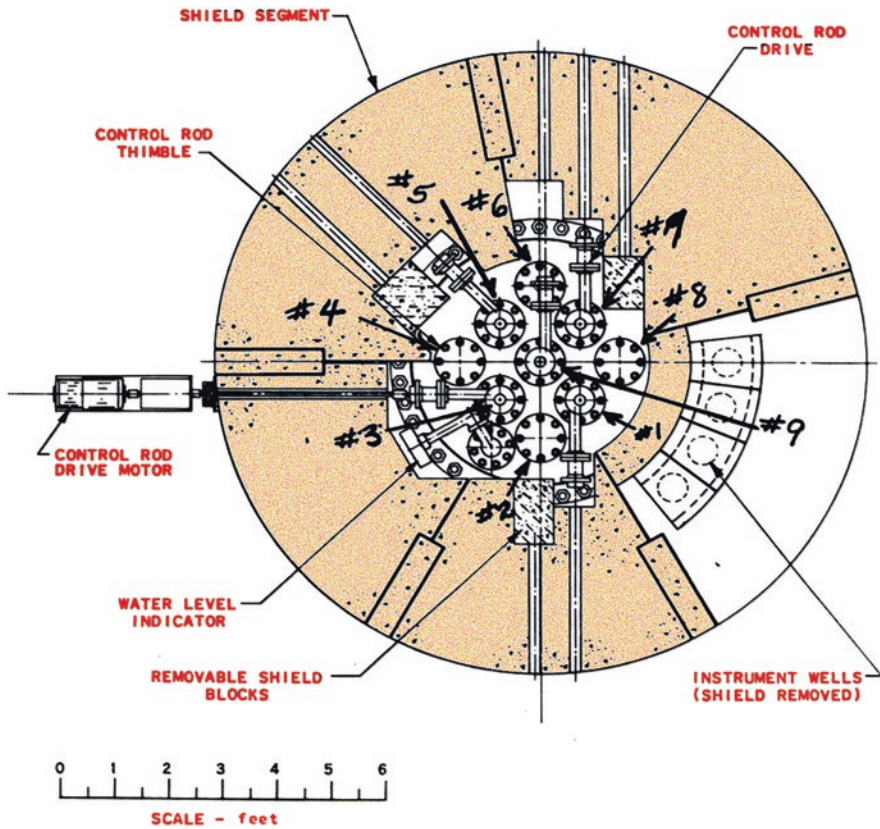
Fig. 2.25 Top view of the SL-1 core: you can see the horizontal views to the cluster control motors and the 5 control rod clusters

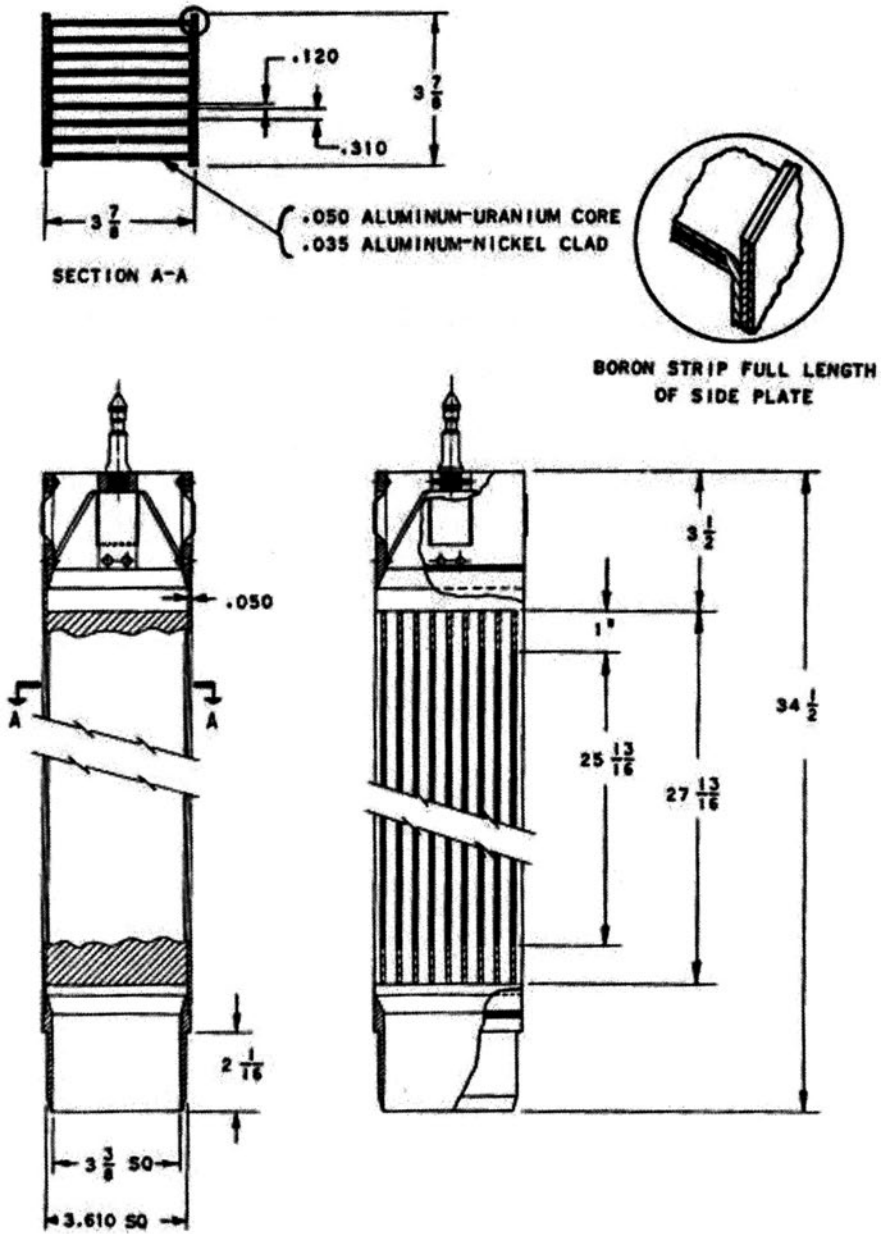
Fig. 2.26 SL-1 fuel assembly using plate-shape fuel

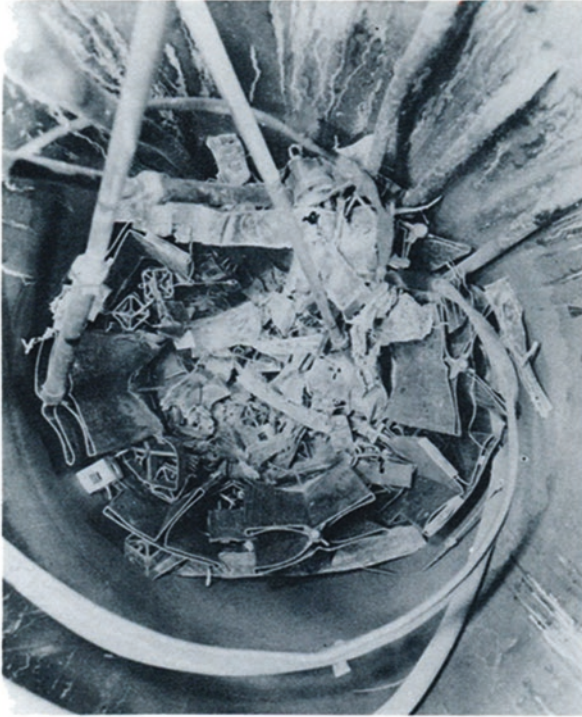
**Photo 2.33** View of the core during disassembly (1962, INEL)

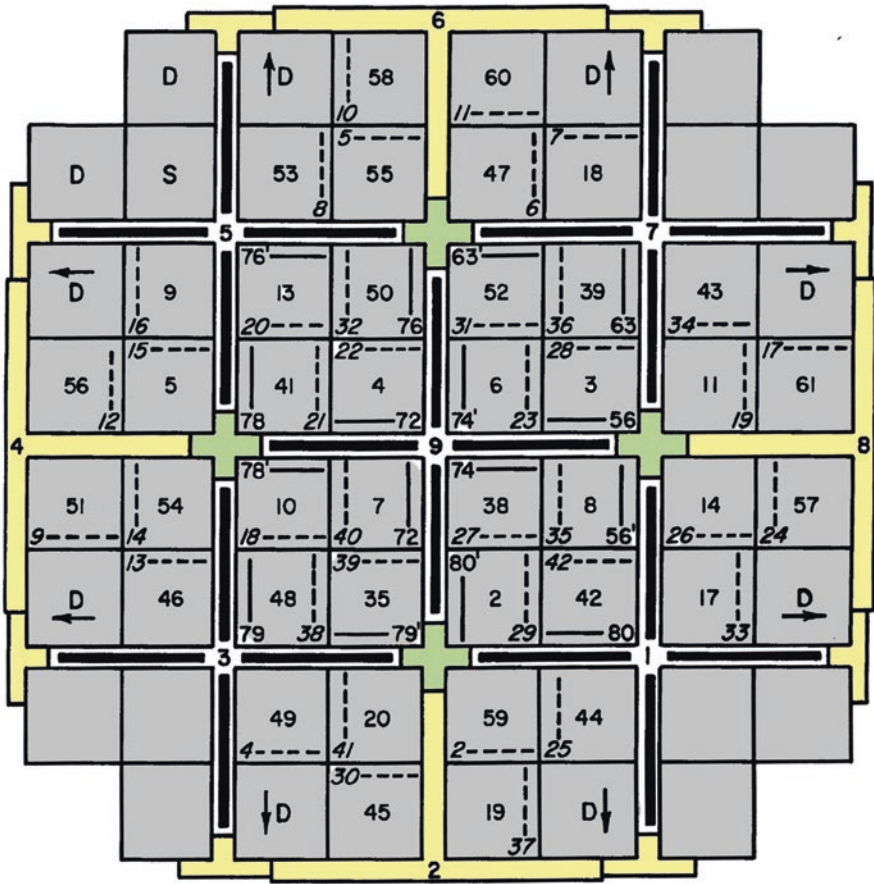
Fig. 2.30 Fuel loading pattern of the SL-1 core. It is easy to see that each control blades will weigh by its size, compared to the size of the core, an important anti-reactivity weight

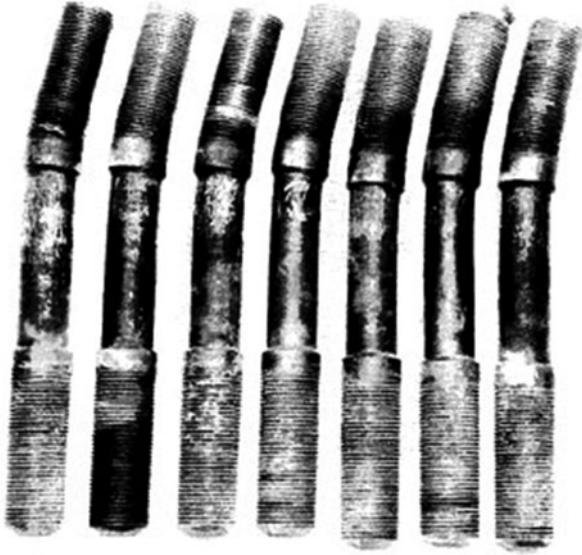
**Photo 2.34** An impressive photo of the twisted SL-1 vessel-cover bolts after the water hammer (INEL)

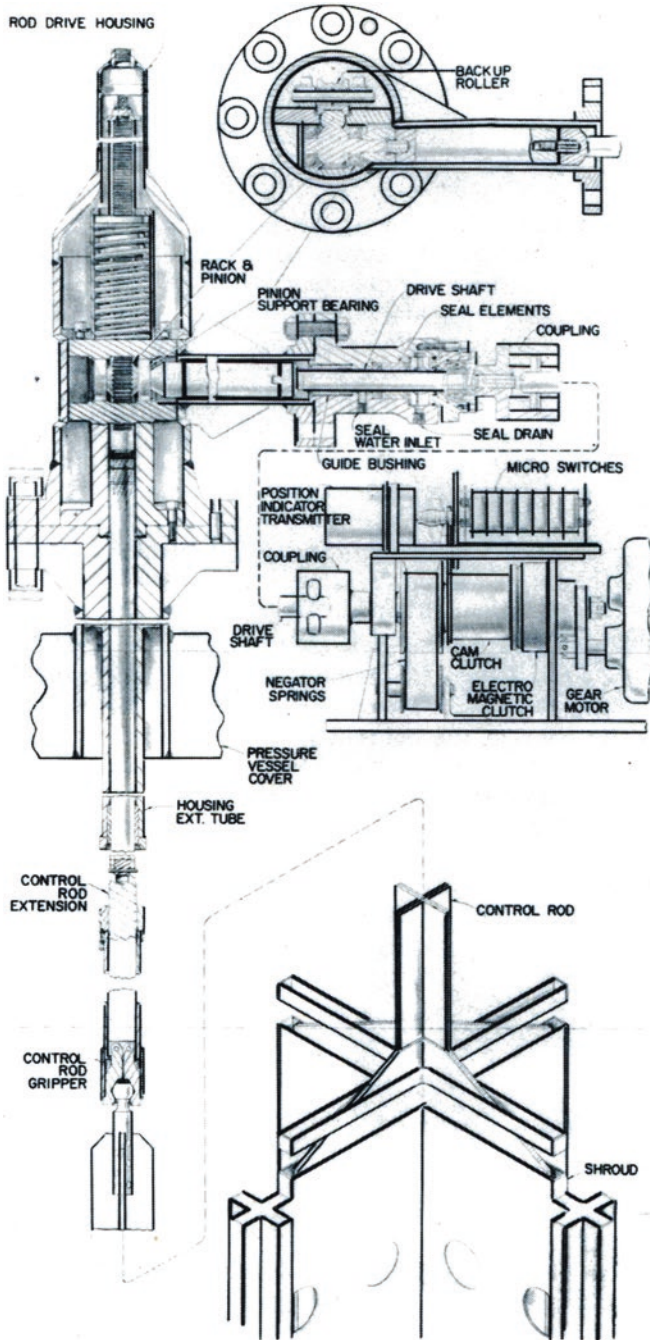
Fig. 2.31 SL-1 reactor control rod cluster mechanism

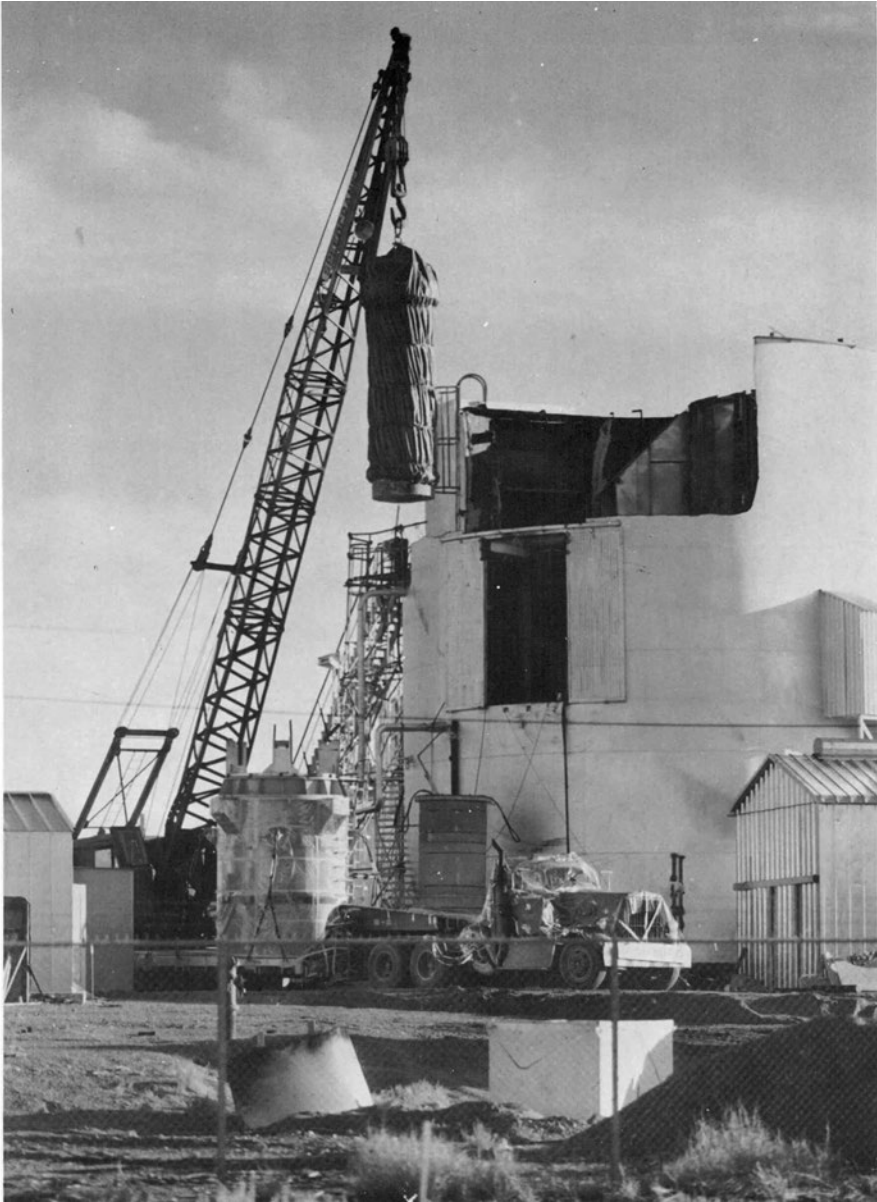
**Photo 2.35** Extraction of the vessel through the reactor dome with a mobile crane. A trailer truck carries a transport cask for the vessel

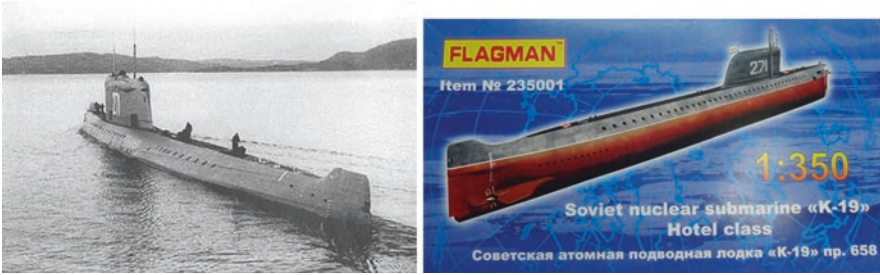
**Photo 2.37** The K-19 on the surface (left) and a modern model of the submarine. The submarine was nicknamed the “widow maker” or “Hiroshima” by the sailors. Numerous accidents occurred during the construction of the ship, causing a dozen deaths even before she was commissioned (fire, asphyxiation, crushing..)

On July 3, 1961, incredibly the same day of the SL-1 accident described just before, the Soviet submarine K-19 (Photo 2.37) was diving during the Polyarni Krug exercise in the Barents Sea when a leak appeared in the primary circuit (LOCA or Lost Of Coolant Accident) of the starboard reactor. The K-19, 114 m long, has two VM-A pressurized water reactors of 70 MW powering two turbines that propel it at 26 knots in diving. The submarine was launched on 8 April 1959. The accident happened on the first day of its service at sea. The K-19 is a nuclear-powered ballistic missile submarine of the “Hotel” class in the NATO breviary. It carries R-13 ballistic missiles, which can only be fired from the surface, unlike the American submarines of the time, which could fire under the water, thus in a much stealthier way.

It was said that the cause of the rupture was due to a pressure test of the primary circuit at the reception of the primary circuit. During this test, the pressure was increased to 400 bars (i.e., twice the permissible design pressure of the primary circuit) because of the omission of an operational pressure measurement system. The incident was hidden or glossed over so as not to hinder the progress of the project or for fear of possible sanctions. In any case, no measurements, even non-destructive ones (X-rays), were taken to verify the conformity of the primary circuit and the real effect of this overpressure. The Russian government will later declare to have found evidence of a defective welding (?), which is difficult to doubt from the survivors’ account. The real question is to know if this failure was structural at the origin (what were the radiography control procedures at that time in the USSR?), or if this failure was induced by the overpressure of the primary circuit test. The accident of July third caused at least eight deaths by severe irradiation in the following two weeks and about 15 in the two years following. The submarine, however
