# A Brief History of Nuclear Reactor Accidents

From Leipzig  
to Fukushima

Serge Marguet  
SINETICS, Bureau O2 EF:05  
Electricite De France, Recherche et D ev  
Palaiseau, France

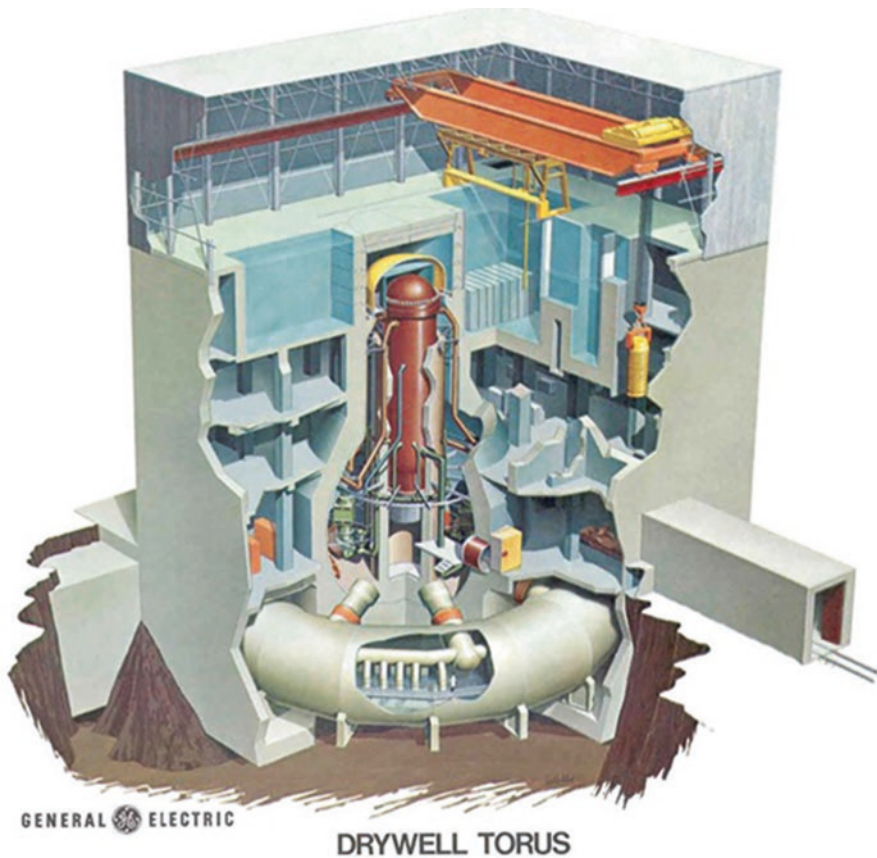
**Fig. 2.32** The Fermi-2 Containment building showing the drywell torus on which the defective paint was found

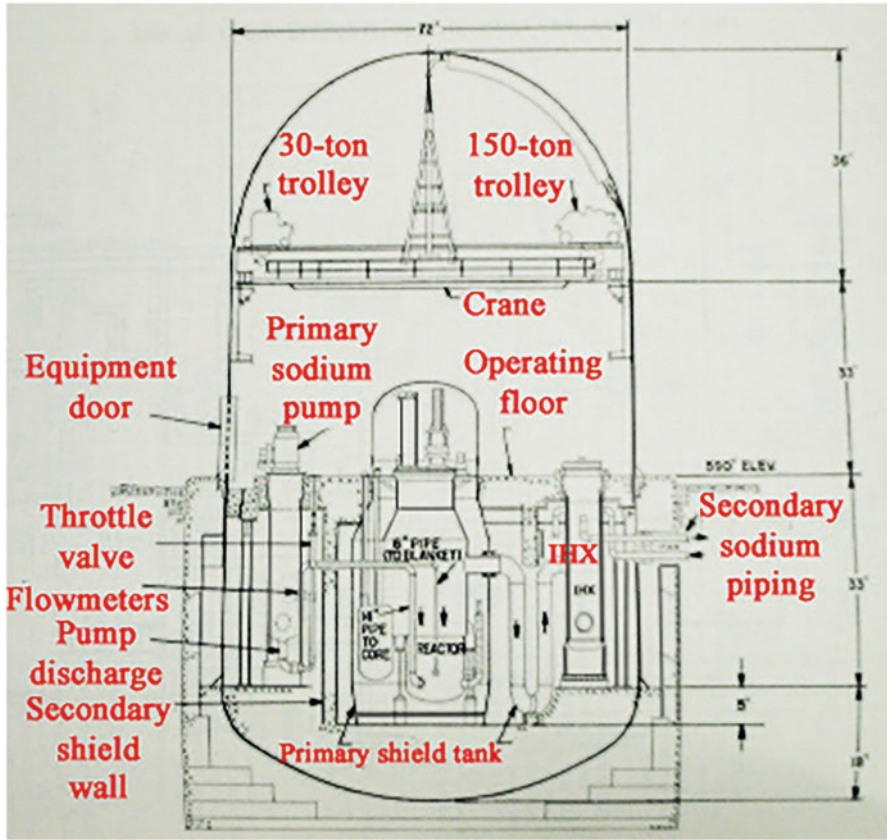
Fig. 2.37 Axial cut of the Fermi-1 reactor building from an old plan. The size of the primary pumps is impressive, almost as high as the vessel (adapted from an old blueprint)

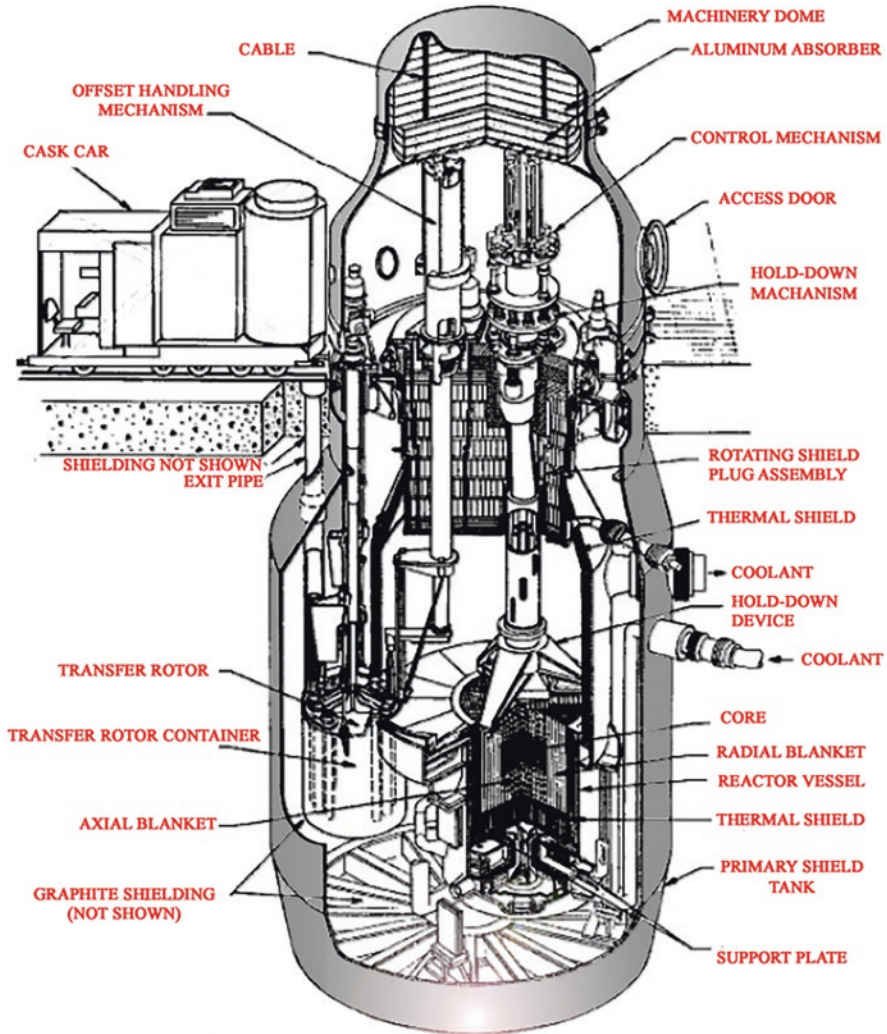
Fig. 2.38 Cut view of the Fermi-1 vessel

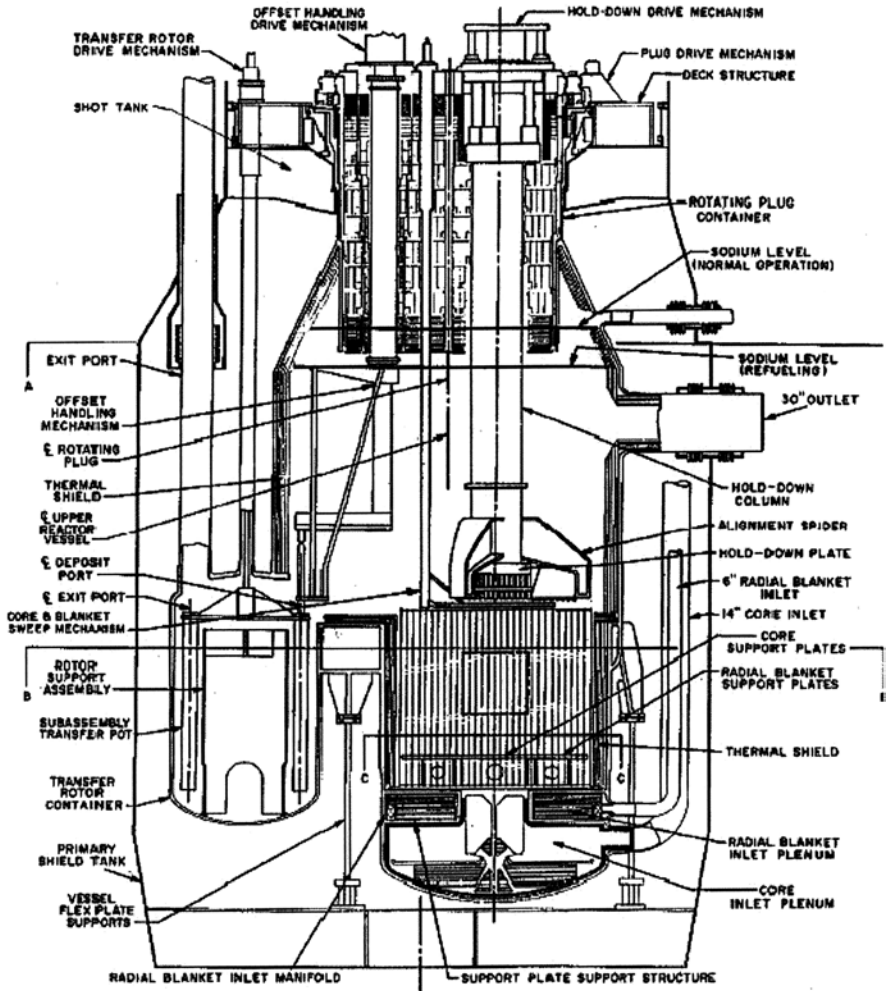
Fig. 2.39 Complete view of the Fermi-1 vessel, including the subassembly intermediate storage barrel on the left of the core. This ingenious device allows a direct transfer from the barrel to the core without lifting the core rotating plug. This technic was also used on the *Superphenix* French FBR (1200 MWe) but could not be longer used as the barrel rapidly appeared to leak. The French barrel was made of carbon steel instead of stainless steel due to economic reasons

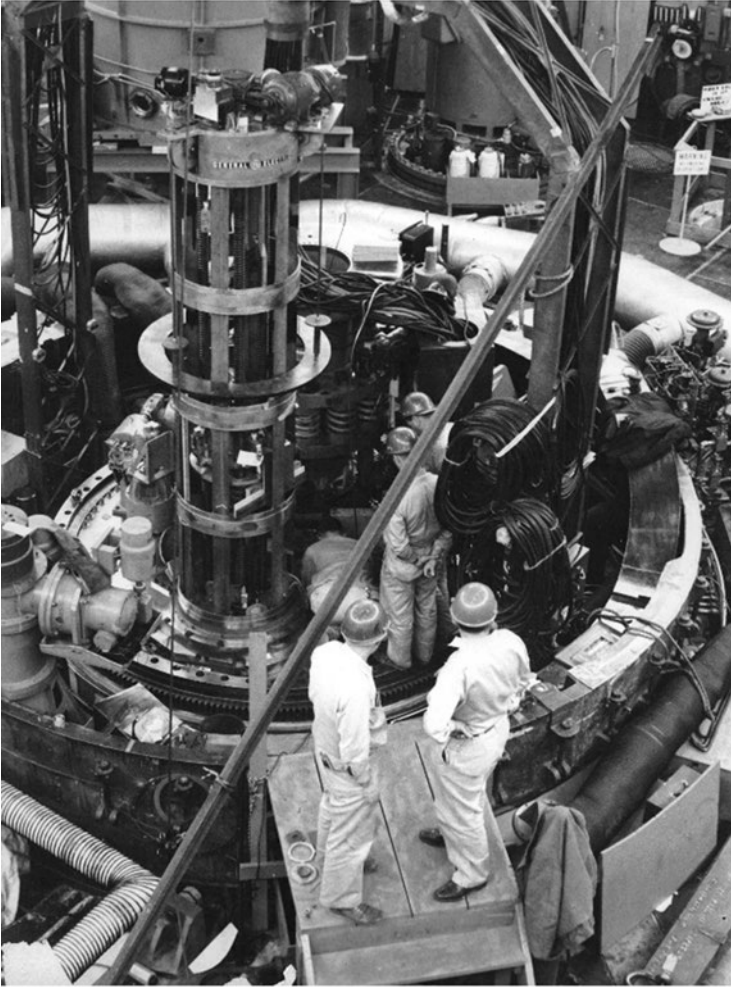
**Photo 2.45** Top view of the vessel cover and the rotating plug

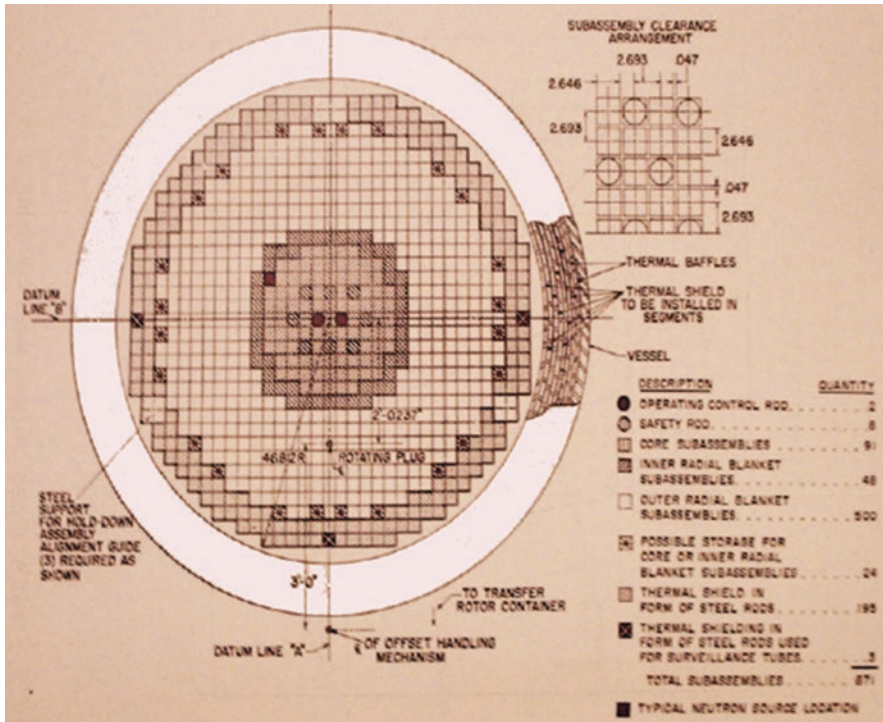
Fig. 2.40 Map of the core

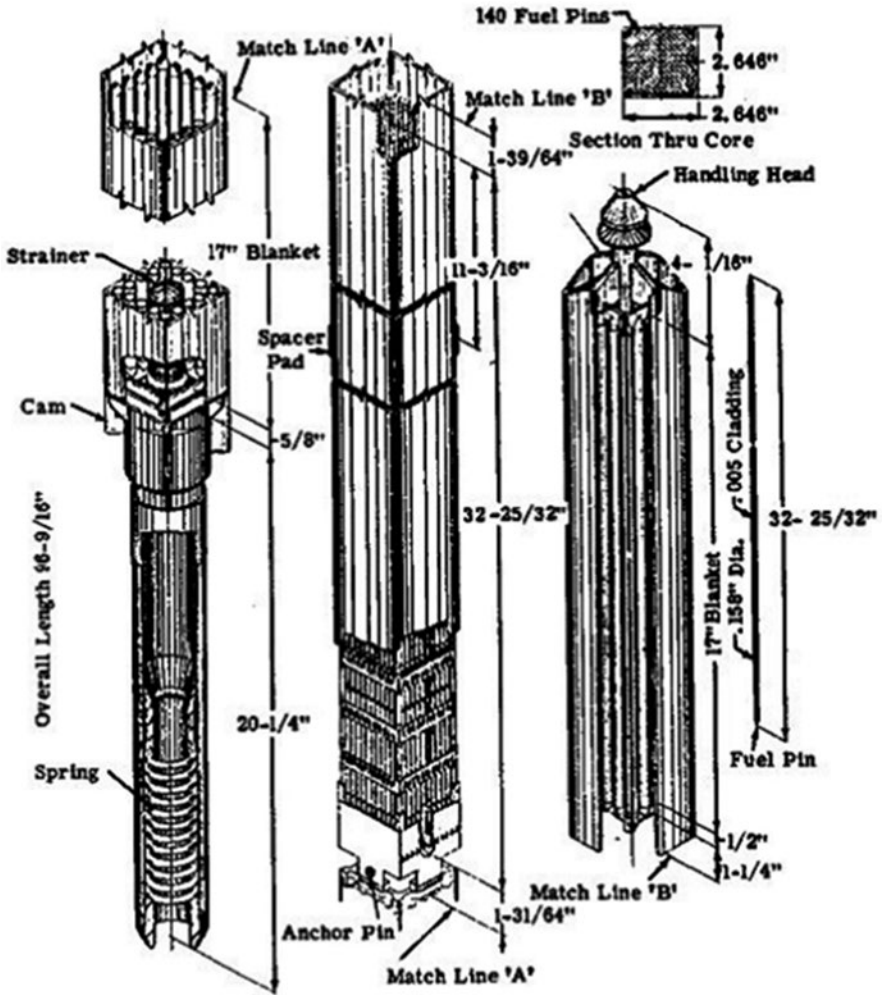
Fig. 2.41 Fermi-1 fuel bundle and control blades

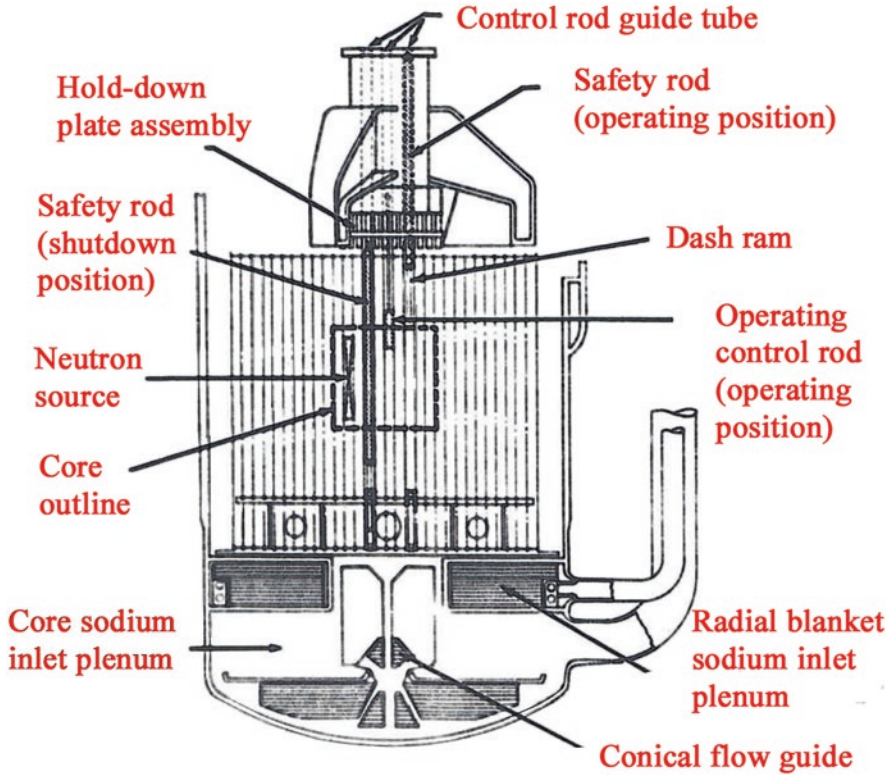
Fig. 2.42 Simplified sketch of the vessel internals

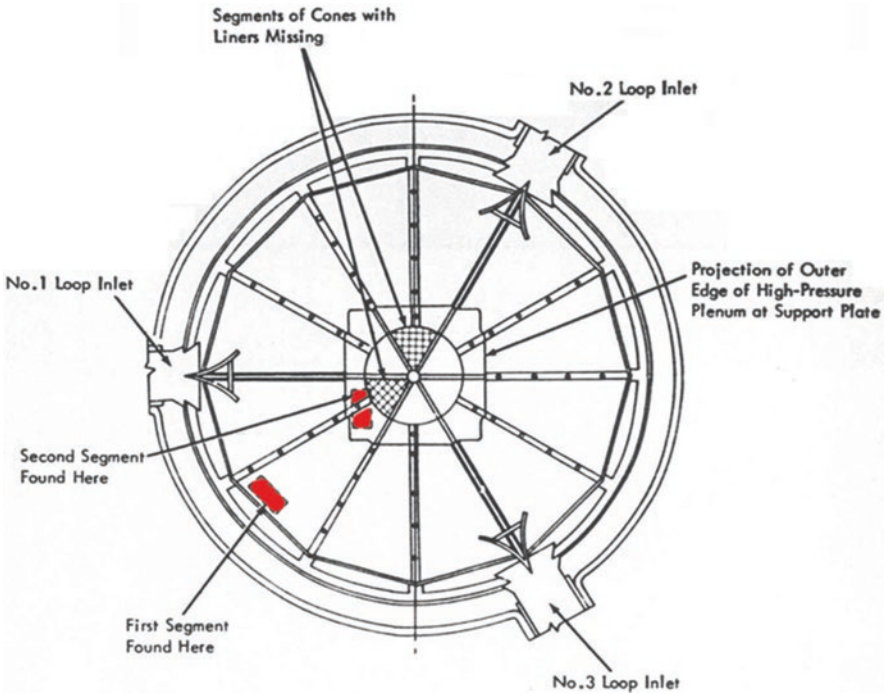
Fig. 2.44 Location of the loose fragments of the corium-divider cone liners spread in the lower plenum

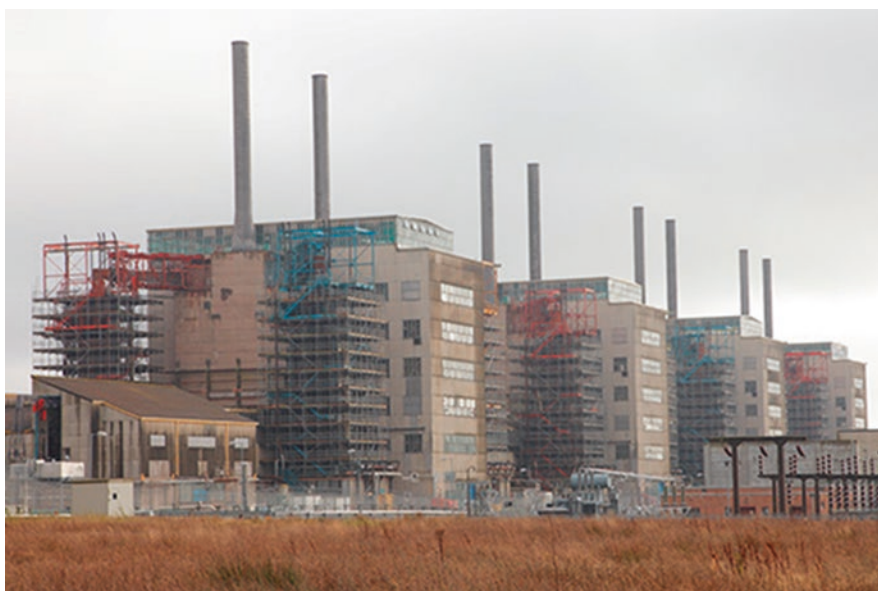
**Photo 2.50** The four reactors of Chapelcross are particularly standardized except for a color inversion of the SGs siding (photo NDA)

and was coupled to the electric grid in 1959. Chapelcross is the sister reactor of Calder Hall (Photo 2.50). Note that the fuel at Chapelcross is slightly different from that at Calder Hall (more on this later). Another difference from Calder Hall is that Chapelcross has its own cooling pool for spent fuel, which is necessitated by its distance from Windscale. The core consists of 1696 channels in a 203 mm pitch lattice for loading fuel rods. The active core has a diameter of 9.45 m and a height of 6.4 m. 112 channels allow the insertion of

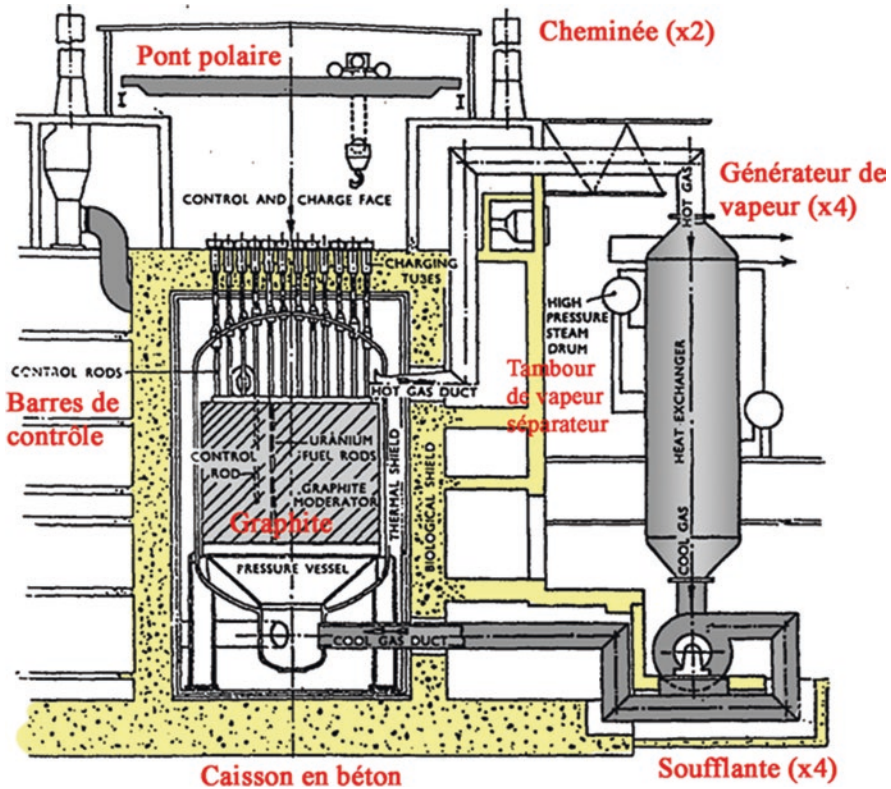
**Fig. 2.46** Axial section of the reactor (Calder Hall and Chapelcross). We notice that the steam generators (imposing!) are located outside the building. They are surrounded by a siding in grating, which allows a visual inspection but has no real function of external protection

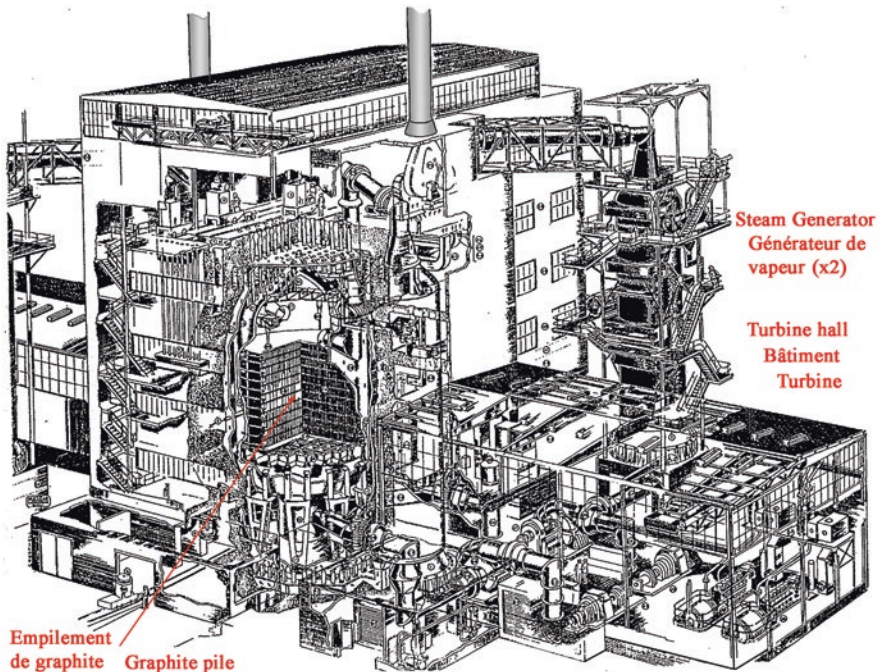
Fig. 2.47 General plan of the Calder Hall and Chapelcross reactors

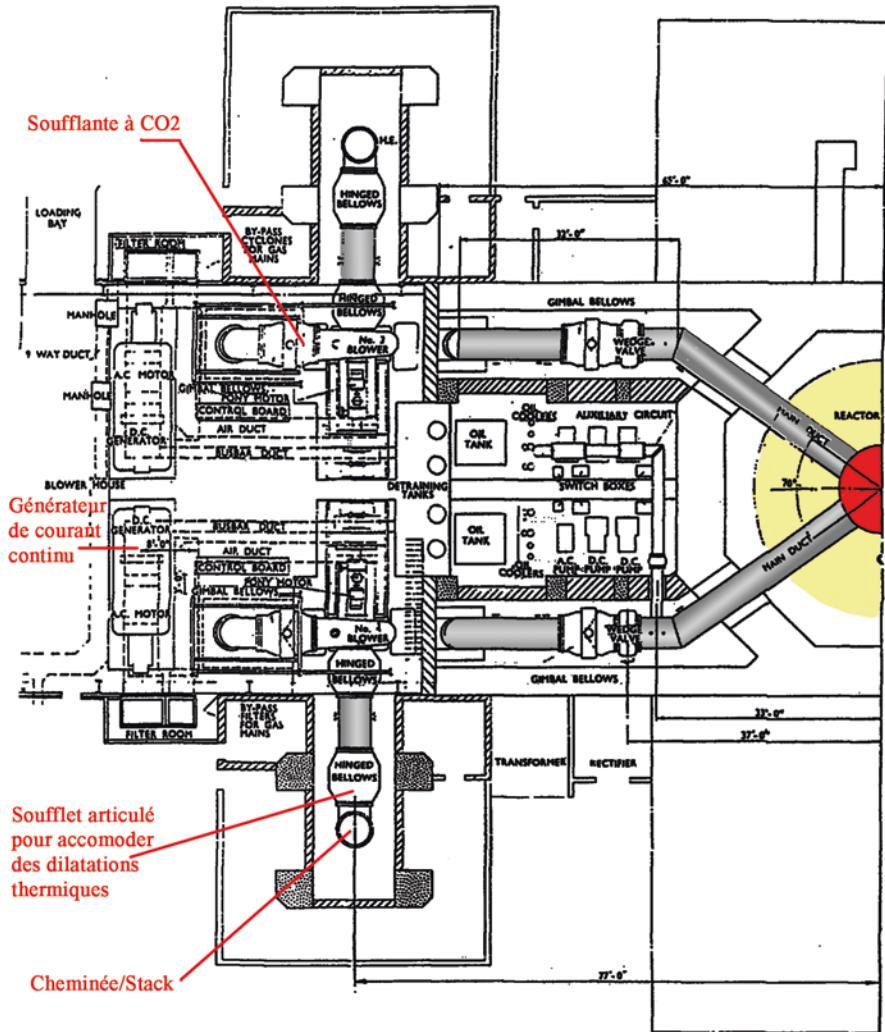
Fig. 2.48 Diagram of a half-circuit for the circulation of carbon dioxide. The same half-circuit is found symmetrically on the other side of the reactor

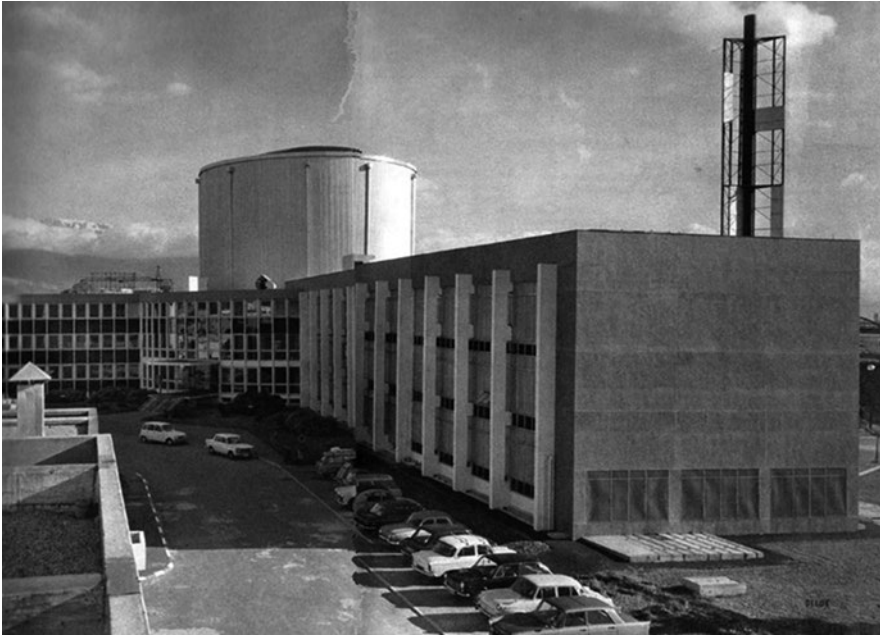
**Photo 2.52** Siloé building inside the CEA site. The reactor is located in the white cylindrical building

Siloé was a French nuclear research reactor, of the pile pool light water type with an open core (but covered with water) and a thermal power of 15 MWth at start-up. Built from August 1961 by Indatom on the scientific polygon of Grenoble on the site of the CEA near the city (Photo 2.52), The reactor diverged on March 18, 1963, at 11:15 p.m., one year after the first Grenoble reactor, Mélusine, and eight years before the high-flux reactor (RHF) at the nearby *Institut Laue-Langevin*. A model of Siloé was tested in April 1962 in the Mélusine reactor. The core is composed of plates made of an alloy of uranium metal and aluminum highly enriched to more than 90% in  $^{235}\text{U}$ . The core is reflected by beryllium plates. The building housing the reactor-pool consists of a vertical cylindrical concrete body 25 m high and 27 m in diameter. The two floors of this hall are equipped with experimental areas. A hot cell for treating the fuel completes the equipment. The primary function of Siloé was the doping of silicon crystals and the production of medical radioisotopes by neutron irradiation. In 1968, the power was increased to 30 MWth, then to 35 MWth in 1974, and even to 40 MWth in order to carry out tests on materials requiring large neutron fluxes. The core of Siloé is submerged by a large quantity of water which acts as a biological protection against radiation, so that one can operate freely on the reactor service desk during operation (Photos 2.53 and 2.54).

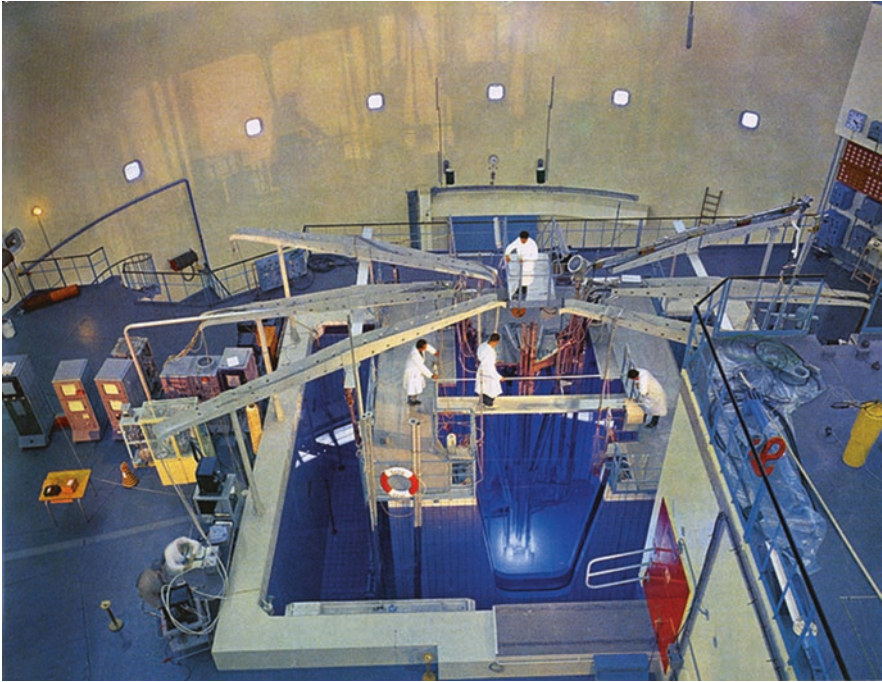
**Photo 2.53** The Siloé core during operation. One can see the intense bluish Cerenkov-Mallet radiation that characterizes the core in operation. The operators can handle the core on the bridge (photo *Association des Retraités de l'Institut Laue-Langevin*)

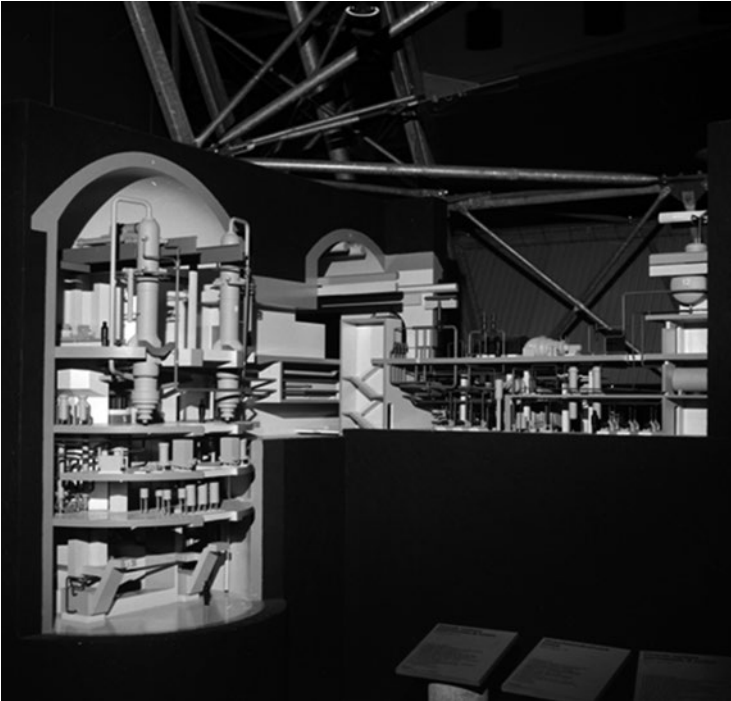
**Photo 2.63** Model of the reactor cavern and the turbine cavern. One recognizes well above the reactor the two vertical steam generators of great height

An access gallery 100 m long (Photos 2.61 and 2.62) led to three caverns respectively for the reactor (Fig. 2.57), the turbine and the fuel element storage pool (Photo 2.63, Fig. 2.58). A ventilation chimney dug in the mountain allows the ventilation of the underground parts. A chimney on the surface evacuates the stale air at altitude. The supplier of the reactor was Ther-Atom. Ther-Atom was also part, with three engineering offices of the *Groupe 8 de Travail de Lucens* (GTL). Their mission was to supervise the studies, the construction management, and the tests of the CNEL. From a technical point of view, the CNEL reactor was a development of the Diorit reactor already mentioned. The Federal Commission for the Safety of Nuclear Installations, founded in 1960, was the first nuclear supervisory authority of the Swiss Confederation (CSA). It accompanied the licensing process of the CNEL from the beginning. However, the CNEL was a real challenge, because the

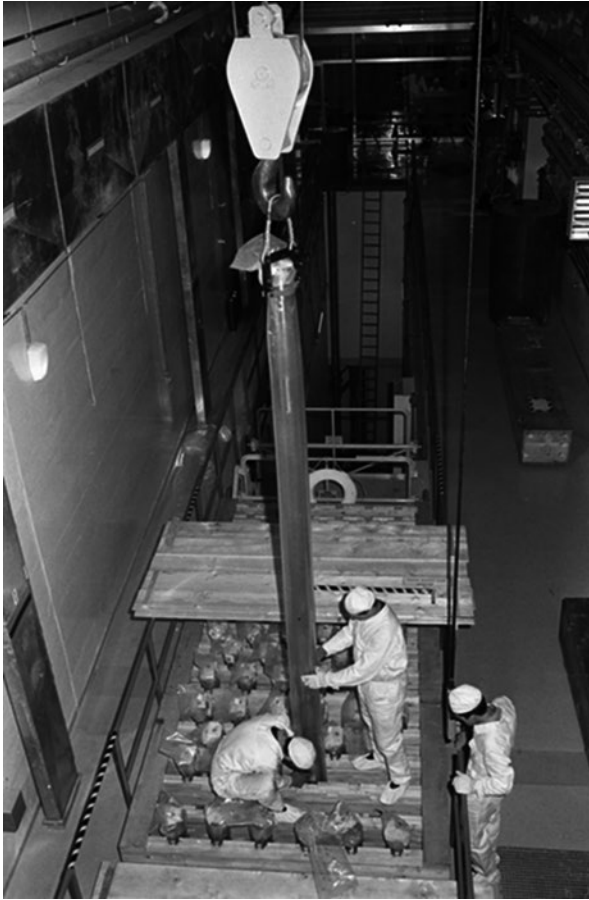
**Photo 2.64** Placing a fresh fuel assembly in a storage rack. The core contains 73 such assemblies. The spent fuel assemblies are evacuated without contact by the unloading machine to the deactivation pool

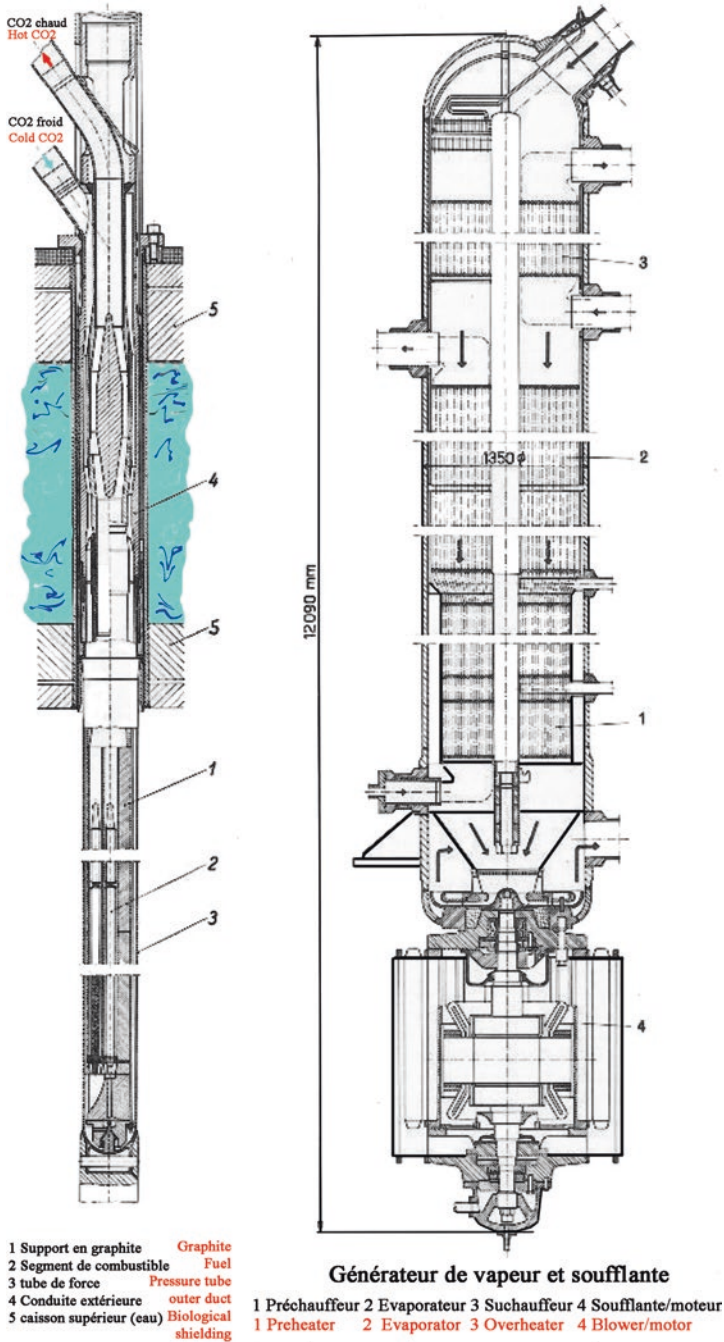
Fig. 2.60 Fuel assembly (left) and steam generator (right) at Lucens

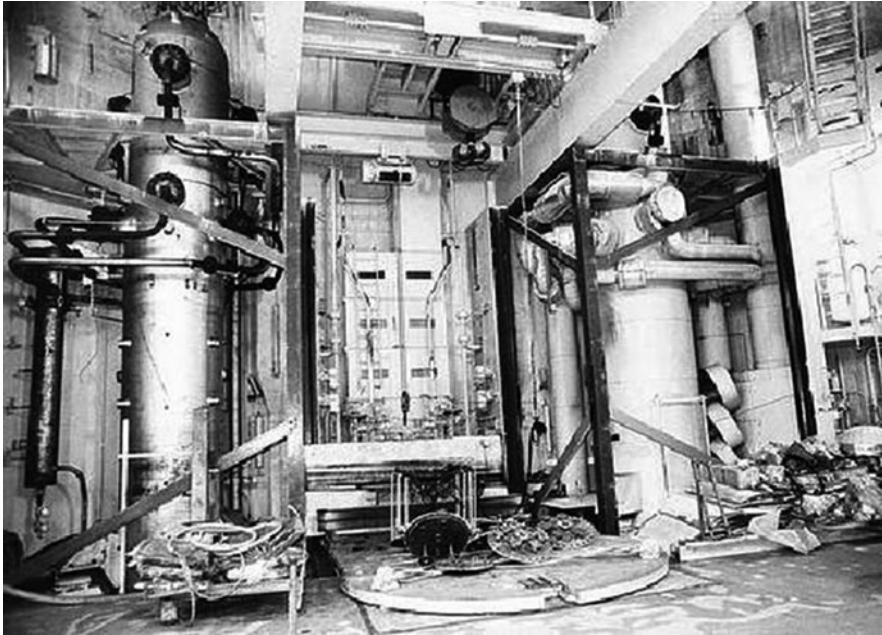
**Photo 2.66** The floor at SGs level after the accident

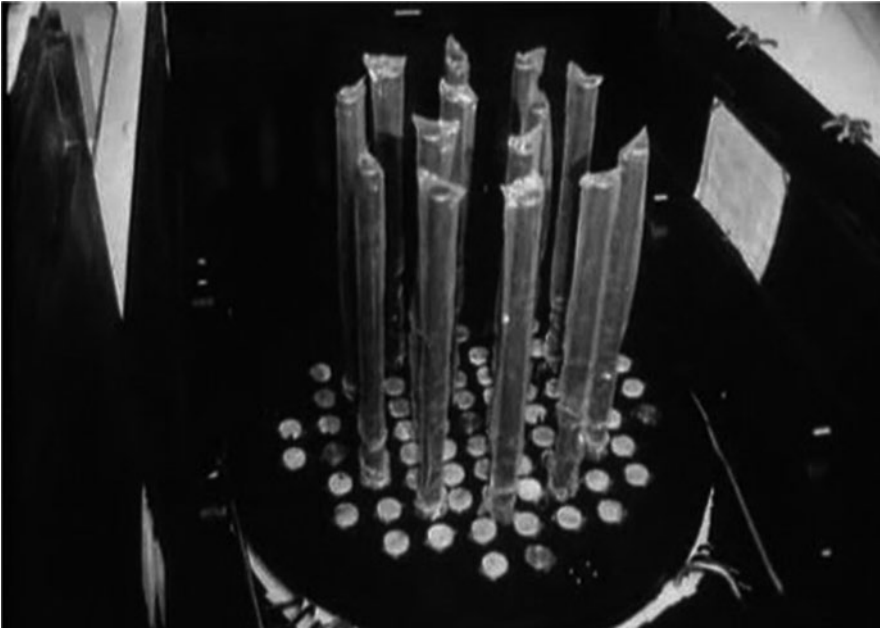
**Photo 2.67** View of the upper side of the Lucens reactor vessel (photo IFSN). The control rods and shutdown control rods, wrapped in transparent plastic, can be seen emerging from the vessel cover

Four shutdown rods by gravity drop are located more in the center of the reactor (Photo 2.67). The rods consist of two concentric tubes, the central part containing a cadmium-silver alloy, two materials that are highly neutron absorbers. The rods are cooled by a flow of  $\text{CO}_2$ .

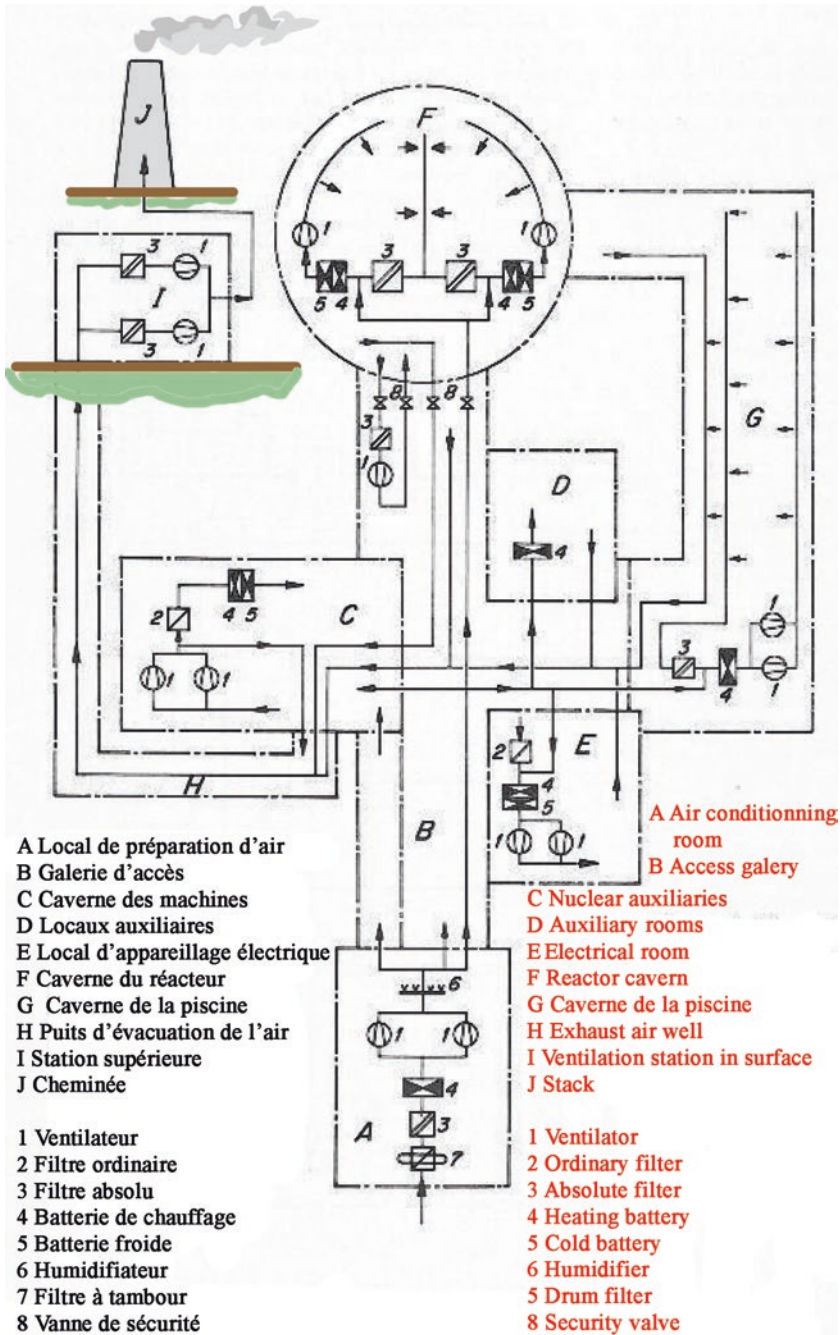
Fig. 2.63 Ventilation system of the underground plant in Lucens. This system will play its role well by isolating the contaminated caverns from the beginning of the accident

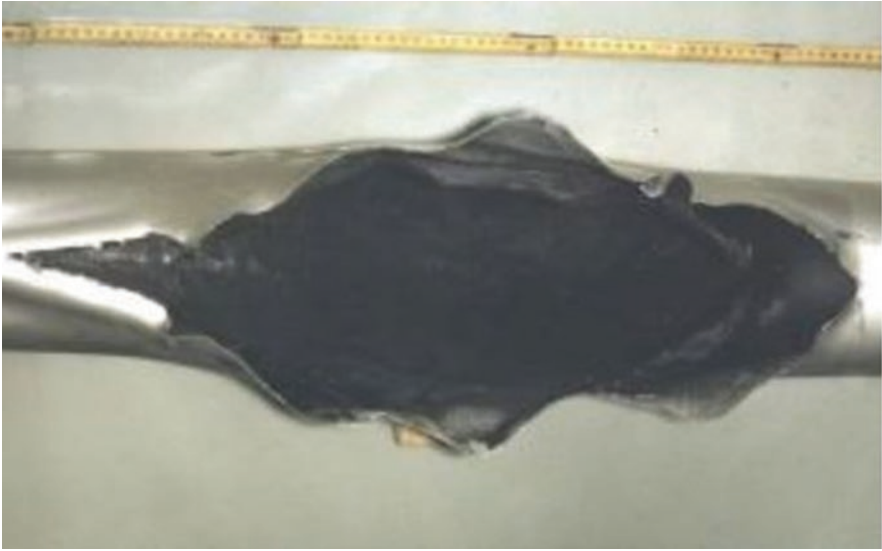
**Photo 2.70** Impressive view of the cladding of fuel element 59. The cladding is completely torn

This oxidation produces hydrogen gas release and flammable magnesium oxide powder. Magnesium oxide is known to be unstable. Moreover, its instability tends to increase with high temperatures. The corrosion products formed then fell into the heat transfer gas circulation channels. It is postulated that the debris fell to the bottom of the pressure tubes and partially clogged them, reducing the flow in some channels. Fuel element 59 was insufficiently cooled due to the reduced CO<sub>2</sub> flow rate inherent in the pressure tube plugging. Several of the seven fuel rods in fuel element 59 (Photo 2.70) thus underwent an overheating that went unnoticed at first because not all the fuel

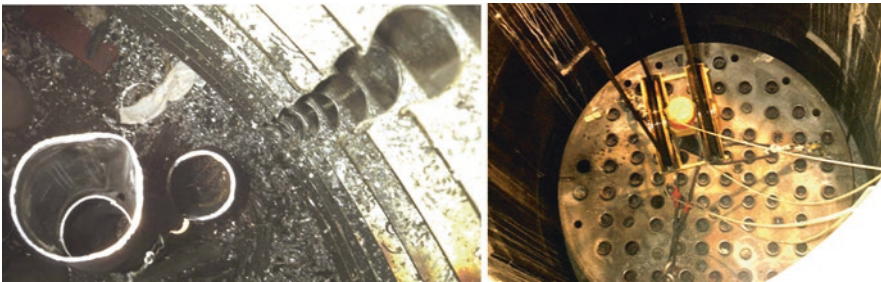
**Photo 2.72** Channel 59 in top view

control rods. The overpressure led to the rupture of the four other rupture discs of the moderator calandria tank, with new projections of radioactive material into the biological shield made of water. This process continued over the next few minutes until the decompression of the primary circuit in the reactor vault was completed. (adapted and commented from <https://www.ensi.ch/fr/2012/05/31/serie-de-lucens-analyse-profonde-de-laccident>). Post-mortem examinations showed that the cladding of fuel 59 had completely burst. The dismantling from above showed the damage caused by the explosion on the double connection of channel 59 (Photo 2.72).

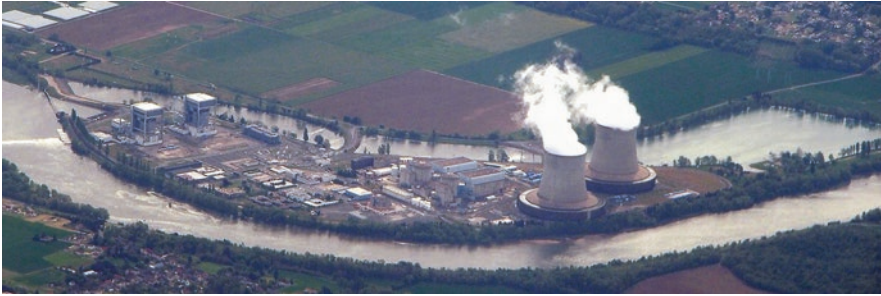
**Photo 2.78** Saint-Laurent-des-eaux site. The two Natural Uranium-Graphite-Gas (UNGG) reactors are located at the far left, recognizable by their cubic shape. Two air-cooling towers in operation are located at the end of the site on the right. The two PWRs that they cool in addition to the Loire River are located just to the left of the towers, recognizable by the hemispherical shape of the reactor buildings and the next large parallelepipedal turbine buildings

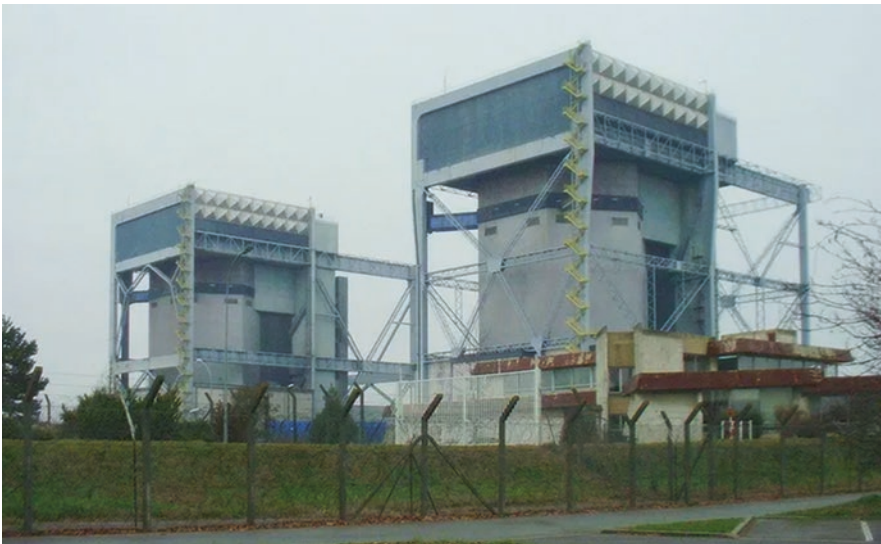
**Photo 2.79** The two reactor blocks of Saint-Laurent-A1 and A2. The welded structures that surround them are characteristic of the French Natural Uranium-Graphite-Gas (UNGG) of the late 1960s

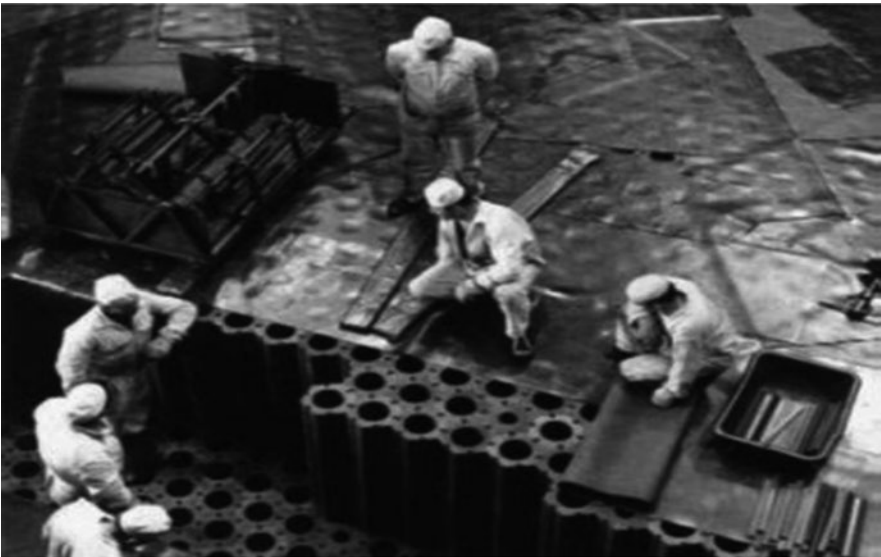
**Photo 2.80** Building the graphite pile: channels through the graphite sleeves are clearly visible

The reactor (Fig. 2.66) contains 446 tons of natural uranium in the form of metal clad with a magnesium-zirconium alloy (43,865 fuel elements called cartridges in the core, 600 mm long, hollow rod 23 mm internal, 43 mm external, surrounded by a graphite fuel jacket 112 mm internal, 137 mm external). The moderator, designed to slow down the neutrons that become more efficient, is made of a stack of 2572 tons of graphite 9 m high (Photo 2.80).

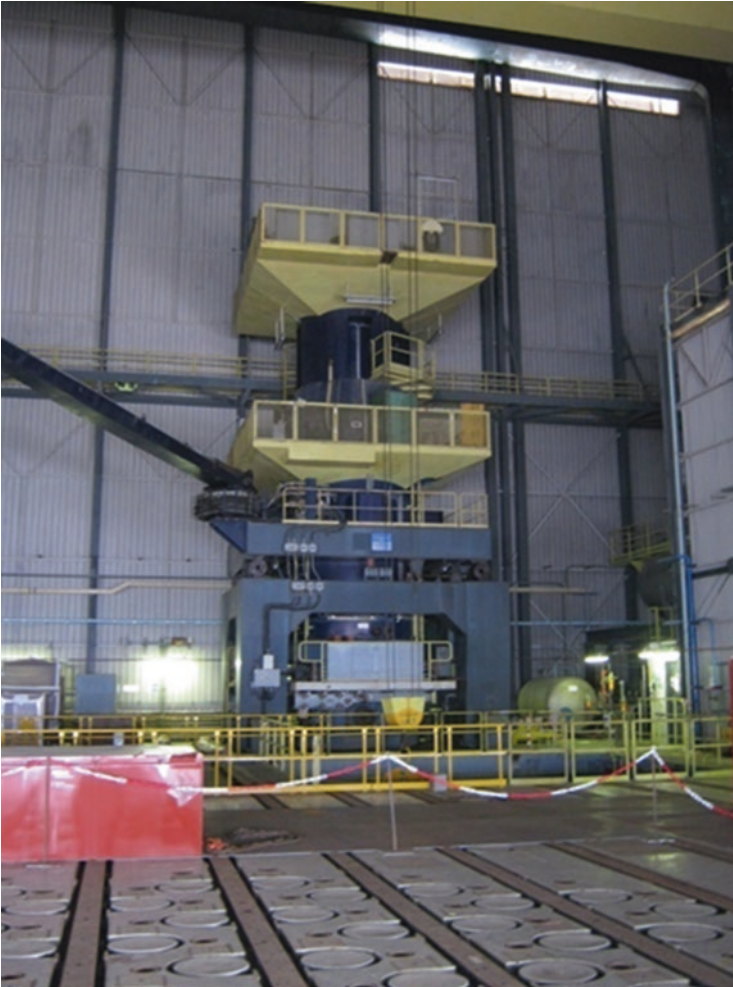
**Photo 2.81** Natural uranium graphite gas reactor (first French reactor type). The Saint Laurent-A loading platform and the Main Handling Device (DPM). The rails of the fuel loading machine and the tulip-shape plugs (with circular top) closing the CO<sub>2</sub> channels are visible in front of the photograph (photo: Bouchacourt-Foissote-Valdenaire-ENSIB)

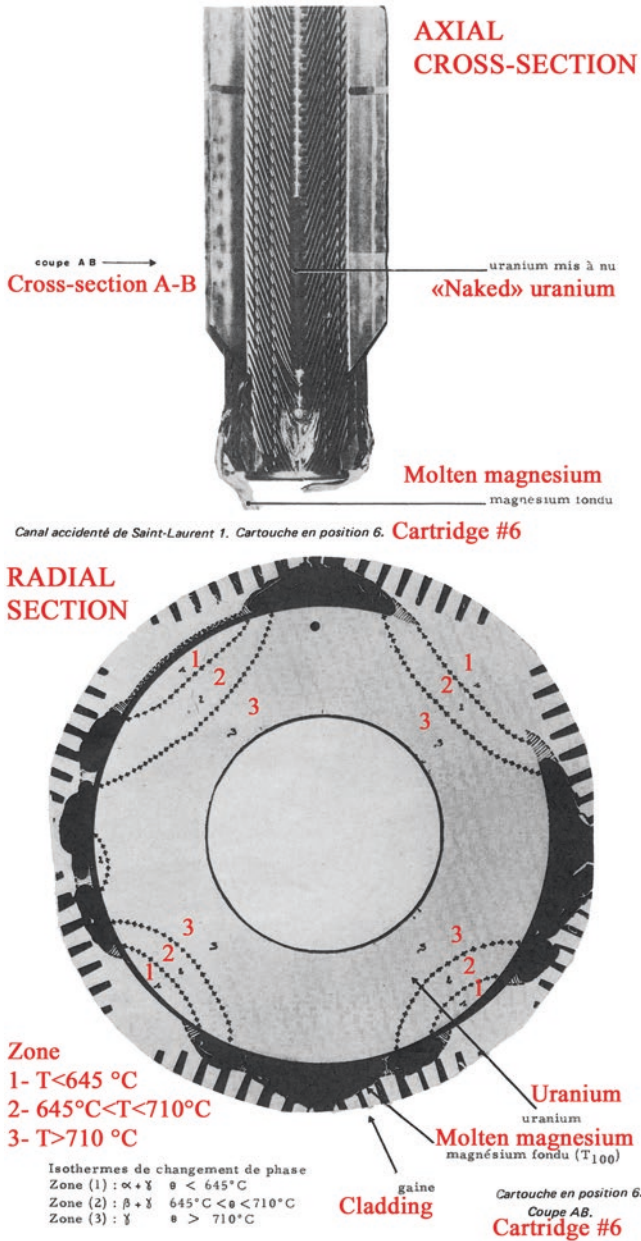
**Photo 2.83** Degradation of a fuel cartridge (vertical section and section) analyzed by the CEA. On the top picture, we see the melt magnesium flows. On the lower picture, we see the radial extent of the magnesium flows as well as the cooling blades around the cartridge (in black)

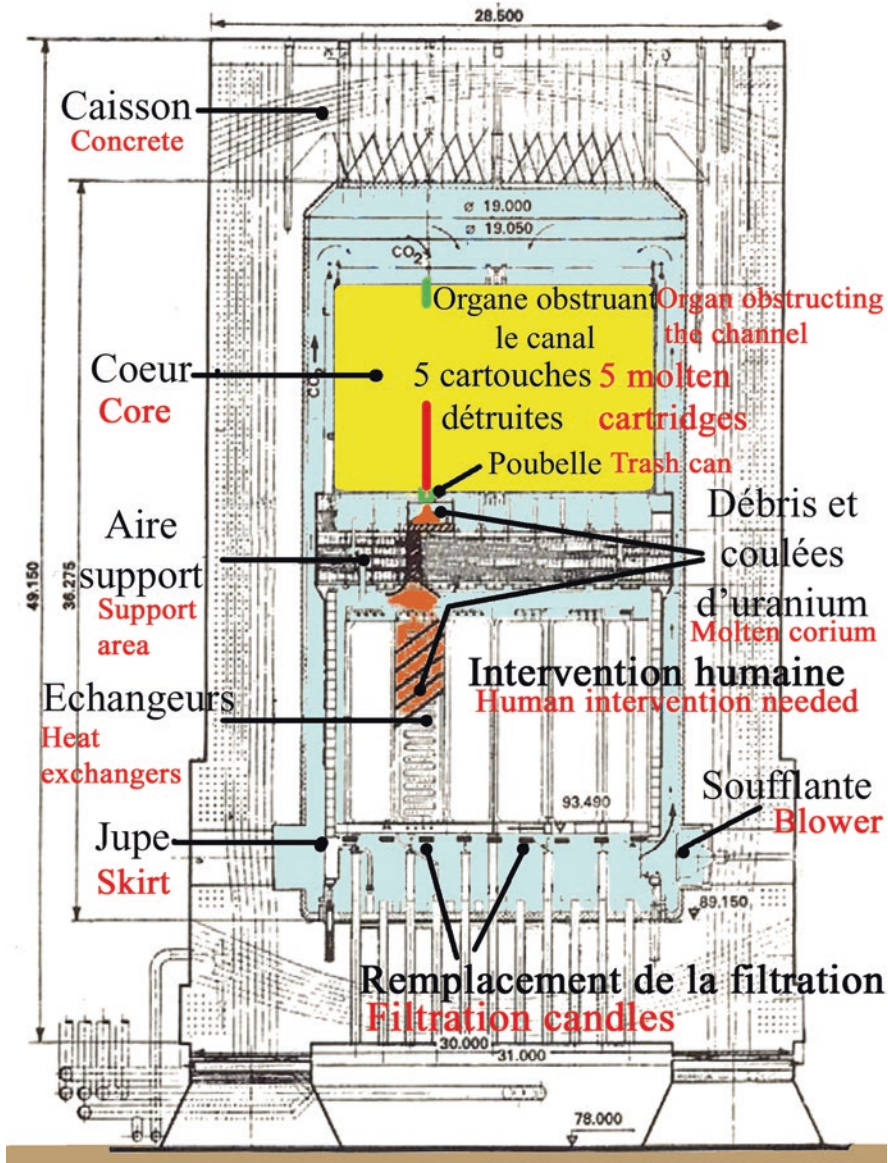
Fig. 2.67 Plan of the core and the damaged channel of Saint-Laurent-A1. The carbon dioxide rises around the core and then passes through the core from top to bottom before passing through the heat exchangers. Note that the core is placed above the heat exchangers, which is antagonistic to natural convection, but which allows the concrete of the caisson to be cooled by cold carbon dioxide, compared to a situation where the core would be placed below the heat exchangers with a cold gas rising and then hot gas descending on contact with the concrete (*jupe* = skirt, *poubelle* = garbage can, *soufflante* = CO<sub>2</sub> blower, *coeur* = core, *échangeurs* = heat exchanger)
