# A Brief History of Nuclear Reactor Accidents

From Leipzig  
to Fukushima

Serge Marguet  
SINETICS, Bureau O2 EF:05  
Electricite De France, Recherche et D ev  
Palaiseau, France

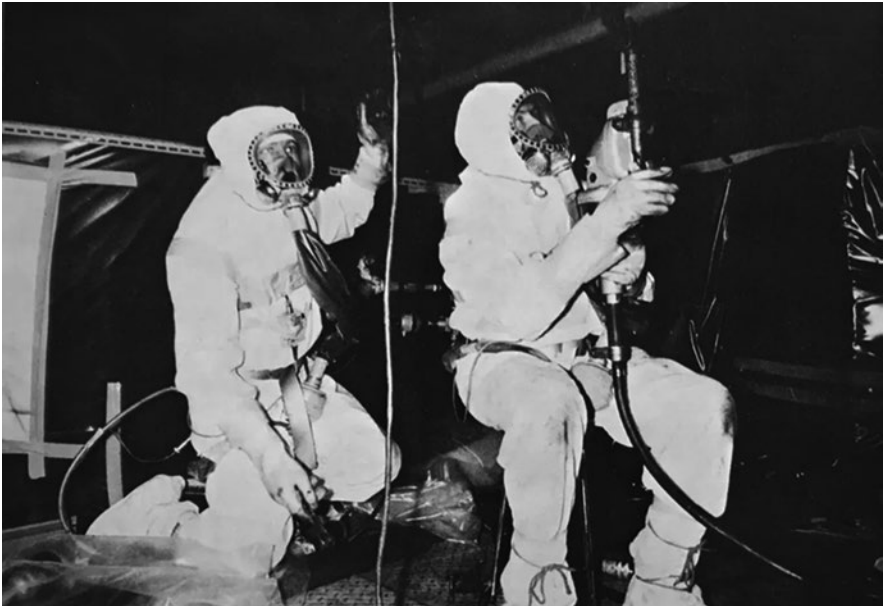
**Photo 2.87** Cutting operation on Saint Laurent-A1 during post-accident repair. The operators are wearing ventilated clothing indicating a possible source of contamination

The rehabilitation of the reactor required the solution of several problems: the cleaning of as much corium and uranium debris as possible (Photos 2.86 and 2.87). EDF used to the maximum the devices controlled remotely from the upper slab such as suction hoses and remote-controlled gripping (pneumatic clamp) of the most voluminous pieces (47 kg of large debris, of which 15 kg were collected thanks to a scraper allowing to make heaps accessible to the clamp). But a human intervention was necessary to remove some debris adhering to the structures. Each of the people who entered the caisson stayed there less than 8 minutes. Because of the limitation to 3 rems per person, 105 people<sup>36</sup> intervened in the caisson maintained under vacuum, after preparation on a scale model, as well as on reactor no. 2 then under construction. They passed through the top of the exchangers after dismantling and cleaning the cell closest to the damaged channel. Dose rate predictions were carried out by the CEA on this occasion, to program the shifts between the teams. The operators entered the caisson through airlocks located at the height of the

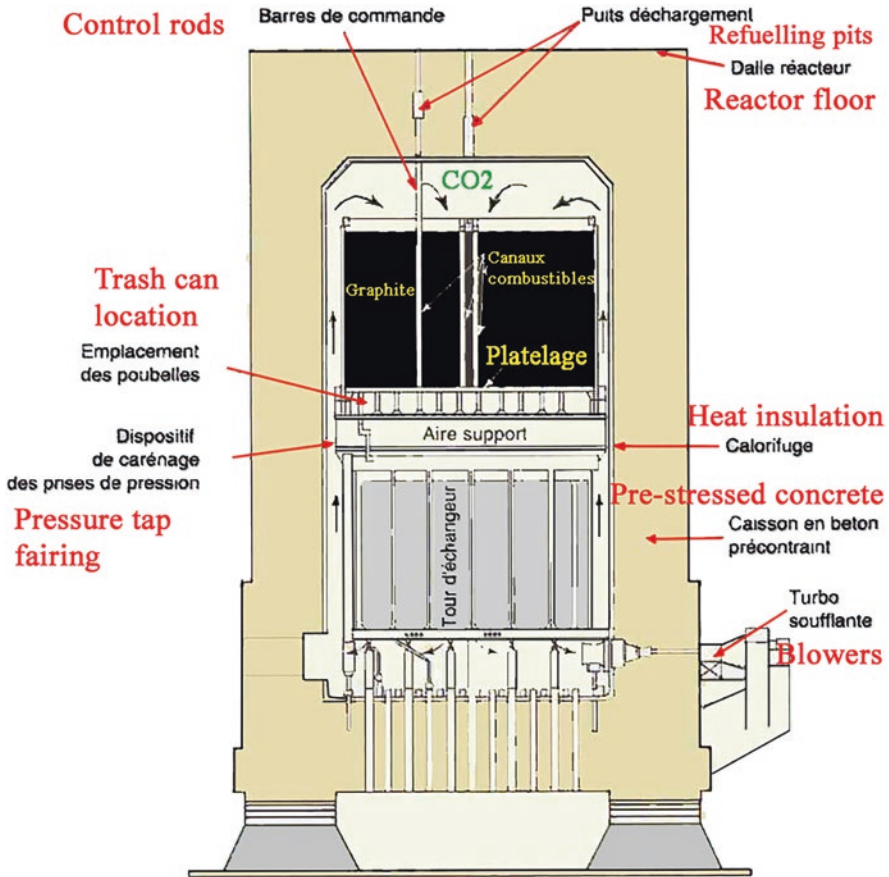
Fig. 2.68 Axial section of the Saint Laurent des Eaux-A2 reactor

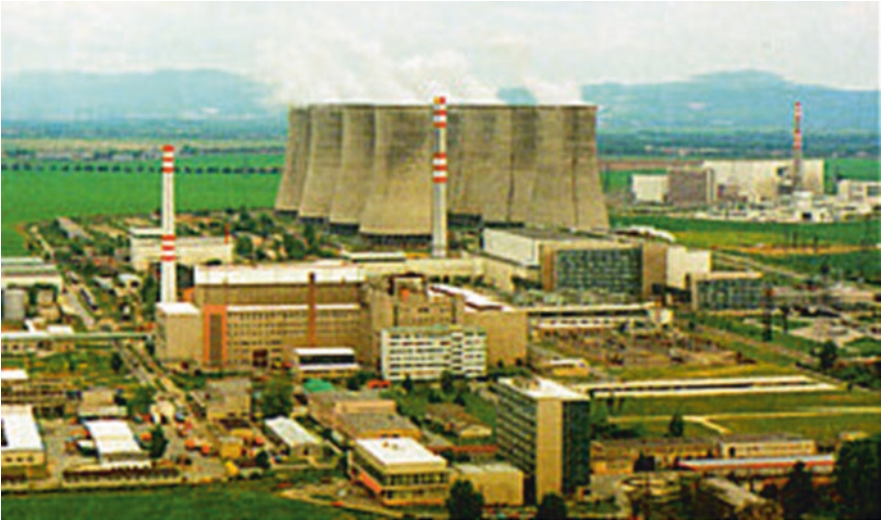
**Photo 2.90** The site of Bohunice. The A1 reactor is recognizable with its very high hall with white roof and by the chimney on its left. The eight air coolers in operation serve the 4 WWER-440 reactors on the right of the picture

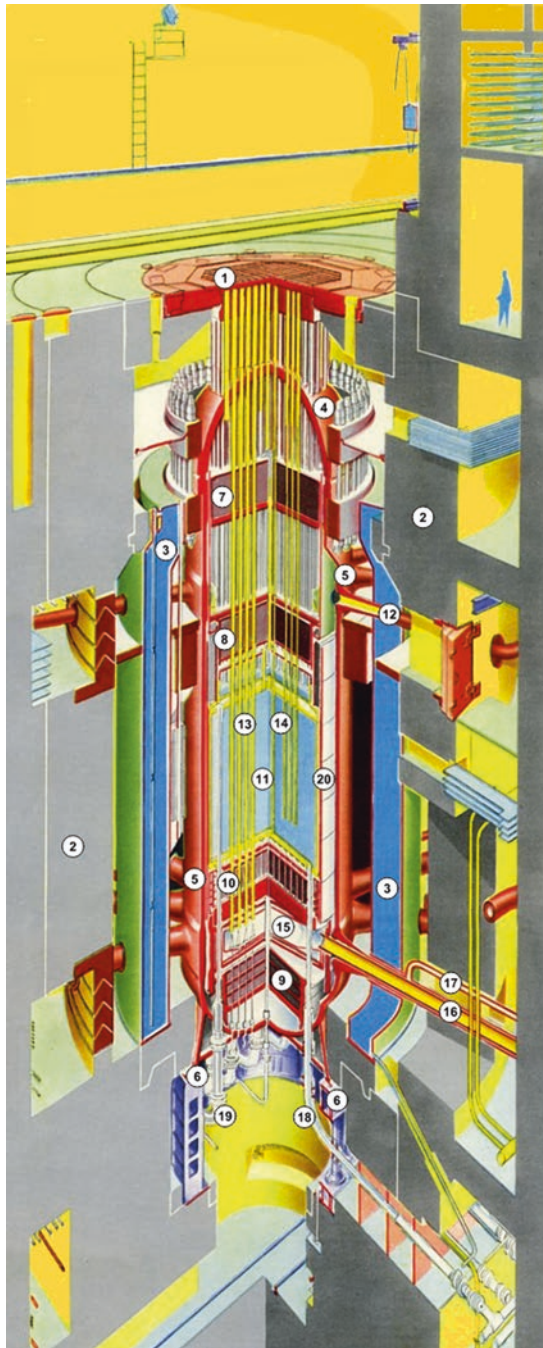
**Fig. 2.71** KS-150 reactor: 1- Loading face, 2- Concrete biological protection caisson, 3- Biological protection water tank, 4- Pressure vessel cover, 5- Pressure reactor vessel, 6- Pressure vessel support, 7- Upper biological protection, 8- Middle biological protection, 9- Lower biological protection, 10- Graphite reflector of the core support plate, 11- Heavy water calandria in the active zone of the core (about 12 m high), 12- Cold leg for carbon dioxide entry from the steam generators, 13- Pressure tubes containing the

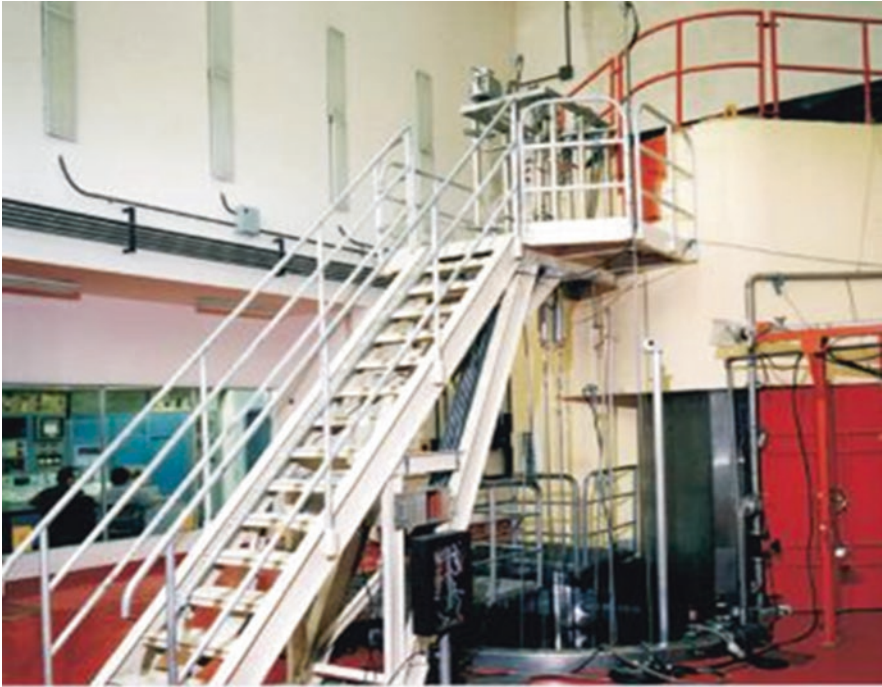
**Photo 2.99** The RA-3 reactor whose main function is the production of medical isotopes such as metastable technetium 99

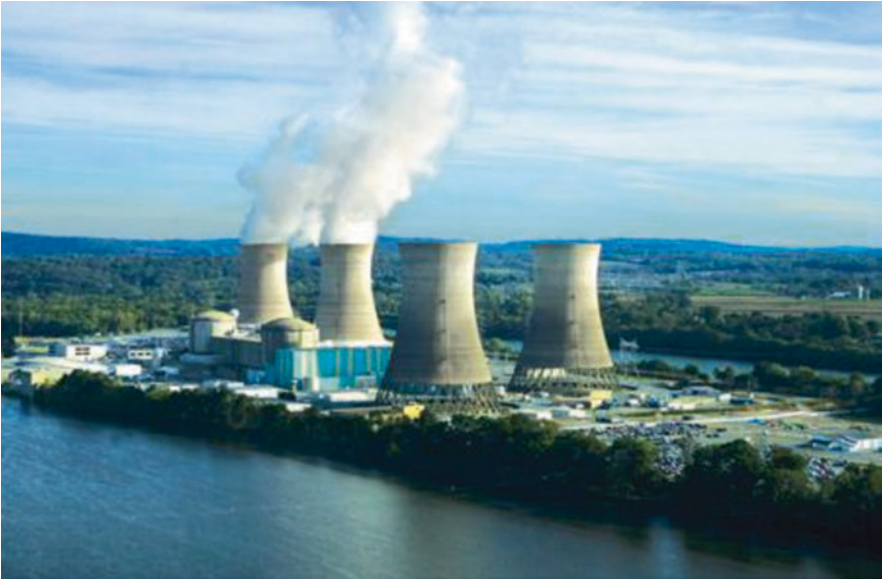
**Photo 3.1** The Three Mile Island plant is located on an island in the Susquehanna River, 10 miles from the city of Harrisburg. The No. 2 reactor is the building with the rounded dome that is located closest to the two non-functional cooling towers. Those in operation produce steam cloud

The Three Mile Island plant (Photos 3.1, 3.2, and 3.3) is located on a small island surrounded by the Susquehanna River, 16 kilometers from the city of Harrisburg, Pennsylvania, and 180 kilometers from the capital, Washington. Here are two similar reactors built by Babcock and Wilcox (B&W) for the Metropolitan Edison Company. TMI-2 first reached criticality on March 28, 1978, exactly one year before the events we will describe. That is, the reactor was completely new. The B&W reactors, whose core is very similar to those of its competitor Westinghouse in the USA or France, have a primary circuit that has some notable differences (Fig. 3.1). The containment is broadly similar to that of a Westinghouse reactor (Fig. 3.4).

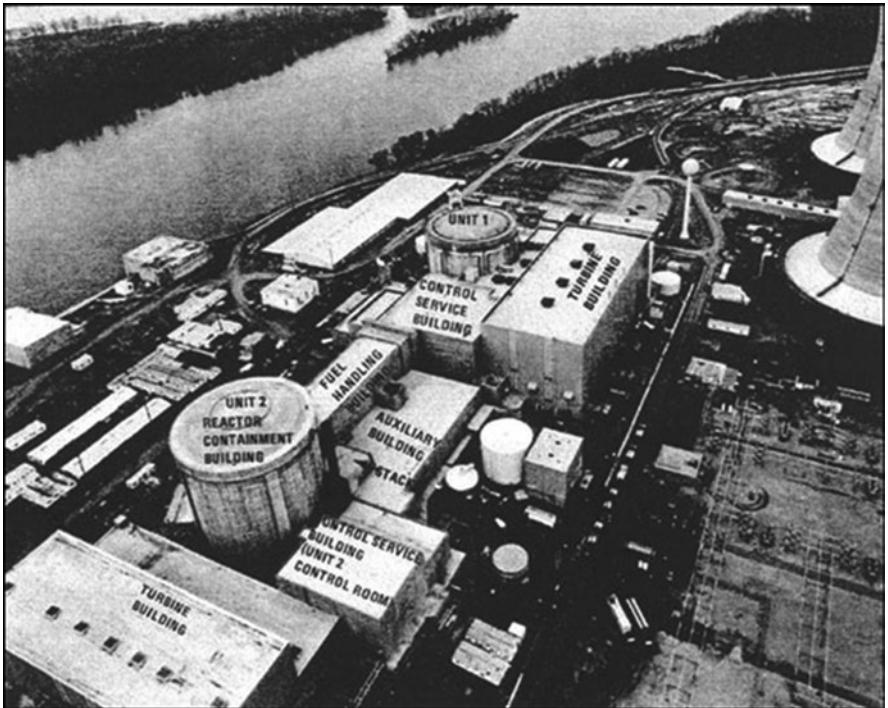
**Photo 3.2** Unit-2 is in the foreground. The photograph is taken from one of the cooling towers of unit-2

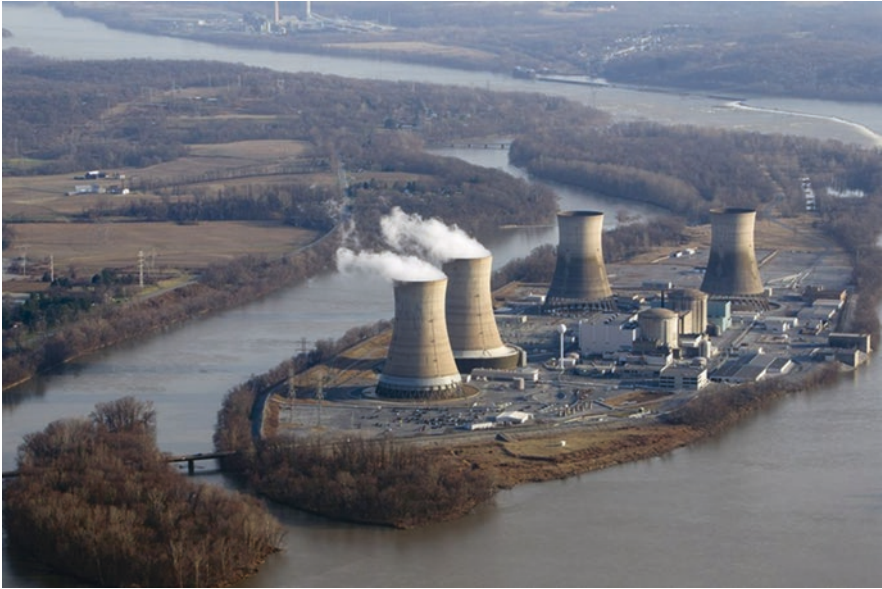
**Photo 3.3** Unit-1 in operation. Two cooling towers are required to cool the condenser. The auxiliary cold source comes from the river

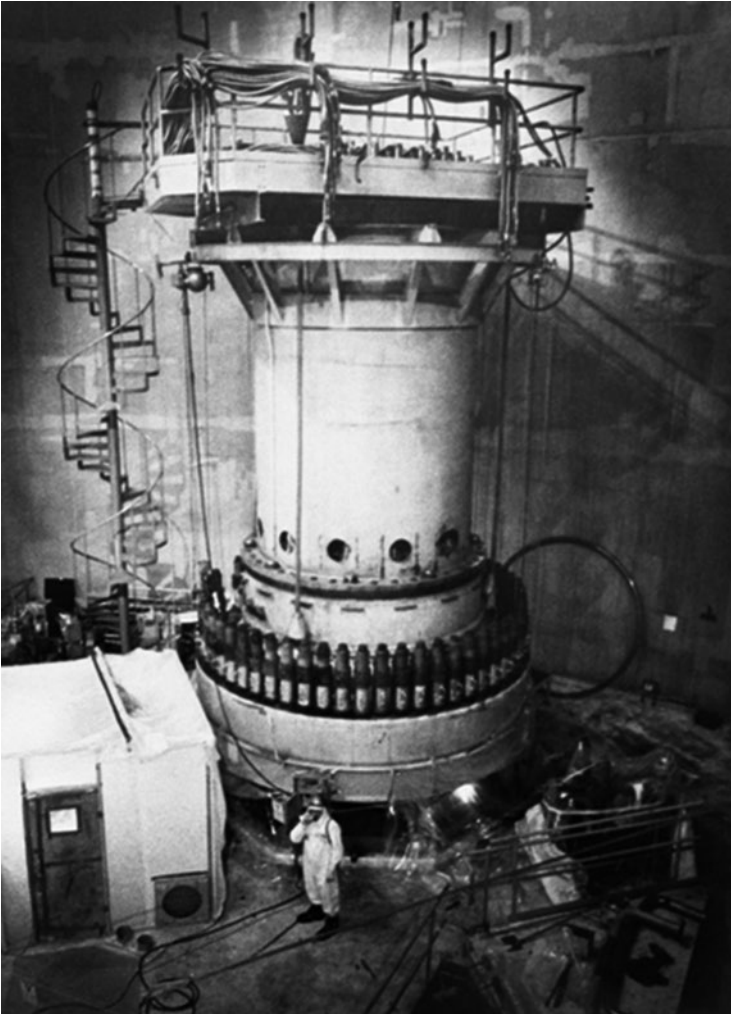
**Photo 3.4** Inside the reactor pool at an undetermined date. The control rod mechanism (RGL) is still upon the reactor vessel cover. One can see the studs closing the cover on the vessel. A ventilated tent allows you to momentarily escape the ambient radioactivity

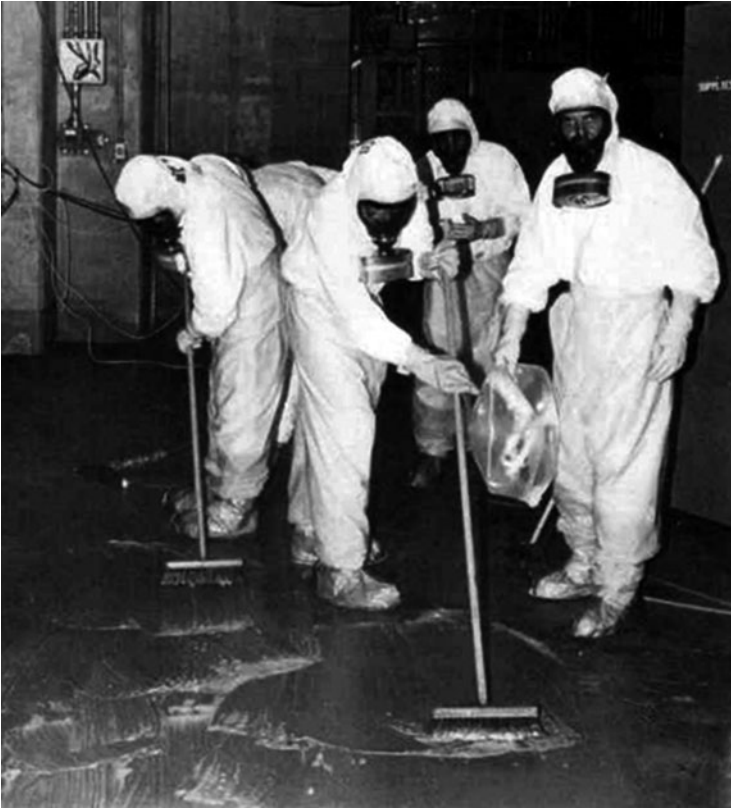
**Photo 3.6** Cleaning the floor for decontamination

From July 1980 onwards, Operators began to enter the reactor building in a cautious way and strongly protected against contamination (Photos 3.4 and 3.5). Decontamination (Photo 3.6) and dose mapping (Fig. 3.9) were performed. The objective was to insert a shielded video camera into the core via a control rod adapter (Photo 3.7). This visual inspection confirmed the presence of a cavity of 9.3 m<sup>3</sup> in the core, resulting from the collapse of the assemblies. The camera allowed to visualize the debris bed resting at the bottom of this cavity.<sup>9</sup>

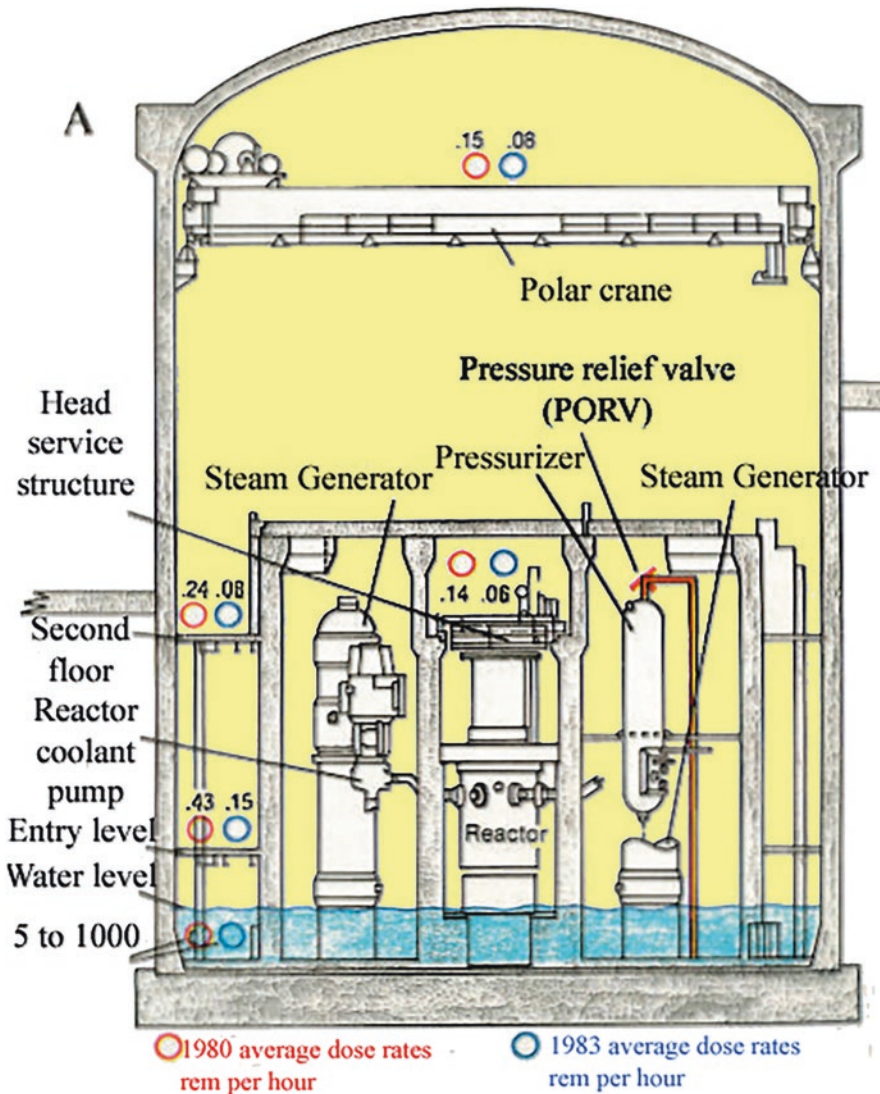
Fig. 3.9 Dose map et evolution from 1980 to 1983

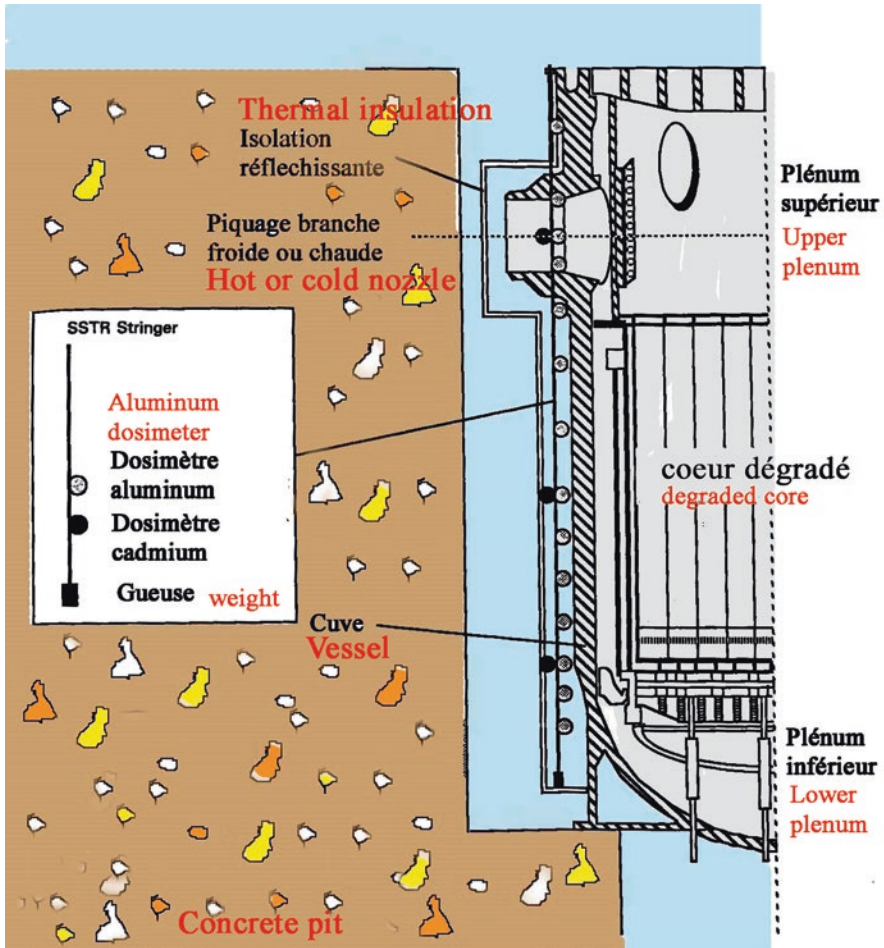
Fig. 3.10 Dose measurement in the vessel pit [from Bandini et al. 1987]

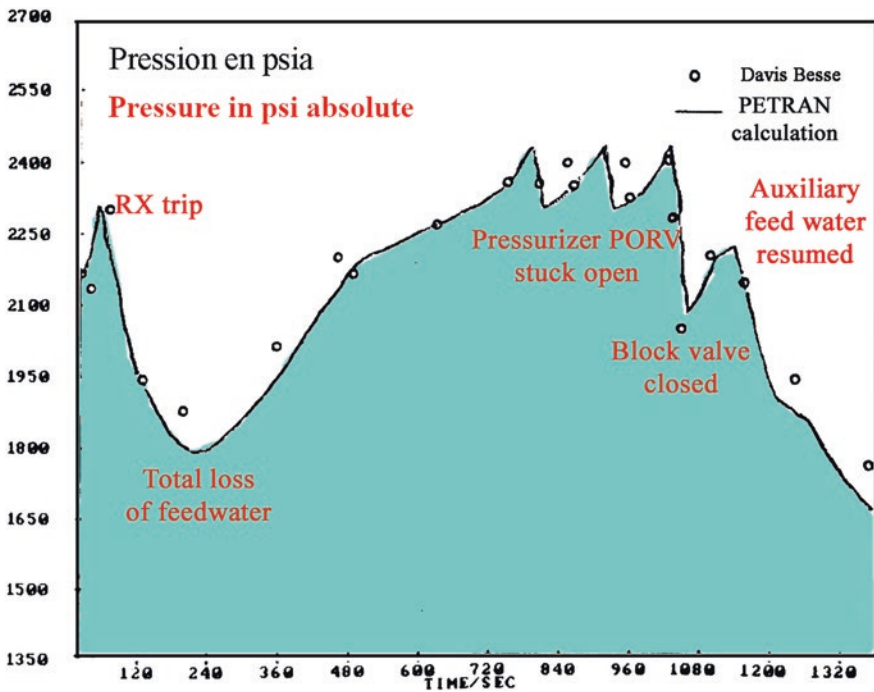
Fig. 3.17 Loss of SGs auxiliary feed water on Davis Besse on June 9, 1985. Fortunately, the fate of this plant was happier than TMI-2

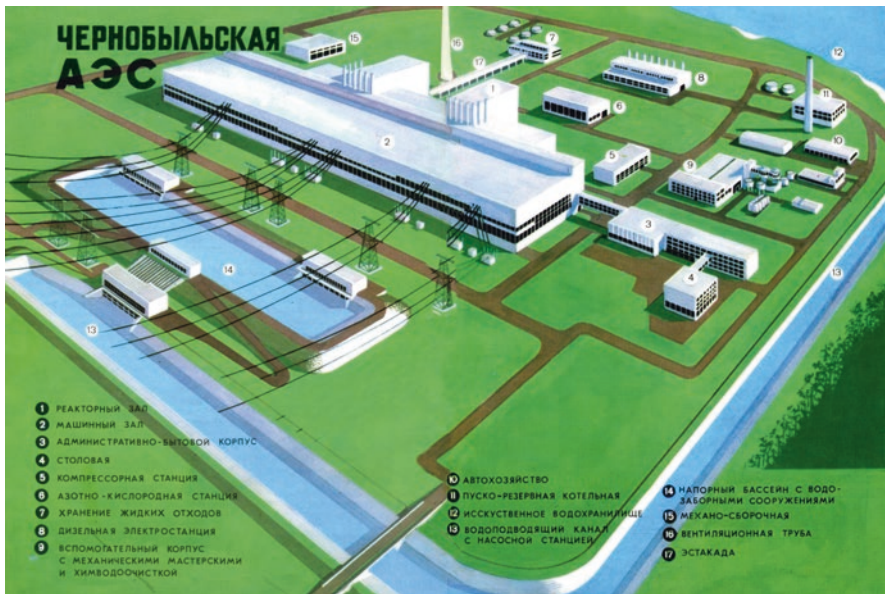
**Fig. 4.1** An artist's drawing presenting an idyllic vision of the Chernobyl site from a 1978 presentation brochure. The turbine building (noted 2) is common to two twin plants. The two twin reactors are noted 1

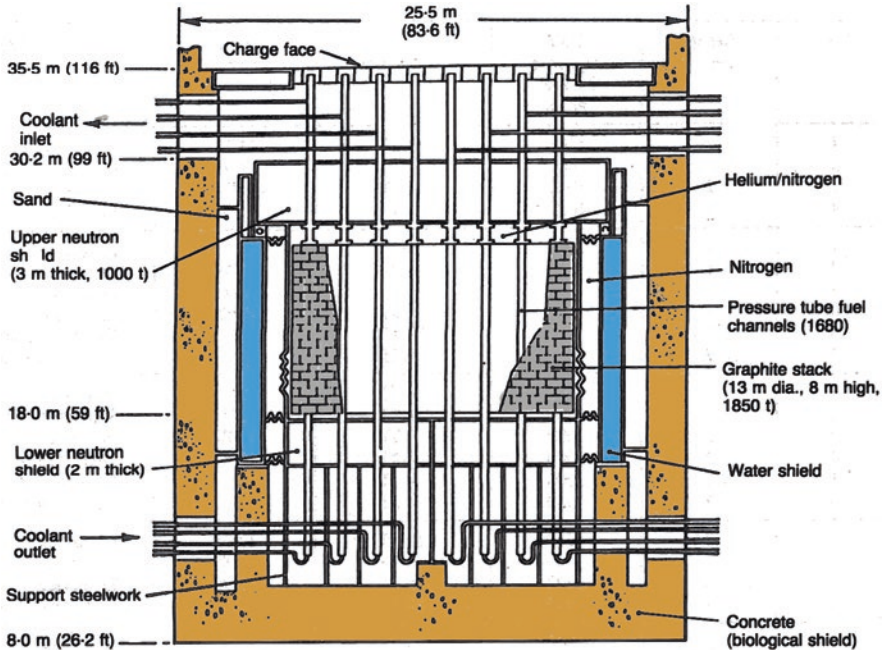
Fig. 4.3 The concrete caisson housing the core

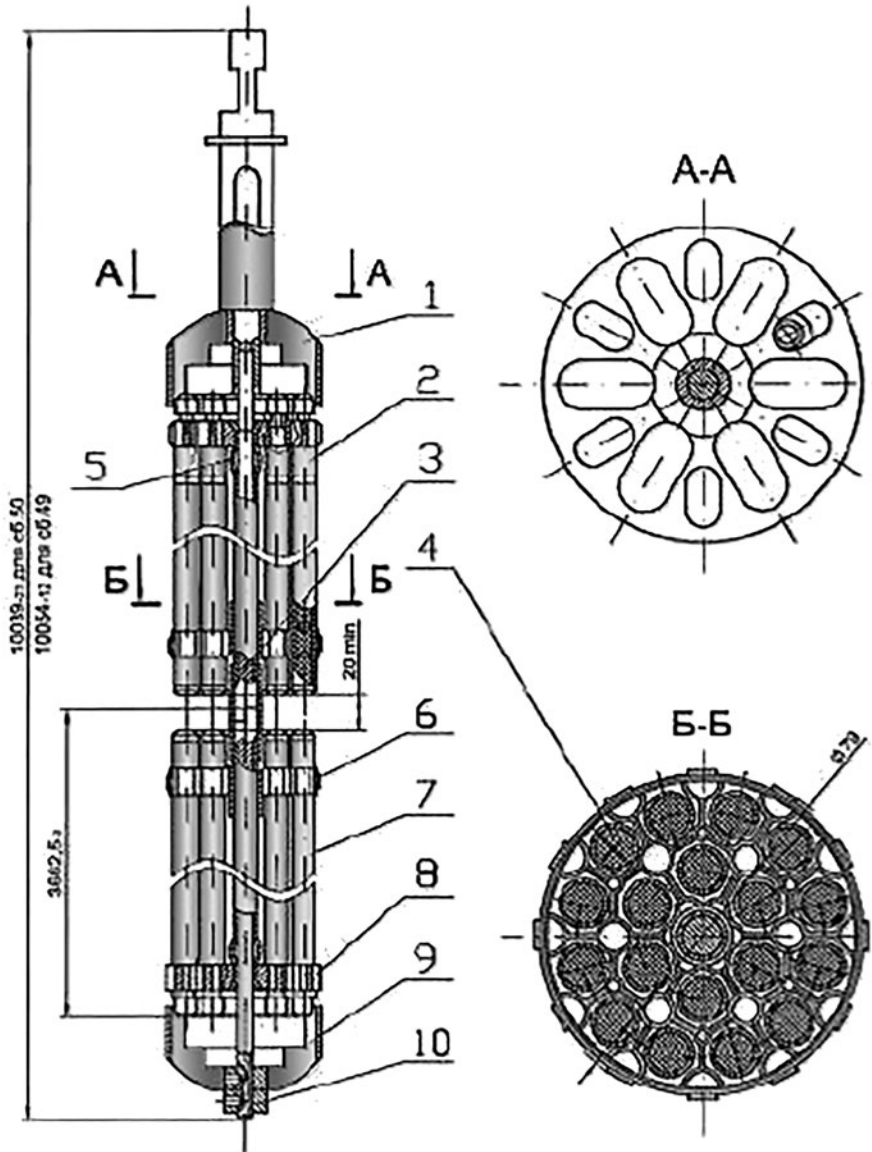
**Fig. 4.4** Configuration of an RBMK-1000 fuel assembly: the assembly comprises two clusters of 18 rods distributed around a central core. (1) Assembly head with tie-down sleeve, (2) Upper control rod cluster, (3) Central core, (4) Fuel rod, (5) Central tube, (6) Spacer grid, (7) Lower control rod cluster, (8) Lower grid, (9) Assembly foot, (10) Holding nut

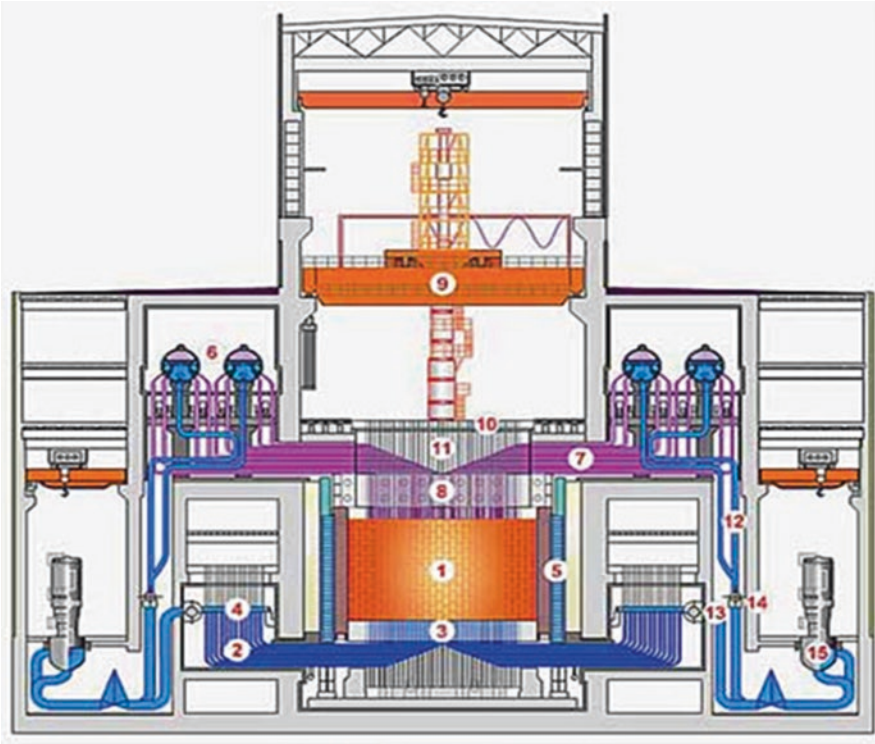
**Fig. 4.6** Axial section of an RBMK-1000: (1) Active area of the graphite stack (2488 graphite columns, 18 m diameter 8 m height, 250 mm × 250 mm × 600 mm graphite block). (2) Demineralized light water pipes for cooling the core. (3) Biological shielding. (4) Pressure tube water distribution manifold. (5) Lateral biological protection. (6) Steam separator drum. (7) Communication pipes for steam and water to the drums. (8) Upper biological containment. (9) Fuel loading and unloading machine. (10) Removable slab decking. (11) Fuel channel ducts accessible after unscrewing the plug at the fuel loading machine. (12) Primary water drainage pipes. (13) Pressure manifold. (14) Suction manifold. (15) Primary circuit circulation pumps

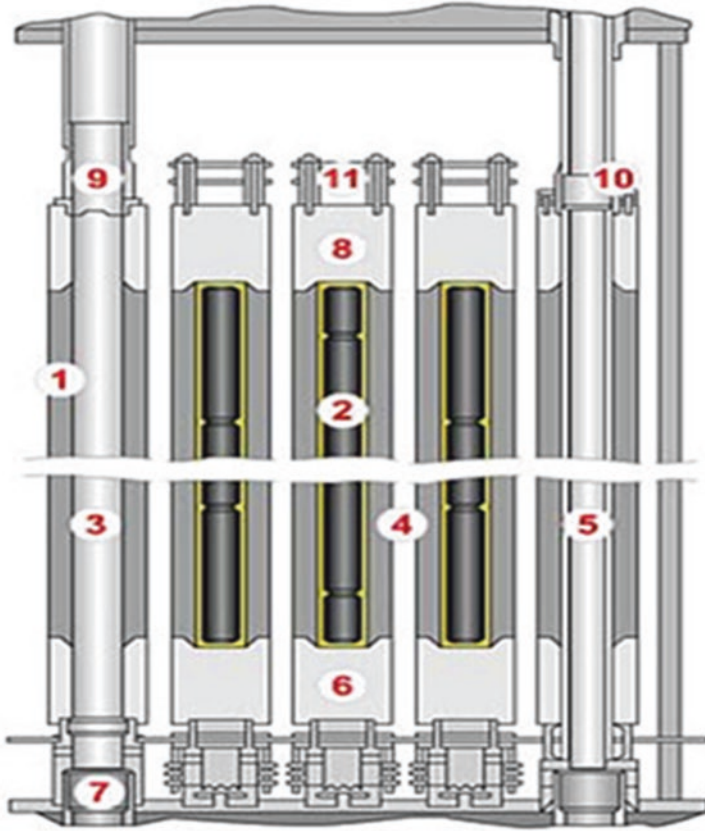
**Fig. 4.8** View of a graphite block made of graphite columns. (1) graphite blocks. (2) graphite rods. (3) Plant column. (4) Columns of reflectors. (5) Peripheral reflector column. (6) Base plates. (7) Support sockets. (8) Protection plates. (9) Flanges. (10) Guide. (11) Heat shields

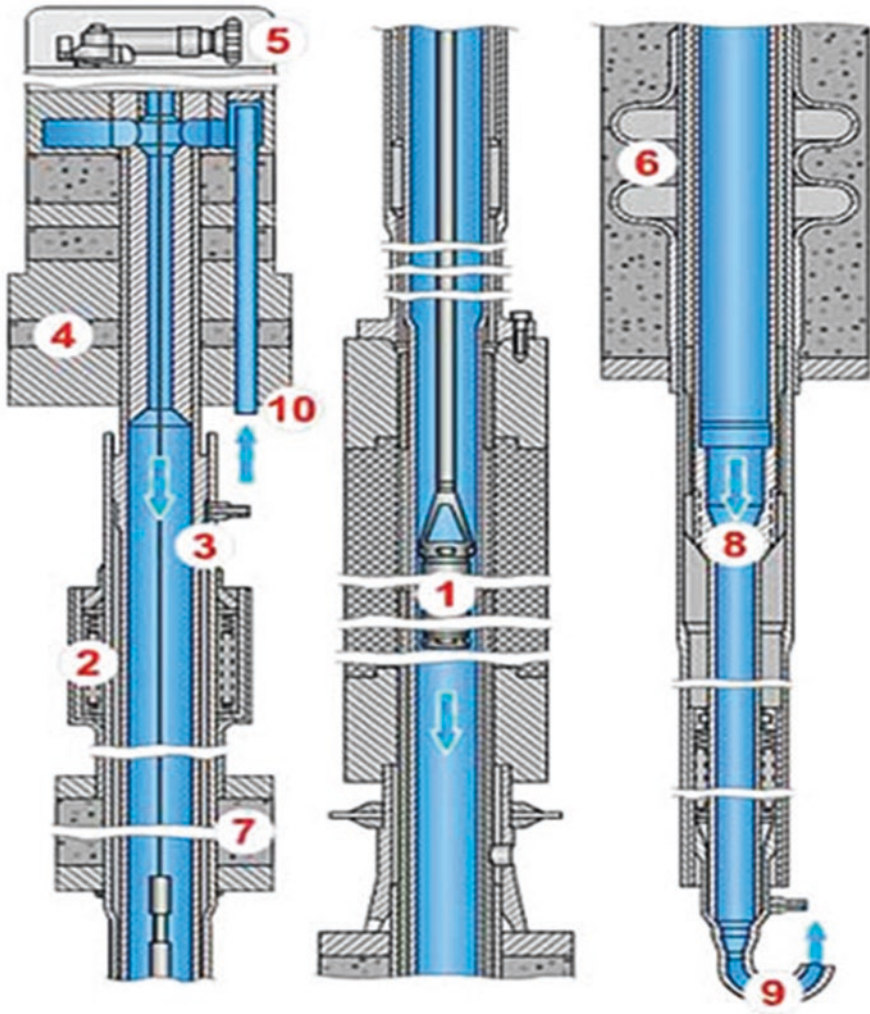
**Fig. 4.10** Schematic diagram of the control and protection system channel: (1) Control rod drive for the sorbent cluster. (2) Bellows expansion joint. (3) CPS top duct. (4) Upper cap. (5) Control rod drive mechanism (6) Lower biological shield. (7) Upper biological shield. (8) Throttling device. (9) Channel drainpipe. (10) Water supply pipe in the channel. It must be ensured that there will be no blockage of the rods in the channels of the control and protection system, taking into account the possible bending of the graphite masonry columns. The control and protection cladding is designed to contain the control rods of the control system and to provide water circulation to cool the electrical actuators of the control system that release Joule energy. The control and protection duct is a welded tubular structure made of zirconium alloy and corrosion-resistant steel. Graphite sleeves are attached to the channel to provide the required temperature control for the graphite column. The upper part of the channel houses the actuator mounting heads and the channel cooling water supply. In the lower part of the channel is a constriction that ensures that the entire channel cavity is filled with water. The calculated permissible deflection of the columns is 50 mm, above which the free insertion of the control rod clusters is compromised

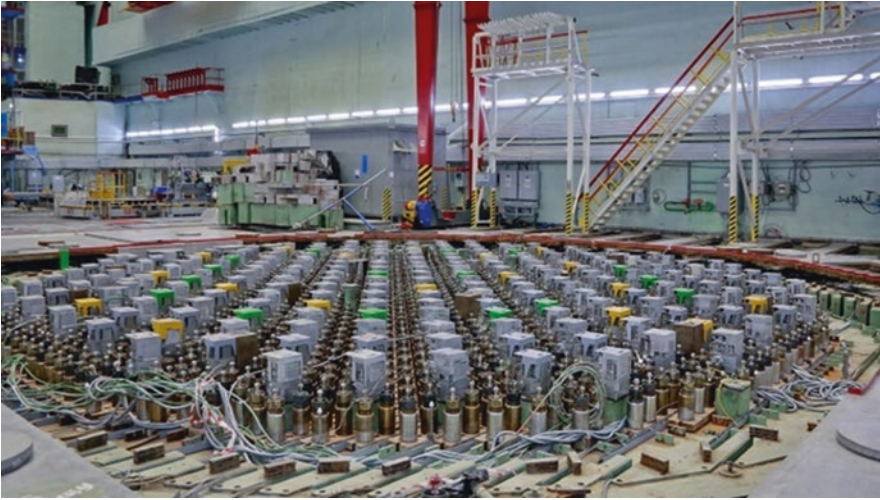
**Photo 4.2** Smolensk-3 loading face being upgraded (photo Rosatom)

well as the radiation monitoring system, and strengthening of the building structure. In April 2015, an application for a 15-year license extension was filed. The upgrade of Smolensk-3 (Photo 4.2) followed. In 2017, work began to restore the lifespan performance of the graphite stacks. The three Smolensk units are planned to operate for 45 years. Eventually, WWERs will replace the old RBMKs (adapted from a Rosatom communication, relayed by World Nuclear News).

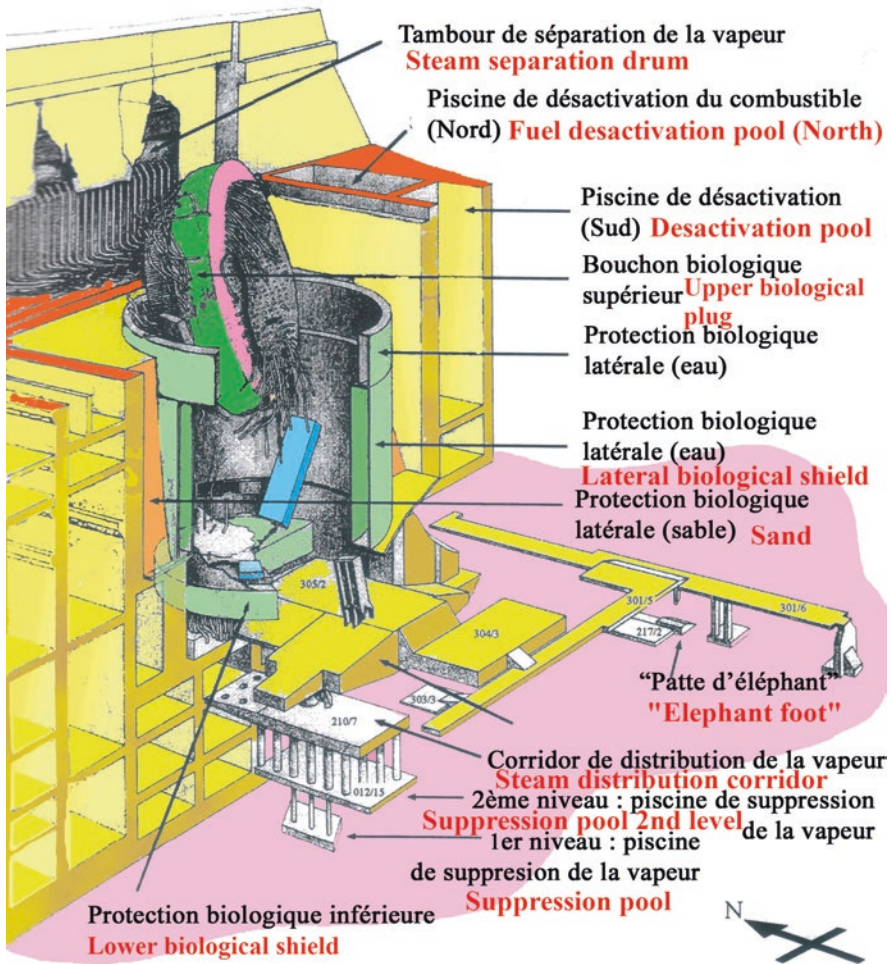
**Fig. 4.20** Inner view of the Chernobyl reactor building after the explosion (adapted from Borovoi and Sich 1995)

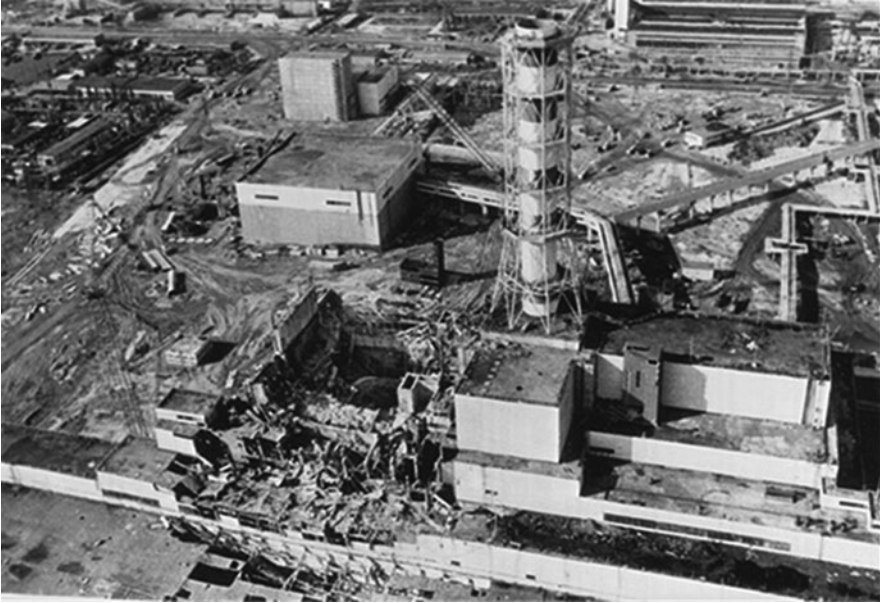
**Photo 4.9** Aerial view of the reactor-4 or rather what remains of it. This view allows to see inside the pit of the reactor

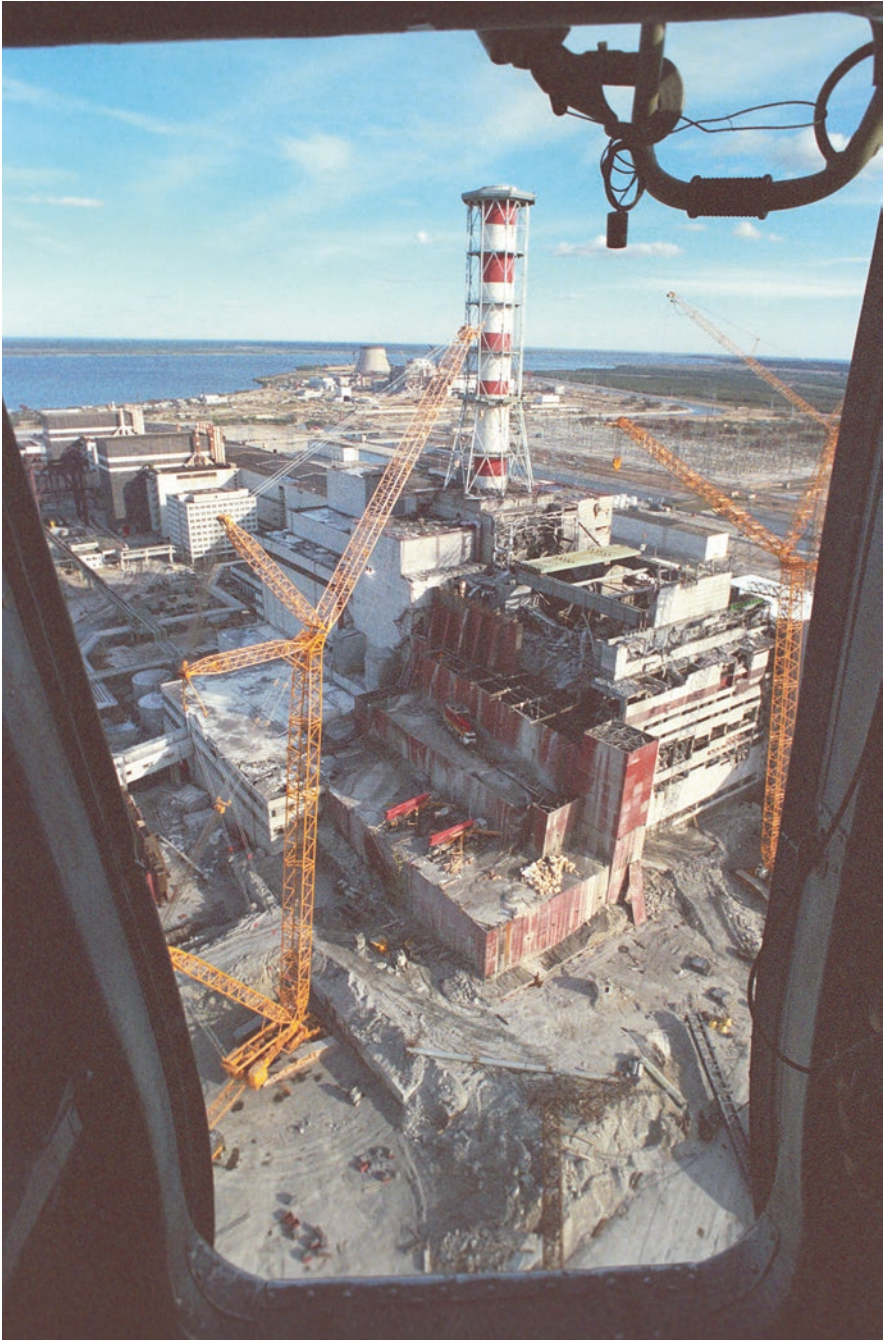
**Photo 4.10** An impressive photo taken through the open door of a helicopter, during the construction of the first sarcophagus (photo DR). A truck, which one wonders how it arrived there, gives the measure of the whole picture

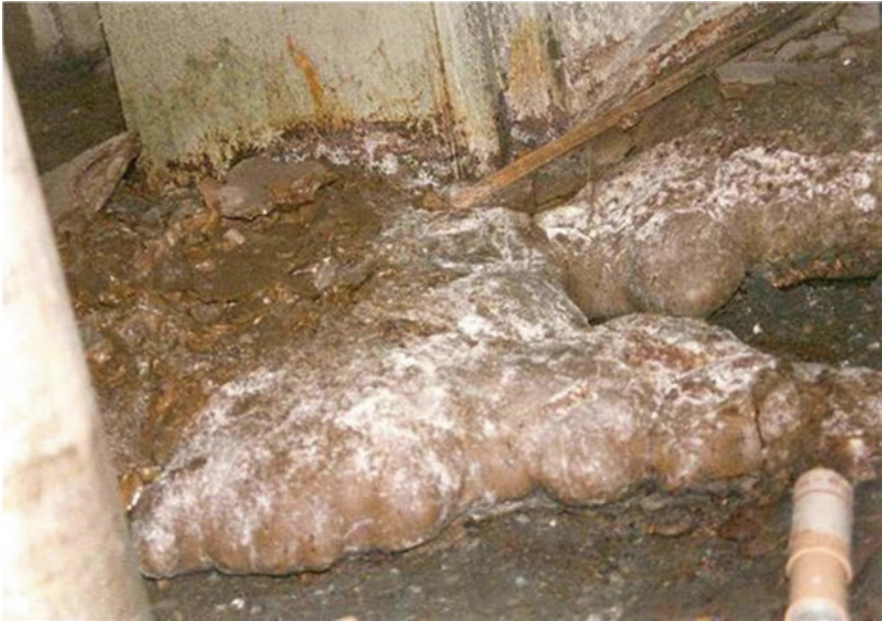
**Photo 4.11** Flow of solidified corium in the shape of an “elephant’s foot.” Even after partial solidification, the residual power can melt this corium until the surface in contact with the air is large enough to evacuate the power by natural convection. The activity of this corium is such that the remotely operated inspection robots that approached it the first time failed due to the intense radiation (photo DR)

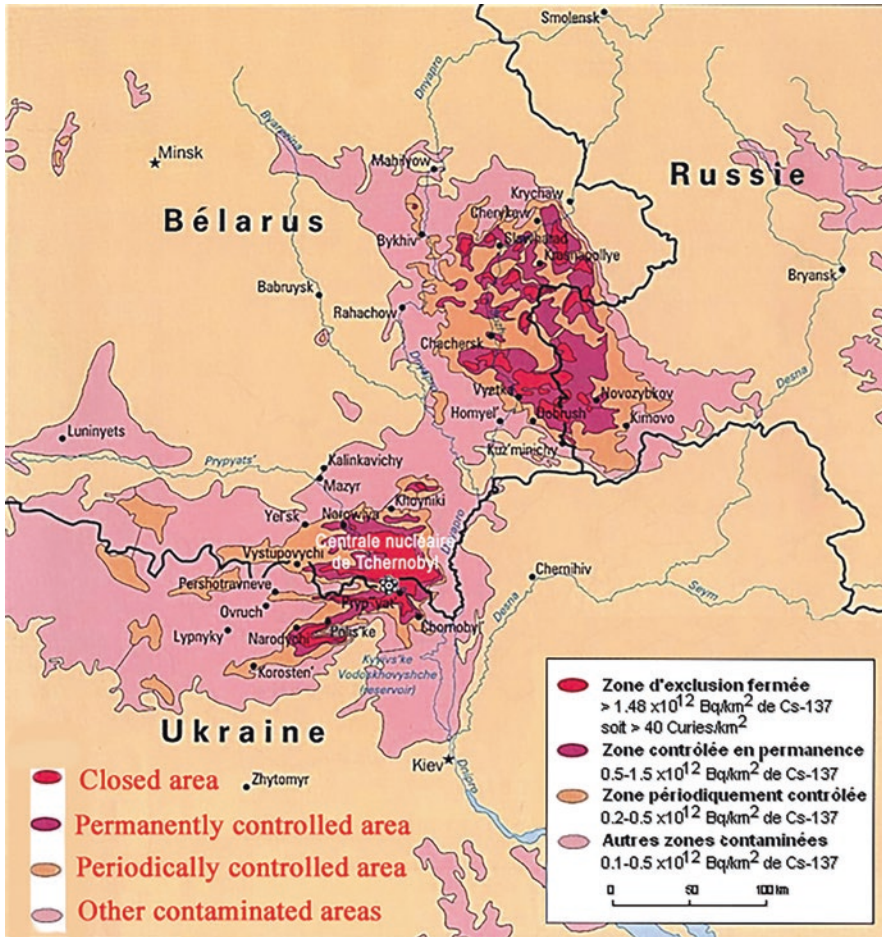
Fig. 4.21 Deposits measured in 1996 around Chernobyl in Belarus and Ukraine (source <http://www.astrosurf.com/luxorion/Physique/tchernobyl-contamination-map.jpg>)

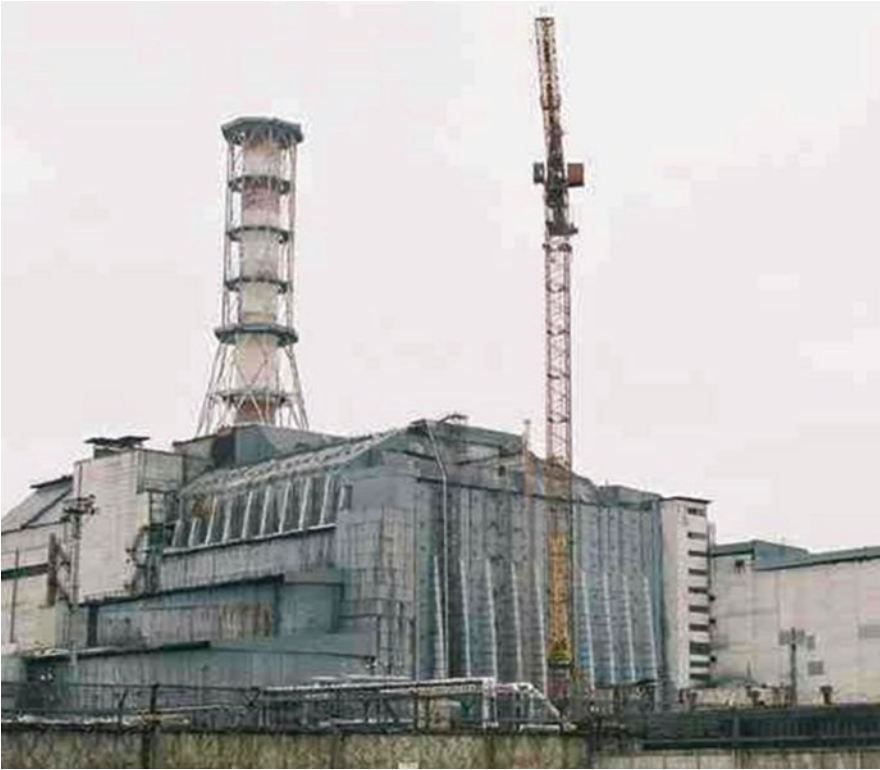
**Photo 4.13** The first sarcophagus of Chernobyl 4

In order to contain the radioactivity, the Soviet state called upon a large number of civilian and military personnel. These liquidators carried out, among other things, decontamination of the site and roads, storage of waste, and the construction of dams. However, their most important task was the construction of the sarcophagus around the reactor. The sarcophagus was built in a hurry from July to November 1986 (Fig. 4.24). The purpose of this

sarcophagus was to prevent the radioactivity remaining in the reactor from dispersing into the environment, to limit the entry of rainwater, which could contaminate the ground, and to continue the operation of reactor no. 3. Indeed, this reactor was adjacent to reactor No. 4 and had common facilities such as the turbine hall and the auxiliary building. This sarcophagus (Photo 4.13) was made of beams and large metal plates, as well as concrete. This 300,000-ton building is 175 m × 70 m square and 66 m high. However, because of the very high dose rates, the beams and metal plates had to be installed with remote cranes, and thus without the possibility of fixing them precisely together. The surface area of the openings in this sarcophagus was estimated to be about 1000 m<sup>2</sup>. Voluntary or not, these openings contributed to cool the structures thanks to the circulation of air, but left escape routes for the radioactive particles, partially stabilized on the ground by deposited resin. These gaps were reduced by half following work carried out from 1995 to 1997.

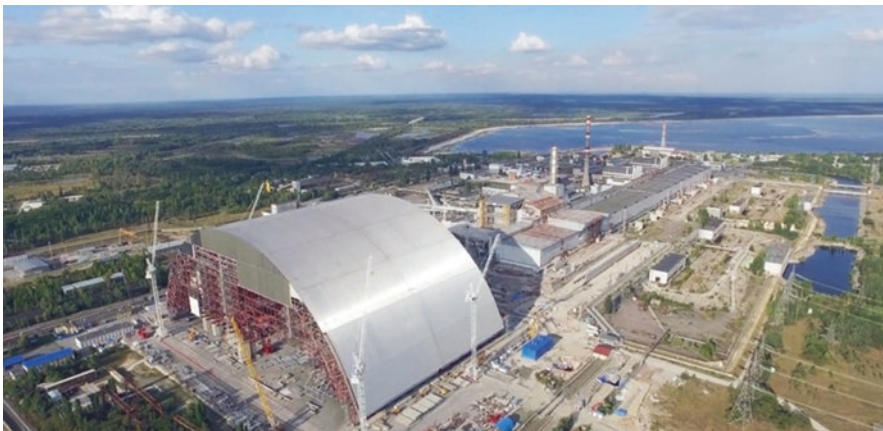
**Photo 4.14** The new containment arch built by the French companies Bouygues and Vinci (source site internet Bouygues)

The new arch-shaped structure will have several objectives: to protect the first sarcophagus against external aggression, to ensure a perfect seal between the radioactive ruins of the destroyed reactor and the environment, and to allow the dismantling of the old sarcophagus and the removal of radioactive materials under safe conditions. Bouygues Travaux Publics and Vinci built the new containment for Reactor 4 between 2007 and 2018. This sarcophagus of titanic dimensions will have an estimated lifespan of 100 years. In particular, it will allow the dismantling of the accident reactor. The workers on the site, intensely decontaminated to limit the doses received, have benefited from reinforced medical monitoring and specific protective equipment. Composed of two metal structures, with a total weight of 25,000 tons, this containment arch is 162 m long, 108 m high and has a span of 257 m. It alone could overlap the Stade de France or the Statue of Liberty! The containment was designed to withstand temperatures ranging from  $-43$  to  $+45$  °C, as well as a class-3 tornado or an earthquake measuring VI on the Mercalli scale. This project involved international expertise. The arch was built in Italy, the siding by a German-Turkish company, and the lifting was outsourced to a Dutch company. On the site, we met Ukrainian site managers, Italian mountaineers for the work at height, and Azeris used to offshore oil platforms for the lifting part (adapted from <https://www.bouygues-construction.com/projet-emblematique/tchernobyl/>).

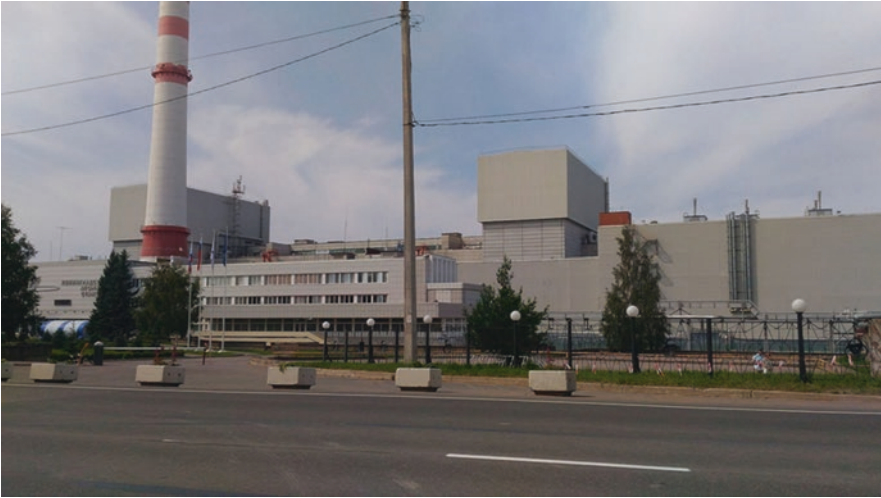
**Photo 4.19** Two reactors of Leningrad (the highest cubic blocks contain one reactor each)

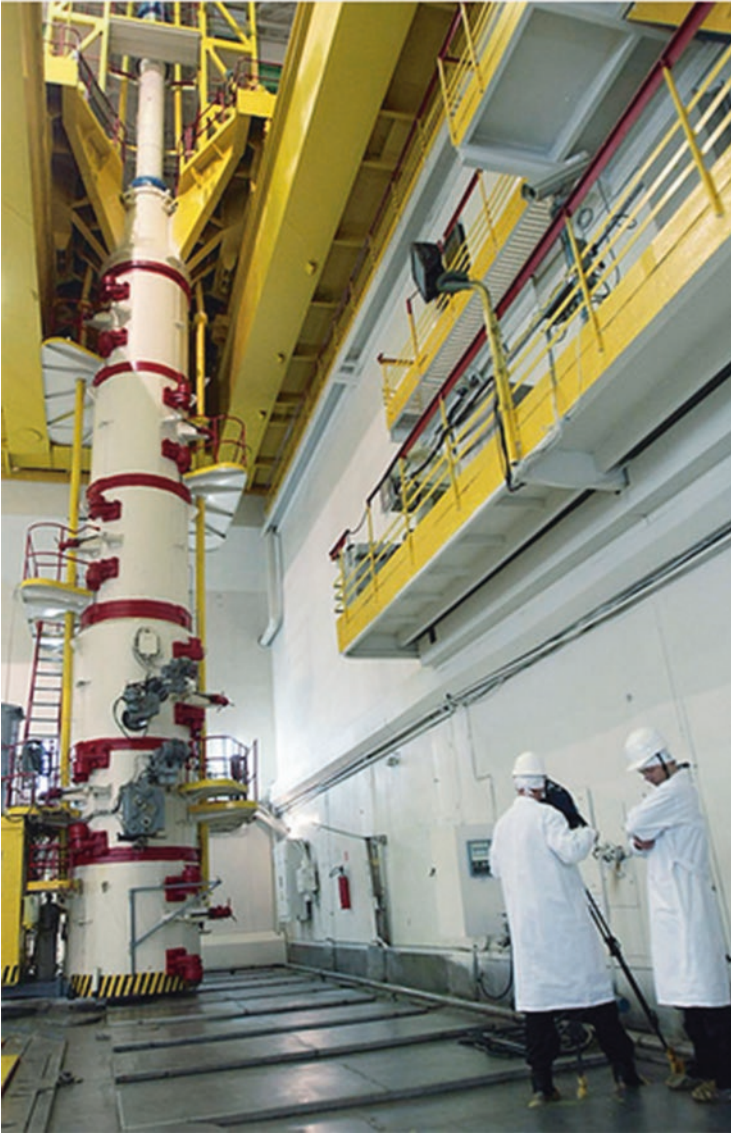
**Photo 4.22** Assembly handling system. The very large size of the system is due to the height of the assemblies (almost 7 m!)
