# A Brief History of Nuclear Reactor Accidents

From Leipzig  
to Fukushima

Serge Marguet  
SINETICS, Bureau O2 EF:05  
Electricite De France, Recherche et D ev  
Palaiseau, France

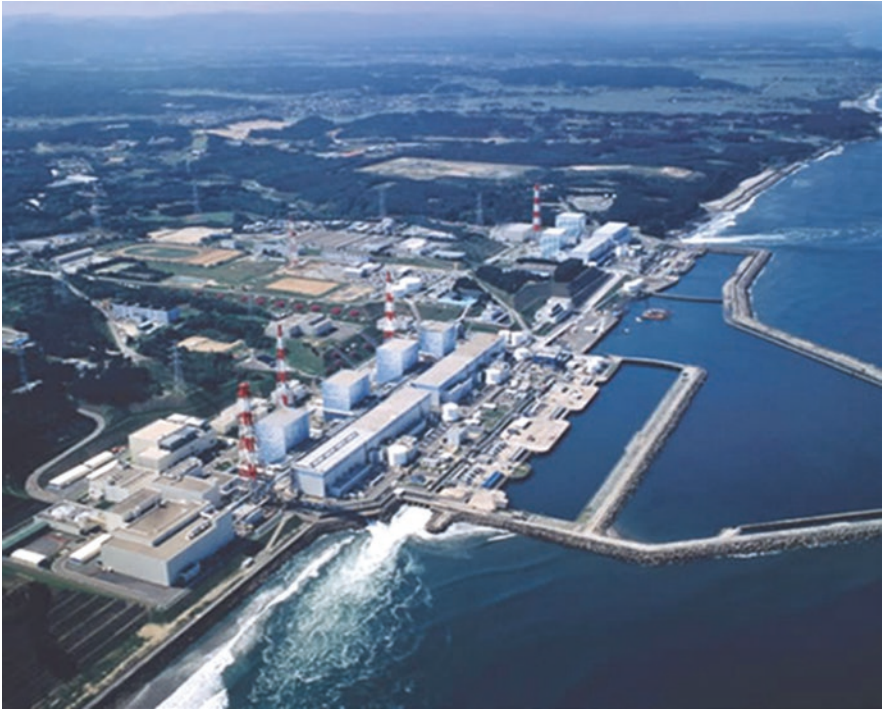
**Photo 5.1** The Fukushima Dai-ichi plant: in the foreground, unit 4 appears as a cube located between the two red and white towers, then reactors 3, 2, and finally 1 (Photo Tepco). A large gap separates Reactor-1 and Reactors-5 and -6 sharing a ventilation stack painted in white and red. The building located between reactor-1 and reactor-5 along the coast is the Dry Cask Storage Facility common to all reactors

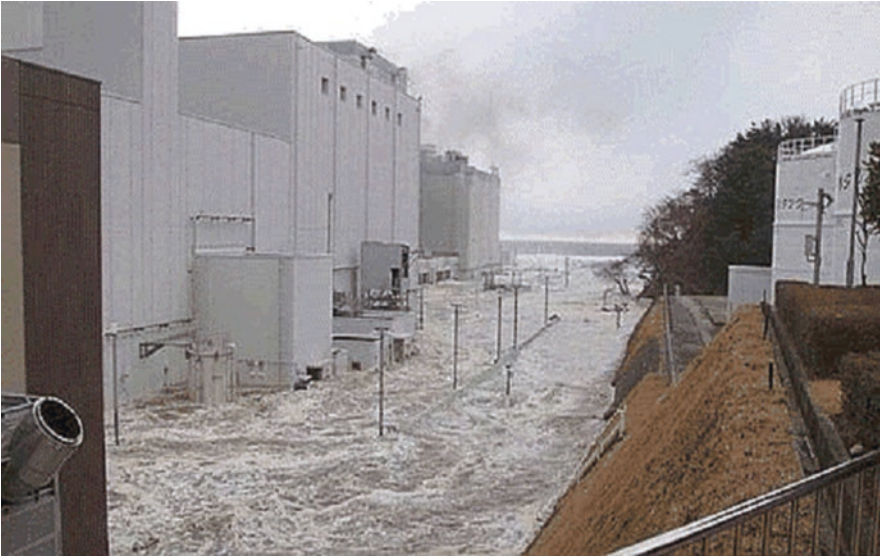
**Photo 5.2** Fukushima plant drowned by tsunami—March 11, 2011 (photo Tepco)

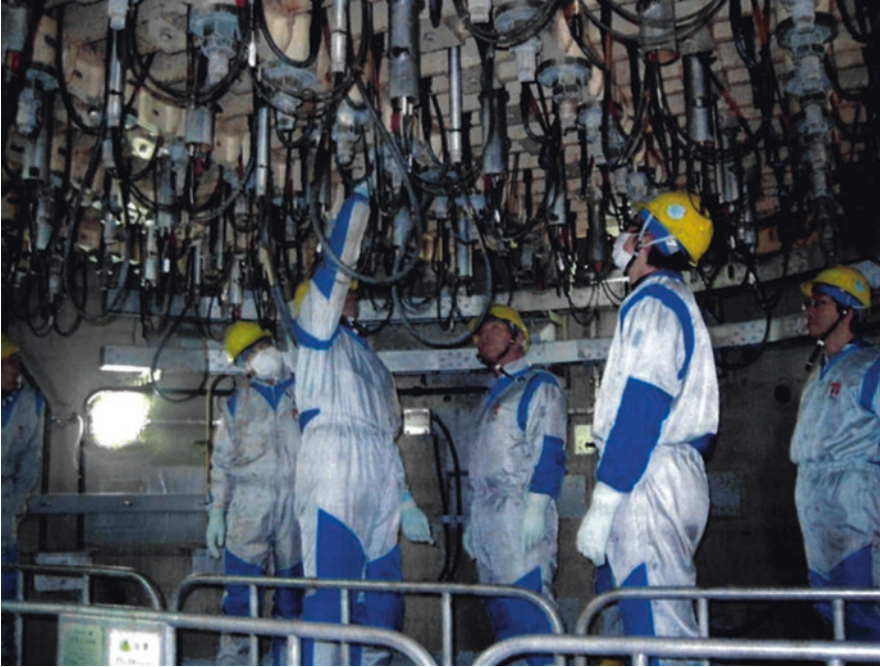
**Photo 5.4** Operators inspecting vessel bottom penetrations by control rods on a Fukushima Dai-ichi plant. The reactor core, shutdown in this photo because one does not go into the reactor pit during operation, is thus located above the operators. The system is identical on Fukushima Dai-ichi (TEPCO)

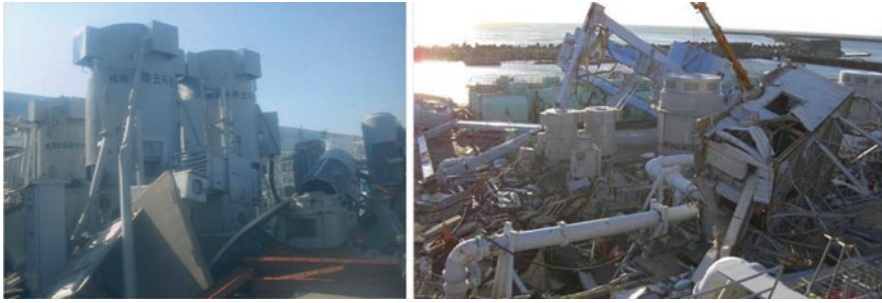
**Photo 5.5** Damage on the seawater pumps: unit-3 (left) and unit-5 (right) (photos TEPCO). One can see the immediate proximity of these pumps to the sea by their function. The dam was ineffective to protect them

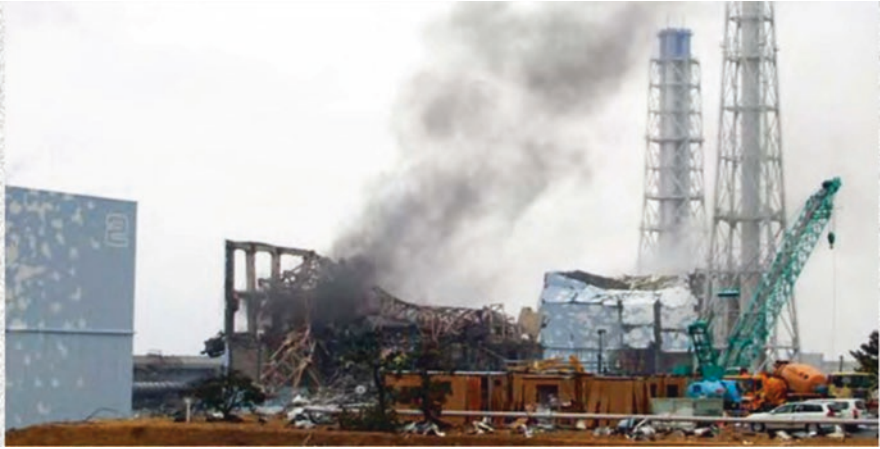
**Photo 5.6** Reactor-3: The disturbingly persistent black smoke from Reactor 3 probably indicates an ongoing corium-concrete interaction in the bottom of the dry pit and possibly on the building foundation (TEPCO photo)

was thus drowned. This did not prevent the corium from relocating to the vessel bottom of reactor-1, by far the most degraded. It is known since TMI-2 that corium can progress even under water. Reactor-3 has also seen a breakthrough in its vessel and the black fumaroles seen coming out of the remains of the building seem to indicate the appearance of an interaction between the molten corium and the concrete of the dry pit (Photo 5.6).

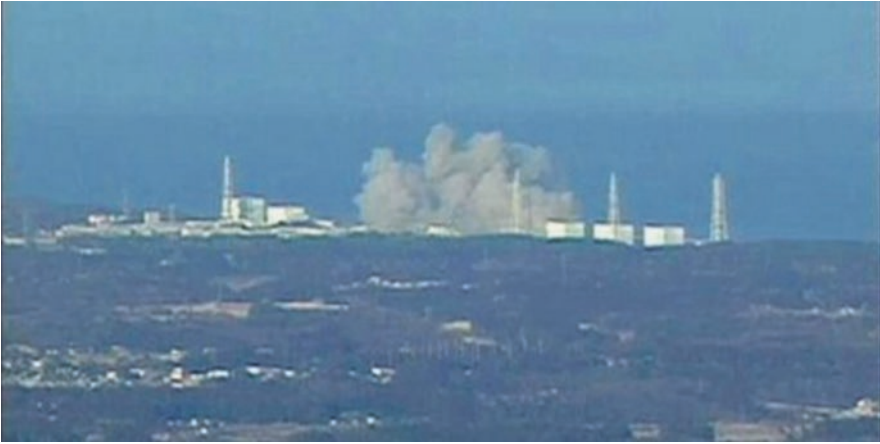
**Photo 5.7** A picture of the explosion of reactor-1 taken on TV (NHK). On the left, reactors -5 and -6 and their shared chimney. On the right, reactors -2, -3, and -4 whose buildings are still intact

03/12/2011 15 h 36	23.83	Hydrogen explosion blows out the conventional containment building (Photo 5.7)

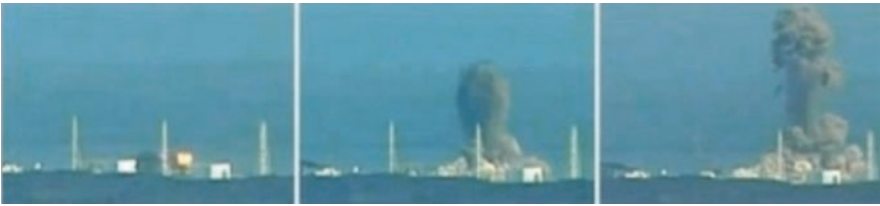
**Photo 5.8** Hydrogen explosion in the building of reactor-3 taken on television (NHK). On the left reactor-2, on the right reactor-4

The explosion of reactor 3 must have destroyed the connecting pipe. If there was indeed a hydrogen explosion in reactor-4 and that this hydrogen does not come from the pool of reactor-4, one can imagine a process of dis-inerting by condensation of steam, creating a pocket of explosive hydrogen (initially coming from reactor-3), and/or a slow stratification of the hydrogen. This hydrogen will concentrate in the upper part of the reactor by gravitational effect (hydrogen is less heavy than air), creating zones richer in hydrogen in the upper parts of the building. The fire will be shut down by the supply of water by helicopters (Photo 5.12) and trucks. No particular attention had been paid to reactor-4 by the operators, since no one could have imagined that a reactor empty of fuel could explode. A simple ventilation of the containment could probably have saved it. This human error, which is finally quite understandable, exacerbates the catastrophe.

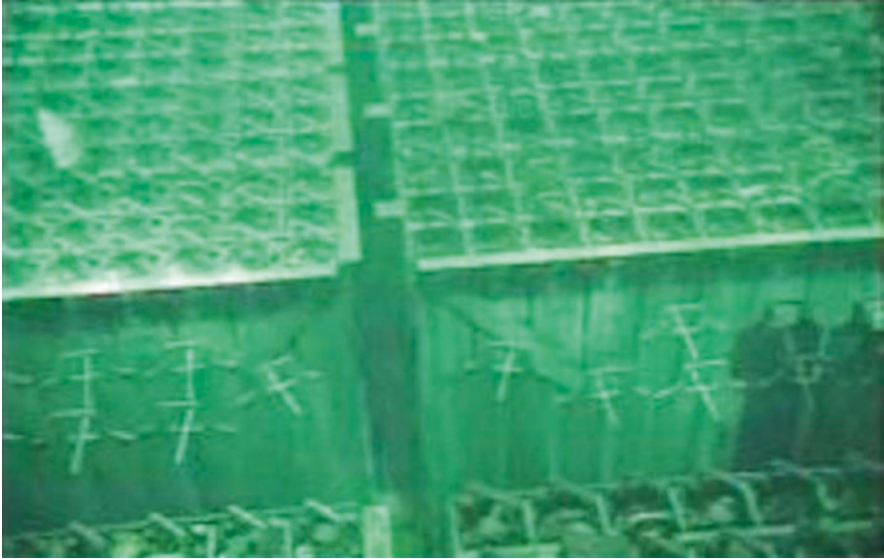
**Photo 5.11** Reactor-4 pool. This view of poor quality taken from a camera still shows that the fuel has not degraded dry in case the pool was dewatered. On the contrary, the assemblies seem intact and little oxidized, supporting the idea of an external origin of the hydrogen (from reactor-3) (TEPCO)

resulting in the production of hydrogen, and then an explosion. This scenario will be particularly considered insofar as the fire broke out in the spent fuel pool located in the upper part of the containment. But the visual inspection by camera after the accident showed that the assemblies in the water-filled pool were in rather good condition (zirconium oxide is easy to spot on the surface of the fuel rods because of its whitish color, while the metallic zirconium has a tinge close to steel). The camera shows quite clearly that the assemblies in the pool are only covered by rubble from the explosion (Photo 5.11).

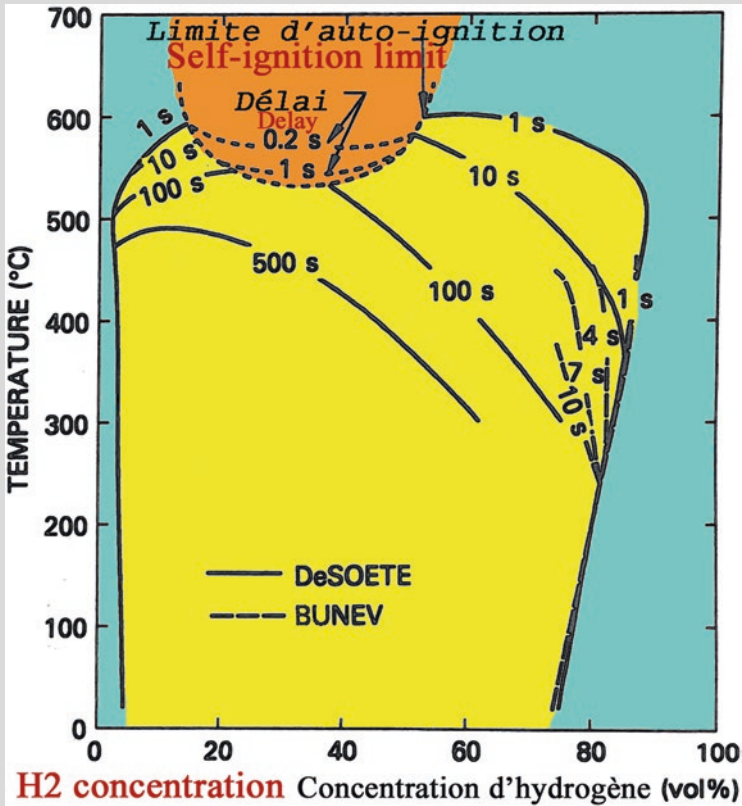
Fig. 5.19 Flammability diagram of hydrogen in air and self-ignition range (according to Douglas W. Stamps, Marshall Berman: *High-temperature hydrogen combustion in reactor safety applications*, Nuclear Science and Engineering Vol. 109, n°1, pp 39–48 (1991))

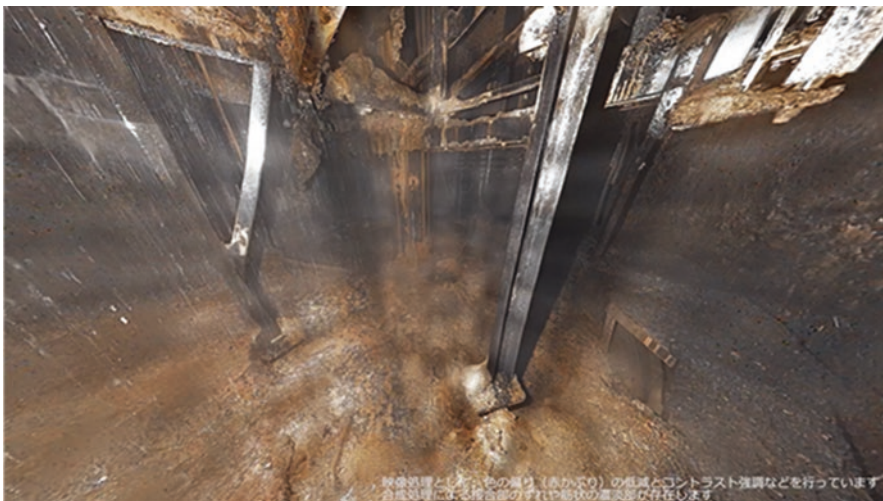
**Photo 5.16** Reactor-2 vessel pit. One can see the vessel bottom torn open by the molten corium and the solidified corium, which has spread in the dry pit (photo TEPCO). One should be wary of the pasty aspect that the cooled corium takes because a metallic corium in meltdown can be more fluid than water

The dismantling of the reactors involves removing the radioactive corium spread in the lower structures of the buildings (Photo 5.16). This task will require the use of teleoperated tools and/or robots, when radiation decreases.

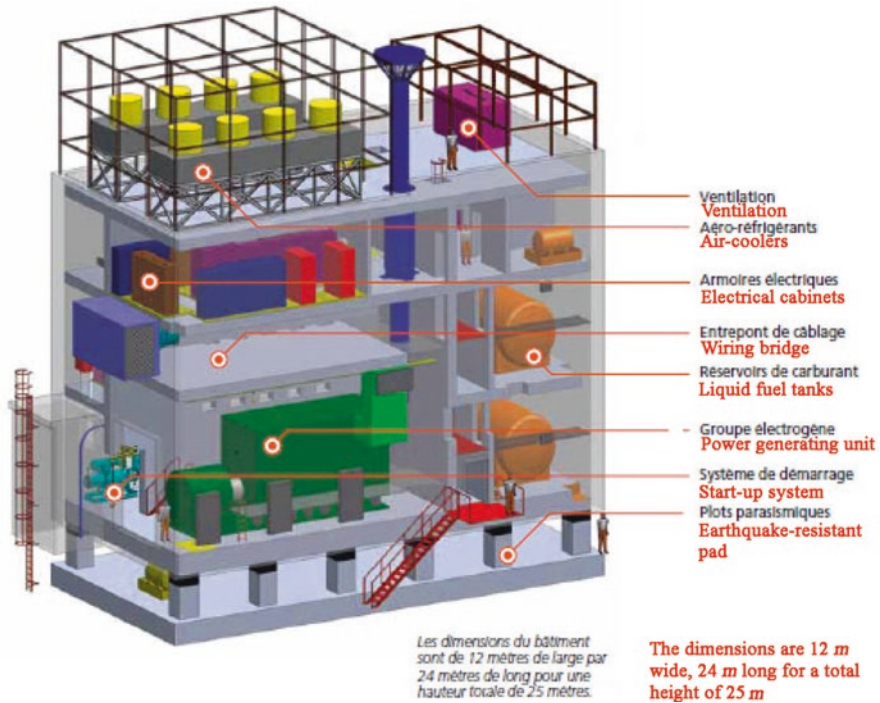
Fig. 5.23 Structure of the Ultimate Safety Siesel (DUS)

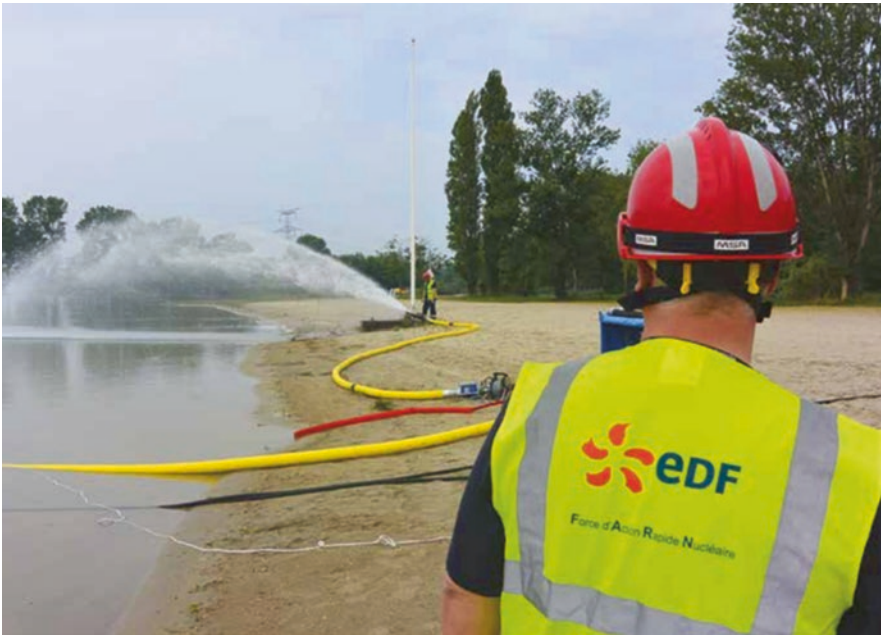
**Photo 5.19** Fresh water pumping test by FARN (Bugey). Taps were placed in 2013 to be able to re-supply the backup circuits with water

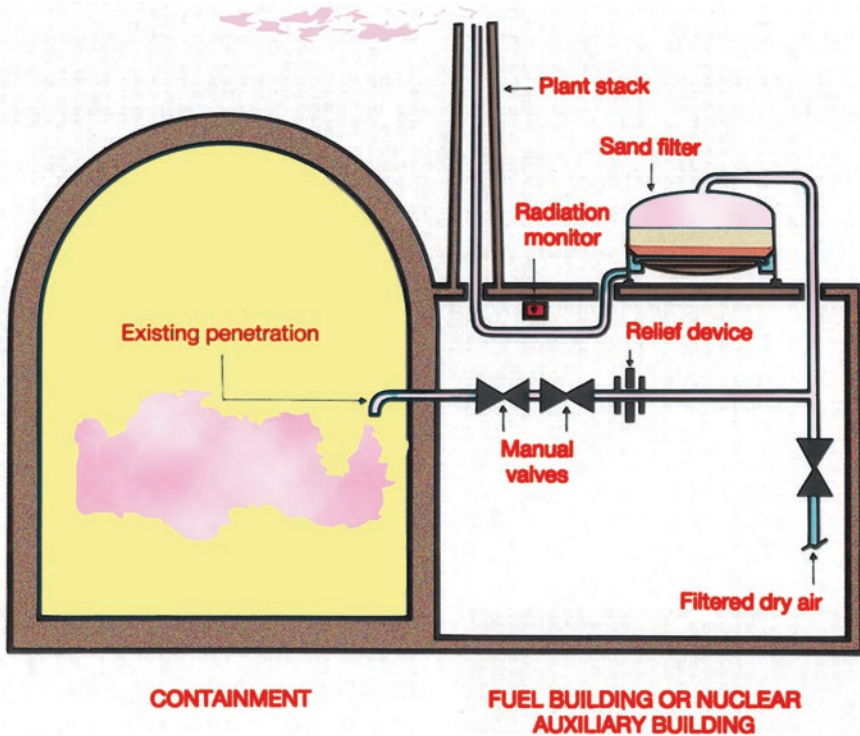
Fig. 4 Location of the sand filter

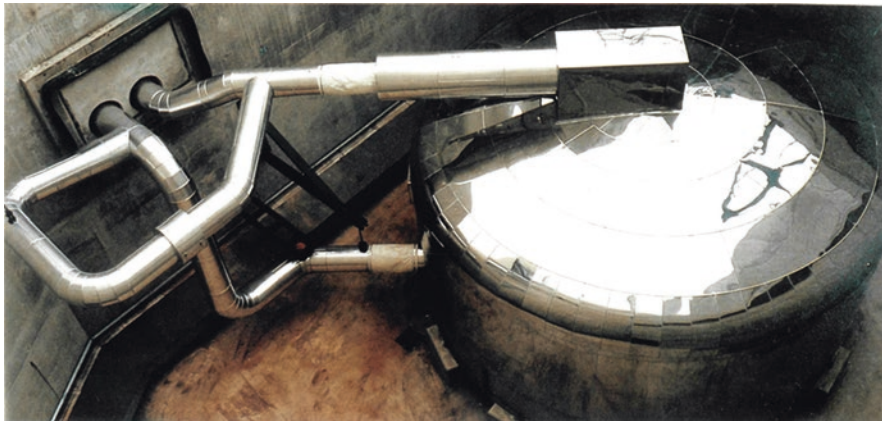
Photo 1 Principle and photo of a U5 filter of a P4 unit (photo EDF). The aerosols arrive at the top of the filter and the non-retained volatile gases are evacuated through the lower pipe toward the TEG stack. The filter can be bypassed in case of severe blockage

So-called ultimate procedures have been put in place to take into account the meltdown of the reactor. To manage severe accident situations beyond the design basis, and as part of the defense-in-depth approach to protect the population and the environment, an ultimate procedure known as U5 of decompression-filtration of the containment has been implemented.<sup>2</sup> The objective of this procedure is to avoid the loss of containment that could result from a slow pressurization of the Reactor Building (BR) atmosphere, leading to exceeding the design basis pressure, following a core meltdown. This pressurization would be the consequence of the production of hot gases coming from the attack of the concrete raft by corium (a mixture of molten fuel, oxidized or metallic cladding, and structural materials of the core internals), flowing from the vessel after it has been breached, but also from the water steam flowing from a possible breach in the primary circuit. The U5 procedure aims at depressurizing the enclosure via a sand filter (Fig. 2), before channeling the filtered releases to the TEG chimney. This should be seen as a last-chance procedure before irreparable loss of the containment, in an extreme situation. The function of the sand filter is to retain aerosols in particular (purification by a factor of about 10), whereas iodine in gaseous form ( $I_2$ ), for example, would not be retained. The filter contains sand, glass wool, and expanded clay (Figs. 3 and 4, Photo 1). The filter box consists of a cylindrical

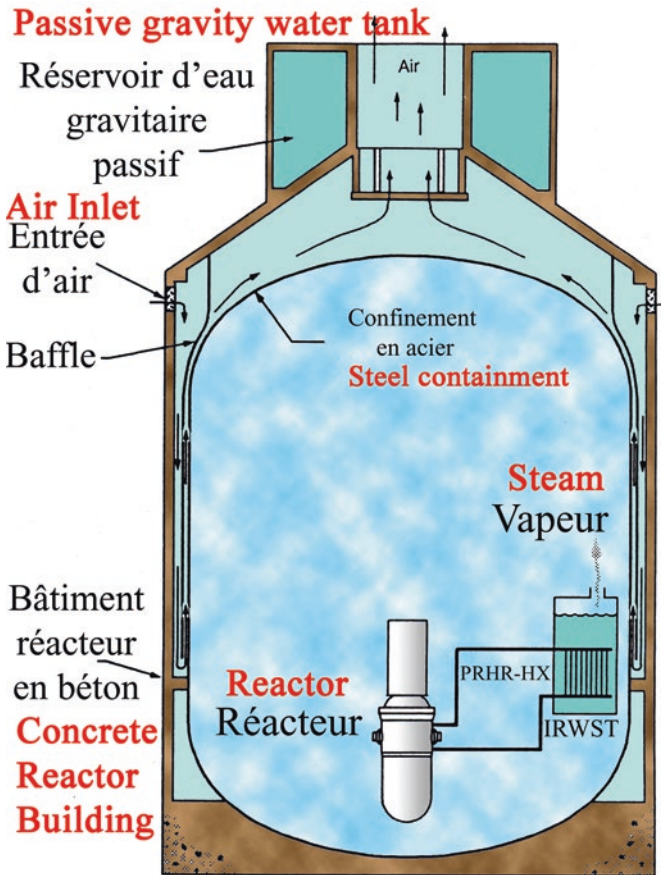
Fig. 6 Passive cooling of the AP600 (Advanced Passive 600 MWe)

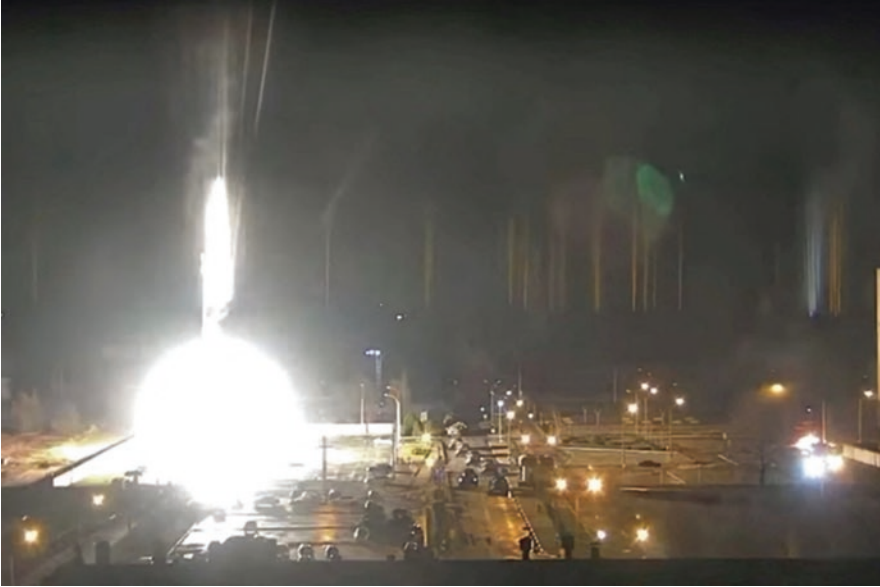
**Photo 4** A flare falls on the parking lot in front of the line of six reactors in the left-hand follower of the shot. Russian armored vehicles are seen at the shutdown at the entrance of the site on the right. The chimneys of the conventional thermal power plant can be seen in the background, at least one of which seems to be in operation. This inconsequential event was repeated on television

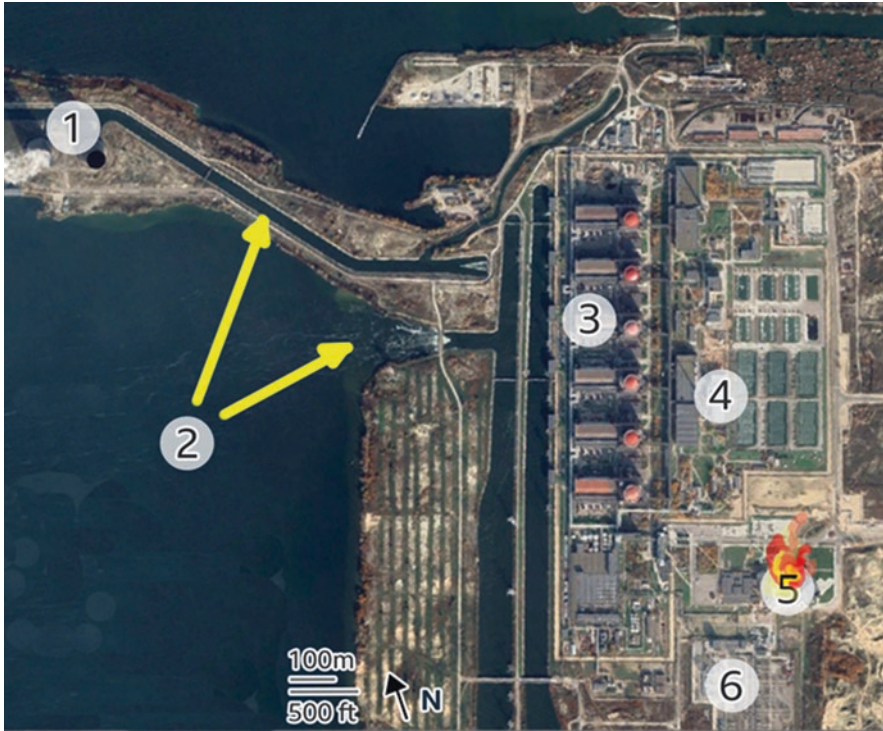
**Photo 6** A satellite view of the site (source IAEA). 1: Air coolers (x2); 2: Channels for the supply and discharge of cooling water (cold source); the channels run along the 6 plants; 3: The 6 WWERs, the rectangular buildings with red roofs perpendicular to the water supply channel for the condensers, correspond to the turbine buildings (engine room); the reactors are in the cylindrical buildings with red domes; 4: Spent fuel and radioactive waste storage area; 5: Training building where the fire started; 6: Power evacuation electrical lines station
