# Monitoring the Cathedral of Milan: An Archive with More Than 50 Years of Measurements

**Abstract.** The paper describes the origin and evolution of the monitoring system of the Duomo di Milano, which was installed during the 1960s. In that period, differential movements induced by the extraction of groundwater (among other factors) caused significant instability and risk of collapse of the monument. Today, the monitoring system is still operative. Instruments, techniques, and calculation procedures were continuously updated considering the continuity of the time series, resulting in a precious archive for structural health monitoring and conservation. The actual configuration of the monitoring system includes a large variety of both automatic and manual sensors, digital and mechanical, in real-time or with an established periodicity. Moreover, the monitoring system inside the cathedral still preserves continuity with the original measurements thanks to continuous maintenance carried out over time. The manuscript illustrates and discusses the original system as well as the updates related to activities that began more than half a century ago.

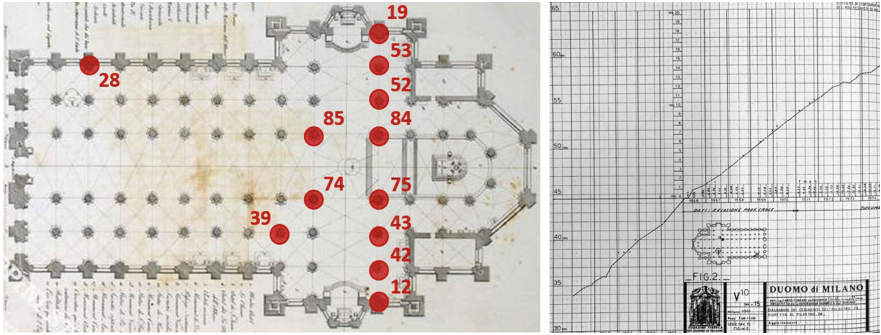
**Fig. 2.** The first system installed to capture vertical movements of some piers.

The initial monitoring system allowed specialists to measure the differential vertical movements and rotations of 12 columns, mainly along a line through the transept, as well as the four columns of the tiburium [3] (Fig. 2).

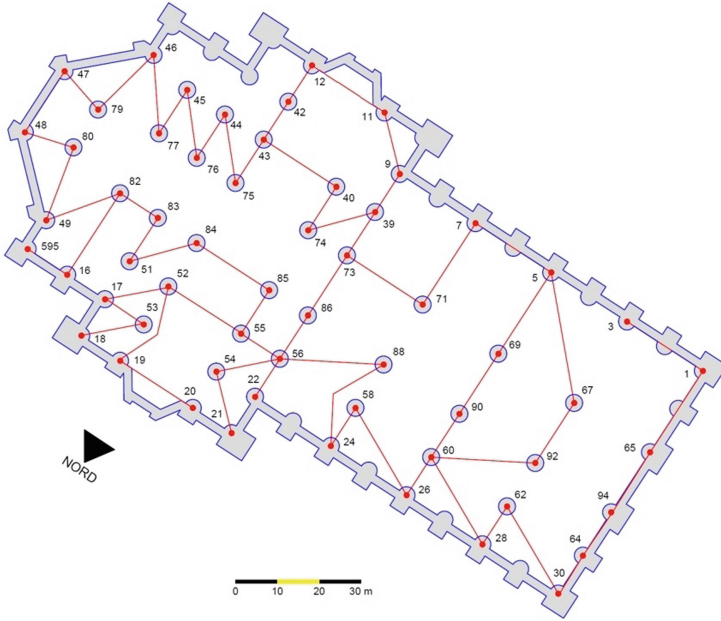
**Fig. 3.** The internal leveling network

The installation of a levelling network started in 1961 when the rapid change of the water table in the city caused differential movements of the structures of the Duomo [4]. As mentioned in the introduction, the first measurements were in the transept area. Nowadays, the internal levelling network (Fig. 3) is made up of 59 benchmarks installed on the columns. It provides a time series of vertical differential movements since 1969 that goes back to 1965 for a subset of points. The configuration and installation of the monitoring system were defined by Veneranda Fabbrica del Duomo di Milano and the Institute of Surveying, Photogrammetry, and Geophysics of Politecnico di Milano, i.e. the Polytechnic University of Milan.

Measurements are still acquired twice a year (always in May and November), notwithstanding initial data in 1965–1978 were also acquired with a higher frequency (4 seasons). The network features several closed loops, and measurements are adjusted via least squares, obtaining elevations with a precision of  $\pm 0.1$  mm. As no stable benchmark is available in the area, point 39 has always been assumed as a reference since the first measurements.

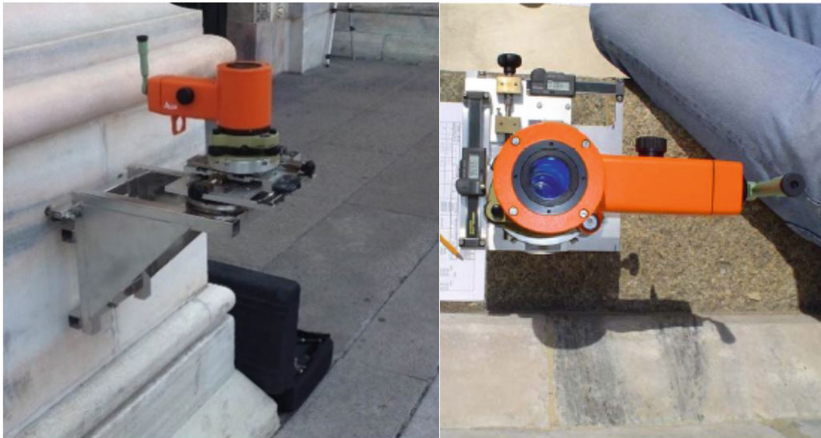
**Fig. 11.** Measurements of tilt variations using an optical plumb installed on the façade and apse of the Duomo. The configuration on the left allows the connection of a vertical surface. The figure on the right shows the installation on a permanent reference on the floor.

A different system is instead used to monitor the variation of inclination outside the Cathedral. 5 monitoring points are installed on the façade, and 2 on the columns of the apse. As the wire cannot be used outside, an optical plummet (Fig. 11) placed on a micrometric sled is used to collimate reference points and measure inclination variations.
