Protocols of Knowledge for the Restoration: Documents, Geomatics, Diagnostic. The Case of the Beata Vergine Assunta Basilic in Guasila (Sardinia)

Abstract. For several decades, the conservation and maintenance of the historical architectural heritage in Italy have become one of the central problems within the scientific community of architects, restorers, and engineers. In fact, historic buildings represent not only an important symbol of the country's culture but also a significant economic resource linked to tourist flows. Unfortunately, many historic buildings are in a state of neglect or in a dangerous state of conservation. It is therefore important to activate a series of actions to preserve and conserve this built heritage. In this context, a transdisciplinary approach that includes an accurate historical, dimensional, and material knowledge has fundamental importance to allow a correct design for restoration actions and the possible reuse as well as to allow this heritage to be usable and active. This article presents this integrate approach carried out for the specific case of the Basilica of the Beata Vergine Assunta in Guasila (Sardinia) with a particular focus on the r

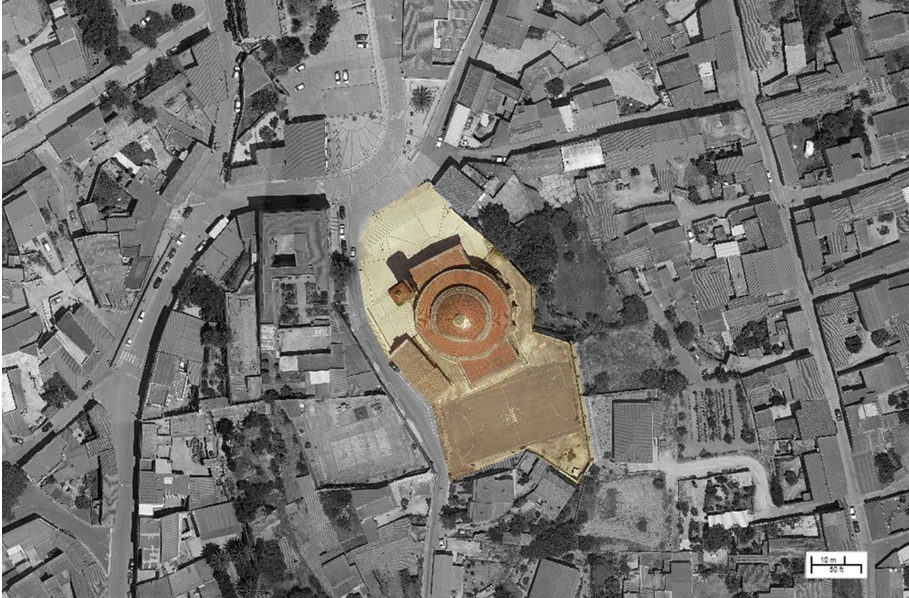
Fig. 1. Aerial view of the Basilica (Pilia E.)

The codified methodology has been carried out for the study of the Beata Vergine Assunta Basilica placed in Guasila (CA), a neoclassic monument designed by the local famous architect Gaetano Cima in the middle nineteenth century (Fig. 1). Since its construction, this monument has shown signs of decay and structural failure such as cracks and infiltration of rainy water mainly located on the dome, on all the smaller vaults, arches, and headers. All these problems concerning the quality of the building materials, a local sandstone historically quarried in the surroundings hills, and the poor building skills have been investigated to understand the origin of the current state of decay and to define, after several years of unsuccessful restorations works, effective guidelines for the safeguard of the monument.

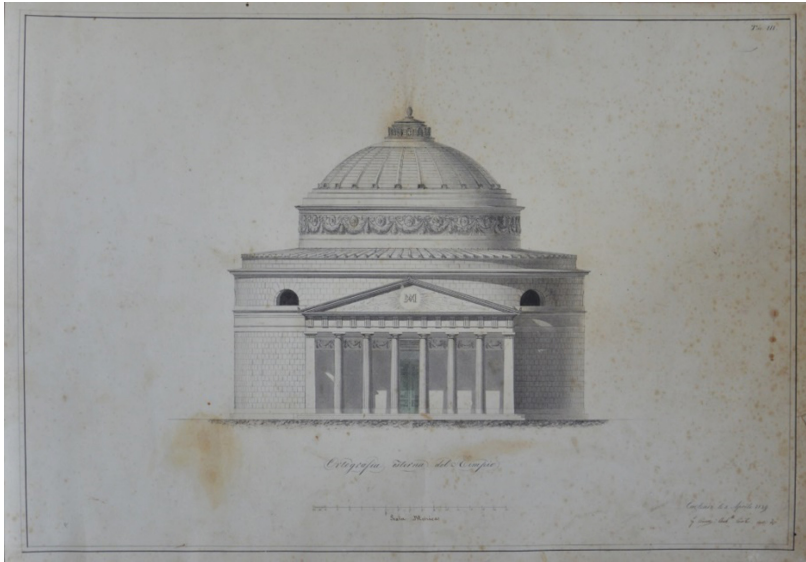
Fig. 2. Drawing of the main façade of the church. Cima's project is conserved in the Archive of the church.

Overall, during these restoration activities, prolonged for over a century, it has been possible to recognise the total incompatibility of materials used and the interventions, often not connected to each other creating significant further discontinuities on the masonries. The indirect study of the monument has therefore, accurately outlined the historical facts concerning the monument, providing important information to re-read the factory thanks to the support and integration of direct analysis, focused on studying with reliability the geometries and anomalies already witnessed at the design level and modified over time due to subsidence and diagnostic analysis of characterisation of materials (natural and artificial), considering the specific properties of building and restoration materials, their compatibility and their current state of conservation (Fig. 2).

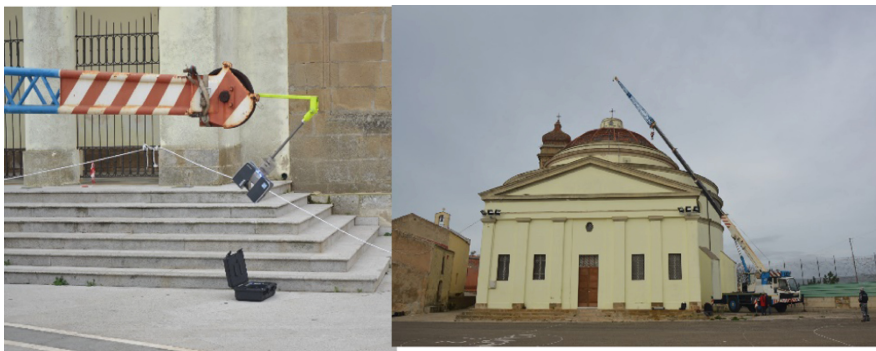
Fig. 3. TLS survey of the roof

For the design of the scans, we started by thinking about the geometry of the building and the scale of restitution. The presence of architectural details and the situation of the deformations to be detected were taken into account. From these considerations, it was decided to perform the scans at a resolution of $\frac{1}{4}$, with 3x quality, which corresponds to a resolution of 7 mm/10 m. To ensure an overlap between the scans of at least 30%, 33 internal scans from the ground and 8 internal scans from the elevator basket were performed to survey some niches not directly accessible by the detector. The external

scans were 15 from the ground and 8 from a crane equipped with a telescopic arm on which the TLS was mounted (Figs. 3 and 4).

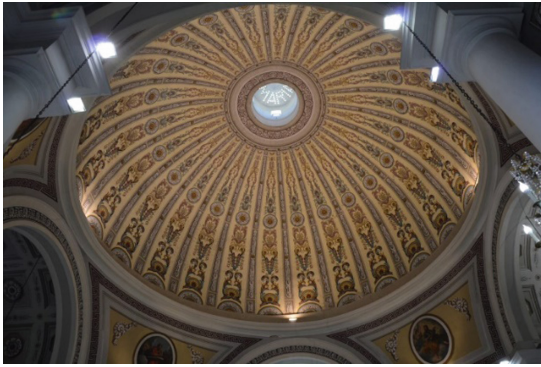
Fig. 8. Internal view of the dome.

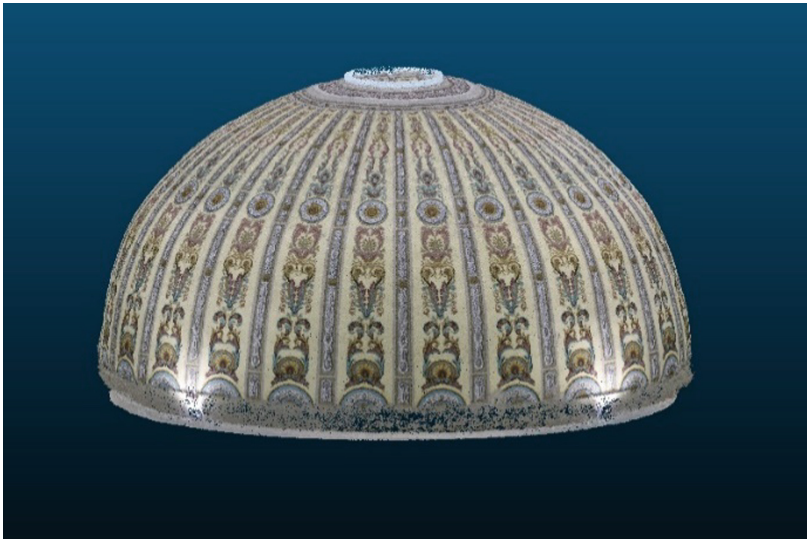
Fig. 9. Dome 3D model

The image processing workflow follows the standard steps of SfM software with the solution of the Bundle Adjustment on sparse point cloud, external orientation of the block and generation of the dense point cloud. All images have been elaborated in Medium mode, in fact, as verified in Grillo, 2019 [38] the accuracy does not vary with respect to UltraHigh mode and processing times are reduced. The processing produced a point cloud of 11,315,919 points with a processing time of 6 h. The cloud was georeferenced

using 10 GCPs extracted from the TLS point cloud. The global RMS of georeferencing is 2 cm. Figure 9 shows the textured point cloud of the dome.
