# The Future of Heritage Science and Technologies

Materials Science

Volume 179

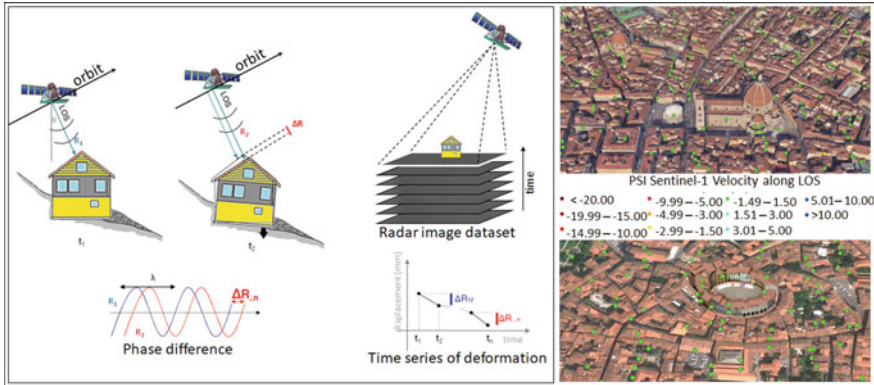
**Fig. 3.2** Sketch of the basic principles of PSI radar interferometric technique (left); examples of spatial distribution of PSI targets on the test cities of Florence and Lucca (right)

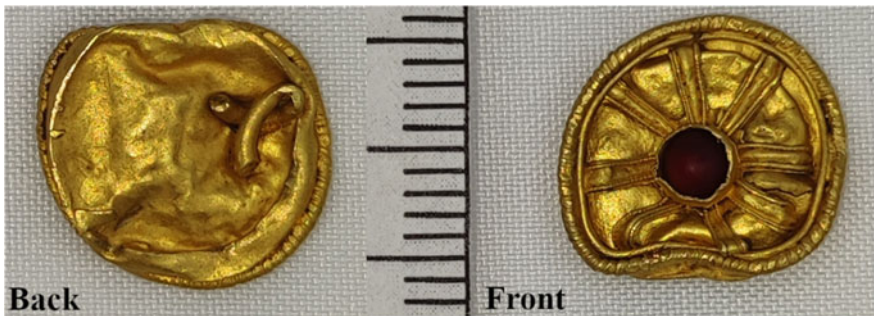
Fig. 5.2 Back and front of the find under study

The case of study consists of a golden round-shaped thin case (Ø 13 mm) with a twisted wire (Ø 0, 8 mm) which is welded on the outer edge. Next to it, there is a straight wire (Ø 0, 5 mm). The case inner bottom is decorated with an eight-petalled rosette which has a red gemstone in its centre. On the back there is a twisted threadlike ring that was used to attach a pendant to the disk, which was unfortunately lost. There are also visible traces of welding where likely the earring hanger was fixed. Finally, the case is slightly deformed and bruised as it can be noted in Fig. 5.2.

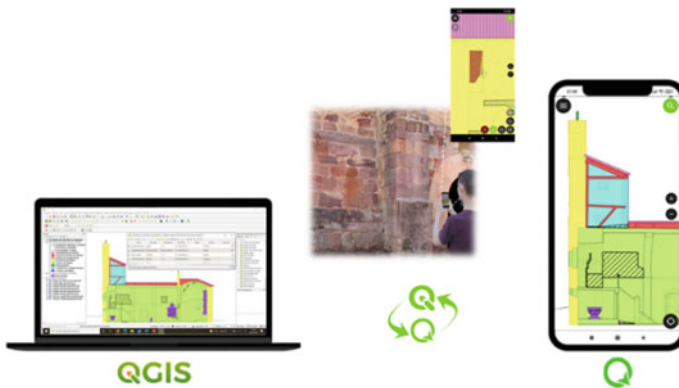
Fig. 6.3 Graphical representation of the connection between the QGIS and QField projects

Complements and updates offered by the GIS program have made possible an on-site collection and management of data through the QField app (<https://qfield.org/>) [13] (see Fig. 6.3). This multifunctional application gathers required shapefiles data within its pertinent attribute, allowing an online or offline mapping and edition. Furthermore, images and videos can be taken directly from the inspect element, with independence of being connected to any network.

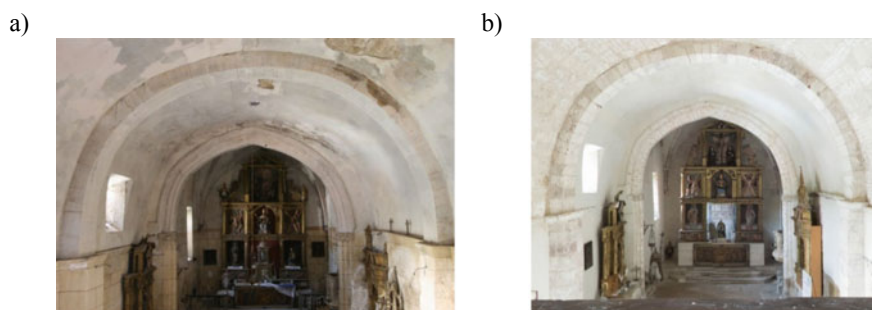
**Fig. 6.6** Indoor images of the main nave: **a** image of the conservation status before the restoration project; and **b** image of the current appearance

leaves, the exterior of sandstone masonry and between them a core of rubble masonry. The northeast wall is reinforced by four buttresses that constrict the pushing of the land that borders the northwest wall (see Fig. 6.6a). The nave is covered by a barrel vault and on reaching the east apse is covered by an octopartite ribbed vault from the late Gothic period. The tower is one of the characteristic elements of the church. It is built in sandstone masonry and on the east side combines sandstone masonry with brick (see Fig. 6.6b).

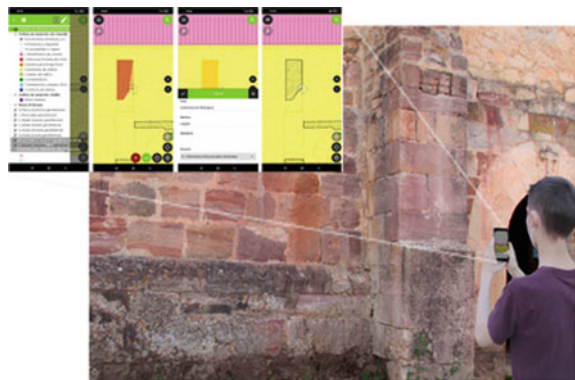
**Fig. 6.8** Capture of on-site data through the QField application

The first step to establish a maintenance plan on the defined case study is to know the constructive systems and damages that are still present, which require periodic control and simple repairs, preventing the pathology from worsening. For this reason, as recently mentioned, thanks to the QField® mobile complement the pathological study of the building is carried out by mapping damages and collecting the necessary

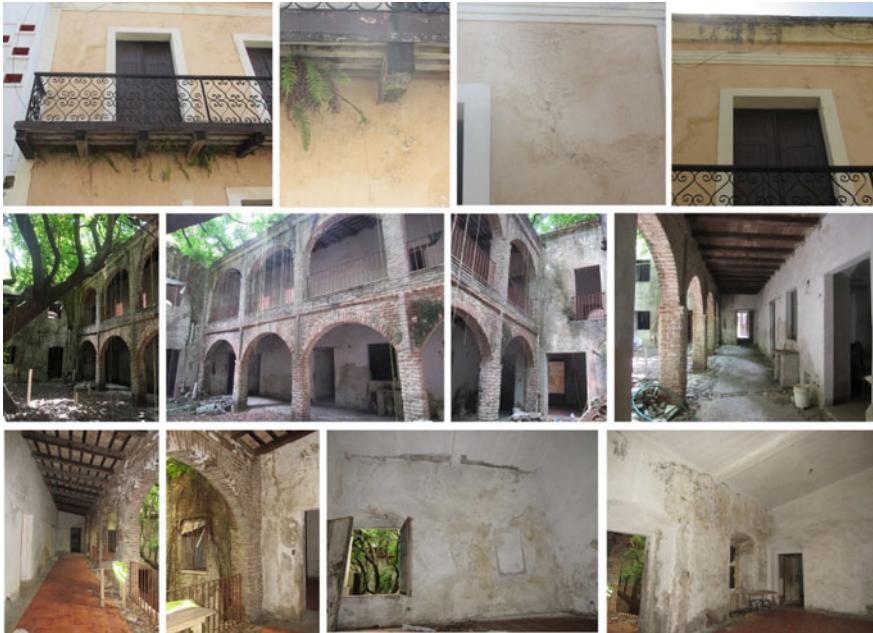
**Fig. 7.3** Current building condition

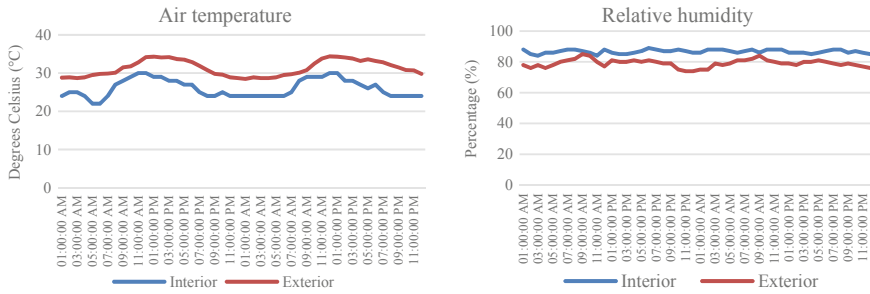
**Fig. 7.4** Ambient temperature and relative humidity indoors–outdoors

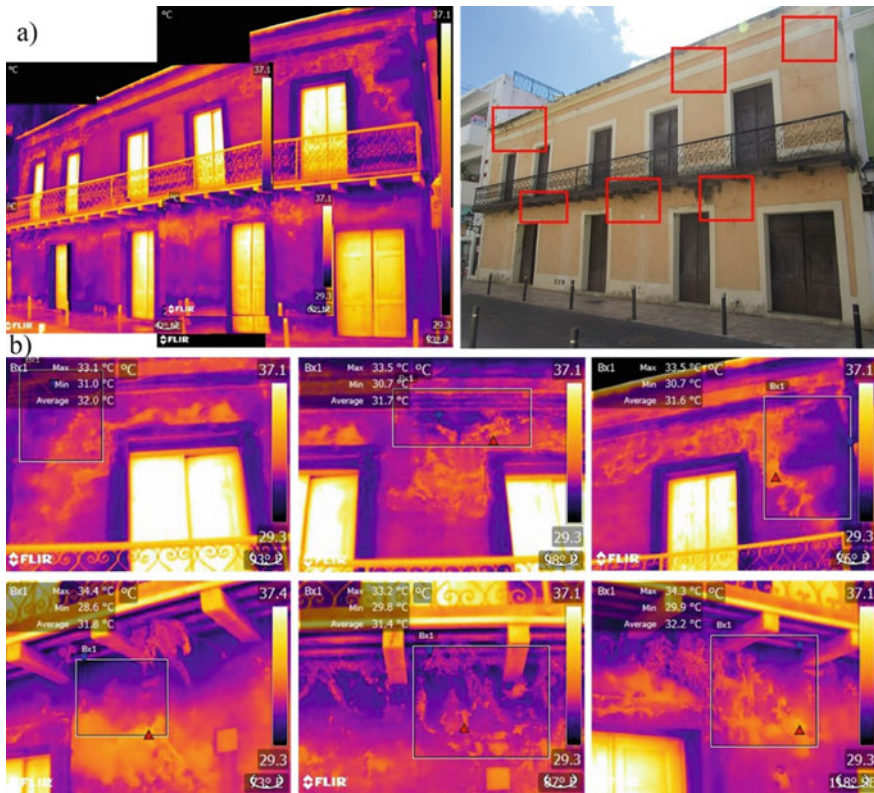
Fig. 7.5 Thermal images of the façade and details

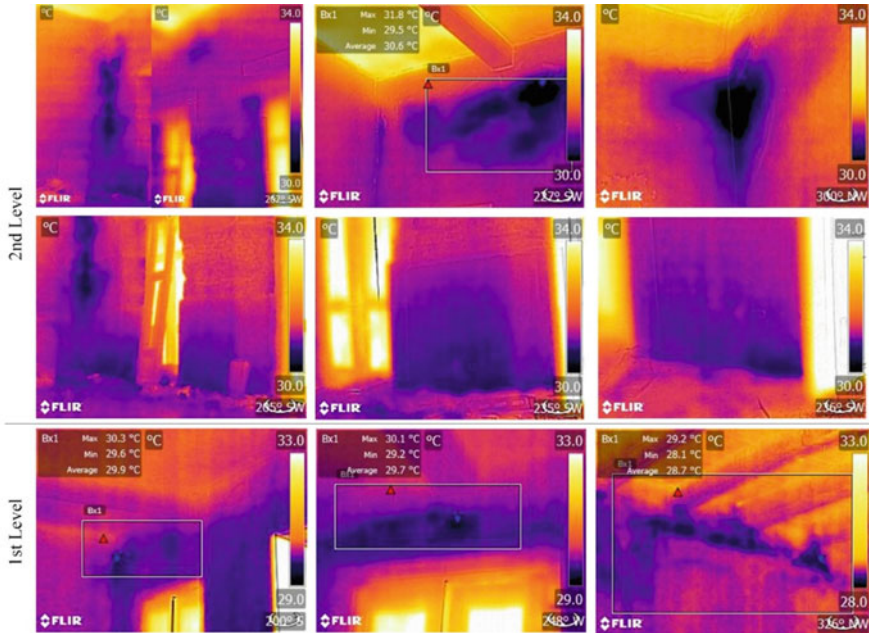
Fig. 7.6 Thermograms of the facade on the inside

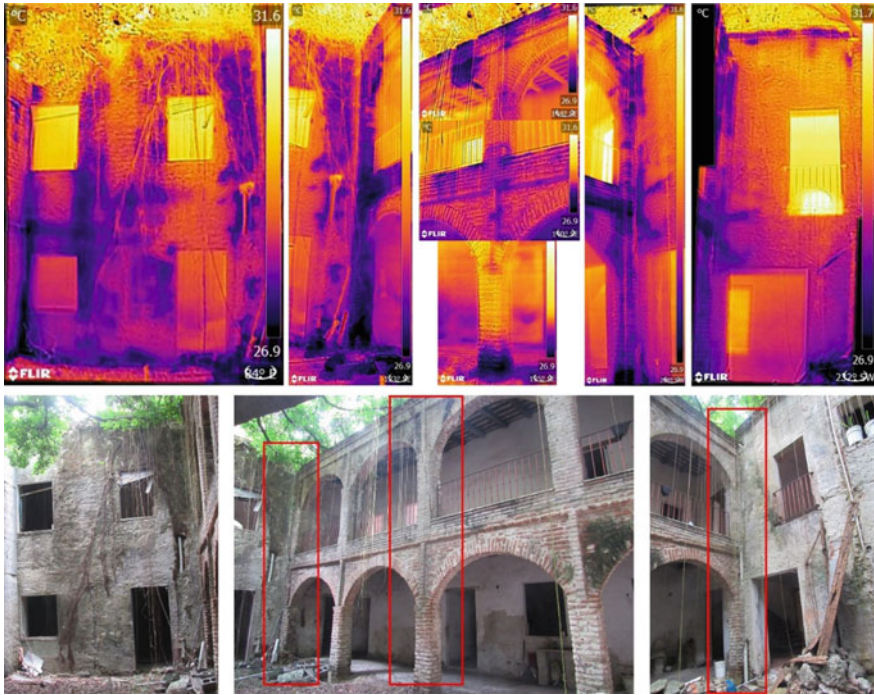
Fig. 7.7 Thermal imaging of the Main Patio

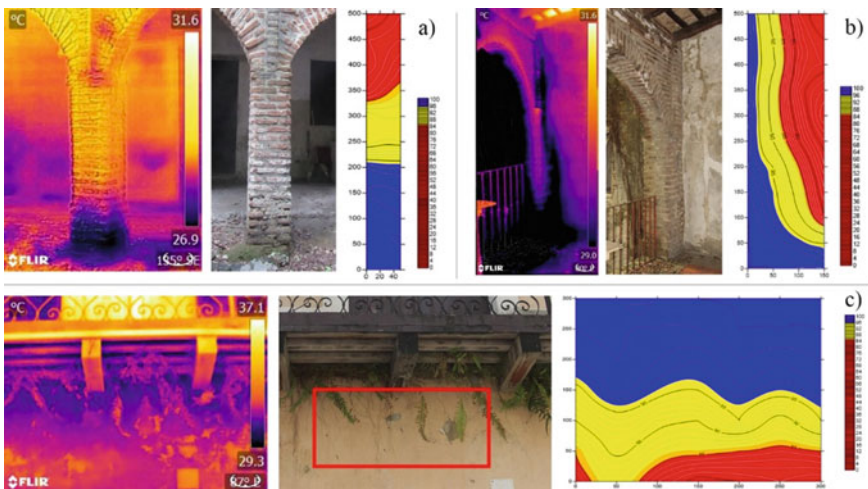
Fig. 7.10 a Column first level, b corner of corridor second level and c exterior façade details

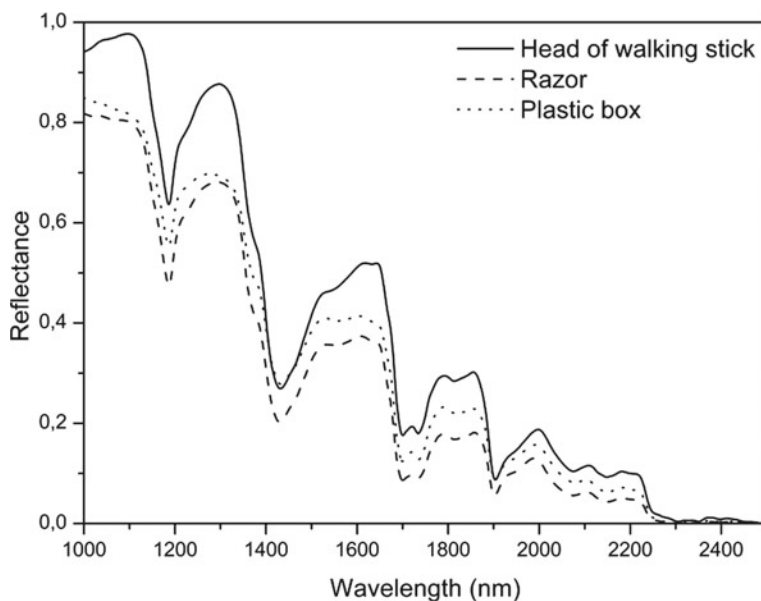
Fig. 8.2 SWIR spectra obtained for a head of walking stick, a razor and a plastic box

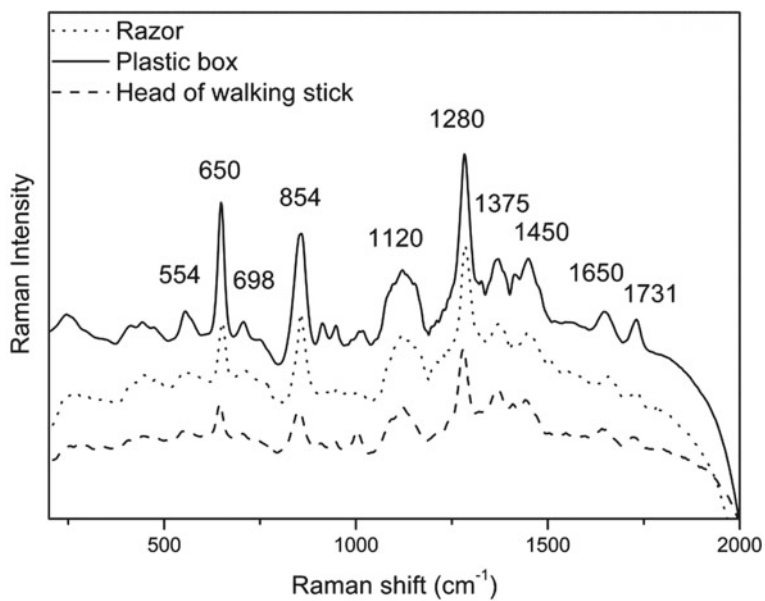
Fig. 8.5 Raman spectra obtained for the head of a walking stick, razor, and plastic box

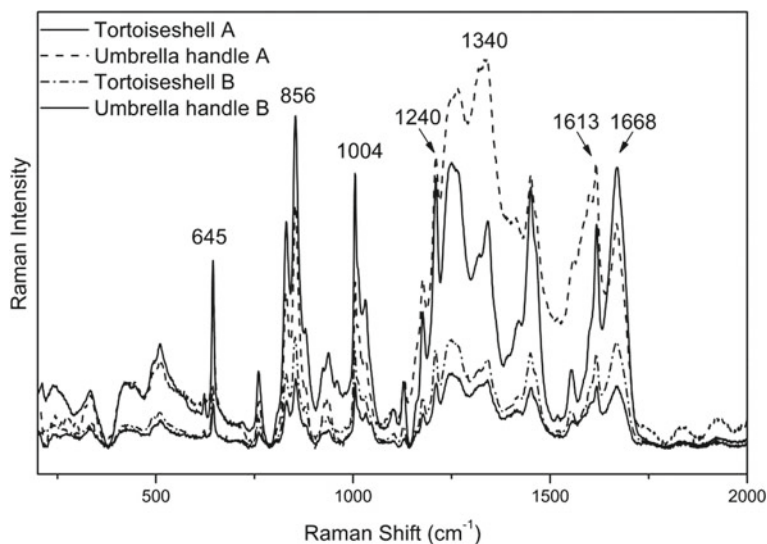
**Fig. 8.7** Raman spectra for the umbrella handles and tortoiseshell samples

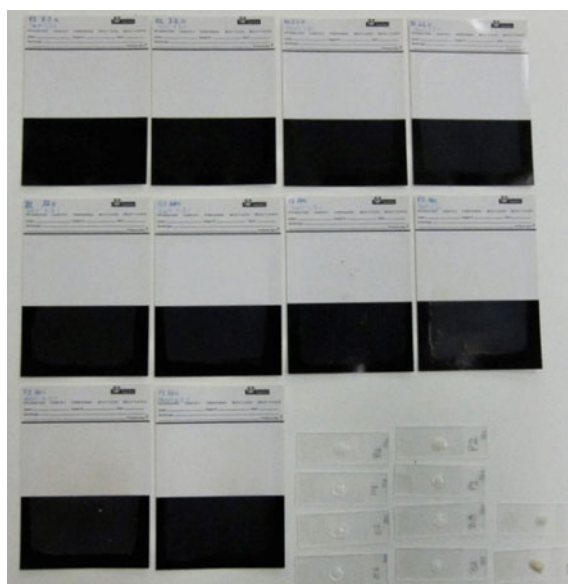
**Fig. 9.3** Adhesive sample brushouts on laminated, opacity cards and drop applications on glass slides before aging (2011). *Photo* Kate Seymour

Common vinylic and acrylic emulsion adhesives found in the SRAL conservation studio were applied to two substrates: brushouts of each adhesive were coated onto laminated, opacity drawdown cards (PA-2854, BYK-Gardner), and drops of each adhesive were applied to glass microscope slides (Fig. 9.3). The majority of these adhesives were aqueous dispersions, although some solvent-based acrylics formulations were studied.

Three glass-based sets were arranged for each adhesive: a reference to be kept in dark conditions (Set 1); a set exposed constantly for 1320 h to light with a high UV content in a light aging chamber (Set 2); a set placed in a Climacell chamber, provided by St. Luc Academy in Liege, exposed to elevated relative humidity (85%) and temperature (65 °C) for 720 h (Set 3). Sets 2 and 3 were placed in dark storage at room temperature after the initial artificial aging. Two additional sets were added for brushout applications: the reference set was kept in the dark from conception, while a second set was exposed to light for an initial period of 3 months and then moved to dark storage. Each adhesive was given a code, with additional labels to track aging conditions (Tables 9.1 and 9.2).

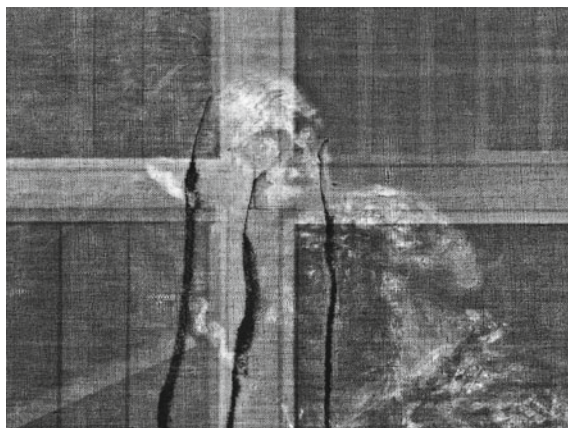
**Fig. 10.2** Traces of knife cuts, left from the attack in 1913. XR image

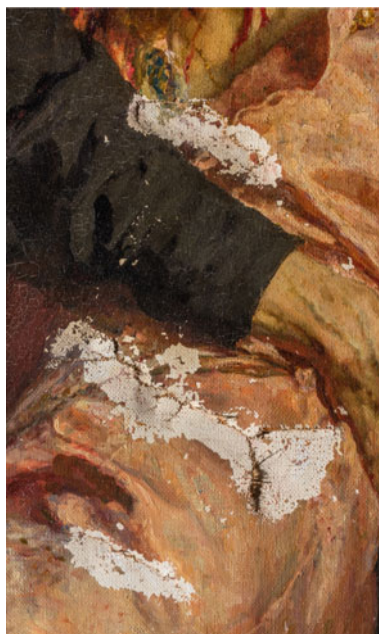
**Fig. 10.4** Example of a paint layer flaking. Photograph shot through the microscope

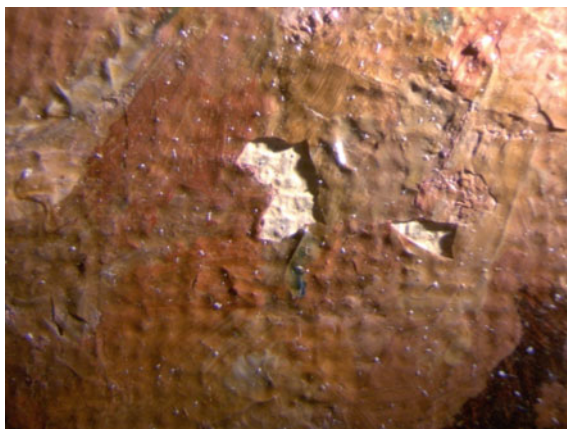
Example of the paint flaking which was mentioned before may be seen in Fig. 10.4. According to the photographs made during previous preventive conservation and the results of micro-photography taken in 2018, the flaking is localized along the perimeter of the image, in areas with smooth relief on the background—where the artist assumingly worked in many layers, but with a more liquid consistency of paints.

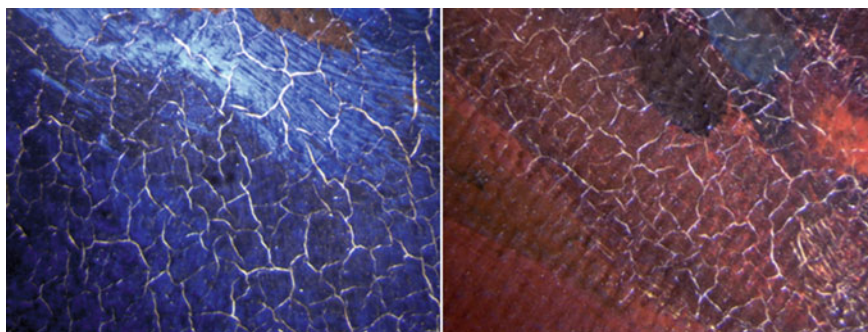
**Fig. 10.6** Dry craquelure with white material protrusions

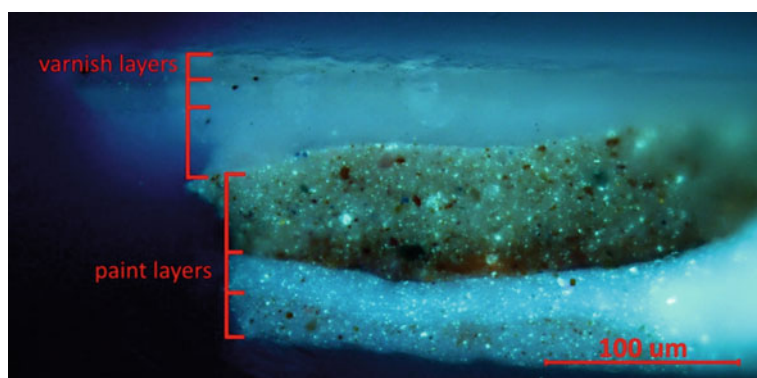
**Fig. 10.8** Cross-section sample of varnish with paint layers

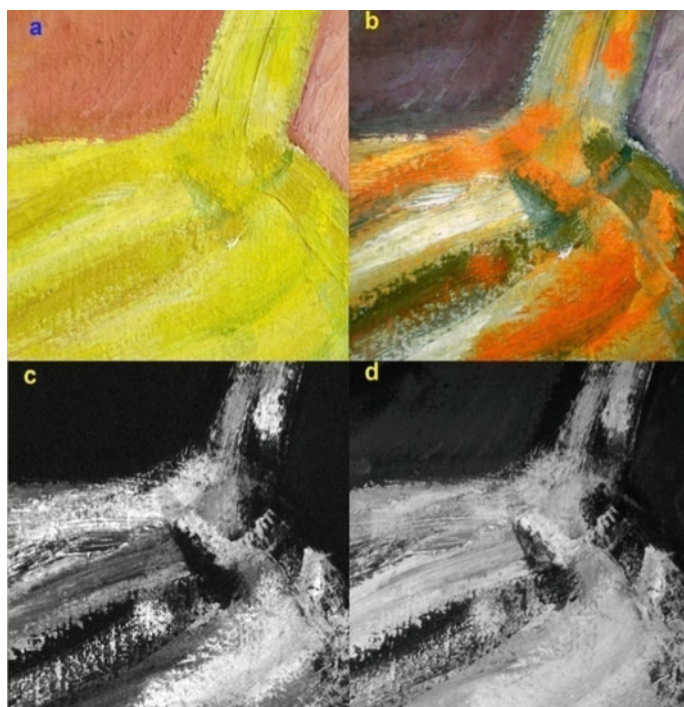
**Fig. 11.4** Detail from the painting in different techniques **a** VIS, **b** UVF  $\rightarrow$  VIS, **c** UVF  $\rightarrow$  NIR, and **d** VIF  $\rightarrow$  NIR

Cd red pigment could explain the larger emission area in Fig. 11.4d. White pigments, binders, and most of the painting's pigments have emission under 700 nm.

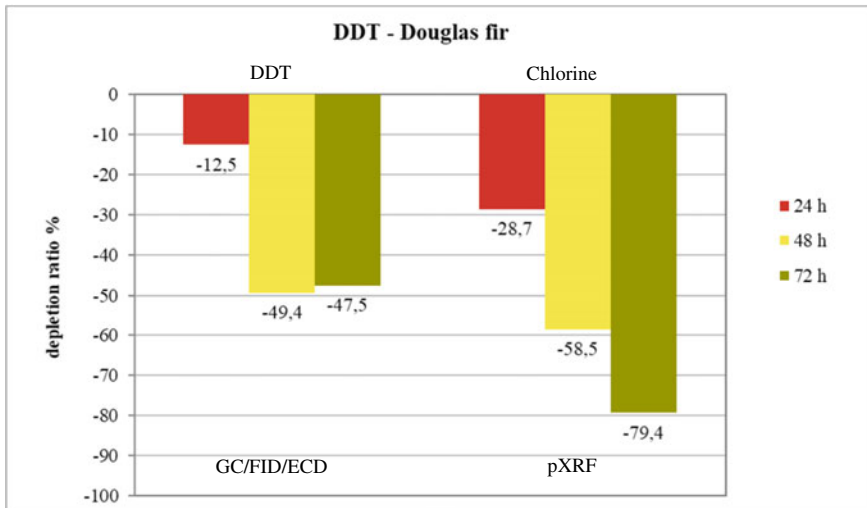
**Fig. 12.6** Comparison of the depletion rates (laboratory results and p-XRF measurements) of DDT using the example of the wood species Douglas fir

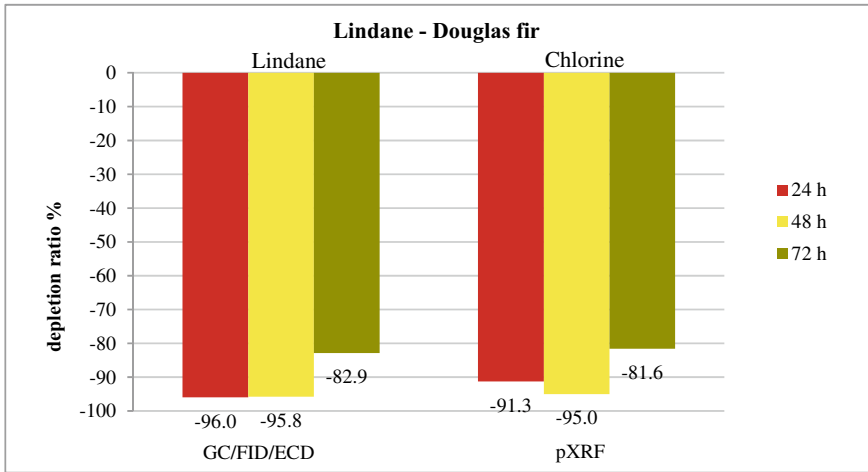
**Fig. 12.9** Comparison of the depletion rates (laboratory results and p-XRF measurements) of lindane using the example of the wood species Douglas fir

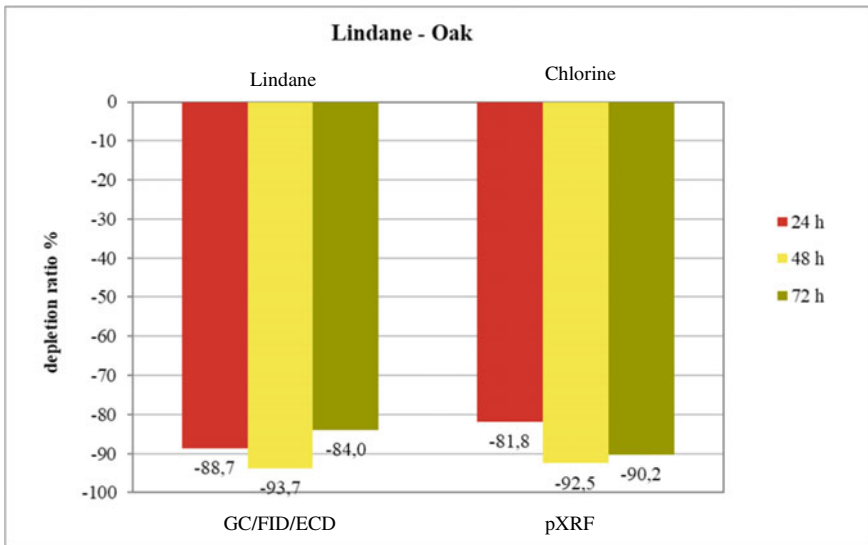
**Fig. 12.10** Comparison of the depletion rates (laboratory results and p-XRF measurements) of lindane using the example of the wood species oak

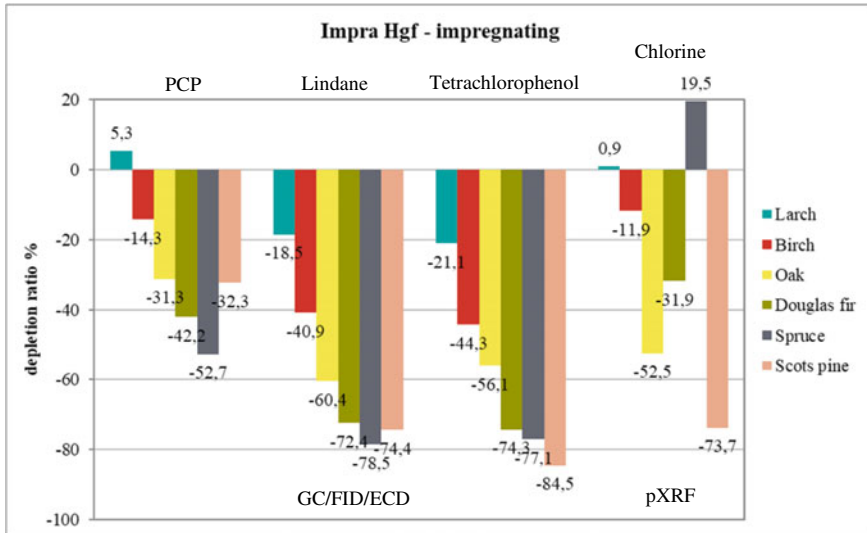
**Fig. 12.17** Comparison of the depletion rates (laboratory results and p-XRF measurements) for the wood samples impregnated with Impra Hgf

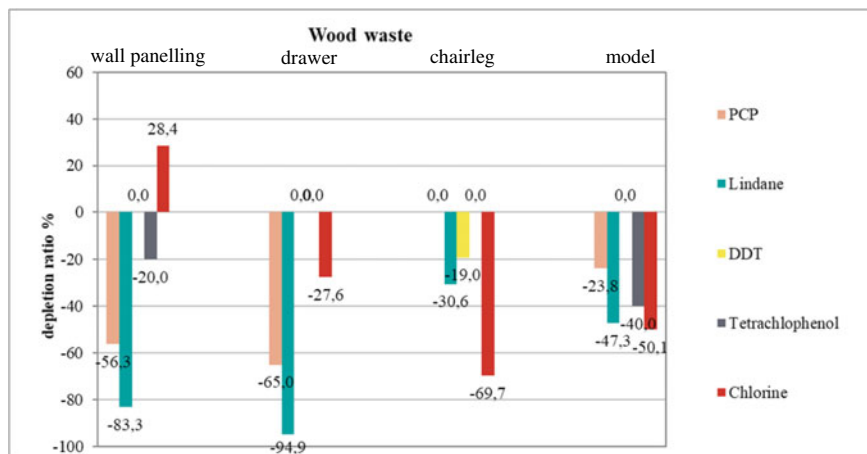
**Fig. 12.18** Comparison of depletion rates (laboratory results and p-XRF measurements) for the waste wood samples

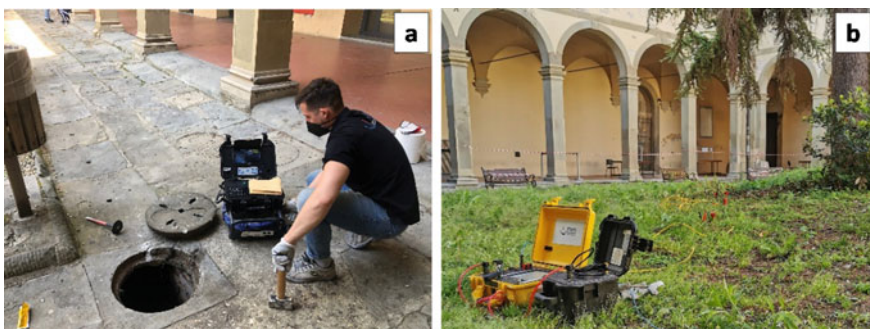
**Fig. 13.2** Execution of the investigations inside the Nigetti cloister: **a** endoscopic investigation inside the pipes found; **b** geophysical investigations for the characterization of infiltrative phenomena

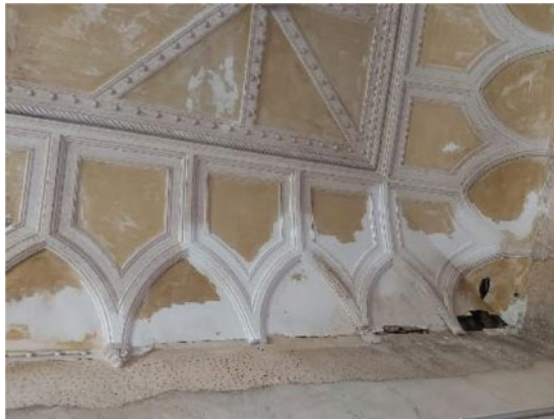
**Fig. 14.7** Detailed view of some of the pathologies identified on the ceiling of the noble staircase and in other adjoining rooms

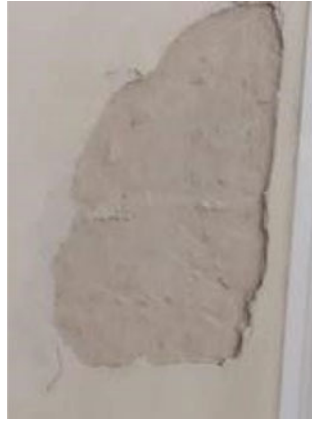
**Fig. 14.8** Detailed view of one of the pathologies on the ceiling

In the other rooms that were intervened, the problems were similar, also related to the presence of leaks and the consequent loss of support material (Figs. 14.7 and 14.8).

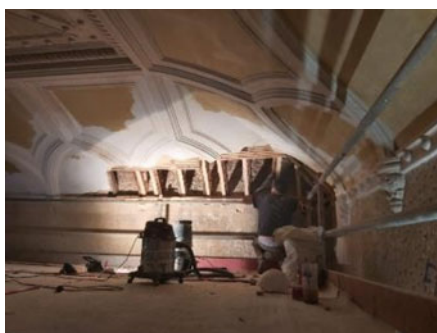
**Fig. 14.10** Detailed view of the structure of the intervention roof, in noble staircase

The ceiling of the noble staircase of the National Archaeological Museum, in the Jerónimos' Monastery, presented some volumetric gaps, both in terms of architectural decorative elements—warhead frames and small corbels (Figs. 14.9 and 14.10).

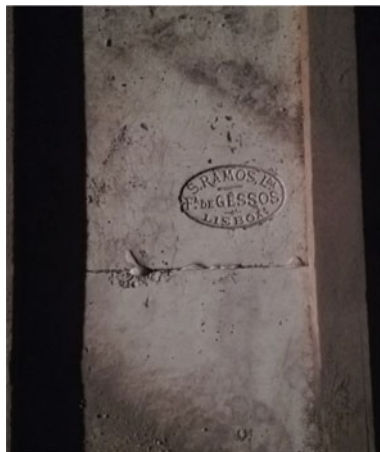
**Fig. 14.12** Example of applying a plasterboard resulting from an old restore

In the area of absence of support, we chose a traditional treatment (bare and mortar) and not resort to more contemporary methodologies such as plasterboard, which consists of a plate that does not exceed the thickness of one and a half centimeters, and is composed of plaster, sisal and bare. In rehabilitation, it turns out to be widely used because it is a lighter and cheaper solution. During the intervention, it was possible to identify the use of plasterboard of old restorations on a ceiling next to the staircase—see Fig. 14.12. However, where possible, the traditional process should be used (Fig. 14.11).

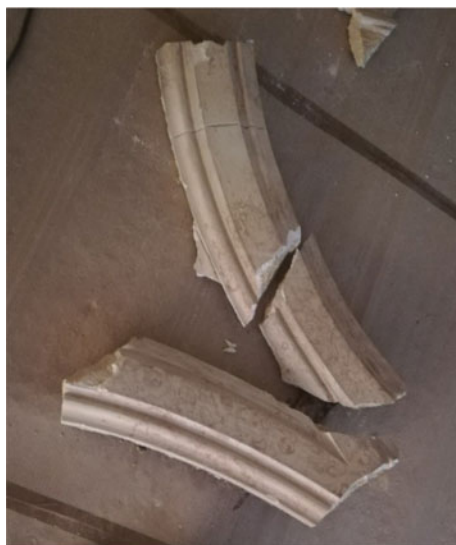
**Fig. 14.13** Elements saved from the warhead frame

Füller [3: p. 13] Thus, with the use of traditional masses, it is avoided the use of synthetic masses, as initially thought to use, in relation to the saved elements, these were replaced again—see Fig. 14.13.

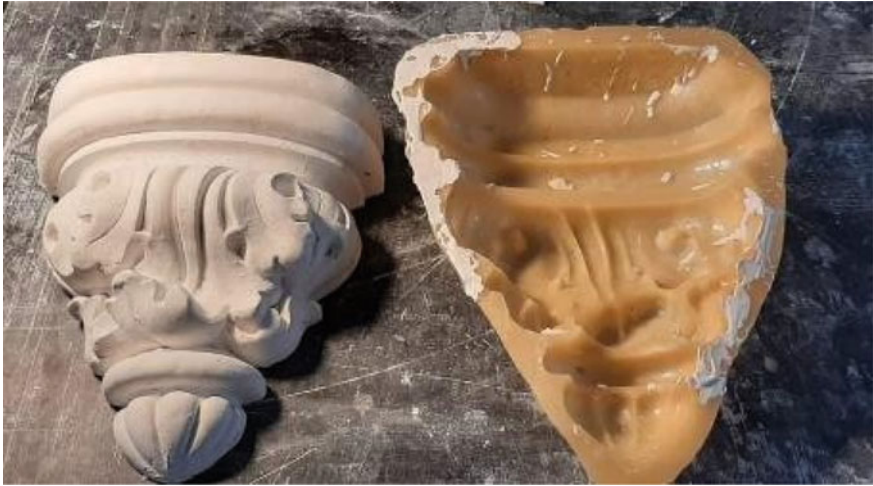
**Fig. 14.14** On the left a replica of the corbel and on the right the mold in beeswax

The case of the cordons was adopted a traditional technique, the wax mold, because only a few replicas were needed. This mold, similar to gelatin, needs a component that gives it some plasticity such as glycerin (Fig. 14.14).

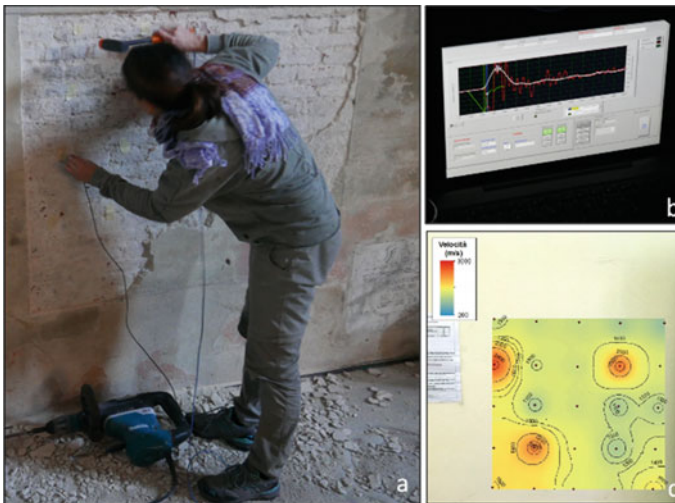
**Fig. 15.1** Sonic Velocity Test: **a** on-site investigation, **b** diagram for time-of-flight analysis, **c** representation of velocity distribution through GIS software

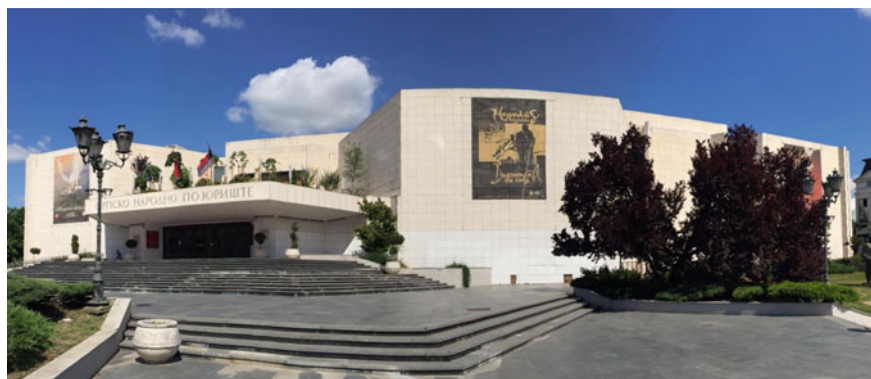
**Fig. 17.1** Southeast-facing façade with the main entrance to the Serbian National Theatre in Novi Sad, before cleaning and protection works done in 2021 (authors' photo)

The building of the Serbian National Theatre (Serbian: Srpsko narodno pozorište) is located in the city of Novi Sad, the cultural and administrative centre of Vojvodina, the northern Serbian autonomous province. Although Novi Sad has never been the capital of the Serbian state, and for that matter was not even a part of Serbia at the time the Serbian National Theatre was founded, its rich and vibrant cultural atmosphere provided the perfect environment for avant-garde Serbian intellectuals and artists in the nineteenth-century Austrian Empire. The theatre was founded in 1861, in times of nineteenth-century European national awakening and the beginnings of the struggle for national freedom. Interestingly, until 1947 the theatre did not have its own central building but used various venues in the city and the region for practising and performing. In 1947, the theatre finally received a building from the state which it will use until 1981. The new theatre building was built in 1981 after an international architectural competition, won by Polish Architect Wiktor Jackiewicz. The chosen location of the new building required intensive adaptation of the urban environment which included controversial demolishing of eighteenth- and nineteenth-century neighbourhood in the very heart of the city [1, 2]. Nevertheless, the new building now represents a new era in the urban development of Novi Sad, a city with continuously growing population and economy. Today, the Serbian National Theatre building is one of the central city landmarks with its characteristic hexagonal-based structure clad with white marble stone façade slabs (Fig. 17.1).

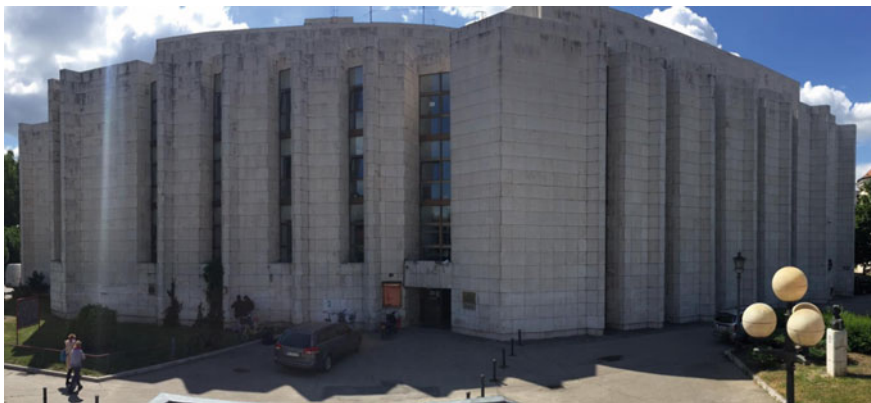
**Fig. 17.2** Northwest-facing façade with the side entrance to the Serbian National Theatre building, before cleaning and protection works in 2021 (authors' photo)

The entire area of the façade (Fig. 17.2) was mapped providing detailed information about observed deterioration patterns, such as cracks, graffiti stains, mechanical damage from previous graffiti removal attempts, soluble salts induced erosion, oxalate salt stains, synthetic resins and glues (from fixed placards), façade paint and paint-induced erosion and microbiological stains and erosion.

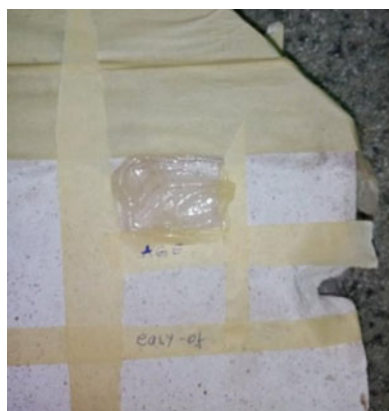
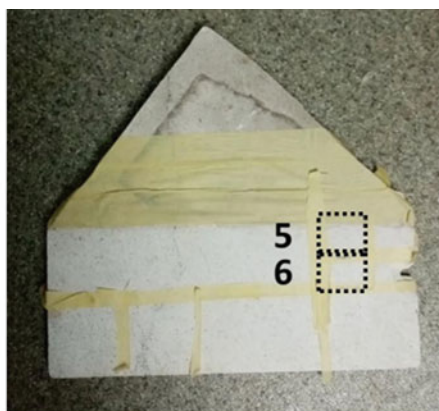
**Fig. 17.4** Stone material divided into testing zones before (left) and after the treatment (right); zone 5—steam cleaning + AGE; zone 6—steam cleaning + easy-off solution

Testing of the available techniques/solutions was done by dividing the original (dirty) stone material into several zones on which the techniques/solutions were applied (Figs. 17.3 and 17.4).

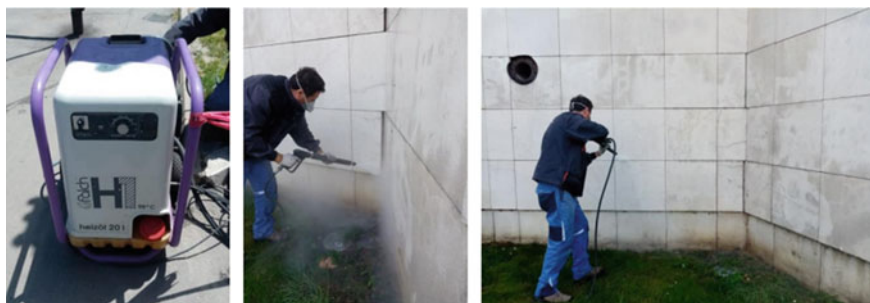
**Fig. 17.5** Hot box machine (left photo) and hot box cleaning process (middle and right photos)

2000, Germany;  $t = 120\text{ }^{\circ}\text{C}$ ,  $p = 60\text{ bar}$ )—Fig. 17.5, and Schmutzlöser and Kiehl Li-Ex soap treatments.

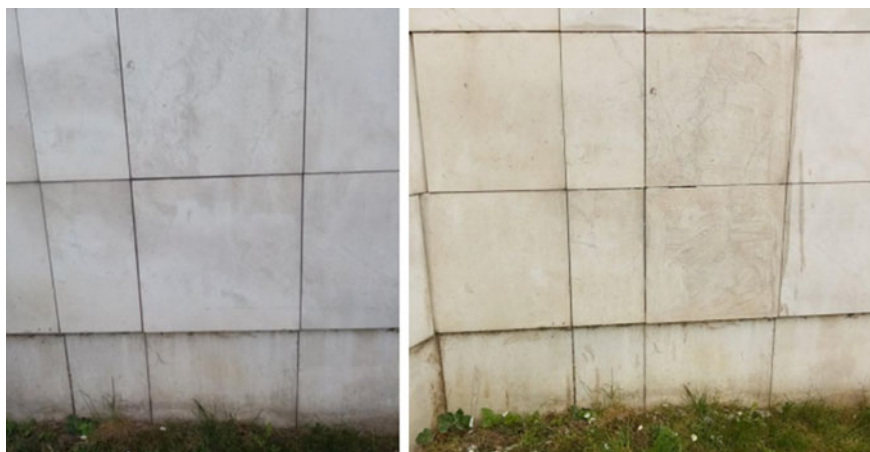
**Fig. 17.6** Trial surface before treatment (left) and after treatment with the soaps (right photo, 2.5% Schmutzlöser—left slab, 10% Schmutzlöser—middle slab, 33% Kiehl Li-Ex—right slab)

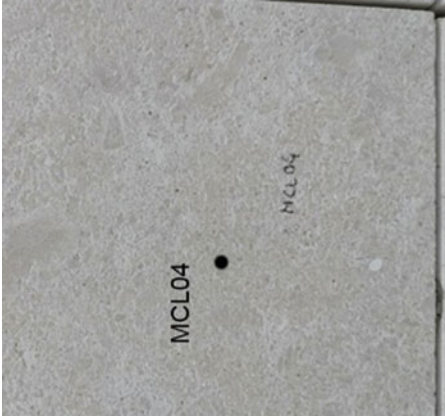
Photo of the trial surface before/during the treatment	Photo of the trial surface after the treatment
Machine cleaning (no soap)

Comment: Machine cleaning using hot box is recommended in all zones of the façade. In the parts of the façade not containing yellow stains, hot box machine process satisfactorily cleaned the surface (MCL04). In the areas of the façade where the yellow stains were present, it was necessary to treat the surface with the soap before machine cleaning. Schmutzlöser soap was not able to remove yellow stains (MCL01 and MCL02), while Kiehl Li-Ex soap managed to remove the stains (oxalate deposits)—MCL03. After the grime was removed from certain areas of the façade, erosion of the stone material was noted. These eroded surfaces present vulnerable spots for future rapid degradation of the material, the reason to be adequately protected

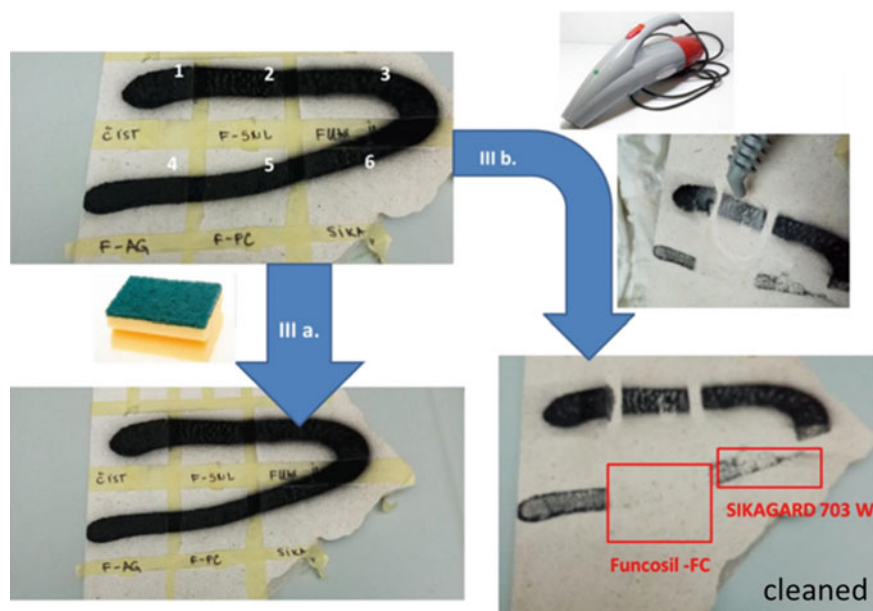
**Fig. 17.7** Overview and visual inspection results of the anti-graffiti function testing: 1—untreated surface, 2—Funcosil-SNL, 3—Funcosil-SN, 4—Funcosil-AG, 5—Funcosil-FC, 6—Sikagard 703 W

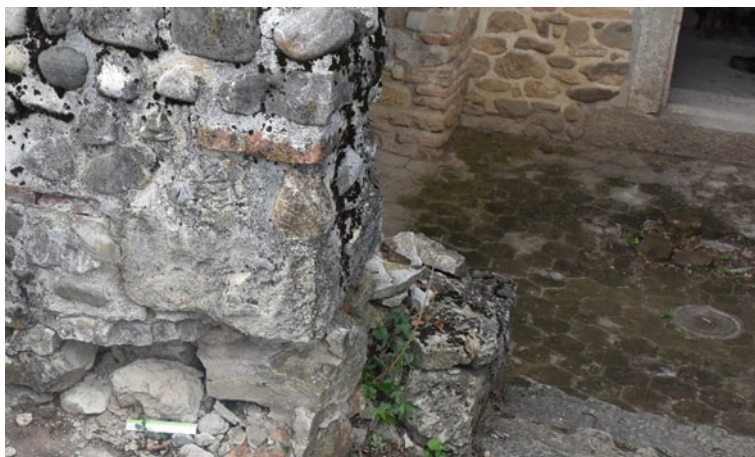
**Fig. 18.3** Sampling position, masonry mortar sample Br1, late Roman tomb in Brestovik (Photodocumentation of the MoDeCo2000 project)

Four samples of lime mortar were collected from this tomb—floor mortar from the grave chamber, mortar belonging to the wall painting from the central room, and two masonry mortars from the entrance area. Laboratory characterisation of mortar samples was performed using sieving, wet chemical analysis, stereo-optical microscopy with colourimetry, chemical–mineralogical analysis (XRF/XRD), mechanical tests (drilling resistance measurements and compressive strength), thermal analysis (DTA/DSC/TG/MS), FTIR and Raman spectroscopy analysis, and identification of binder–aggregate ratio (wet chemical analysis and interpretation of petrography and thermal analysis) [12]. Data obtained in situ and by laboratory tests presented the basis for the development of compatible conservation mortars (Fig. 18.3).

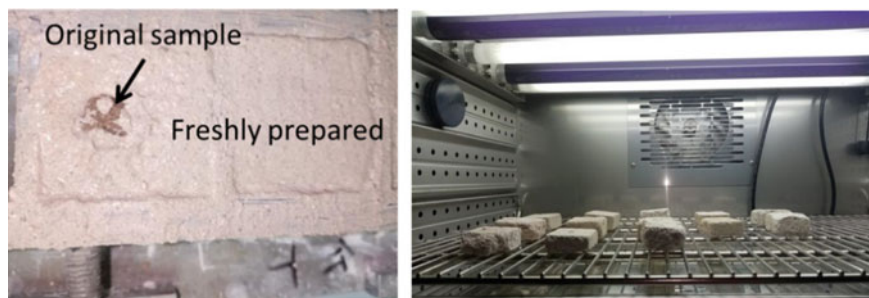
**Fig. 18.4** Freshly prepared samples (left) and their artificial ageing in the chamber (right) (Photodocumentation of the MoDeCo2000 project)

The mixture composition and production technology of the conservation mortars for the Brestovik tomb was established based on the results of a comprehensive historical mortars characterisation. The models of conservation mortars were prepared in the laboratory and artificially aged using a weathering chamber (KBWF 240, Binder, Germany). The comparative characterisation was performed for historical and aged conservation mortars to examine their compatibility (colour, mechanical properties, and formation of contact zone between designed systems and historical ones).

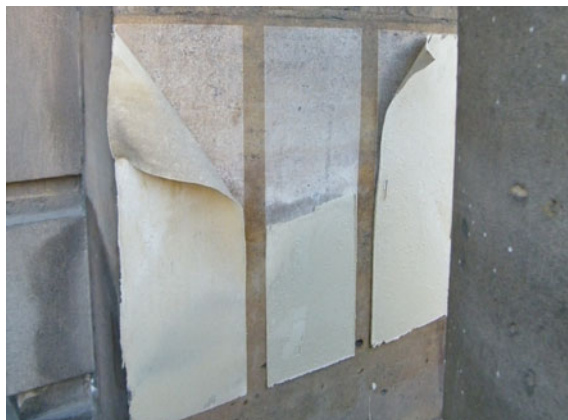
**Fig. 19.1** Sample surfaces to determine the optimal application thickness (continuously increasing within an area of 2 mm to 6 mm) or application quantity one day after application. The self-detaching effect at low film thickness is clearly visible. [Photo: Remmers]

An unplanned, but not undesirable side effect of cleaning with the compress material was a clear brightening of the natural stone surfaces that went beyond the removal of the heavy metal load (Figs. 19.1 and 19.2).

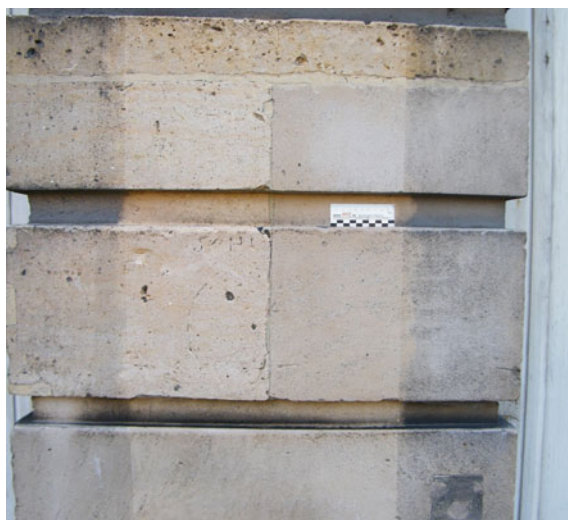
**Fig. 19.2** Cleaning results on sample surfaces with different natural stone substrates. [Photo: Remmers]

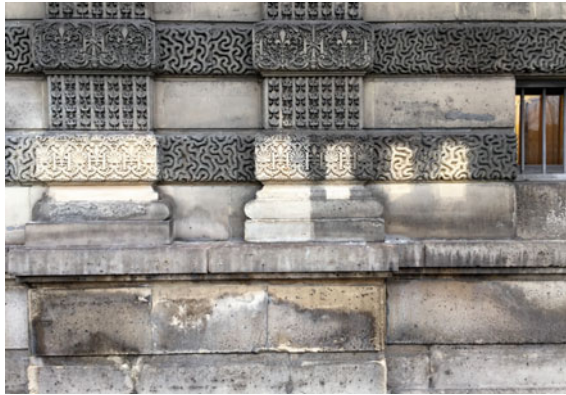
**Fig. 19.3** Cleaning sample areas at the Louvre, Paris [Photo: Tollis]

After the extremely positive results at the Hotel de Rohan, the French authorities decided to test the cleaning poultice again on an in terms of monument preservation even higher-ranked object, the Musée du Louvre. These tests were also used to draw comparisons between the newly developed poultice and a proprietary poultice of the restoration company carrying out the work (Fig. 19.3).

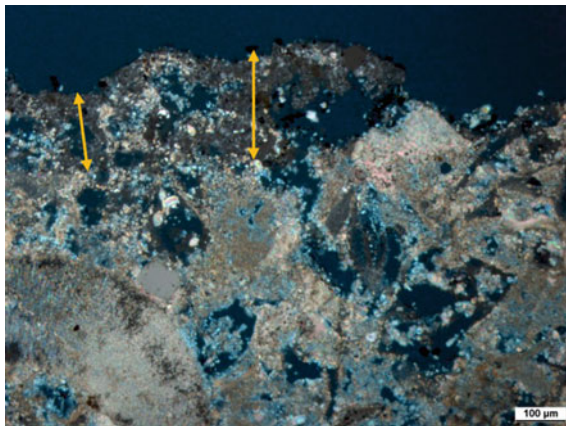
**Fig. 19.4** PolMi image, under crossed polarisers, sample 1, uncleaned. There are dirt particles in depressions in the surface (area 3). Plastering on the surface and in the microstructure section near the surface (arrow mark) [Photo: MPA Bremen]

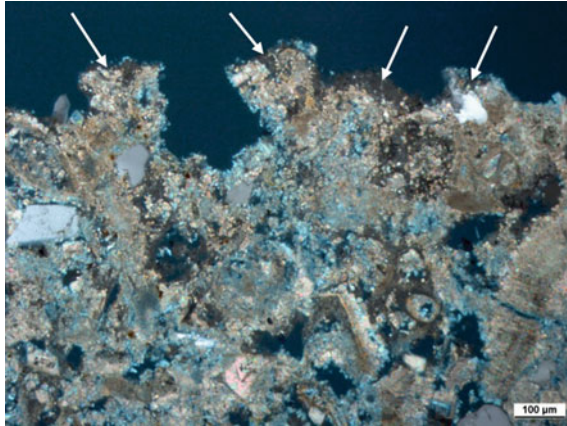
**Fig. 19.5** PolMi image, under crossed polarizers, sample 2, cleaned. No dirt particles are visible on the surface. The plastering (arrows) on the surface does not appear to have been altered by the cleaning. [Photo: MPA Bremen]

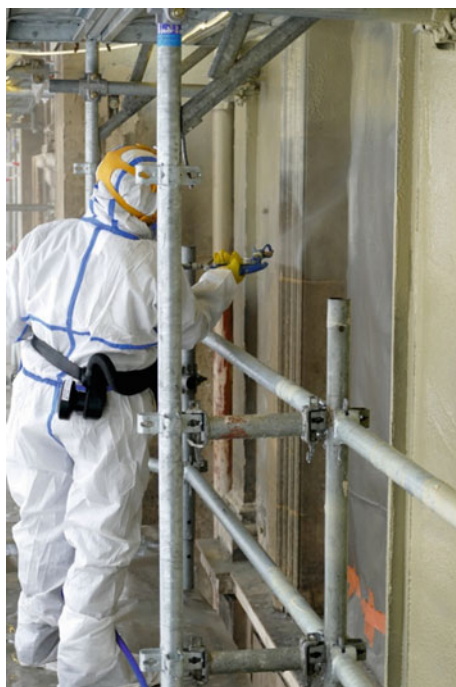
**Fig. 19.10** Cleaning test area at the Musée Carnavalet in Paris [Photo: H. Chevalier]

The cleaning effect of the compress has been very sufficient in all test areas (Fig. 19.10).

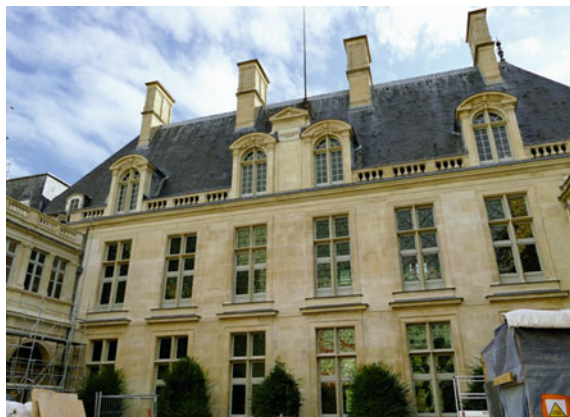
**Fig. 19.13** Facade of the Musée Carnavalet after cleaning [Photo: H. Chevalier]

to municipal regulations; if necessary, the heavy metal load of the compress must be examined for this purpose. The dried poultice material was not considered critical and could be disposed of as “household waste” without special treatment (Fig. 19.13).

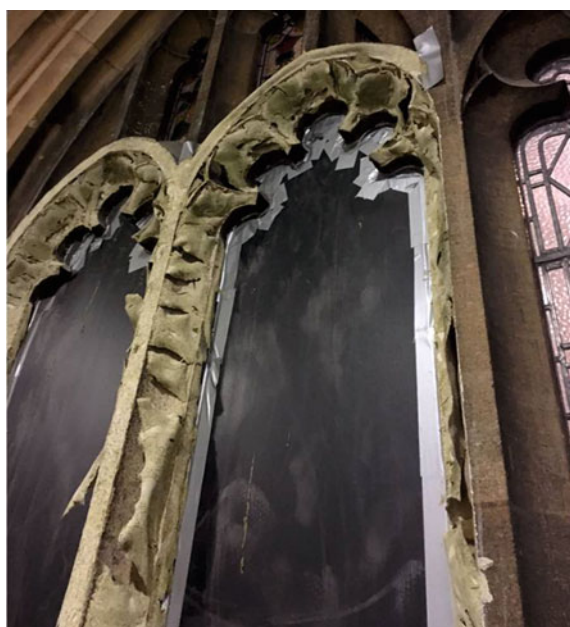
**Fig. 19.14** Cleaning of a tracery at Westminster Palace, London [Photo: Remmers]

Meanwhile the cleaning of facades at Westminster Palace including Big Ben has started (Fig. 19.14).

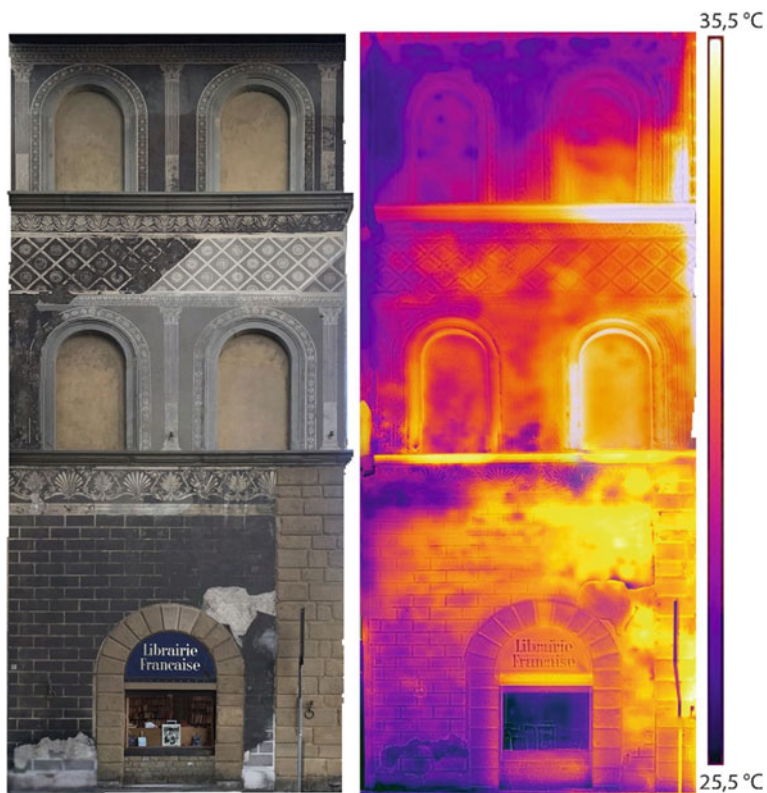
**Fig. 20.4** IR and VIS image on the left façade (view from Montebello Street)

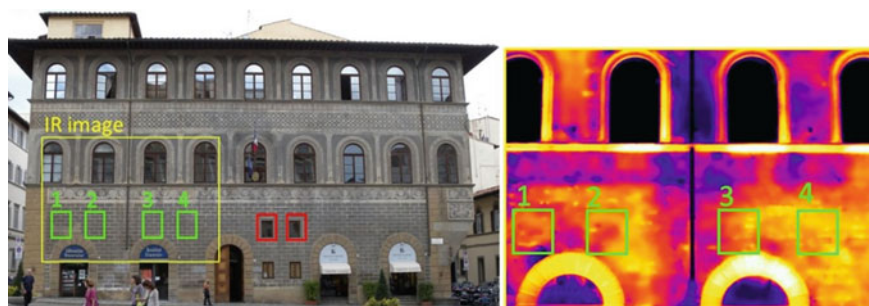
**Fig. 20.5** Green line is highlighted the probable location of the four covered windows on the frontal façade. In red line, the existing windows
