# The Future of Heritage Science and Technologies

Materials Science

Volume 179

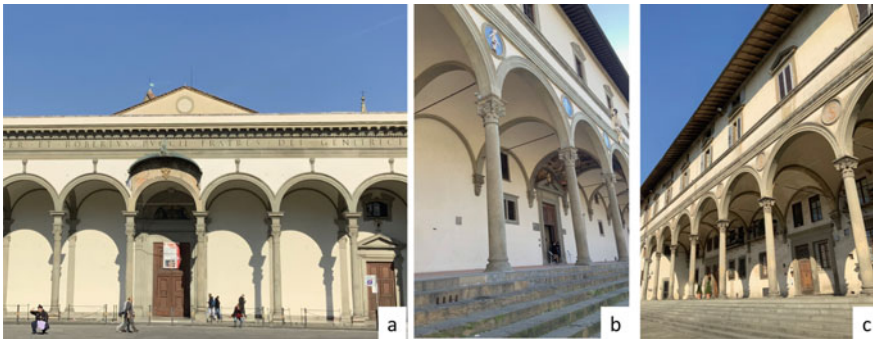
**Fig. 21.3** a Santissima Annunziata basilica; b Spedale degli Innocenti; c Loggiato dei Servi di Maria. Columns, capitals, and arches are in Pietra Serena sandstone, stairway is in Pietraforte sandstone (Spedale degli Innocenti) and in Pietra Serena sandstone of Firenzuola (Marnosa Arenacea Formation) [4] (Loggiato dei Servi di Maria). Images are from the PWA [1]

The Basilica della Santissima Annunziata (Fig. 21.3a) represents the main Marian sanctuary of the city. The construction of the church began in 1250 by the brotherhood of the Servi di Maria; the current name derives from the fresco of the Annunciation executed by the painter Bartolomeo and kept inside the church. Today's aspect is the result of three centuries of works; from 1280 until the first half of the fourteenth century, many internal modifications were done; successively the church was significantly enlarged. The external loggia (1601), by Giovanni Battista Caccini, was built to connect the façade with the arches of the Spedale degli Innocenti and the Loggiato dei Servi di Maria. In 1857, a great restoration was carried out by the architect Giuseppe Poggi. The columns, the arches, the tympanums, and the cornices are realised in Pietra Serena sandstone [1]. The floor of the loggia is in Apuan marble, Alberese limestone, and Colonnata black limestone [1–3].

The initial project, by Filippo Brunelleschi, of the Spedale degli Innocenti (Fig. 21.3b) started in 1419. After a long interruption, the works restarted in 1436 under the direction of Francesco Della Luna, and in 1445, the spedale was inaugurated. The spedale stands on a stairway in Pietraforte sandstone and is characterized by an arcade defined by nine large arches on columns having Corinthian capitals, and, on the sides, by two other arches flanked by grooved pilasters. On the upper part of the arcade, in 1487, ten white and blue glazed terracotta rounds, by Andrea della Robbia, were inserted. Many restoration and transformation interventions took place after the earthquake of 1842, when the damaged columns were replaced. The

columns, the external arches, the capitals, the buttresses, the string course, the tympanums and the frames of the windows, and the corbels under the arcade are in Pietra Serena sandstone. The entire structure is in white plaster. Under the arcade, there are frescoes and busts in Apuan marble [1].

The construction of the Loggiato dei Servi di Maria (Fig. 21.3c), commissioned by the Servi di Maria order and designed by Antonio da Sangallo il Vecchio and Baccio d’Agnolo, began in the period between 1516 and 1525. The loggiato consists of an arc joining a series of houses each of which corresponds to one span. The house construction was very complex and lasted over the centuries until 1720 when the works were completed. The columns of the loggiato, the external arches, the corbels, the window and door frames are in Pietra Sera sandstone; and doors, the tympanum and window frames, the decorations, and the string courses above the loggiato are in Pietra Serena sandstone. The entire structure is finished by plaster. The steps of the entrance stairway are realized in Pietra Serena sandstone of Firenzuola (Marnosa Arenacea Formation) [4]. In the external loggiato, there are rounds realized with painted plaster and finishing in Pietra Serena sandstone [1].

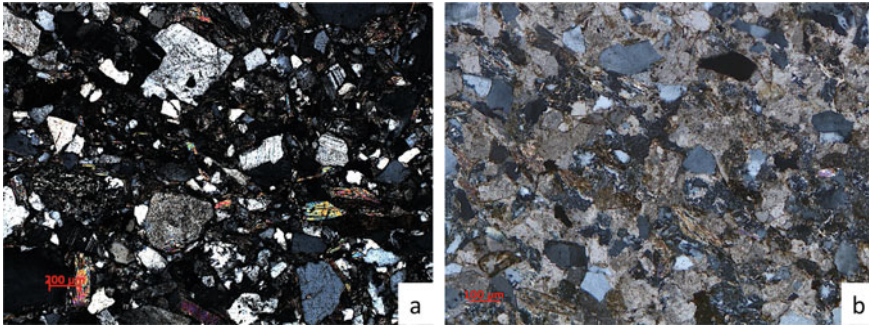
**Fig. 21.5** Photomicrographs of thin section in crossed polarized light of **a** Pietra Serena sandstone, **b** Pietraforte sandstone. Images are from the PWA [1]

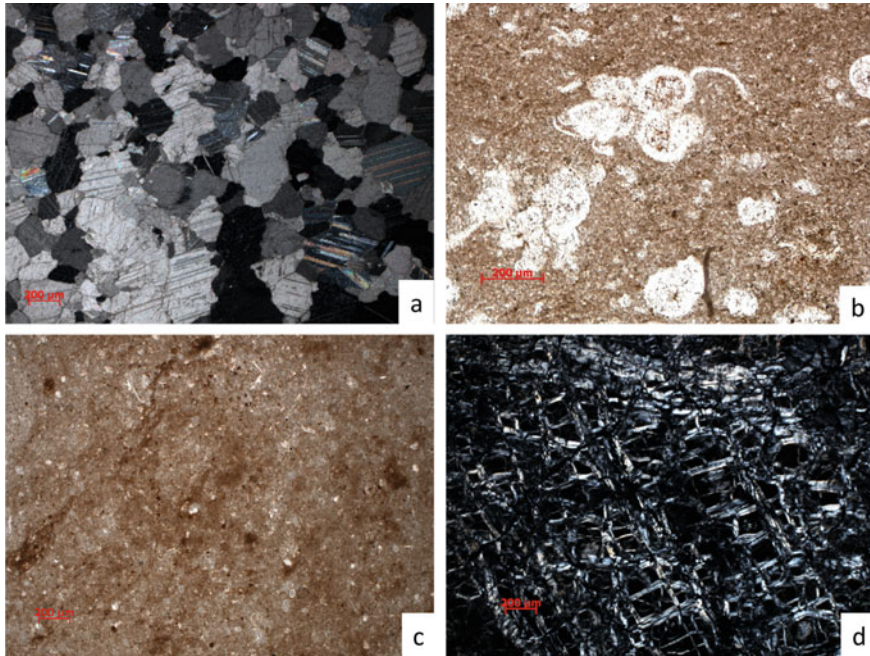
**Fig. 21.7** Photomicrographs of thin sections of rocks observed in crossed polarized light. **a** Apuan marble, **b** Red ammonitic limestone, **c** Red marly limestone, **d** Serpentinite. Images are from the PWA [1]

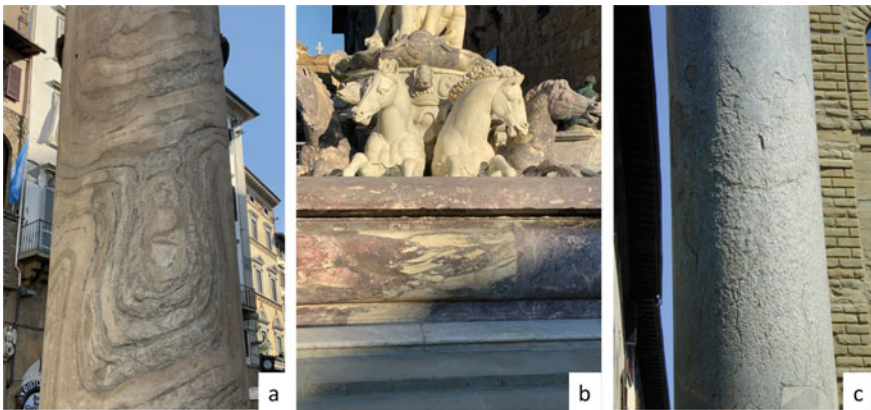
**Fig. 21.8** a Colonna di San Zanobi; b Fontana del Nettuno; c Colonna della Giustizia. Images are from the PWA [1]

The Colonna di San Zanobi (Fig. 21.8a) stands in Piazza San Giovanni, in front of the North door of the Battistero di San Giovanni. According to some historical sources, the column is a reconstruction of 1334; the terrible flood of 1333 that swept away all the bridges of Florence, inexorably destroyed it; other sources report that the column is the original, dated to the second half of the twelfth century; accordingly, the column was only restored after being overwhelmed by the flood of the Arno river. The column was built in the same place where a miracle, linked to the cult of San Zanobi, occurred; during the moving of the San Zanobi relics to Santa Reparata, a dry elm, in the middle of winter, at the contact with the sarcophagus, would be miraculously revived. In 1338, the column was crowned with the cross at the top, and in 1375, an inscription, recalling the legend of San Zanobi, was added. To date, the cross and the original pedestal are housed inside the Museo dell’Opera del Duomo, while above the column, there is a fibreglass copy. The column is made of Greek marble (Cipollino/Carystium) [1].

The Fontana del Nettuno (Fig. 21.8b), locally called “il Biancone”, is located in Piazza della Signoria and represents the monument celebrating the power of Cosimo

I de' Medici as well as the maritime domain of Florence. The first project of the fountain was due to Baccio Bandinelli in 1549. At the death of Bandinelli, in 1560, Bartolomeo Ammannati took over the work that continued until 1565 when the fountain was inaugurated. In 1575, the bronze sculptures (attributed to Giambologna but, according to other sources, made by Ammannati and his assistants) of marine divinities (Doride, Teti, Oceano and Nereo), all flanked by pairs of satyrs and nymphs and the marble parts of the tub, were completed. The fountain is characterized by a large octagonal tub with bronze sculptures and many decorative elements along the edges. The statue of Nettuno, the tritons, the chariot, two horses, and the decorations on the tub are in Apuan marble; the tub and the other two horses are in Breccia di Seravezza. The marine divinities, the satyrs, and nymphs are in bronze [1].

The Colonna della Giustizia (Fig. 21.8c) was placed in Piazza Santa Trinita by order of the Grand Duke Cosimo I de' Medici to symbolise the virtues and glory of his family. It came from the monumental swimming pool of the Terme di Caracalla in Rome, and was donated by the Pope Pius IV to Cosimo I. It is a large monolithic column, 11.2 m high and weighing about 50 tons, arrived in Florence after a long journey, which lasted one year. The column was dedicated to Justice and, for this reason, at its top was placed a statue of Justice, originally made of wood and terracotta, then replaced by another made of ancient red porphyry. The processing of granite lasted about eleven years; six blocks, probably coming from ancient Roman columns, were assembled together to realize the statue (1581). The base of the column is obtained by using the Breccia di Seravezza and marble stones; the stem is made of granite; the Statua della Giustizia is made of red porphyry, an igneous silica-rich rock, containing large crystals of feldspar and quartz; the cloak is realised in bronze [1].
