The Evaluation of Stone Column and Jet Grouting Soil Improvement by Conducting a Comprehensive Experimental Program

Arshiya Abadkon and Erol Güler

Experimental program in this study was conducted during soil improvement works of Ashgabat International Airport Project in Turkmenistan. Existing soil at the site consisted of mostly loose silty sand with thin clay layers. Due to weak soil conditions bearing capacity and settlement problems were foreseen during geotechnical evaluation of the project for structures transferring high loads to the ground such as Main Terminal, Cargo Terminal, Aircraft Hangars and etc. In addition, because of the cohesionless structure of the existing soil and high groundwater level liquefaction risk at the site was very high. Therefore, jet grout columns with 16 m length and 0.6 m diameter and stone columns with 16 m length and 0.8 m diameter were designed to remove the mentioned risks for the soils below the foundation of the

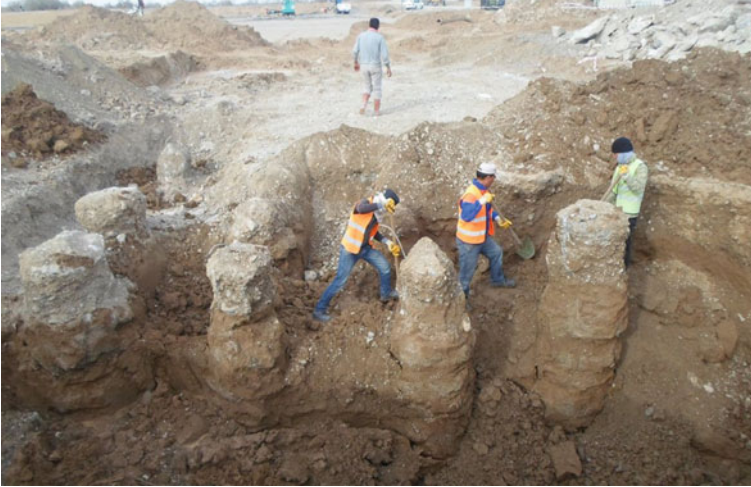
Fig. 2 Excavation around jet grout columns

After post production tests soil around the jet grout columns was excavated to measure the diameter of the columns (Fig. 2). In addition full length coring was conducted on some of the produced jet grout columns to check the integrity of the produced columns.

Results showed that there is not a homogeneous structure in the whole length of jet grout columns. Moreover, in some columns there were soil inclusions resulting from existence of hard clay which avoided jet grout slurry to mix with soil and produce the soil-crete columns. This might cause bearing capacity and settlement problems for the geotechnical design.

In case of jet grout columns practically no improvement was observed in the soil in-between the columns. Also full length coring results for jet grout columns showed

that there is a risk of soil inclusion or discontinuities within jet grout column length due to ground conditions.

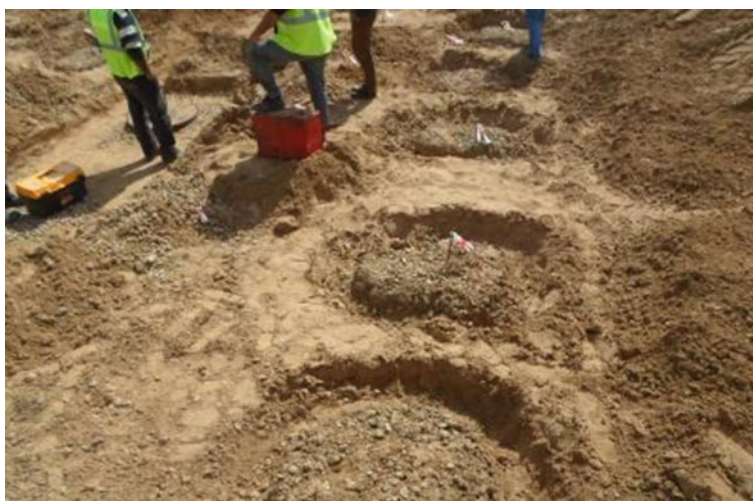
Fig. 4 Produced stone columns in test area

Seismic reflection tests were also conducted on this test area to compare the shear wave velocity of the soil before and after improvement (Fig. 4).

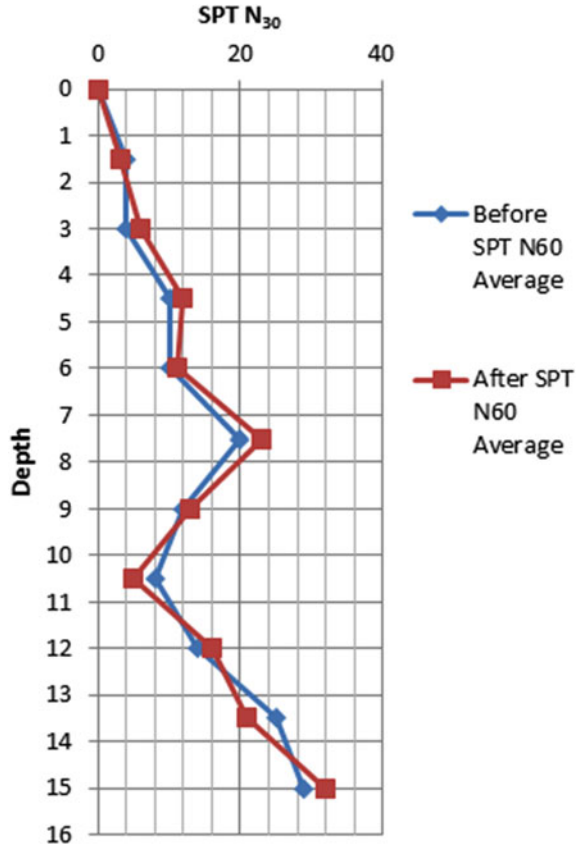
Fig. 5 SPT results for jet grout area

SPT and CPT test results showed almost no change in the strength of the soil between columns before and after jet grouting improvement. Results of SPT tests are shown in Fig. 5.

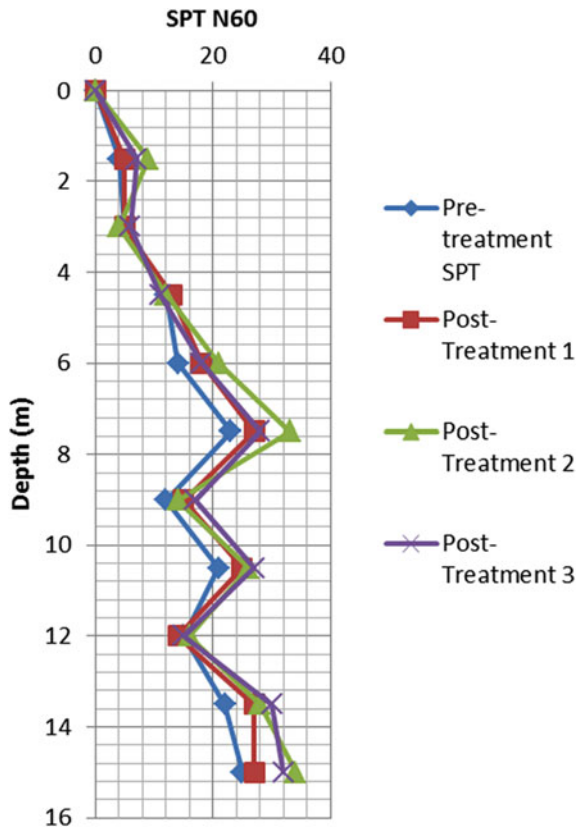
Fig. 6 SPT results for stone column area

Standard penetration test results showed a slight increase in average SPT N60 values after stone column soil improvement which indicated that in addition to the area of the stone column itself, soil mass between columns has also been improved (Fig. 6). This plays a key role in reducing seismic risks and liquefaction hazards. CPT results also showed that strength parameters of the soil mass between stone columns have increased. The purpose was to determine the liquefaction risk before and after soil

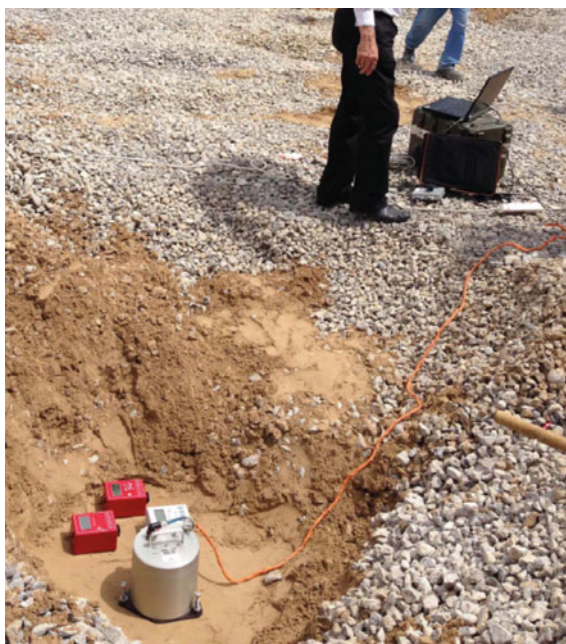
Fig. 8 Seismic test for stone column test area

Moreover, seismic tests as seen in Fig. 8 was conducted on site. The seismic tests showed that shear wave velocity of the soil increased from 170.4 m/s before improvement to 250.7 m/s after improvement which indicates a 47% increase. Average value of shear wave velocity until depth of 30 m was increased from 290 to 370 m/s after improvement.

Another indication of the increased density was the significant increase in shear wave velocity by the use of stone column technique. Similarly the increase in shear wave velocity is an indication of a decrease in the risk of liquefaction hazards.
