Chapter 6

Assessing Human Control on Planform Modification over Floods: A Study of Lower Mahananda–Balason River System, India

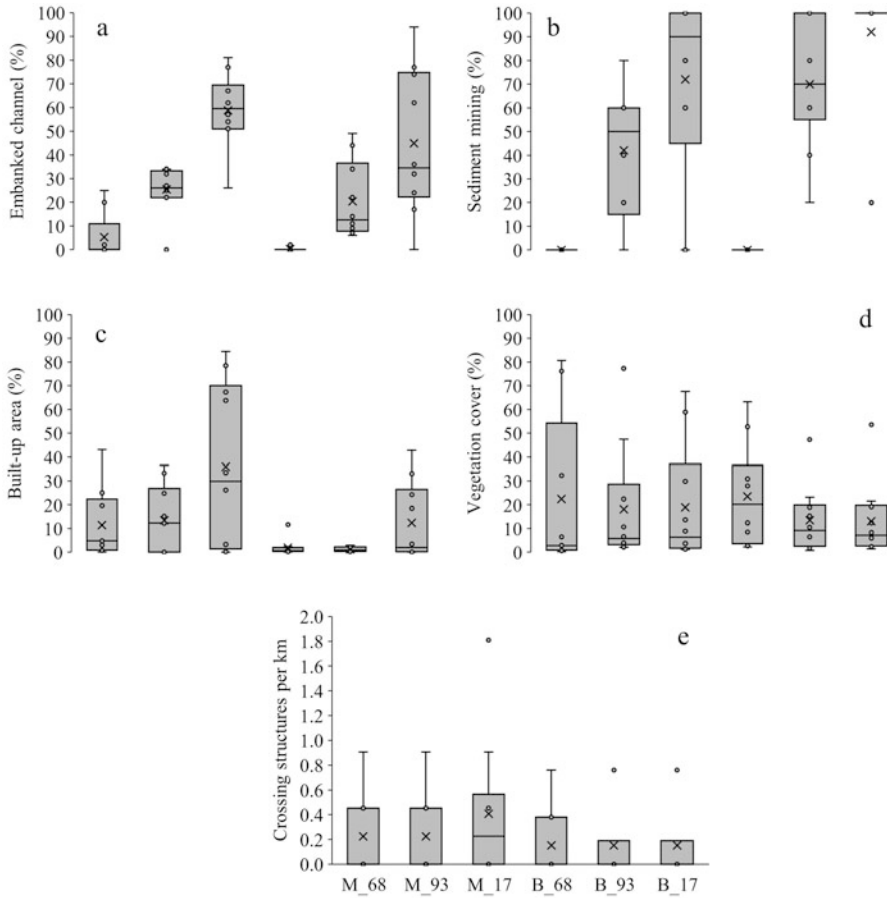
Fig. 6.3 The dynamicity of the indicators measuring anthropogenic interventions: (a) EM (%), (b) SM (%), (c) BA (%), (d) VA (%), and (e) CS (structures/km). (Figure prepared by the author)

The indicators measuring anthropogenic intervention showed (Fig. 6.3, Table 6.5, Supplementary Table 6.1) a sharp change through time in most cases. At the

beginning of 1968, the presence of concrete embankments (EM) and practice of in-channel sediment extraction (SM) was negligible, which in 49 years, increased to such an extent that more than half of the channel banks are now embanked (58.80% of M and 44.90% of B) and almost entire channel bed is under active sediment mining (72% of M and 92% of B). Since Siliguri is situated at the banks of M, therefore, it was heavily embanked to protect the urban setup. On the other side, B having a larger catchment area (287 km² compared with 116 km² of M) produces more sediment and hence more extracted. In 1968, negligible bank protection measures were identified in the reaches such as M8 and M9, but with time, embankments were built in the upstreams (M2–M6 and B5 and B6). Similarly, extraction from channel beds was initiated in the late 1980s in the reaches adjoining the Siliguri (M8–M10 and B8–B10) and expanded upstreams. Following this, the

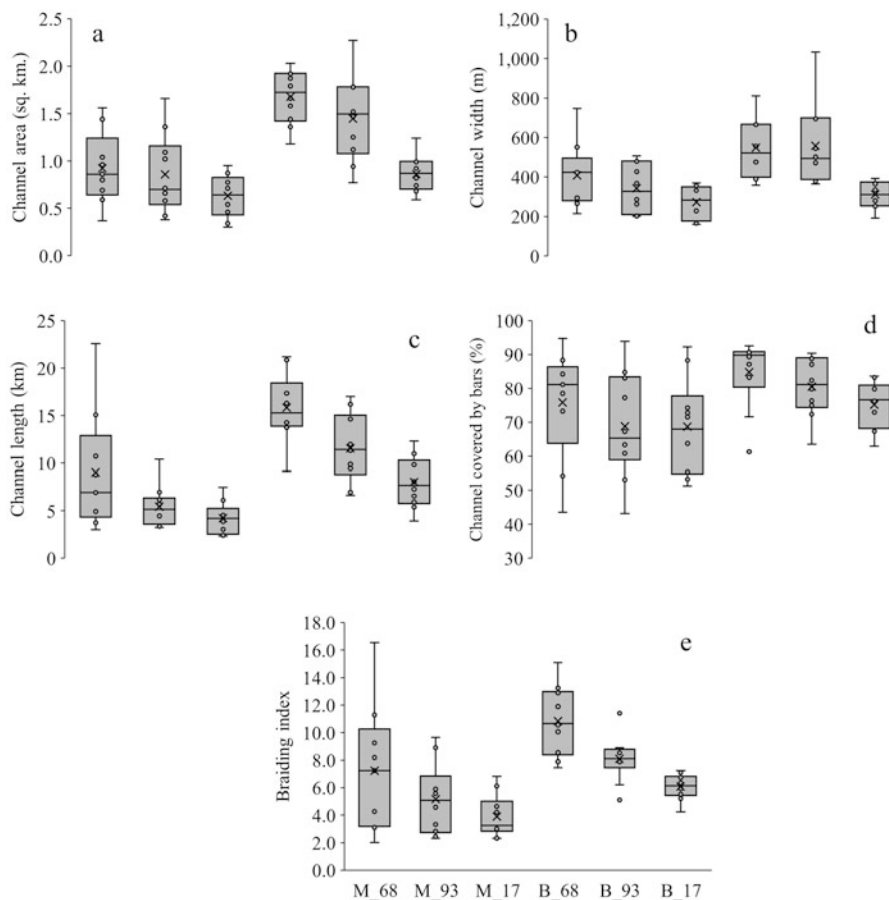
Fig. 6.4 The dynamicity of the indicators measuring channel planform properties: (a) CA (km^2), (b) CW (m), (c) CL (km), (d) CCB (%), and (e) BI. (Figure prepared by the author)

A reversal of the sharp increase of anthropogenic interventions was observed in the measurement of planform properties (Fig. 6.4, Table 6.5, and Supplementary Table 6.2). The overall CA was reduced by 40.43%, and the rate was even higher in the case of B, amounting to 48.60% compared with a reduction of 23.95% in the case of M. Similarly, the overall CW was also heavily decreased by 39.54%, and the rate of this for B was higher (43.23%) than that of M. The rate of narrowing was mostly accelerated in the second half for both rivers. Most of the loss of CA and CW was observed in the reaches from M3 to M8 and for the entire B. Interestingly, M1 and M2, devoid of interventions, exhibited channel widening. Following the general trend, nearly half of the CL (48.87%) for the entire system was reduced during this period. While B had lost 49.30% of its CL, M being slightly on the lower side got reduced by 48.04%. Reaches such as M3–M8 along with B1–B4, and B6–B10 had experienced a relatively higher reduction of CL. As a result, this multi-threaded channel pattern had become single-threaded in many reaches. The reduction rate was much lower in the case of CCB. Overall, 10.69% of CCB was reduced. Contrary to this, CCB was increased in some of the reaches such as M1, M9, and M10. Following the reduced CL, BI was also reduced noticeably. The reduction rate was 45.35% for the whole system. Interestingly, in this case, the BI of M was largely reduced (45.99%) than that of B (44.00%). Relatively upstream reaches such as M2–M7 and B1–B4 and B6–B8 had experienced higher alterations regarding BI. In some reaches, the BI was reduced to such an extent that it resembled a pseudo-meandering channel.

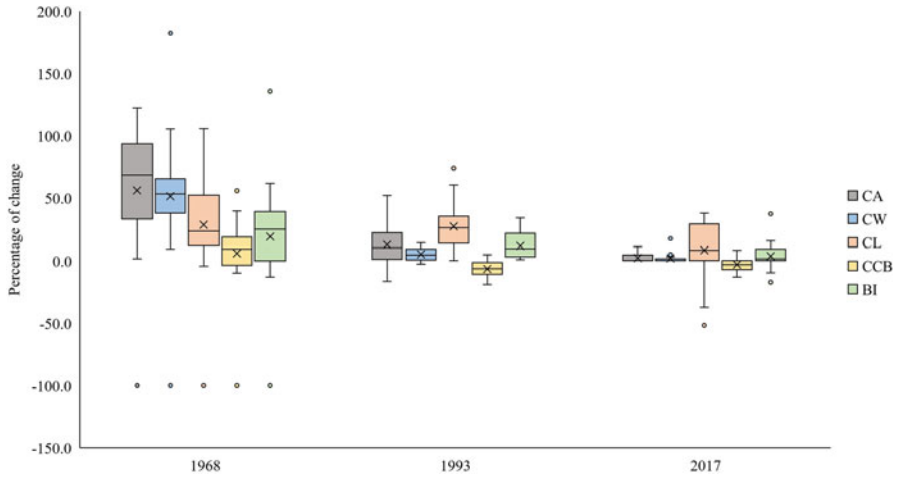
Fig. 6.5 Sharp decrease in inter-seasonal changes of the planform properties in 1968, 1993, and 2017. (Figure prepared by the author)

Inter-season comparison (Fig. 6.5, Table 6.6, and Supplementary Table 6.3) of channel planform properties revealed that in most cases, after the flood discharge, the measurements were increased. In between the pre- and post-flood season of

1968, overall CA, CW, CL, and CCB were significantly increased by 74.29%, 54.55%, 63.46%, and 14.71%. BI was also increased by 26.98% but not significantly since those increases were confined to a few reaches only. Marked changes on such a scale were completely absent in the later years, i.e., 1993 and 2017. The percentage of change mostly had become <10%, and even negative change of 4.5% and 3.15% was measured for CCB after the floods of 1993 and 2017, respectively. However, CL had increased by 33.67% between the pre- and post-monsoon of 1993, but most of this increase was insignificant, since they were restricted to a few reaches such as M4 and M6 and B4, B6, B7, and B8. The seasonal changes of B in 1968 were relatively more significant than those of M. During the initial year (1968), while CA, CW, CL, and CCB were significantly changed by the flood discharge in B, only the CA and CW were increased significantly in M. The percentage of change was also higher in B than in M. Despite being increased by 41.13%, the change of BI in M was not significant since it was confined in M4, M6, and M8. During the later years, no significant inter-seasonal changes in planform properties were observed. But among those, an increase of CL by 62.77% and BI by 24.88% in 1993 along with a reduction of CL and BI by 12.73 and - 6.68% in 2017 was noticeable.

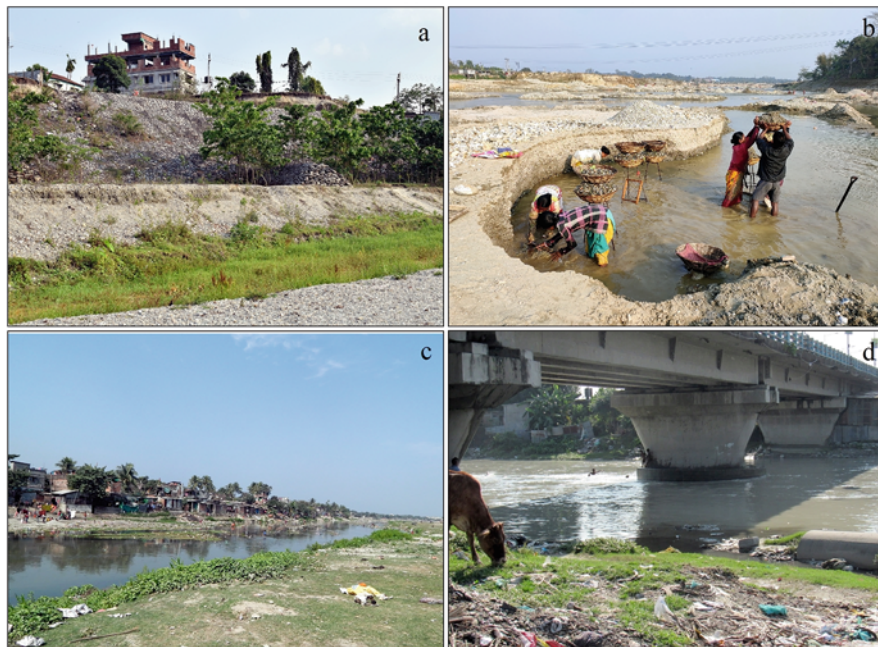
Fig. 6.6 Glimpses of ongoing anthropogenic interventions in the study area: (a) large embankments with groynes and bed stabilization structures along the banks of M, (b) intensive sediment extraction from the B river bed, (c) encroached banks of M, and (d) bridge pillars altering the flow of M. Pictures were taken by the author in December 2016 and April 2017. (Figure prepared by the author)

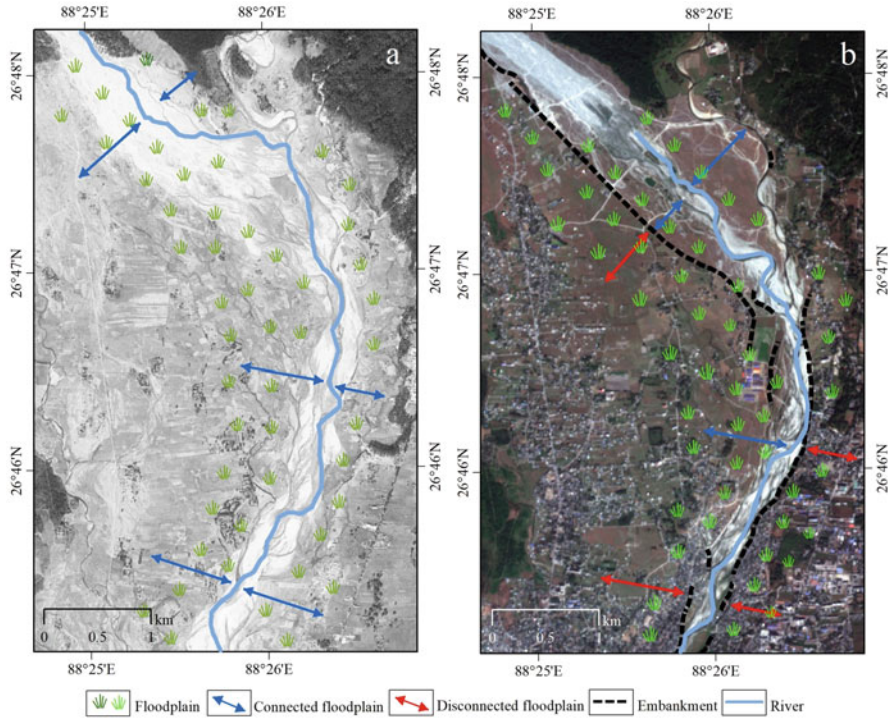
Fig. 6.7 Concretized embankments are laterally disconnecting the river from its floodplain and narrowing the channel corridor: (a) planform in 1968 with no embankments and laterally connected floodplains of M and (b) planform in 2017 with mostly embanked, laterally disconnected and narrowed. (Figure prepared by the author)

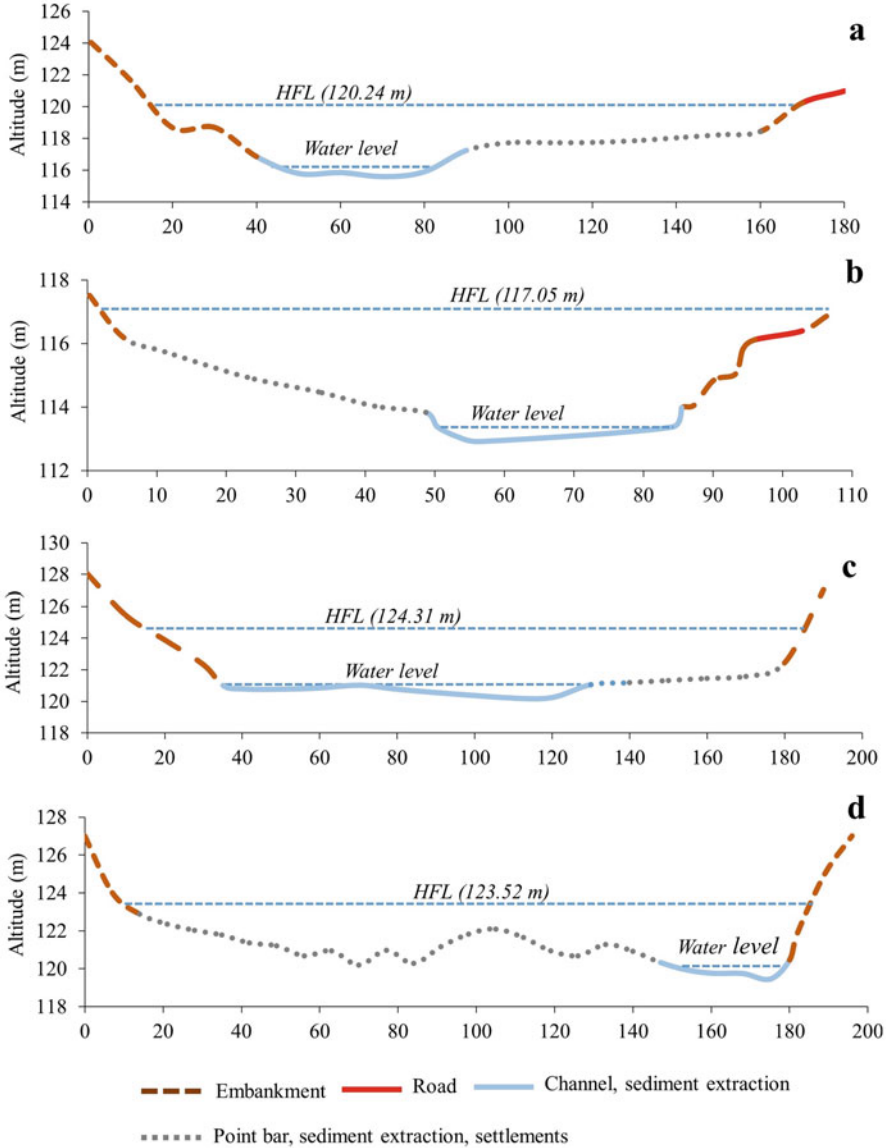
Fig. 6.9 Superimposition of the HFL (1968 flood level) on the present cross-section shows in most of the reaches embankments are so high that they can be hardly overtopped even with the largest scale of flood discharge in the recorded history. The cross-sections are situated at (a) Champasari (M7), (b) Airview more (M8), (c) Matigara-Balason bridge (B9), and (d) Matigara-Balason Railway bridge (B9). (Figure prepared by the author)

The superimposition of the HFLs on the present cross-sections (Fig. 6.9) depicts that most of the sites are protected with such huge embankments that even a flood-like 1968 cannot overtop it. Areas such as Airview more, where the river can spill its water, are now being embanked also, and the remaining chances of lateral migration and spilling of flood discharge are being reduced at an alarming pace. So with such rapid anthropogenic interventions, channel modification due to floods is becoming negligible.

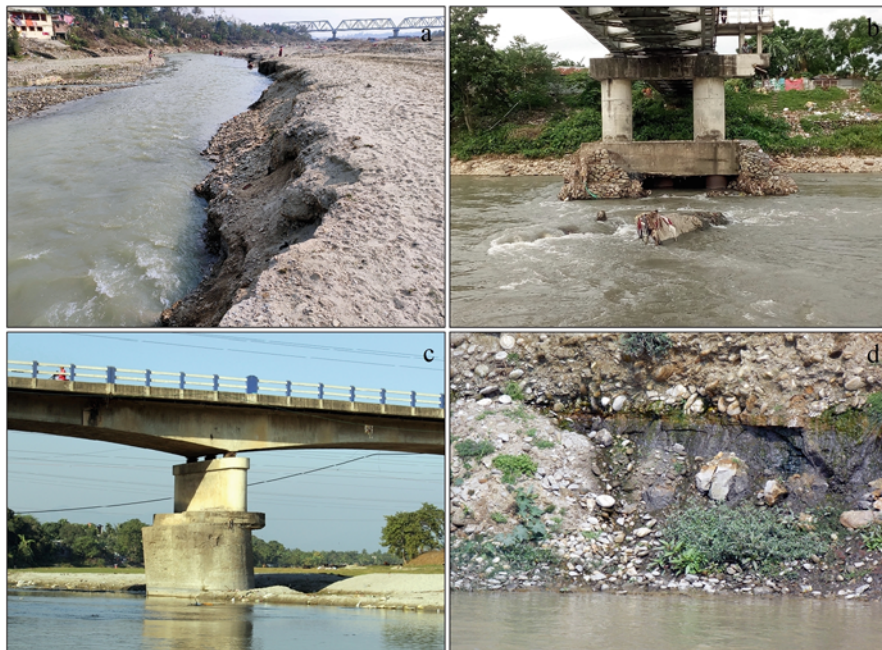
Fig. 6.10 Problems associated with channel adjustments: (a) recent incision noticed on B in December 2017, (b) signs of bed lowering on B at Matigara Railway bridge, (c) destabilized bridge pillar on M at Champasari, and (d) discharge of vadose water noticed from the black clay layer along the banks of B. Pictures were taken in December 2017 by the author. (Figure prepared by the author)

Reshaping of the rivers in the unconfined floodplains would have an impact on the entire system such as incision tendencies can migrate upstream and accumulation of sediments in the debouching areas can increase. The recharge–discharge cycle of groundwater also is being disturbed as incised river channels have a lower level than the vadose zone; therefore, recharge of that zone from river water has become impossible (Fig. 6.10). On the other side, the groundwater table maintains an equilibrium with the water level of the nearby river; now if the water level of that river goes down, the groundwater level should go down to maintain that equilibrium. The floodplain region of M7–M8 and B5–B9 is experiencing similar problems where the continuous discharge of vadose water can be seen along the river banks, and as a result of that, the non-monsoon lack of groundwater is becoming prominent (Biswas, 2016). Furthermore, the finer particles released during the sediment extraction can also clog the pores, which will obstruct the hyporheic exchange. Finally, the living biota, especially fishes, will suffer enormous habitat destruction. Fishes of these rivers are mostly benthopelagic, bottom feeders, and live in shallow rivers with a rocky or sandy bottom and higher currents. Now with such alteration in channel planform, all these preferable living conditions shall be altered, which will ultimately reshape the biotic assemblage of these river systems. Personal interviews with fishermen supported this notion as they confirmed the large-scale lowering of consumable fishes, observed by Paul et al., 2009.
