# Evaluation of Biotic Damage to Structures as a Risk Factor for Environmental Pollution During a Comprehensive Survey of the Cultural Heritage Site of Regional Significance “The Building of the Izvestia Newspaper”

**Abstract.** This article presents the results of mycological studies and determination of the composition of water-soluble salts found during a field survey of the facades and interiors of the cultural heritage site of regional significance “The building of the Izvestia newspaper”, 1927, arch. Barkhin G.B. with the participation of Barkhin M.G. The reasons for the destruction of finishing materials are determined. The factors whose influence affects the chemical destruction of materials resulting from the action of acidic products on them have been identified. A base has been formed for determining the actual state of building and finishing materials of a structure under the conditions of the existing operating mode.

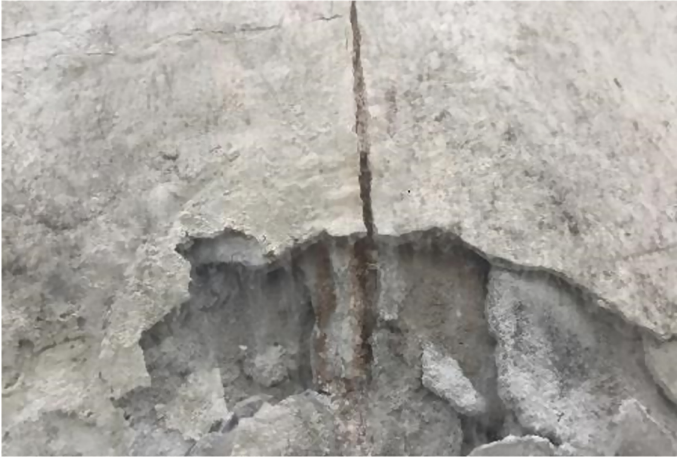
**Fig. 1.** The place of sampling in the basement.

The sample #1 was selected in the basement. On the wall in the place of destruction of finishing materials as a result of the release of salts and biological damage. (Fig. 1) Under the microscope, the surface of the selected sample. Efflorescence and biodamage in the form of mold. (Fig. 2).

Sample number	Sampling location	Identified bio-destructors	Number of colony-forming units
1. Petri dish 1	1 sample - taken in the basement. On the wall in the place of destruction of finishing materials as a result of the release of salts and biological damage. Photo 1, 2	Aspergillus flavus; Alternaria alternata; Torula herbarum; Cladosporium herbarum; Mucor spp.	467 KOE/r

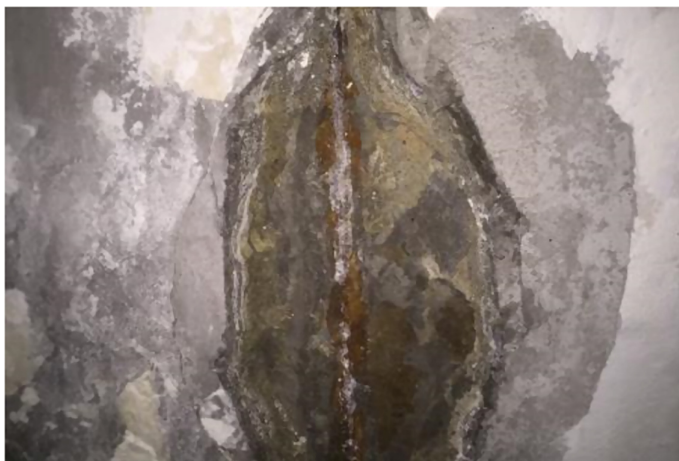
**Fig. 3.** Place of sampling in the interior of the basement.

The next sample was selected in the interior of the basement. Visible damage on the surface of finishing materials. Salt outflows, metal corrosion, biodamage in the form of black mold (Fig. 3). Under the microscope, the surface of the selected sample (Fig. 4).

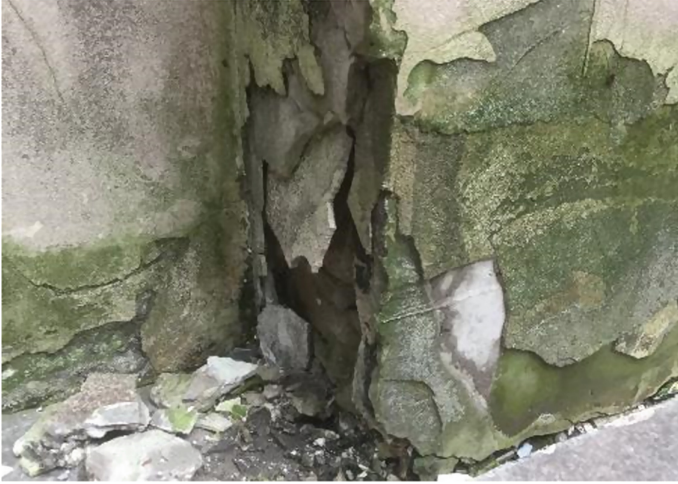
**Fig. 5.** Place of sampling on the surface of the facade at the level of the 1st floor.

The third sample was taken on the surface of the facade at the level of the 1st floor. Visible destruction of the plaster: delamination, salt outcrops, fouling with biodegradations in the form of algae and mold (Fig. 5). Under the microscope, the surface of the selected sample (Fig. 6).

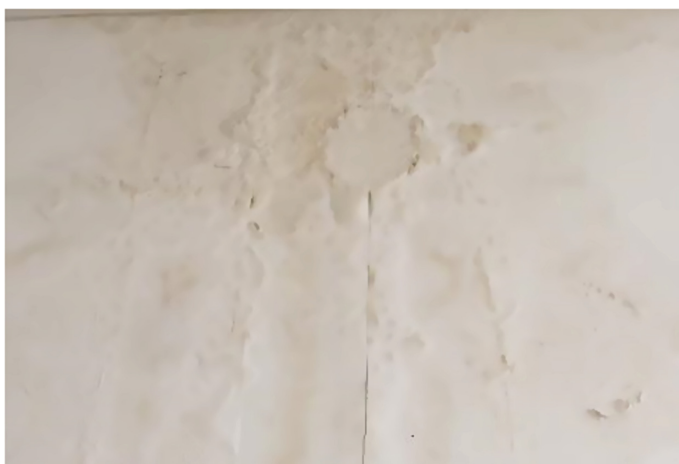
**Fig. 7.** Place of sampling for laboratory research on the wall of the 6th floor.

The sixth sample was taken on the wall of the 6th floor. Delaminations of wall finishing materials are observed in places of leakage. Salt outlets (Fig. 7). Under the microscope, the surface of the selected sample (Fig. 8).

Analyzing the obtained results of water-soluble salts present on the surface of building materials, we can say that they were formed as a result of prolonged waterlogging of the wall surface. The reason for the appearance of salts is the migration of water-soluble salts. These are places of leaks, water suction - the destruction of masonry mortar, bricks from excess moisture. It is required to carry out measures to drain water from the walls of the building and dry the masonry, as well as to carry out measures to waterproof the basement of the walls. The roof and drainage system needs to be repaired.
