Chapter 12

The Risk of Marine Erosion in Tunisian Beaches: A Retrospective Reading for a Prospective Vision

Ameur Oueslati

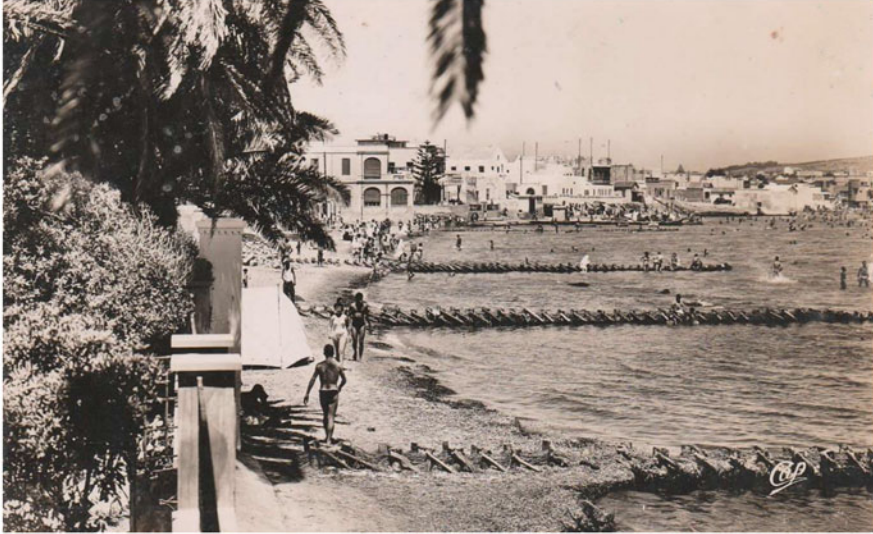
Fig. 12.3 One of many postcards from the first half of the twentieth century showing the narrowing of the beaches in the northern suburbs of Tunis and the wood groins (the original photo is owned by the author)

However, the problem has started for over a hundred years as evidenced by different documents. Among the last are postcards which circulated during the first half of the twentieth century, in the 1920s and even the 1900s. Some of these photos show beaches that have become very narrow and sometimes crossed by many alignments of wood groins (Fig. 12.3). The same idea is found in various archival

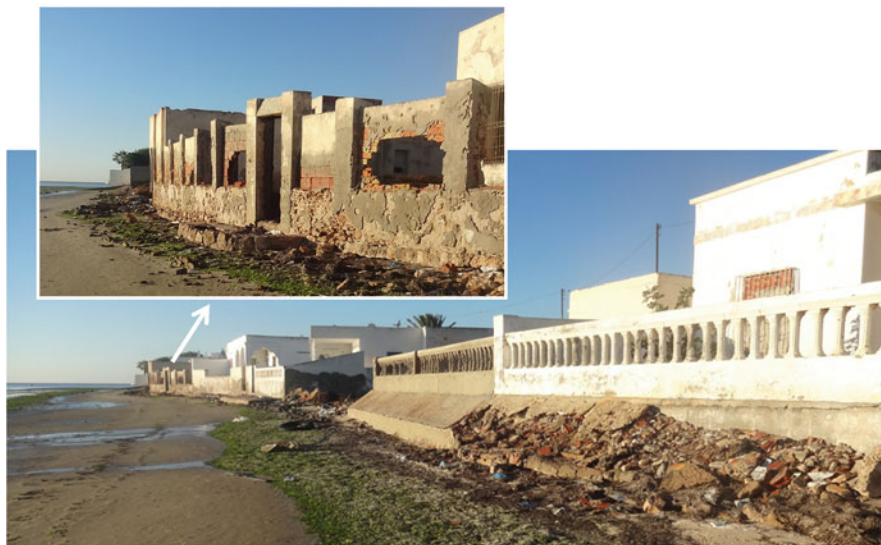
Fig. 12.4 Sidi Mansour coast; North Sfax; photo taken by low tide. Part of the dwellings is yet abandoned (example indicated by the white arrow) (photos, Ameer Oueslati, Nov. 2017)

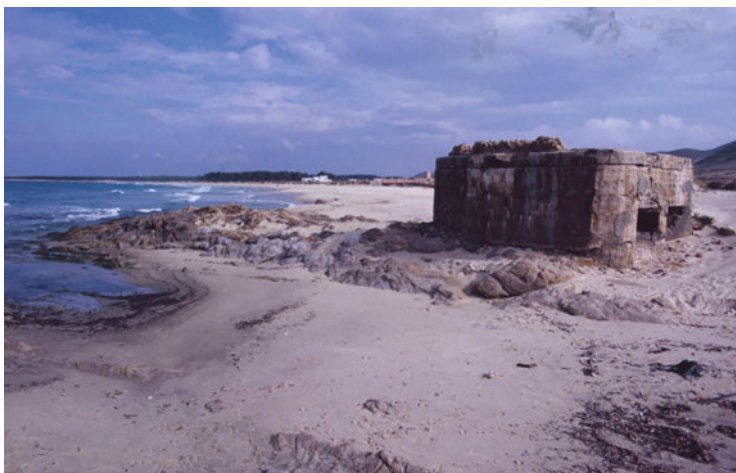
Fig. 12.5 Blockhaus at El El Ghirane, annexed to the foreshore area. It owes its conservation to the fact that it rests on a resistant substratum. Originally, it must have been in the dune area. (photo Ameer Oueslati, July 2015)

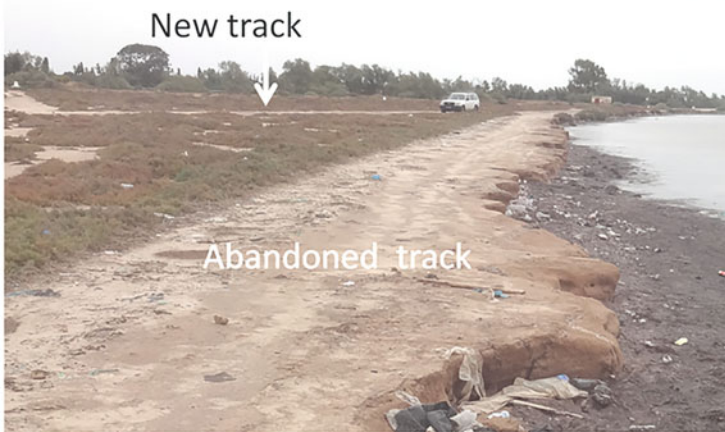
Fig. 12.6 South to Melloulèche (between Mahdia and Sfax): the importance of marine erosion sometimes forced the displacement of coastal tracks. However, the coast is characterized by the weakness of its bathymetry and still away from seafront managements (photo, Ameur Oueslati, Nov., 2017)

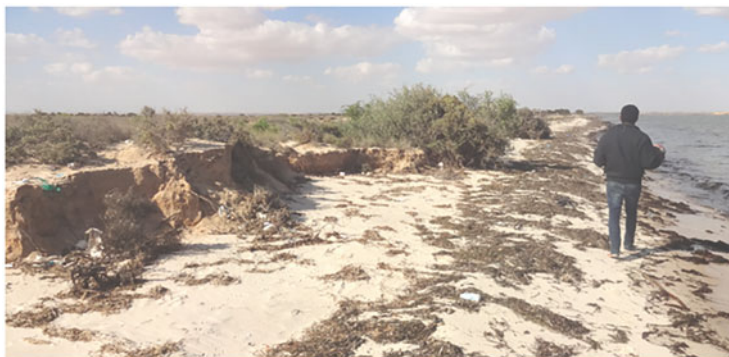
Fig. 12.7 The state of the coast at Bou Said (South Skhira), in an area far from all human intervention. The beach has become very narrow, the foredune is truncated and its vegetation bare (photo Ameer Oueslati, Oct. 2018)

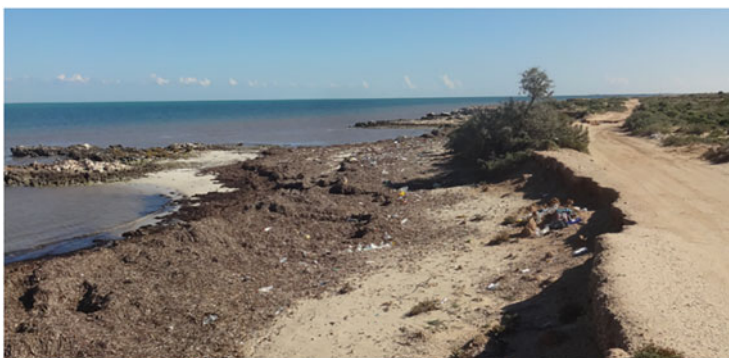
Fig. 12.8 On the eastern face of the Slob Echchergui (near the Libyan border), an area equally far from all human interventions, beaches are undergoing a severe erosion. As in the case of the coast of Melloulèche, the state of the vegetation and a coastal track give the measure (photo Ameer Oueslati, Nov. 2017)

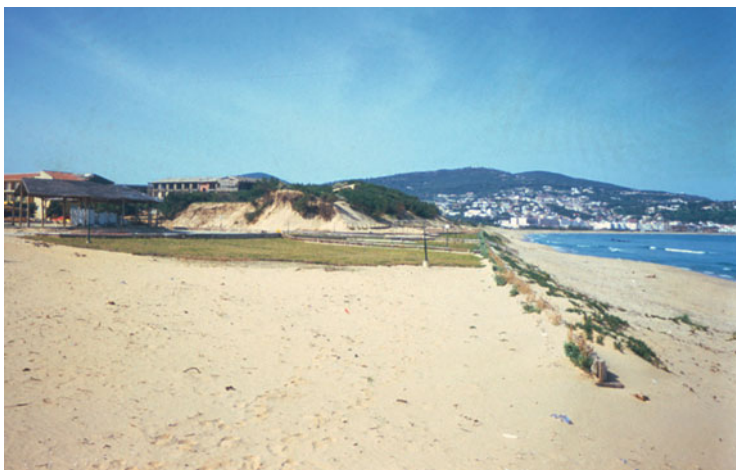
Fig. 12.9 Example of a foredune leveled to allow an open view on the sea; beach of the Ismail hotel in Tabarka (photo, Ameer Oueslati 2004)

dynamic is, as is well-known today, of capital importance for beaches' balance and their adaptation to sea conditions. We also know the importance of the foredune mainly during the difficult moments that a beach can face, such as during storms. It constitutes a vital sedimentary reserve and acts as a screen against the strong waves and the flooding of the lowlands which relay it. Unfortunately, this has been very often overlooked. In addition, other weakening practices have been added over time. Even when it escaped the concrete, the foredune was sometimes razed just to allow the occupants of certain constructions to have a view of the sea (Fig. 12.9).

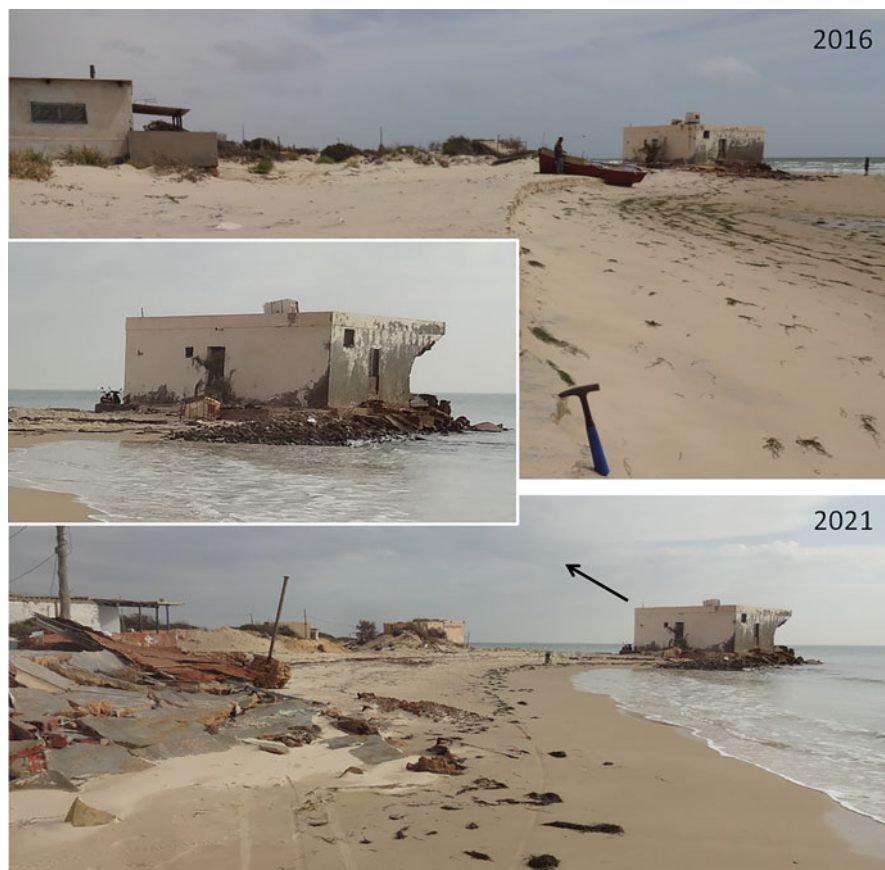
Fig. 12.10 The state of the beach and the recent constructions a few hundred meters from the mouth of Oued Chaffar: the comparison of the photos is revealing as to the significant reduction in the width of the beach and the rate of the shore retreat (Photos, Ameer Oueslati)

In recent decades, practices that have harmed beaches and increased the risk of marine erosion have multiplied and diversified. The interventions which had the most impacts on the dynamics and the sediment budget took place both inland and on the shore. Inland, varied managements have reduced terrigenous inputs to the beaches. They consist of a multitude of dams as well as different water and soil conservation works in the watersheds of a large part of the exoreic wadis. Their consequences were felt most in the beaches of the northern and central parts of the Gulf of Tunis, which receive the two largest exoreic rivers. However, even in smaller streams on the east coast, the effects were sometimes startling. The situation at the mouth of Oued Chaffar south Sfax gives one of the expressive illustrations. The creation of a dam and the multiplication of obstacles in the watershed of this wadi have caused an unprecedented acceleration of the erosion of the beach (Fig. 12.10).

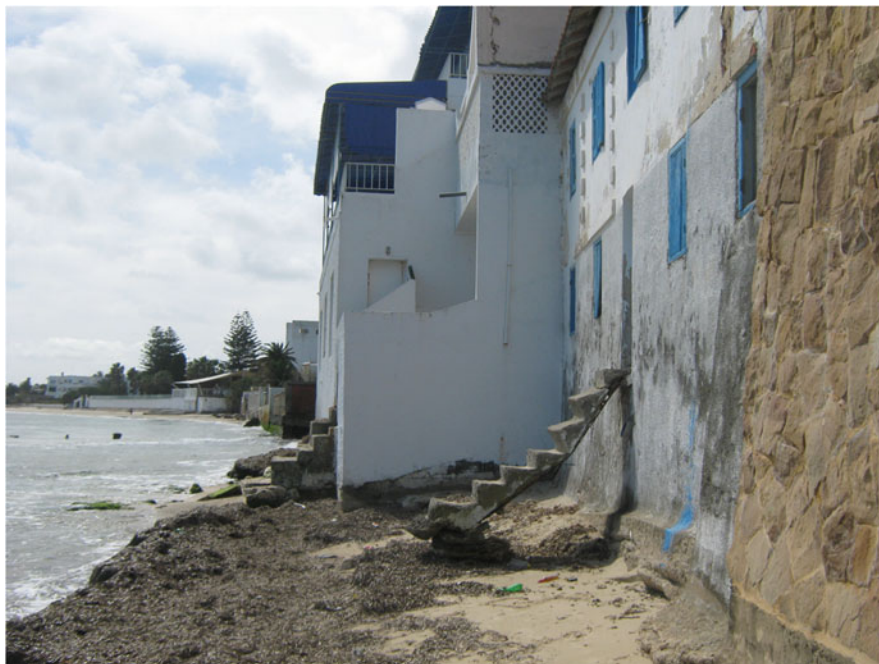
Fig. 12.11 The situation at the Corniche de Bizerte, in the vicinity of the Petit Mousse restaurant: the state of the stairs, witnesses of the important lowering of the surface of the beach (Photo, Ameur Oueslati, April 2010)

Near the Petit Mousse restaurant, in the southern part of this sector, dwellings dating from the colonization period have not benefited from protection which allows a better appreciation of the effect of marine erosion. All the constructions were severely damaged and have lost the entire beach to which they had come to seek proximity. In addition to the shore retreat revealed by various aerial photography missions, direct field observation concludes a vertical lowering of the beach surface, at least several decimeters. This is evidenced, for example, by the steps of the doors overlooking the sea, which have become perched. The owners then resorted to the construction of stairs, some of which in turn became perched (Fig. 12.11). One of these stairs is now suspended more than a meter and a half above the foreshore. Here, we have the expression of one of the crucial modalities of the beach regression that a work limited to the exploitation of documents does not allow detection or measure.

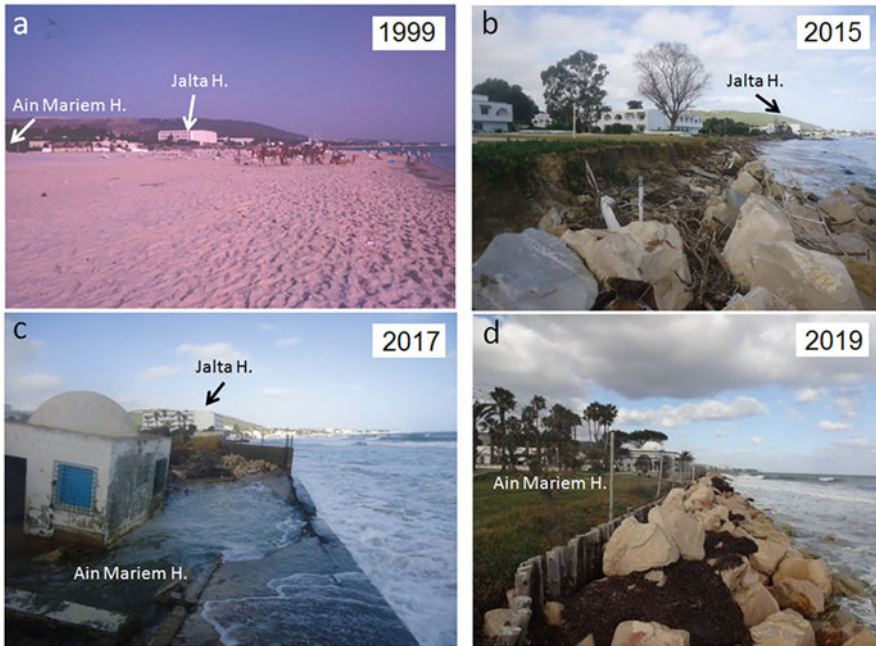
Fig. 12.12 The evolution of the beach between Ain Mariem and Jalta hotels in the space of 20 years (1999–2019) (photos, Ameer Oueslati). **(a)** The beach in 1999; **(b)** disappearance of the beach and formation of a small cliff showing allogenic materials on the sand of the beach and the foredune; **(c)** the situation towards the end of a storm in November 2013; **(d)** the current situation; the place is given to protective structures

width, which we measured on different occasions during the 1995–2005 period, has always varied between 70 and 90 m (Fig. 12.12a). Such situation was explained by the hydrographic context: mainly the existence, about 700 m offshore, of an important shoal (Bou Barrek) lying parallel to the coast and playing in a way the role of a natural submerged breakwater (Mathlouthi and Paskoff 1981). However, the persistence of a wide beach until very recently despite a multiplication of managements since the 1980s could also have links with the evolution undergone by the previous sector. The coastal drift, mainly directed towards the south, has long had an important contribution by the sediments torn from the beaches situated further north. The last having been completely eroded or almost, a new conjuncture took hold, so much so that we are in a situation which may, in a certain way, recall the phenomenon of sedimentary wagons. In any case, everything suggests that the risk of erosion has, over time, increased and moved towards the south in the whole Corniche beach. The big beneficiary is the beach of Sidi Salem located further to the south where it leans against the long jetty of the front port of Bizerte.

riprap dikes (Fig. 12.12d). Before the implantation of these structures, the waves have regularly, especially during storms like that of November 2013 (Fig. 12.12c), shaped small cliffs in the material occupied by the hotels and their external gardens (Fig. 12.12b). The sections reveal the witnesses of practices that have been condemned by various researchers long before the occupation of this part of the Bizerte coast. Indeed, everywhere the sections show the sand of the beach and the foredune covered by various and sometimes harmful materials (landfill products, remains of construction sites, etc.). We also guess that the beach and dune material was used in construction sites because the sections show the sand only over a minimal thickness. In contrast, the old aerial photographs and the morphology of the sectors still not yet built indicate undeniable foredune.

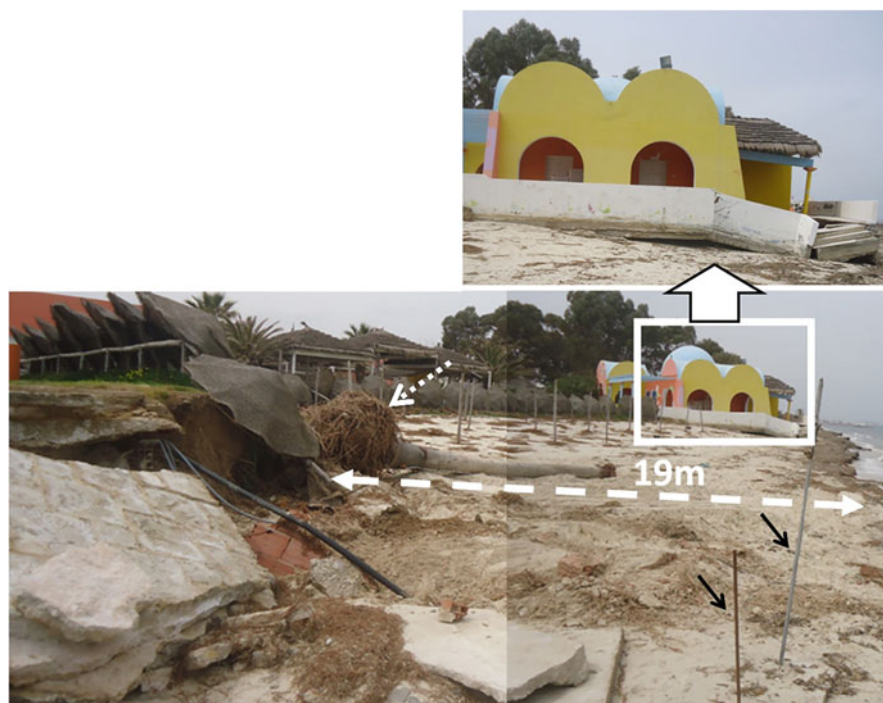
Fig. 12.16 One of the illustrations of the state of the beaches of Skanès coast in the aftermath of the storm in March 2012. 19 m is the width of the space that was part of the hotel enclosure before the storm. It corresponds to the distance which separated the felled palm tree (small dashed white arrow) from the sea. We also recognize the debris and the external limit (dark arrows) of a pool which was originally implanted at the expense of the inner part of the beach (photos, Amour Oueslati, March 2012)

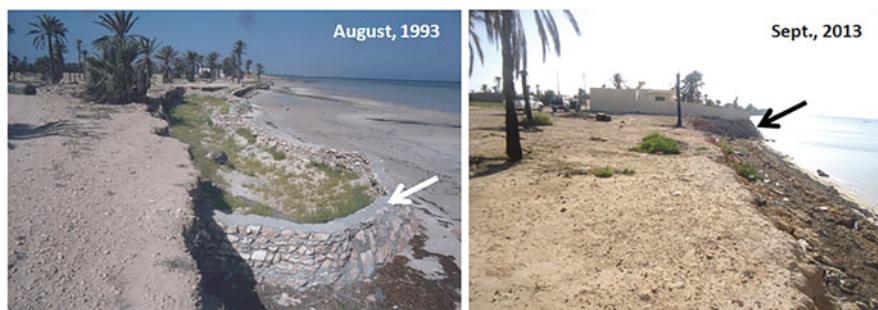
Fig. 12.18 One of the many illustrations of perseverance in reproducing the same mistakes in the Kerkena archipelago. Appearance of hard constructions in a clearly eroding coast. The arrows indicate the same low wall, originally (in 1993) created as a protective structure (photos, Ameur Oueslati)

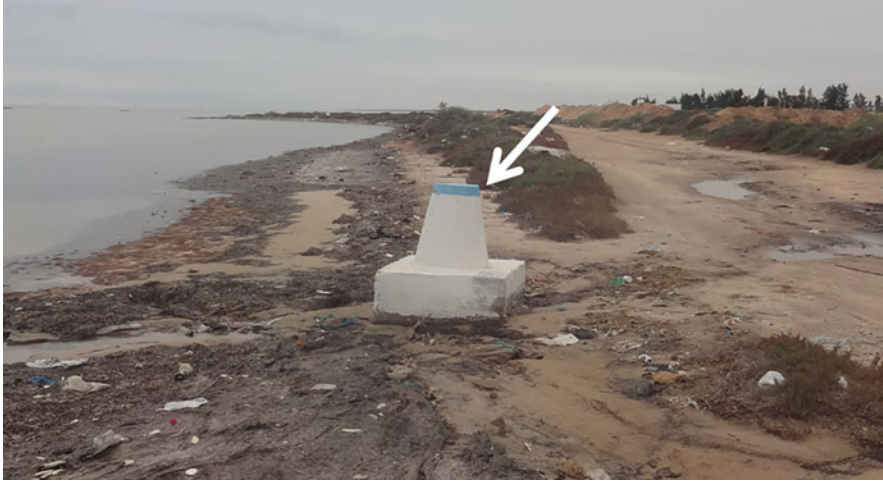
Fig. 12.19 A very recent boundary marker of the Public Maritime Domain located in the intertidal zone (photo, Ameer Oueslati, Nov., 2017). It is already beginning to be dislodged by waves and is overtaken by seawater during storms, as the puddles visible on the track suggest. According to the DPM definition, it must be further inland!

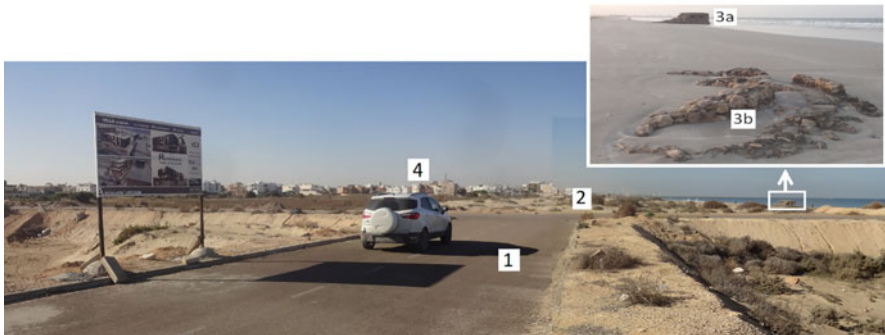
Fig. 12.20 The northern end of the Bou Chemmaoui estate created at the expense of the dunes bordering the beach in a coast in clear erosion (Photos, Ameer Oueslati, Nov. 2021): 1. the northeastern part of the estate; 2. the foredune; 3a. blockhaus; 3b. machine gun nest; 4. recent dwellings but already exposed to the problem of marine erosion

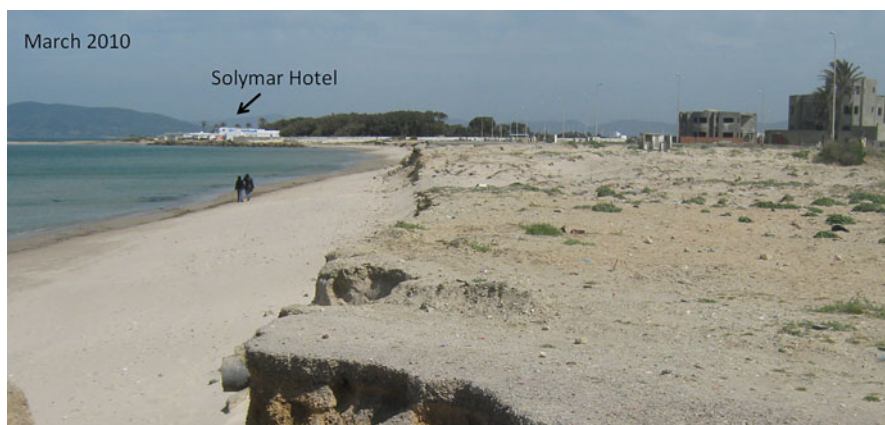
Fig. 12.21 The culmination of the evolution in a part of the coast of Sidi Ejjeimi-Soliman over the past 12 years: the beach that attracted the housing estate was sacrificed. The same fate was reserved for the dunes which relayed it on the internal side (photos, Ameur Oueslati)

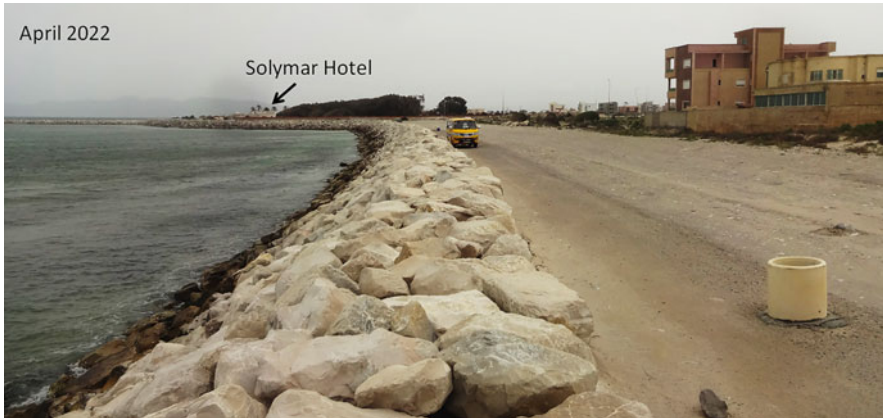
Fig. 12.22 The culmination of the evolution in a part of the coast of Sidi Ejehmi-Soliman over the past 12 years: the beach that attracted the housing estate was sacrificed. The same fate was reserved for the dunes which relayed it on the internal side (photos, Ameur Oueslati)

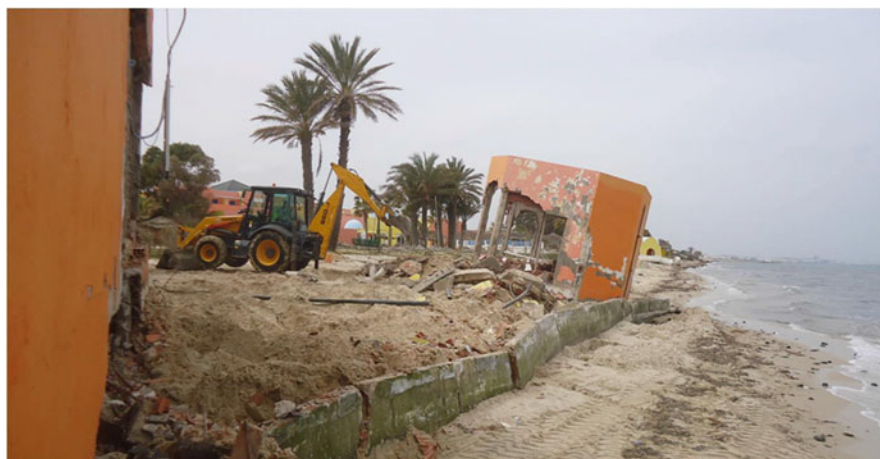
Fig. 12.24 Willful destruction of buildings encroaching on the beach. Example in Skanès the day after the storm of March 2012 (photo, Ameer Oueslati, 2012)

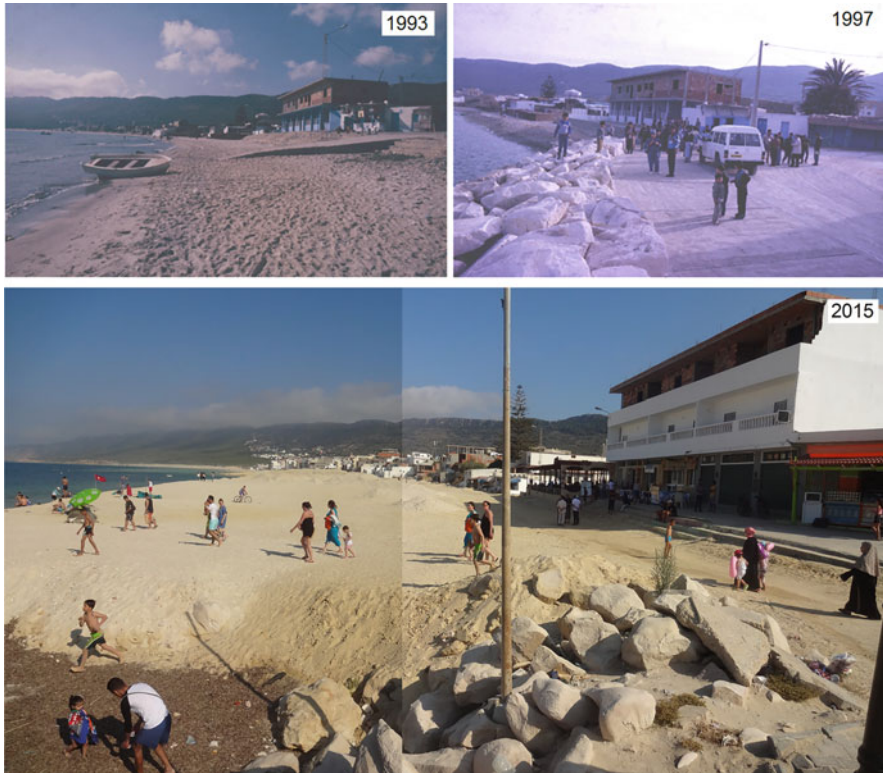
Fig. 12.25 Raf Raf beach, one of the rare beaches to have benefited from important artificial replenishment (the coast of Ejjeimi-Soliman in the Gulf of Tunis offers another significant example). This followed attempts at protection by hard structures. The photos also show the evolution of the situation since 1993. We recognize the same building (unfinished on the first two photos) that serves as a landmark. The rapid erosion is mainly due to the waterfront constructions all built on the foredune (photos, Ameer Oueslati)
