Mortars and Binders During a Time of Emerging Industries: 19th Century Austro-Hungarian Fortifications in Montenegro

Keywords: Historic Army Construction Sites · Montenegro · Austro-Hungarian Empire · Early Portland Cement · Historic Mortars

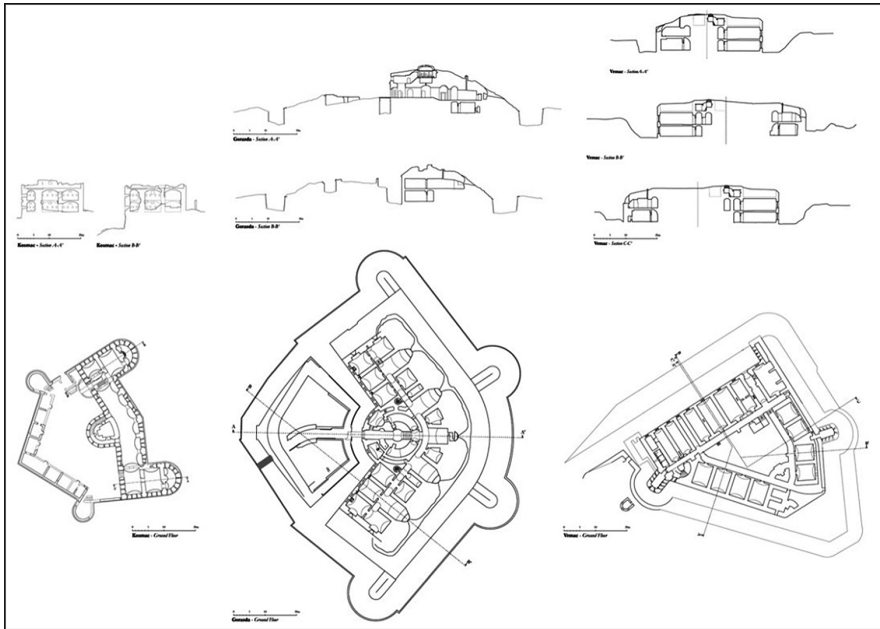
Fig. 2. The fortresses of Kosmač (1858), Goražda (1884–1886) and Vermač (1884–1897), ground plans and sections (© ÖAW-ÖAI, drawing by Nicola Math based on 3-D laser scans by Christian Kurtze).

In 2020, project activities focused on the preparation of building survey plans for the Kosmač, Goražda and Vermač fortresses, which had been investigated since 2018 (Fig. 2), and on the analysis of a set of stone and mortar samples taken during the course of both field campaigns. As sampling for laboratory analyses had to follow certain constraints, careful selection of samples was based on the idea to achieve insight into the major construction elements of each of the sites.

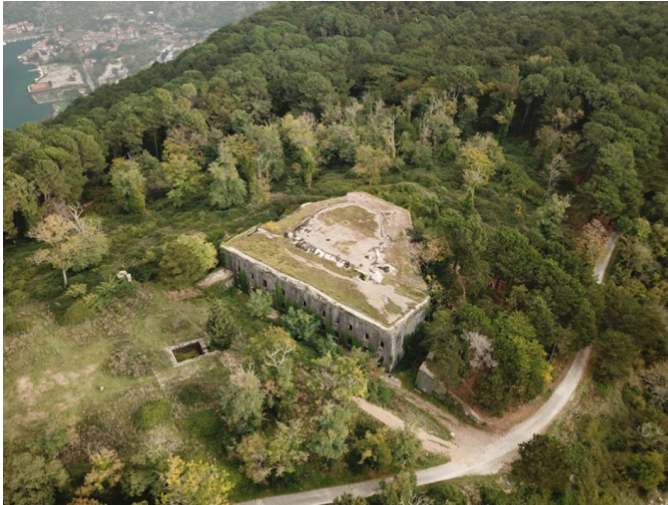
Fig. 3. Vermač, view of the fortification in the terrain with its “block-like” appearance (© ÖAW-ÖAI, C. Kurtze)

As mentioned above, written records describe in detail the materials and techniques of construction of Vrmač [4]. Similar reports would most probably exist for all the other Austro-Hungarian military buildings in the area, though so far they could not be traced by the authors, with the exception of the nearby Battery of Vermač [5] which was built about 10 years earlier than the fort there (Fig. 3).

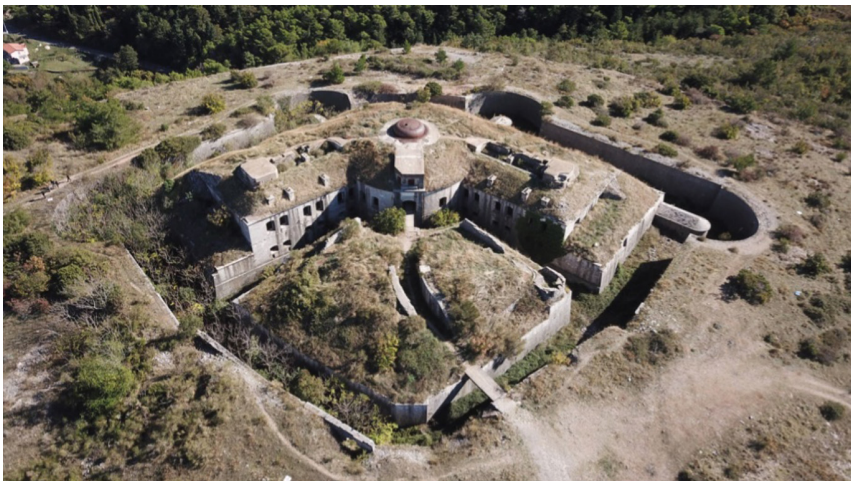
Fig. 4. Fortification of Goražda (constructed 1884–1886) (© ÖAW-ÖAI, C. Kurtze)

Samples taken from mortar elements of the Goražda fortification during this survey comprised tamped concrete, bedding of the stone masonry, pointing on different types of stone masonry outdoors and indoors, outdoor renders as well as plasterwork on interior walls. The results of analysis reveal the use of dolomitic lime mortars for masonry beddings and interior plasters, while the selection of binders for masonry pointing seems to depend on the type of masonry: Roman cement was found in pointing mortars of interior and free-standing single shell stone walls, while Portland cement-based pointing was mainly detected on exterior masonry, repairs and on later added interior walls. Also the concrete samples proved the presence of Portland cement. More details are reported below (Fig. 4).

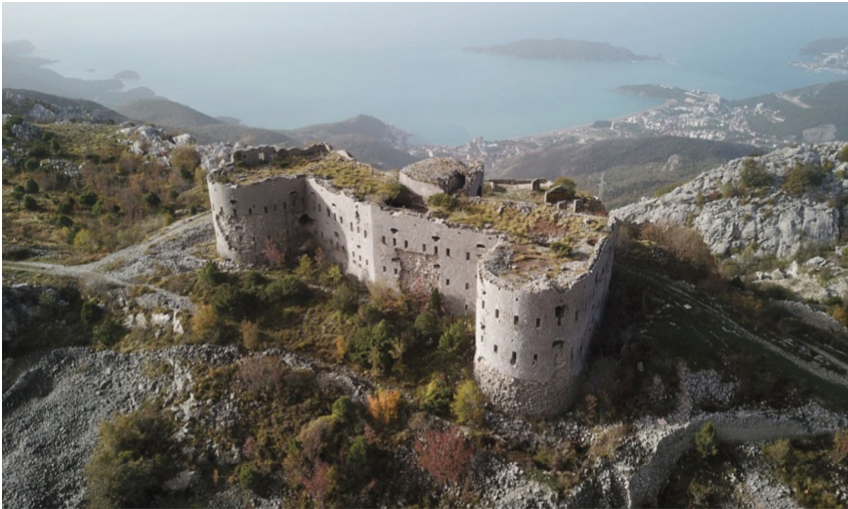
Fig. 5. Fortification of Kosmač (constructed 1858) 2018 (© ÖAW-ÖAI, C. Kurtze)

The building was almost completely executed in natural stone in the form of uniform courses of dressed stone ashlars. Like the other two fortresses described above, the unrendered masonries were constructed in a core-and-veneer mode with two parallel shells filled with quarry stones and mortar. A greyish limestone of local origin was used. The walls in the interior of the building are comparatively less regularly textured, built with quarry stones and chips of stone and platy bricks filling the wide joints. It is thus assumed that the interior walls were plastered and probably whitewashed at least in parts, which is confirmed by a number of mortar residues preserved on the stone surfaces. All interior spaces are covered with barrel vaults made of a lightweight porous karst limestone; just the uppermost ceiling had been reinforced with a thick layer of tamped concrete. Most of this layer had been destroyed by the 1918 explosion, so that fragments of this concrete can be found in the debris which today covers the site, along with stones from the masonry and chips of slate from the former roofing (Fig. 5).

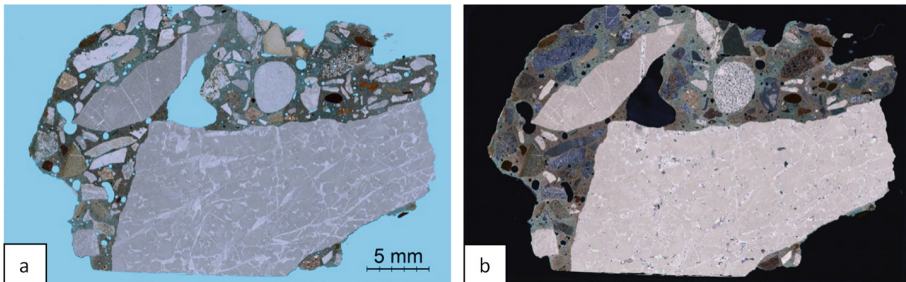
Fig. 6. Limestone chips as coarse aggregates along with a few river or sea gravels (rounded grains) from carbonate and silica (chert) in a PC-based tamped concrete from Kosmač; thin section scan at plane polarized light, PPL (a) and crossed polarized light, XPL (b).

Coarse gravel for the construction of Vermač was obtained from a nearby quarry by crushing the rock to the required size, usually up to several cm. This kind of aggregate is supposed to be unsorted. It is explicitly stated that attention was paid to use just sound and uncontaminated rock material and that therefore no careful washing was required. The angular chips obtained by crushing reflect the immediate geological environment of each fortress – compact limestone of locally differing lithological character. Silica layers of dark radiolarite are always frequently intercalated, though the form a minor constituent and were probably rather avoided by the stone workers. Such limestone chips (>1.5 cm) eventually mixed with river gravel were found in one concrete sample from Kosmač (Fig. 6), while the concrete of Goražda contains much smaller (<5 mm) subangular gravel of chert with just occasional carbonate gravel.

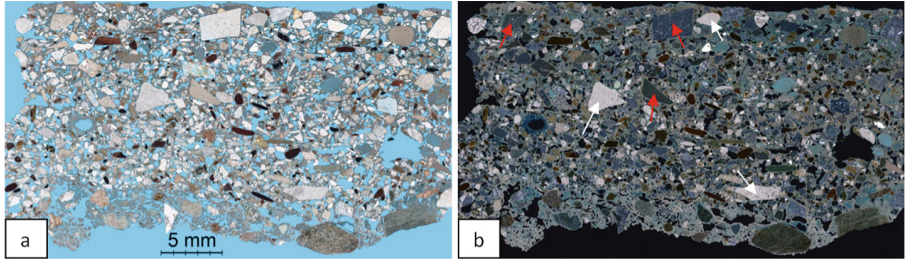
Fig. 7. Unsorted, mostly angular to subangular river sand of limestone (white arrows) and chert (red arrows) in a lime-based indoor plaster from Kosmač; thin section in PPL (a) and XPL (b). (Color figure online)

River gravel as aggregate was observed in many of the mortar samples from all three sites. They can be attributed either to bedding mortars of the rubble core in cavity walls, or to indoor plaster mortars (Fig. 7), or, as mentioned above, to the tamped concrete of Goražda (Fig. 8, with predominance of chert components).

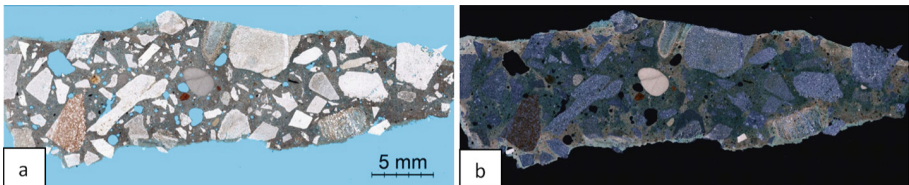
Fig. 8. River sand and gravel from subangular chert with just occasional well-rounded limestone grains (centre) in a PC-based tamped concrete of Goražda; it is likely that chert-rich sand was intentionally selected to make this concrete harder; thin section in PPL (a) and XPL (b).

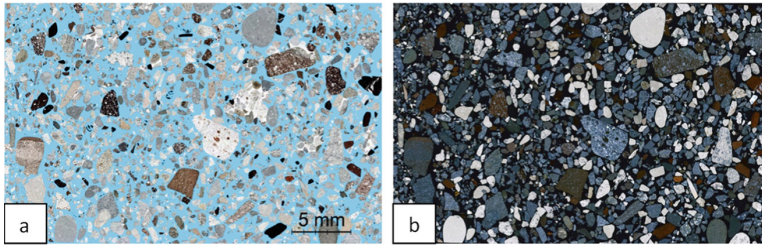
Fig. 9. Sea sand from Budva beach, composed of limestone and chert components; according to the army report on Vermač [4], such sand was used as “fine sand” for construction purposes; thin section in PPL (a) and XPL (b).

A sediment sample collected from a beach near Budva matches the sand aggregate of the historic mortars to a high extent (Fig. 9): again, limestone and chert form the predominant components of this moderately well sorted sediment, but the former appears spherical with high roundness, while the latter is also isometric though just subangular. Such “fine sand” forms the aggregate in most of the pointing mortars studied, while in some other mortars it was probably mixed with “coarse sand” for a broader grain size distribution (Fig. 10).

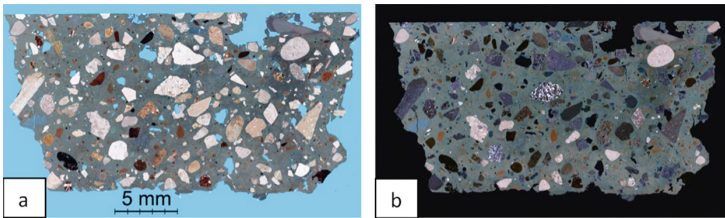
Fig. 10. Fine sand presumably from the seashore of the Budva area, composed of limestone and chert, in a RC-based indoor pointing mortar of Goražda; thin section in PPL (a) and XPL (b).

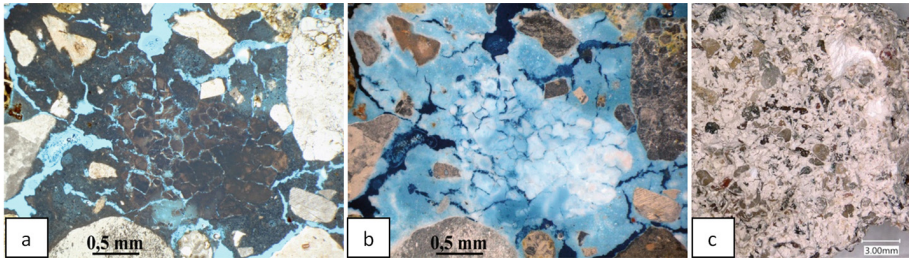
Fig. 11. Mg-rich lime lump in a dolomitic lime bedding mortar of Goražda; thin section in PPL (a) and XPL (b); c = mortar fracture face.

Mg-rich inclusions exhibiting a spotted appearance clearly indicated the dolomitic nature of the lime binder (compare e.g., the lumps in Fig. 11 to those in Fig. 12), hence the origin of the raw material differs from the other two fortresses despite the close vicinity to Vermač. The same dolomitic lime constitutes the bedding mortar of the stone masonry of Goražda, while the bedding mortars of Vermač are based on pure lime - occasional lime lumps in these mortars point to a quick or “dry” process of slaking [8] in accordance with the fact that no lime pit is mentioned in the otherwise rather detailed report on the construction of this fort. Kosmač, on the other hand, has slightly hydraulic bedding mortars.

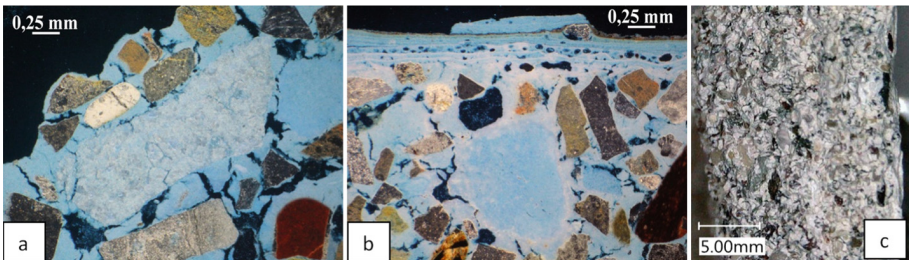
Fig. 12. Binder-related particles in indoor lime plaster samples from Vermač where quicklime was obtained from fossil limestone calcined by local producers in Korčula and short-term slaked on the construction site; residual structure of the raw feed stone (a), and undispersed lime lump (b). Thin section at transmitted light, dark field; in the diffuse light of the dark field mode, microporous areas appear bluish whilst white and compact areas show bright;

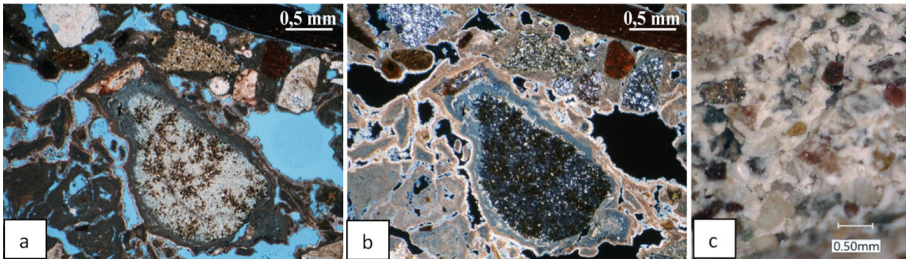
Fig. 13. Reactive chert aggregate in a porous lime-based core filling mortar of the Kosmač stone masonry; thin section in PPL (a) and XPL (b); c = mortar fracture face.

As indicated above, a group of samples which might be related to the intentional use of reactive chert as aggregate can be found in some mortar samples from Kosmač. These mortars, particularly rich in chert, appear as bedding, or core filling mortars, respectively, of the stone masonry. It can be assumed that prolonged conditions of moisture in the specific positions of the wall have contributed to the development of hydrated rims around the chert, as illustrated by Fig. 13 and 14. Thus, even if these mortars are extremely leached, they appear as extraordinary hard and strong.

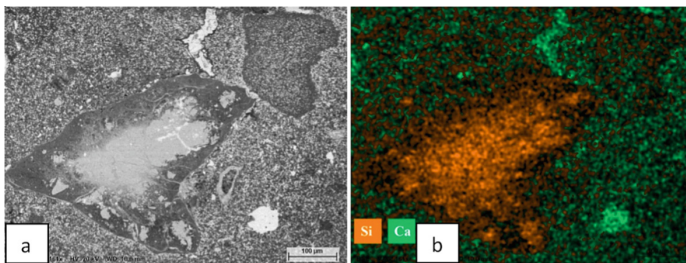
Fig. 14. SEM micrograph of a chert aggregate with leached outer reaction zone in the same mortar as Fig. 13; the binder matrix reveals tiny bright spots of secondary calcium carbonate, a characteristic feature of aged hydraulic binders [13]; SEM-BSE (a) and EDS spot map of Si and Ca (b).

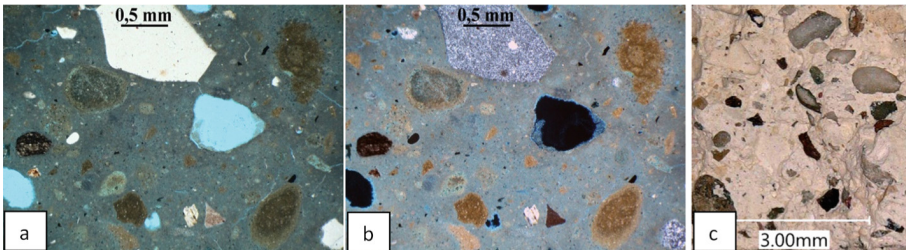
Fig. 15. Binder related nodules characteristic of Roman cement in an exterior pointing mortar of the Goražda stone masonry; thin section in PPL (a) and XPL (b); c = mortar fracture face.

However, in Goražda, the largest of the fortresses from which the most samples were taken, Roman cement mortars were found, as pointing mortars from interior and exterior masonries surfaces (see Fig. 15). The typology of binder related nodules found points to a relatively low burned product, where the higher burned portion present in any Roman cement of that period had most probably been removed in the factory.

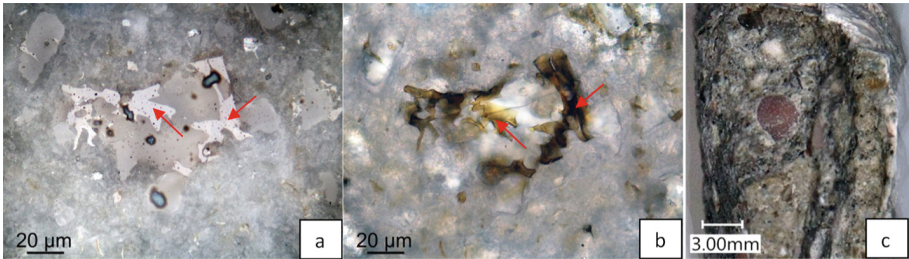
Fig. 16. Coarse PC clinker residues in a late 1890s pointing mortar of a stone masonry in Vermač; due to an improved quality of calcination, the variety of clinker types is less pronounced here than in the earlier PC clinkers of Kosmač; coarse interstitial phases (mostly calcium-aluminoferrite, see arrows), (a, b) point to low cooling rates of a shaft kiln; thin section at incident light (a) and PPL (b); c = mortar fracture face.

By microscopy, all the PC-mortars studied clearly revealed their early age of production by the coarseness of clinker residues in the binders, and by their internal phase structure, such as coarse aluminoferrite and calcium silicates pointing to the use of vertical shaft kilns with prolonged times of residence and slow cooling (Fig. 16). Moreover, the use of a single, natural raw feed to calcine the cements is suggested by the range of varying clinker microstructures containing insufficiently calcined residues of the raw material [11] in most of the samples (Fig. 17). This means of production was quite common for the majority of cement plants in the territory of the Empire thanks to the

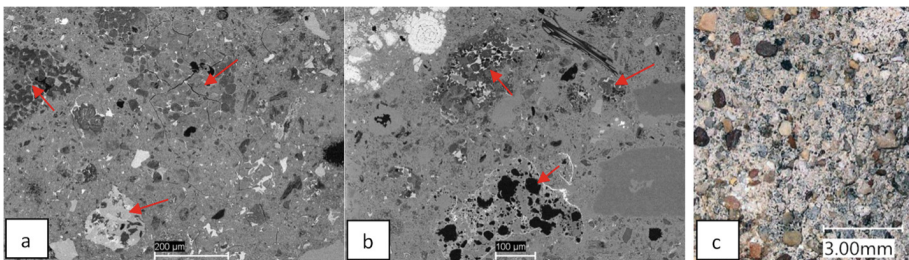
Fig. 17. PC binder matrix of a pointing mortar on an exterior stone wall of Kosmač, both micrographs (a and b) show clinker residues of strongly varying internal texture and composition, a feature characteristic of natural Portland cements; SEM-BSE (a, b), c = mortar fracture face.
