# Repair Mortar for a Coloured Layer of Sgraffito Render – A Technological Copy

**Abstract.** Sgraffito technique was used to decorate renders by scratching the top layer of lime wash in the Renaissance time. In order to contribute to the preservation of surviving sgraffiti in the town of Slavonice in the Czech Republic a study was carried out assessing the possibility to replicate the original materials and the application techniques. Historical sgraffito layers were sampled in situ and studied in a laboratory by commonly used analytical methods - OM, TA, XRD, SEM-EDS. The raw materials, lime binder and sand, were characterised and the mixing proportion app. 1 to 0.7 (vol.) of lime putty to sand was determined. Based on the character of the local limestone, a similar raw material was obtained and burnt in an experimental lime kiln. The sand was obtained locally from a disused pit quarry. Obtaining the raw materials from similar sources as the historic ones allowed studying possible production technologies and application techniques. Appropriate and probable techniques were verified by a series of practical experiments. These considered: lime putty v. dry slaked hydrate; thickness

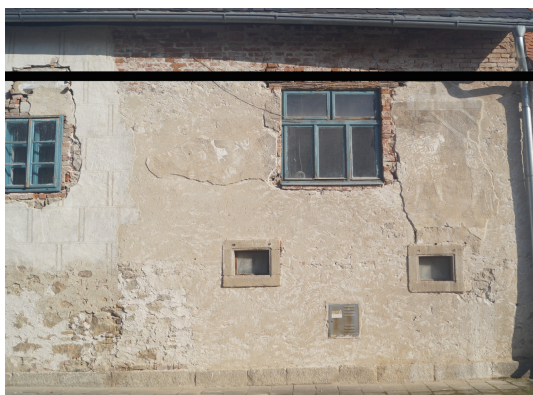
**Fig. 1.** State before reconstruction of the facade with the Landsknechts. On both sides of the secondarily placed window there are fragments of the original Renaissance sgraffito. The sgraffito pattern on the left side of the picture belongs to the later Renaissance decoration.

In the historical centre of Slavonice, on the side facade of the house No. 545, there were found fragments of a Renaissance sgraffito with figures of Landsknechts. (A term used for mercenary soldiers in the period of the Renaissance in the territory administered by the Habsburg emperors. The term has a deeper meaning: a servant of the country fighting for Christian ideas.) The sgraffito used to be covered with a plaster, which protected it from the weather, and thanks to this protection, it has survived in an authentic state, which documents the original craftsmanship and art techniques. These sgraffito fragments offered an ideal opportunity to study the originally used materials and applied technologies. The subject of the research were the figural sgraffito fragments on the right side of the façade depicting a Landsknecht parade. Five figures have been preserved in their entirety, of the other two only fragments of their body (hand) and parts of armament (sword) have been preserved (Fig. 1).

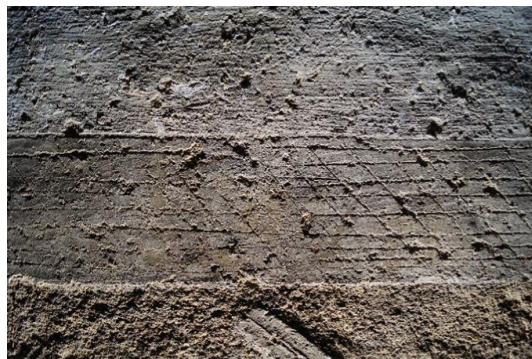
**Fig. 2.** Detail showing three basic surface finishing techniques of the sgraffito. In the upper third, the lime wash is untreated and this finish acts as the brightest one, in the middle third, the lime wash is partially removed and smoothed with a spatula. This surface was subsequently decorated with hatching. The darkest part at the bottom was created by completely scraping away the lime wash and partially also the mortar surface.

Sgraffito, or “scratching” in render, or plaster, is usually defined as an engraved figural and ornamental decoration of the exteriors, and exceptionally of the interiors of buildings. The period in which sgraffito originates influences the character of artistic appearance and techniques. Sgraffito as a distinctive decorative technique, as found on the Renaissance facades in the Czech Republic, comes from the Italian Renaissance [6]. In the Renaissance, the authors of contemporary texts describe the sgraffito technique and point out its painting aspects, which consist of shading. Giorgio Vasari (1511–1574) and Filippo Baldinucci (1625–1696) describe details of a technique called “scraping on facades” such as hatching (*tratteggiare*), “pushing” (*aggravare*) and adding “light shadow” (*chiari e scuri*) or “semi-coloured” (*mezzo colore, tinta di mezzo*), which is clearly a description of shading [7]. Both authors also suggest a further colouring or supporting of shadows with watercolour as part of the technique [7] (Fig. 2). Most

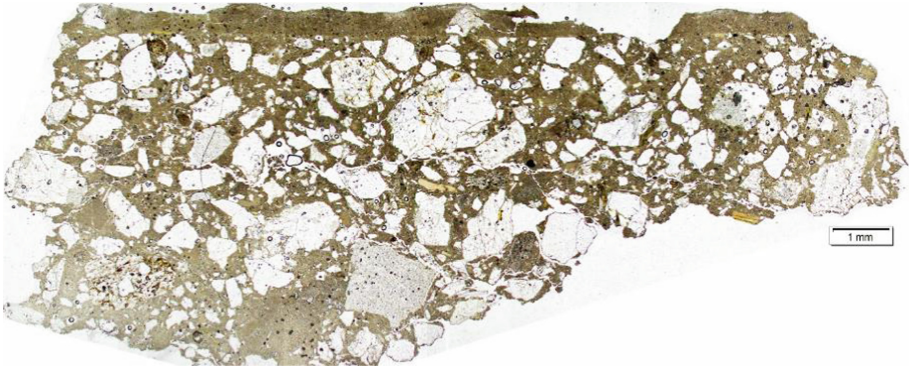
**Fig. 3.** The coloured intonaco layer is composed of fine-grained binder with occasional binder related particles and an aggregate - predominantly quartz and gneiss. The lime wash does not contain filler and appears as one about 0.2–0.4 mm thick single layer. Sample OSL 4, PPL.

Thickness of layers and their composition Methods used: <i>in-situ</i> survey, OM	The studied sgraffito consists of three layers: an underlying background layer, a 5–10 mm thick coloured intonaco and a 0.3–0.6 mm thick lime wash coating. The intonaco is sound and contains only lime and sand with no other colouring additives (Fig. 3). The lime wash does not contain any filler, only isolated binder related particles up to 0.4 mm in size. The lime wash is a single coat, no application sublayers were detected. A good bond between the lime wash and the substrate is probably due to fresh-on-fresh application. The surface area of the lime wash is enriched with the binder. The lime wash shows brush stroke-marks and different variations of thinning and smoothing down to the substrate
Characteristics of the binder Methods used: OM, SEM-EDS, TA, XRD	The same or very similar calcitic binder was used for both the coloured layer and the lime wash (Figs. 4 and 5). The coloured layer contains macroscopically visible light-coloured binder related particles up to a size of 4 mm. They are mainly composed of partially burnt binder related particles formed by imperfect slaking or during mortar preparation. There are also calcium silicate particles (lesser extent) and their composition differs from the binding matrix. These are very probably relics of silicate minerals from the original raw material, crystalline limestone. These particles potentially add hydraulicity to the binder

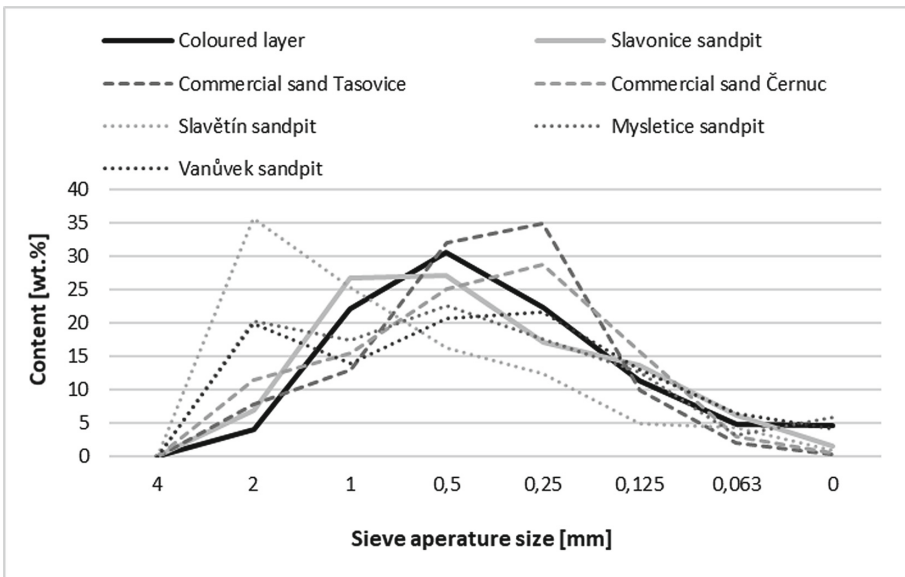
**Fig. 6.** Comparison of the sand used in the coloured intonaco layer with the samples from Slavonice sandpit, two commercially available sands and other local sandpits.

from extinct sand pits in several places near Slavonice corresponded in their mineralogical composition to the sand used in the Slavonice sgraffito. Apart from the regional affiliation, the selection of suitable sand took into account grain size distribution and mineralogical composition, as well as the proportion of fine and clay particles. The workability of mortar, its colour and the appearance of the sgraffito lines and surface finishes were also crucial in the evaluation. In terms of colour and plasticity, the mortar made with sand that had the lowest content of the finest fraction among the sands from the local pits was the most suitable. The granulometric curve of this sand also corresponded best to the original, both in the amount of fine fraction and in the majority of the 0.5–1 mm fraction. This sand from the now abandoned sandpit in Slavonice was chosen as a suitable one (Fig. 6). It contained a very small amount of organic particles and therefore did not need to be cleaned by washing, only the max. Grain size was limited by sieving. The content of  $\text{Cl}^-$ ,  $\text{NO}_2^-$ ,  $\text{SO}_4^{2-}$  anions was checked and was found to be low.

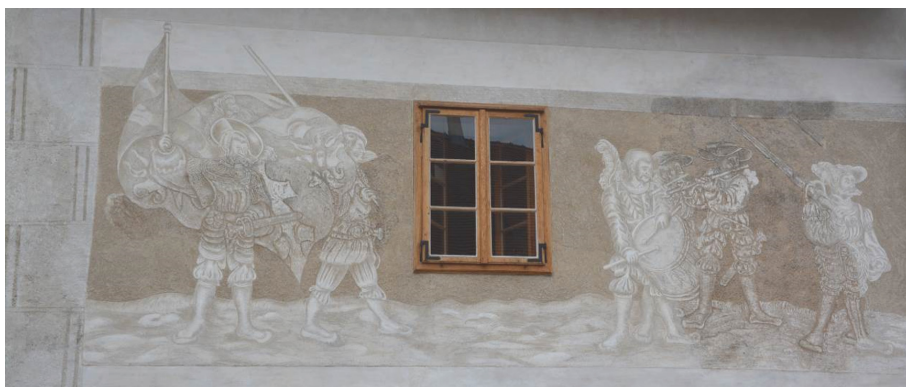
**Fig. 8.** The reconstructed sgraffito facade after two years. Slavonice, house No. 545.

The findings related to the sgraffito technique itself, as well as the restoration procedures, are not discussed here in details but can be found elsewhere [16, 17]. The restoration project was successfully completed. The new sgraffito parts were slightly retouched with pigments from the local sand to reduce the contrast between the old and new areas (Fig. 8).
