Large-Scale Tests on RC Purpose-Built Buildings for Improving Robustness

Abstract. Although recent years have been marked by a substantial research effort on the progressive collapse of steel as well as cast-in-place and precast concrete structures, the fact is that almost all studies are focused on reduced-scale tests, tests on isolated frame structures, tests on substructures or analytical and numerical analysis. Within this context, large-scale tests avoid size effects and allow all resisting mechanisms that a structure can develop after an initial-local failure to be studied. This paper presents the case of large-scale tests performed on two purpose-built buildings: one made of cast-in-place concrete and the other with precast concrete elements. In both cases, sudden column removal scenarios were considered for the robustness assessment of the structural system. The structures were provided with simple solutions to enhance the robustness and arrest progressive collapse initiated by the sudden failure of a column. The cast-in-place concrete building had two 3 m high floors, with 2×2 bays of 5 m span length. The total in-plan dimensions of the building were $10 \times 10 \text{

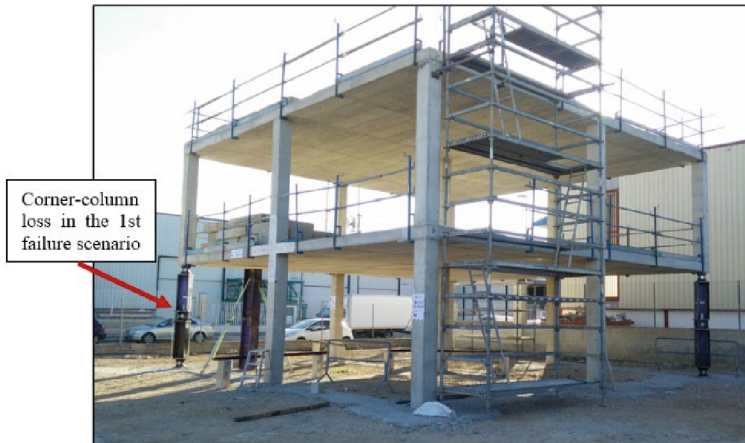
Fig. 1. Building and definition of the first failure scenario.

Two experimental tests for two different failure scenarios were considered in this study. In both cases, a corner-column loss was considered, selecting two opposite corners columns to avoid the influence of a damaged structure in the second test. These columns were steel-based (HE-300B profile) and prepared with a mechanism to reproduce a sudden failure. Only the structure of the building was tested for the first failure scenario, whereas infill masonry walls were also introduced for the second failure scenario. These masonry walls were only constructed on the first floor and in those modules with more influence in the defined corner-column failure scenario. Figure 1 and Fig. 2 show the actual building prepared for the first and the second failure scenarios, respectively. A complete description of the building and test can be found in Adam et al. and Buitrago et al. [9–11].

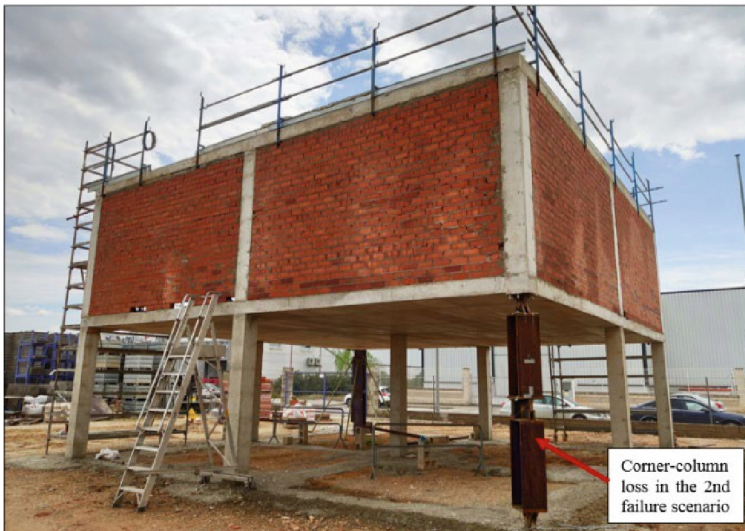
Fig. 2. Building and definition of the second failure scenario.

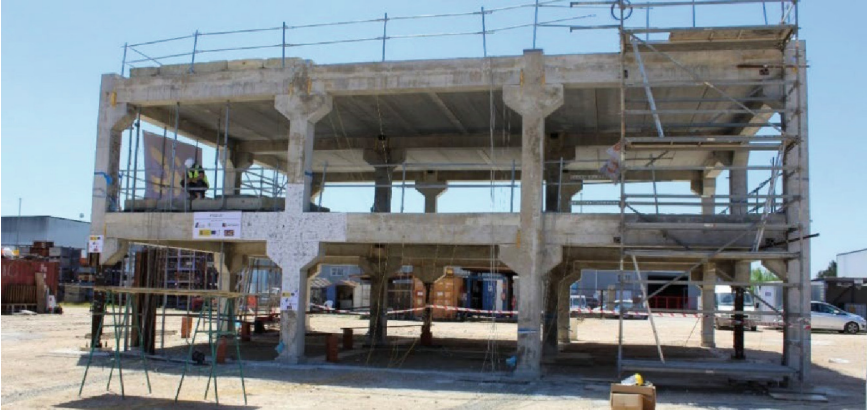
Fig. 3. Completed building specimen prior to testing.

The building specimen constructed for the purpose of this study (Fig. 3) has a rectangular shape with six bays in plan and two floors. The longest 15 m side consists of three 5 m spans, while the shorter 12 m side consists of two 6 m spans.

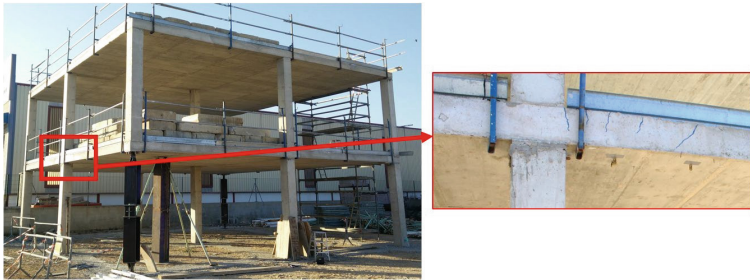
Fig. 5. Cracks on the slabs near the slab-column joint next to the failed column after its sudden failure.

As an example of what occurred in the experimental test, Fig. 5 shows a photo of some cracks produced on the slabs near the slab-column joint attached to the failed column after the accidental event.

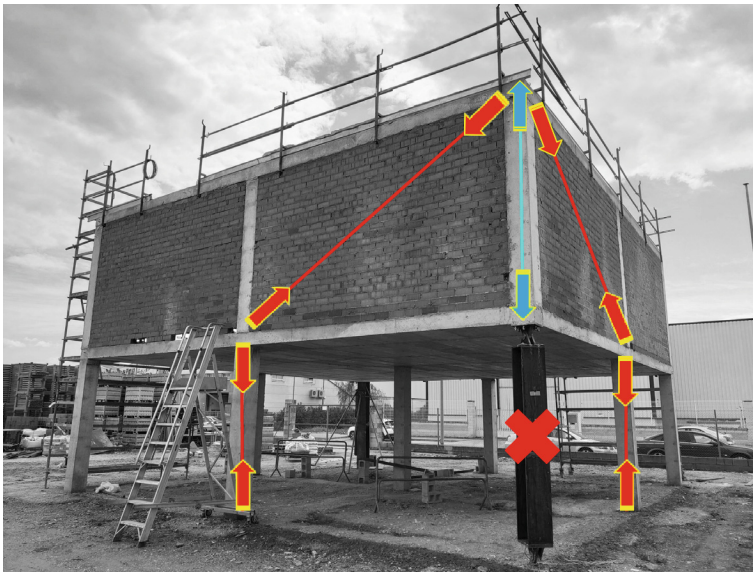
Fig. 7. Activation of an alternative load path based on the infill masonry walls.

Results showed that the main alternative load path comprised the activation of the infill masonry walls, as represented in Fig. 7.

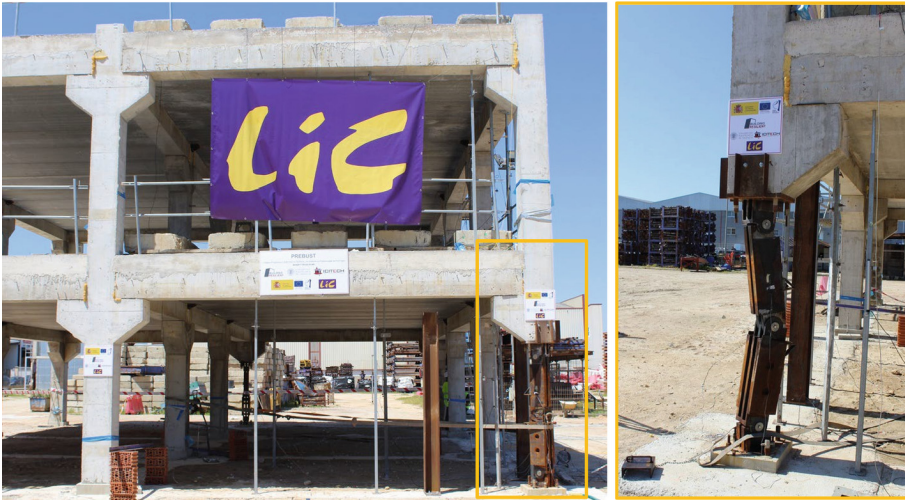
Fig. 10. Structure after the test.

After the test, the structure only showed minor residual damage (cracking) around the beam-column connections. The state of the structure after the test can be seen in Fig. 10, which shows the state of the building with the hinged metal column (yellow box) that allowed the free fall of the corner (12.1 mm maximum drop).
