Preservation and Innovation of the Rinnovata Pizzigoni School, a Symbolic Place of the Early 20th-Century Experimental Pedagogy in Milan

Maria Fianchini, Nicola Berlucchi, Franca Zuccoli and Flavia Mainardi

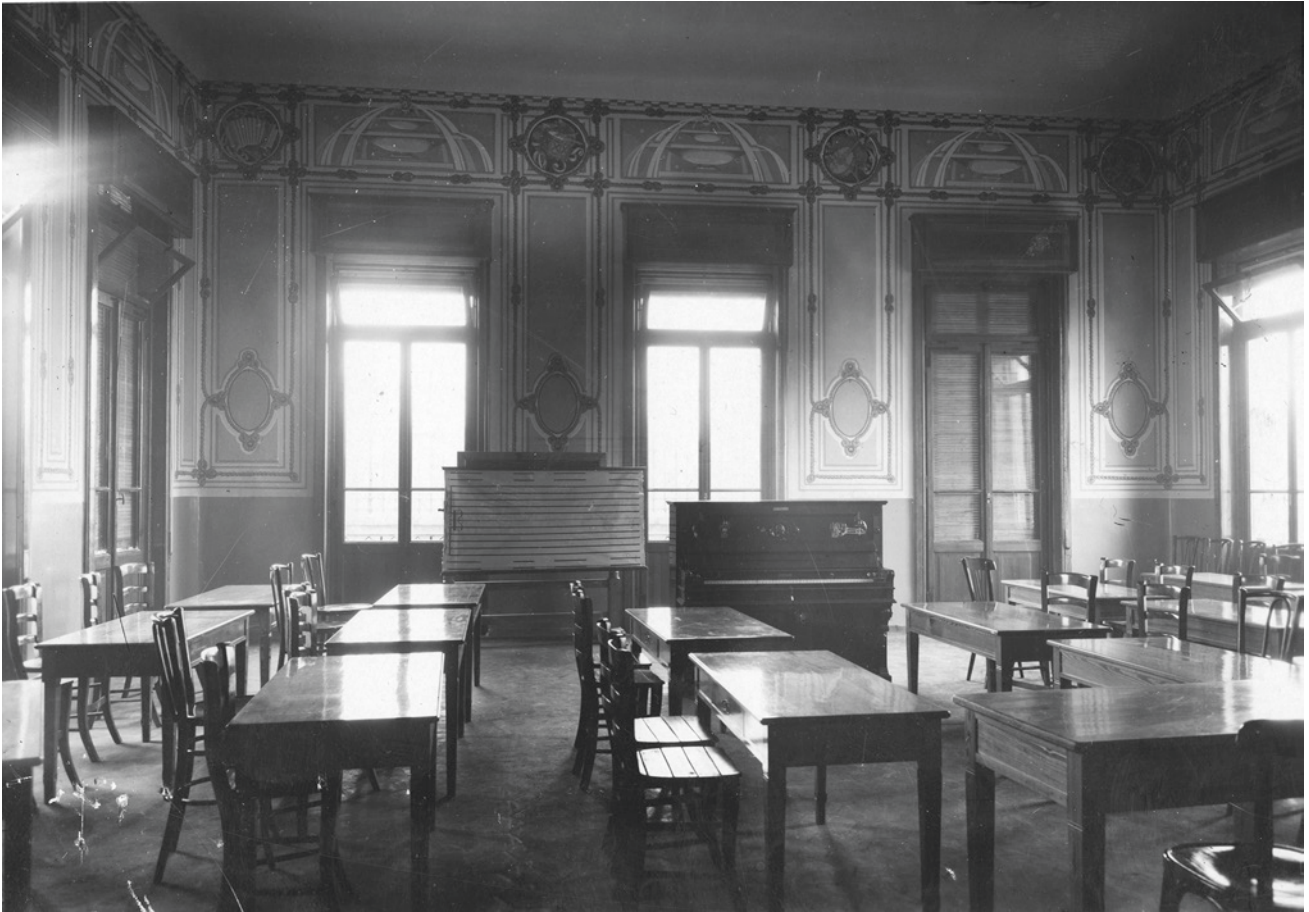
Fig. 18 Historical image from Archivio Storico Opera Pizzigoni (AF442)

The investigations brought to light a valuable decoration under the white paintwork in one of the classrooms (Figs. 18 and 19), which was once used for the laboratory of plastic design. Here too a conservative restoration intervention will be carried out.
