Landslide and Its Impact on Agriculture in Kottiyoor Panchayath, Kannur District, Kerala

R. Nirmala

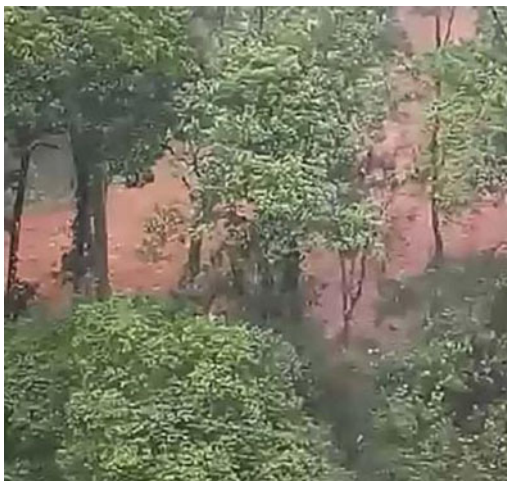
Fig. 17.4 On August 16, 2017, Thursday, a landslide occurred at Ambayathode in Kottiyoor (www.thehindu.com)

Kottiyoor, the origin of Bavali River and Panchayath in Kannur district, experienced one of the worst landslides on August 16, 2017, with a total of eight landslides due to heavy rains (Figs. 17.4, 17.5 and 17.6), about 116% more than the usual rainfall in Kerala. In the first 48 h of rain, the state received 310 mm (12 in) of rain (www.deccanchronicle.com). The study terrain is undulating and densely forested with very steep slopes. According to a report by Kasthoori Rangan and Gadgil.

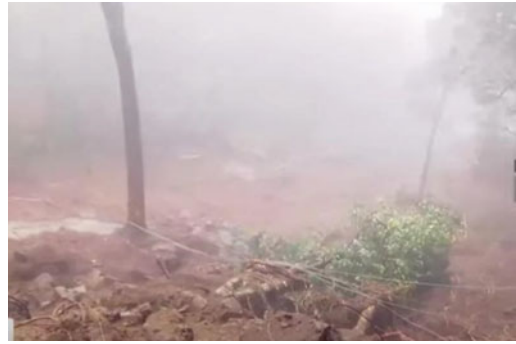
Fig. 17.5 Agricultural land has been destroyed by landslides in Kottiyoor (Screengrab/manoramanews Tuesday, August 02, 2022—15:12)

have been permanently wiped out, and about 15 acres of cropland have been damaged (Fig. 17.5). Accumulation of silt, stones, muddy soil, etc., in agricultural fields, increased soil acidification, loss of topsoil fertility, and mass mortality of soil organisms such as earthworms (Xu et al. 2020; Gu et al. 2019). This natural calamity results in a reduction of latex production in rubber plantations and an increase in crop

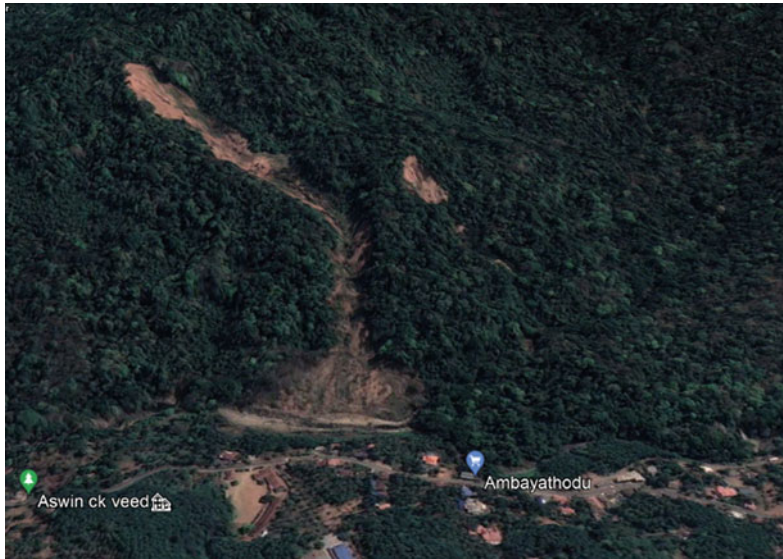
Fig. 17.6 Google earth image of landslide occurred at Ambayathode on August 16, 2017
