# Stability Interpretation for the Tomb of King Muryeong and the Royal Tombs in Baekje Kingdom of Ancient Korea Using 3D Deviation Analysis and Microscale Behavior Measurement

**Abstract.** The Tomb of King Muryeong and the Royal Tombs in Gongju, Republic of Korea has been registered as UNESCO World Heritage sites in 2015 regarding the values as one of the representative cultural heritages of the Woongjin period (475 to 538 AD) in Baekje Kingdom. After the excavation of tombs, several damages occurred due to rapid environmental change. This study uses a 3D precise scanning to visualize microscopic changes in wall composition materials that are difficult to distinguish using sensors and record 3D shape information on vulnerable parts within the tombs. In addition, the obtained data were used to calculate the displacement during the study period through comparative analysis with the previous data of the tomb complex. Based on the RMS deviation analysis, no visible deviation was found in the tolerance ranges  $\pm 2$  mm and  $\pm 1$  mm. The results indicate that no additional cracks or detachment occurred in all vulnerable parts. However, the displacement analysis confirmed the sag

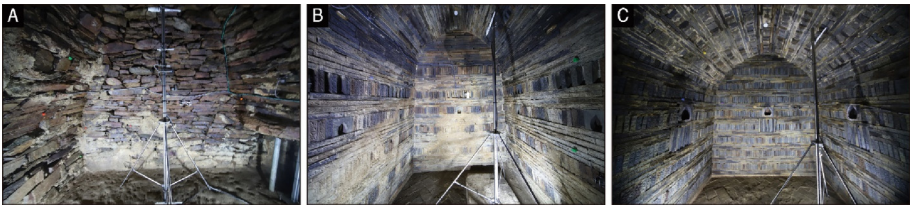
Tomb No. 5 was built using gneiss, which are not uniform in shape. And plaster is applied in each wall, but only traces of it remain. Tomb No. 6 is made of bricks and murals are painted on the walls. The murals in the Tomb No. 6 are the only example in Korea painted on bricks. However, most of the murals have been lost, and only the base layer remains. The Tomb of King Muryeong is the only tomb in the Three Kingdoms Period that records the identity of the deceased and the construction date of the tomb. Since then, the Tomb of King Muryeong has become a standard for the study of tomb culture and chronological research during the Baekje Period, and it is evaluated as a cultural heritage that can examine the historical and cultural influence of neighboring countries at the time. However, after the royal tombs was opened to the public, various damages such as leaks, cracks and behavior of walls have been occurred due to rapid environmental changes inside the tombs [2, 3].

**Fig. 2.** Photographs showing the Tomb of King Muryeong and the Royal Tombs in Gongju. (A) Tomb No. 5. (B) Tomb No. 6. (C) Tomb of King Muryeong.

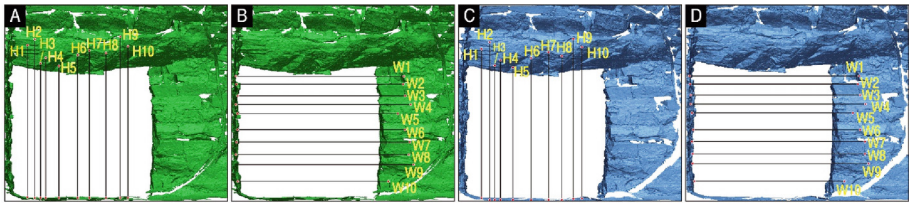
To analyze the deviation of the plaster wall, displacement on the entrance lintel stone was performed in the Tomb No. 5. The 3D data obtained in the study were used for the displacement analysis, and the distance between the members was measured by selecting 10 points in the vertical and horizontal directions on the lintel stone and the surrounding wall, respectively. Then the data was compared with the previous data in 2020 to identify the behavior of the lintel (Fig. 5).

**Fig. 5.** Measurement points for vertical and horizontal distances in lintel stone of the Tomb No. 5. (A, B) 3D data acquired in 2020. (C, D) 3D data acquired in 2021.

As a result of the displacement analysis of the lintel stone of the Tomb No. 5, it was found that between the lintel and the bottom of the entrance, the sinking occurred from 0.24 mm to 0.54 mm with average 0.40 mm in vertical direction. In addition, it was confirmed that the horizontal distance between the walls constituting the lintel part increased from 0.03 mm to 0.21 mm and average 0.12 mm (Table 3). It is considered that sinking occurs in the lintel stone of the Tomb No. 5, and that the wall that make up the entrance subjected to vertical loads are slightly pushed to the outside of the tomb. Through this, it was found that the lintel stone is currently in the process of sagging behavior.

As a results of the displacement analysis, it was found that sagging occurred in the lintel stone of the Tomb No. 5, and it was estimated that the wall of the entrance was outward the tomb. The sag of the lintel stone that occurred during this study period tends to be like the results reported in 2019 (vertical direction; 0.40 mm sag, horizontal direction; about 0.32 mm outward) and 2020 (vertical direction; 0.32 mm sag, horizontal direction; 0.36 mm outward). Considering these results, it can be seen that the lintel stone of the Tomb No. 5 is sagging every year by a certain amount.

This unusual behavior was also found in the position transducer. Currently, the steel support supporting the lintel is corroded, and its strength is weakened, so it is judged that the bearing capacity should be restored through reinforcement or replacement. And if changes are identified through continuous monitoring of the same point and reviewed together with precise measurement monitoring data, it will be an essential primary data for evaluating the structural stability of the Tomb of King Muryeong and the Royal Tombs in Gongju.

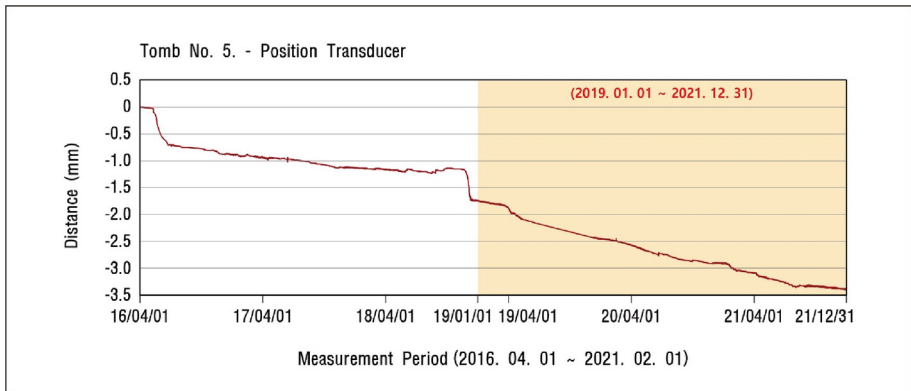
The sagging behavior of the lintel stone is also confirmed by the position transducer located at the entrance, during this study period, no rapid deflection displacement was found, but fine behavior appeared continuously (Fig. 7). When the results of displacement analysis through 3D scanning and the results of measuring instruments are analyzed together, it is discussed that sagging occurred in the lintel of the Tomb No. 5 during this study period.

**Fig. 7.** Diagram showing the displacement on position transducer of lintel in the Tomb No. 5.
