The Authenticity and Integrity of the Soil and the Foundation of the Heritage Structure of Bayon Temple, Angkor

Abstract. Soils and foundation of Bayon temple of Angkor Thom has been studied since 1994 by Japanese Government Team for Safeguarding Angkor (JSA). The main tower of Bayon of 32 m in height from the base foundation mound which consists manmade fill of 14 m in thickness. The foundation was studied and found as a simple shallow direct foundation. This is just like a 10 story RC building standing upon thick manmade sand fill without such a deep foundation with piling. At present, such a structure based upon thick sandy fill will lose the foundation stability in rainy season under monsoon climate of South-eastern Asia. The amazing mechanism attributed to the monument the standing for 700 years has been revealed as the unsaturated characteristics of well compacted silty sand.

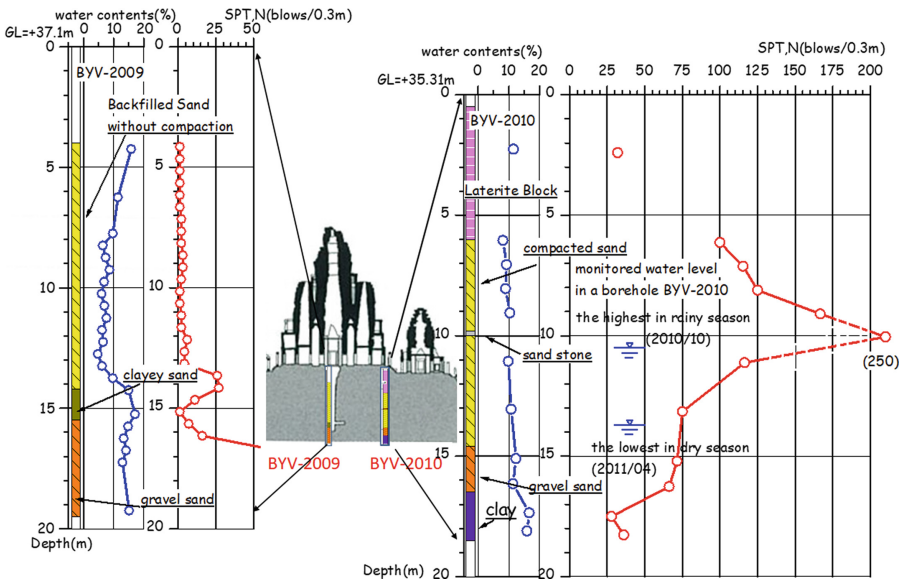
Fig. 7. Borings at the vertical shaft and at top terrace

Geotechnical boring was performed at the backfilled vertical shaft and at the top terrace of the original manmade filled mound as shown in Fig. 7.

The backfilled soil for BYV09 was found in a very loose state of SPT, N-values $N < 4$ of BYV2009. Another boring of BYV2010 at the top terrace shows the sandy fill lower than GL-6m of $N = 100-150$, which is a very large value compared to the expected values of 20-40 for common filled sandy soil [3, 4].

In the coming climate warming period, the rain type of “squall” at present is anticipated to change to “long and heavy” rain. This change of climate could result in the deeper penetration of rainwater into the sandy filled mound and weaken the foundation mound. As noted in Fig. 7, the vertical shaft with backfilled soil in very loose state could cause inwards displacement and finally failure of the shaft resulting the collapse of the main tower of Bayon.

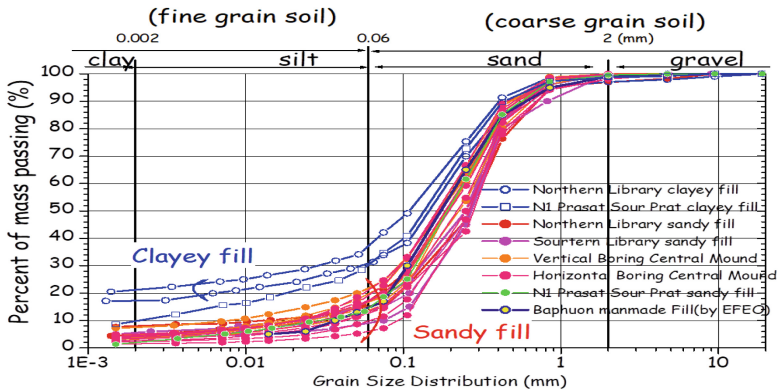
Fig. 8. Grainsize distribution.

The grain size distributions of the sampled soil by the boring of BYV2010 and BYH2010-30 as well as other sites are shown in red and blue colour for sand and clay soils respectively in Fig. 8. The sandy soil is filled soil and the entire samples of the filled soil show the same distribution, which implies very uniform fill material. The silty/clayey fill was found at the boundary of such zone to prevent seepage as laterite blocks retain the sandy fill mound. The ancient Khmer engineers in clearly identify these two types of clayey fill and sandy fill.

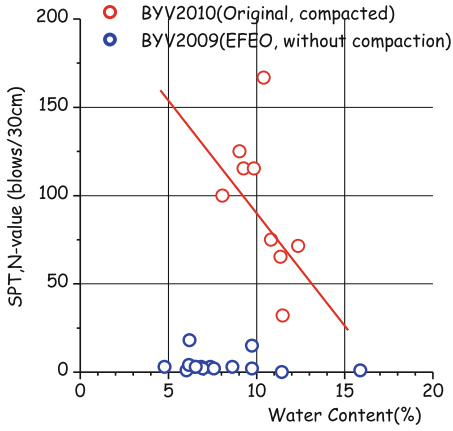
Fig. 9. SPT-N values vs. water contents

The obtained SPT, N-values are plotted against water contents of the sampled soils for both borings and is shown in Fig. 9 No relationship is found for BV09 of the backfilled soil; however, the decrease of water is found to result in the increase of the SPT, N-values for boring BV10. Sampled soil of very high SPT-N-value for boring BYV2010 looks like soft sandstone as shown at the upper left position of Fig. 10. When the sampled soil was put into water, it sucked water, and finally collapsed within 10 min as shown in Fig. 10.

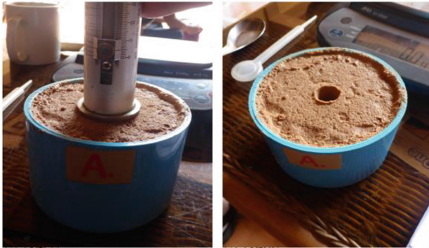
Fig. 11. Yamanaka Cone test

A series of laboratory tests were performed to see how much strength changes due to the decrease of the moisture contents. More than 25 samples in containers were prepared with water content of 15%, which almost creates a 100% saturated condition. The samples were placed outside of the test room and the water evaporated from the sample and the water content decreased day by day. Yamanaka cone penetration tester was used to evaluate the bearing strength of the soils as shown in Fig. 11. The results are shown in Fig. 12 and It shows clearly an increase of strength more than 50 times due to the decrease of the water content.

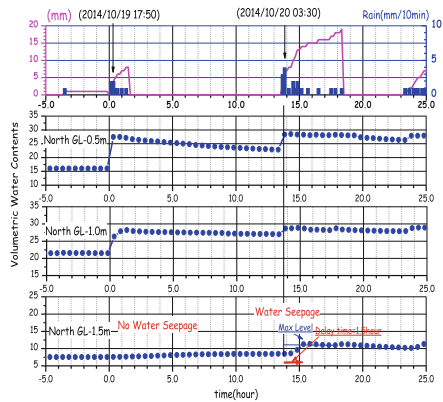
Fig. 17. Monitored results of water in the filled mound

the platform mound at Bayon temple [5]. Moisture sensors (Fig. 16) had been installed at several depths at GL-0.5, -0.75, and -1.0 m and the monitored results are shown in Fig. 17 with rain fall results. As expected, the volumetric water contents increases when the rain falls.

In Fig. 17, the monitored results at S-point of two cases of rain events are shown. The earlier case shows the increase of the volume water content are found at the upper two depth points. The deepest point at GL-1.5 m, the volume water content keeps the constant value, which means the infiltrated rainwater reached to the upper two sensors but did not reach the bottom one. The amount of the rain was too small to provide enough rainwater in the earlier case. In the latter case, the sensor at the bottom of GL-1.5 m increases with a time delay of about 1.5 h compared to the top sensor at the GL-0.5 m. The infiltration rate is about 1.0 m/1.5h.

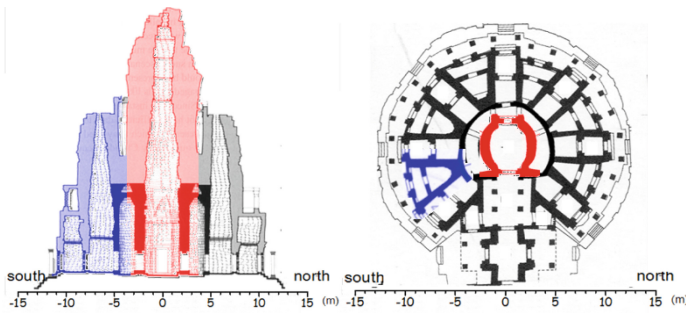
**Fig. 23.** Sections of the main tower and a sub-tower

Central tower section is colored in red and sub-tower in blue in the Fig. 23 below.

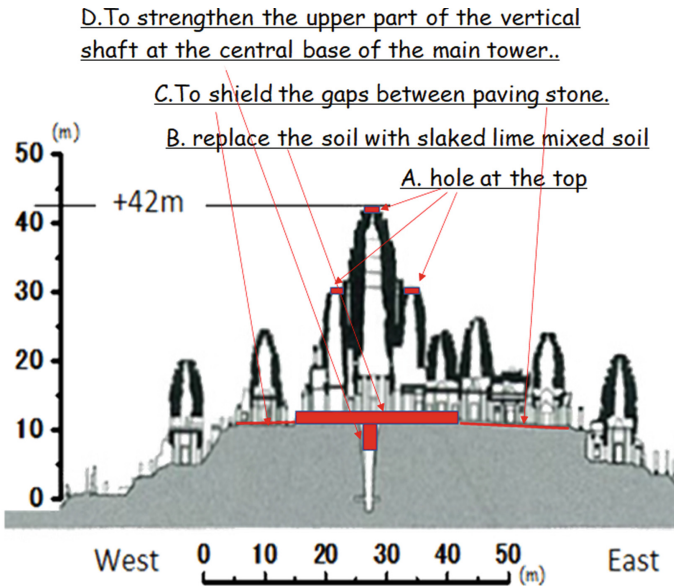
Fig. 26. Countermeasures against water penetration to the foundation mound

The proposed method at present consists of the following four methods to prevent the rainfall penetration into foundation mound and strengthening the upper portion of the vertical shaft from the top to about 5 m in depth as shown in Fig. 26.

- A. To close openings at the top of main and sub-towers to prevent rainwater infiltration.
- B. To replace soils under stepped stone with lime mixed sand to stop infiltration of rainwater.
- C. To shield the gaps between paving stone.
- D. To strengthen the upper part of the vertical shaft at the central base of the main tower.
