Structural Analysis of Historic Absorption Building in Turner Valley, Alberta

Abstract. Many historic structures in Canada are deemed unsafe and are closed or of limited access to the public. An “unsafe” steel and concrete heritage building rebuilt in 1930 has been analysed structurally. The building in question is the absorption building at the Turner Valley Gas Plant (TVGP), a National Historic site. Throughout the building lifespan the structural skeleton has been adapted to accommodate changes in the oil and gas processing. The TVGP was Alberta’s first natural gas plant built and thus the birthplace of the energy sector in Western Canada. The absorption building housed the first ever absorption plant in Canada in 1914. The load path, effects of modified and missing members, and capacity of elements were assessed. Due to a lack of historical records, Non-destructive testing methods were used to determine building properties. Geometrical data was collected with laser scanners and ground penetrating radar systems. X-ray diffraction, scanning electron microscopy, hardness tests and tension/compression tests were used to determine material stiffness, strength, and chemical microstr

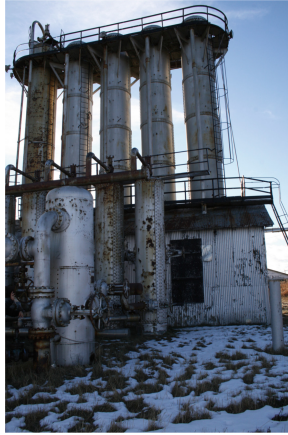
Fig. 1. The absorption building at the Turner Valley Gas Plant.

A geometrical survey was conducted to obtain the geometrical properties of the building. The building is 6.1 m wide and 13 m long. The height of the apex is 5.2 m and the roof slopes $26\text{--}27^\circ$ (Fig. 1). Five 1-m-wide absorption tanks run through the middle of the building. The tanks obscure the view of trusses and roof members. Additionally, the building has vaulted ceilings and missing or deformed members (Fig. 2).

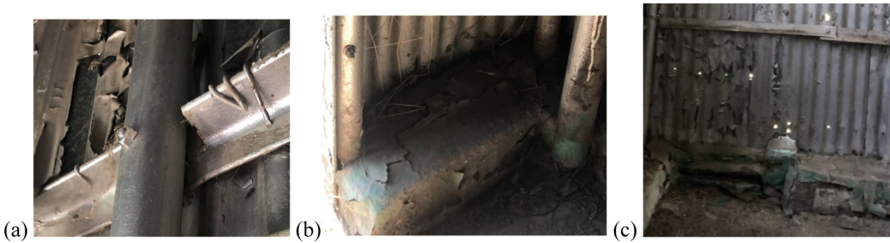
Fig. 6. a) Depicts the corrugated iron sheathing wall connected to both a pipe column and an angle beam using ties on an interior repetitive section, b) Depicts the concrete ledge in which a pipe beam is encased, c) Depicts corrosion that is seen throughout the sheathing.

The gravitational load system consists of the roof sheathing tied to the roof angles, and roof angles tied to the angled pipe columns, which are simply supported on the top of the wall. The walls consist of corrugated sheathing tied to both horizontal beam angles and column pipes as seen in Fig. 6a. The column pipes were connected to a horizontal pipe beam at their base, tying all the frames together. For extra rigidity the horizontal pipe beam was cast into a concrete ledge. The ledge then carried the load to the ground. Figure 6b depicts pipe columns encased in the concrete ledge. The corrugated iron sheathing had begun corroding in various areas, but the corrosion was not significant to raise concerns (Fig. 6c). A goal of the modeling was to determine if the sheathing is carrying loads and if the corrosion and connections should be addressed.

The connections within the building lack consistency and vary from welds, to ties and bolt connections. The exact method used to create the tie connections is unknown, however they are best described as bent nails. Figure 6a shows tie connections and bolt connections. The connection strength was not tested in this case study. However, it was noted that the connections between the sheathing and the columns at the base of the walls were beginning to fail in various locations.
