Estimating the Structural Characteristics of Historic Armenian Church Buildings and Examining Their Strengthening Applications

Keywords: Armenian Church · St. Hripsime · Etchmiadzin Cathedral · Structural Properties · Damage and Deterioration

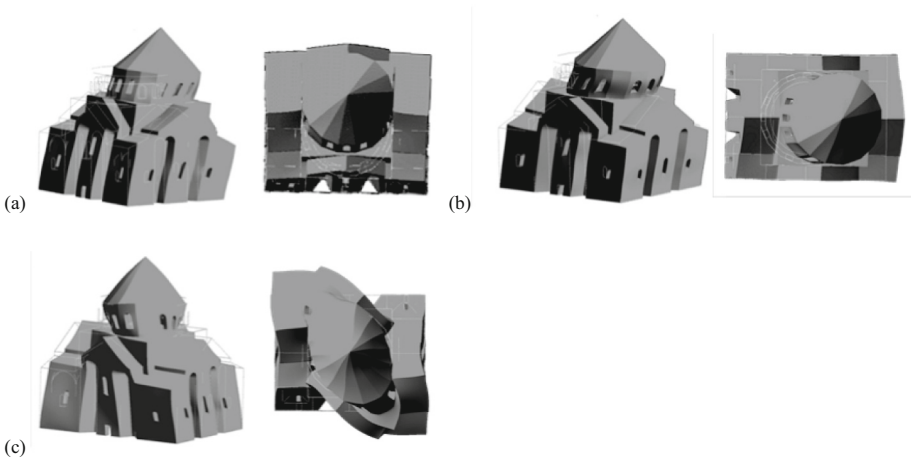
Identification of Eigenmode. By the eigenvalue analysis, calculated eigenmodes and natural periods corresponding to the first, second, and third modes are shown in Fig. 3 and

Table 2, respectively. By the on-site vibration measurement result using the microtremor survey [7] and the numerical analysis result, the first and second vibration modes were identified successfully.

Fig. 3. Eigenmode of St. Hripsime Church: (a) First mode; translational, N–S direction, (b) Second mode; translational, E–W direction, (c) third mode; torsional

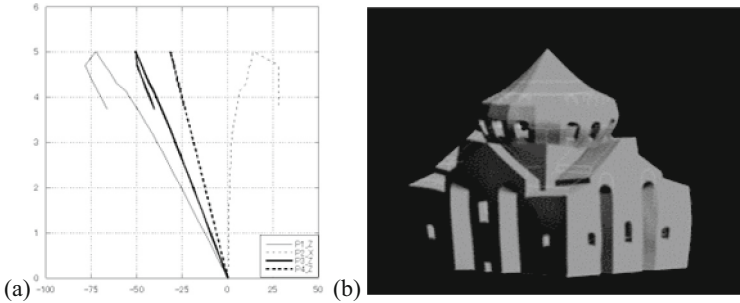
Structural Performance under Vertical and Horizontal Loads. At first, the action of the self-weight type load was evaluated by elastoplastic analysis (Mutoh, 2010). The relationships between the factor for self-weight type load and displacements at the

principal locations of the structure are shown in Fig. 4, along with the deformed shape. From the obtained result, it may be seen that there are about five times as many ultimate load margins as the self-weight type load and that the drum portion is the first weak point of the structure.

Fig. 4. Load-displacement relationships and deformed shape to self-weight type load: (a) load-displacement, (b) deformed shape, 1.0 times self-weight (deformation is enlarged 50 times)

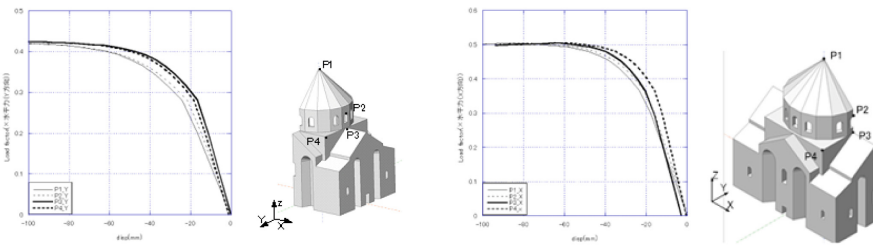
Next, to estimate the outline of the earthquake-resistance performance, the characteristics under lateral load are examined. The relationships between the factor for the mass proportional uniform lateral load and displacements at the principal locations of the structure are shown in Fig. 5. From the result obtained, it may be seen that there are about 0.4–0.5 times as many ultimate load margins as the uniform lateral self-weight type load (after the preceding vertical self-weight loading).

Fig. 5. Load-displacement relationships and deformed shape to self-weight type load

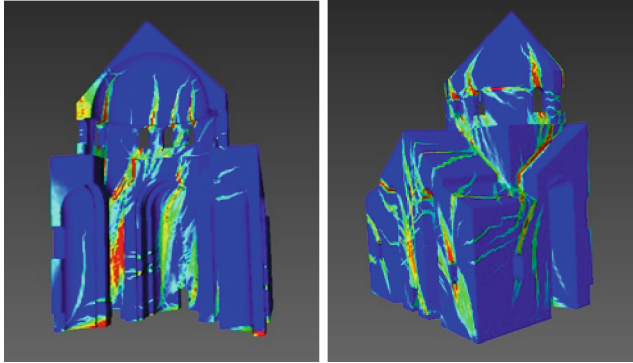
Estimated crack patterns around the ultimate strength for Y-dir. are shown with incremental crack strains in Fig. 6.

Fig. 6. Crack patterns due to the uniform lateral loads (1.0 times self-weight + $C0 = 0.4\text{--}0.42$ uniform lateral load), crack incremental (max. crack strain = 50000μ)

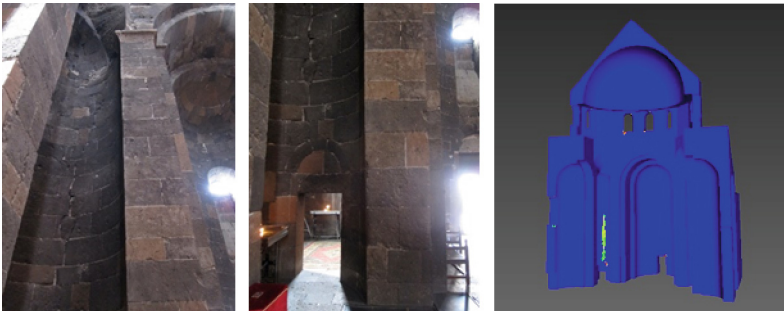
Trial to Identify the Observed Structural Damage. Concerning St. Hripsime Church, a clear and wide-band vertical crack is observed in the wall between the niche and room located in a corner. We tried to identify the structural cracks and found that the simulated cracks, due to 1.0 times self-weight + uniform lateral load ($C_0 = 0.2$, Y-dir.) show good agreement with the observed cracks (Fig. 7). According to the analysis result, it is presumed that the penetrated vertical crack, which is observed may have been generated resulting from the middle-scale earthquakes experienced in the past. Although the influence this damage has on the drop in ultimate strength is not judged to be urgent, future detailed analysis is desired with continuous observation.

Fig. 7. Correspondence of the observed structural cracks and the simulated crack pattern

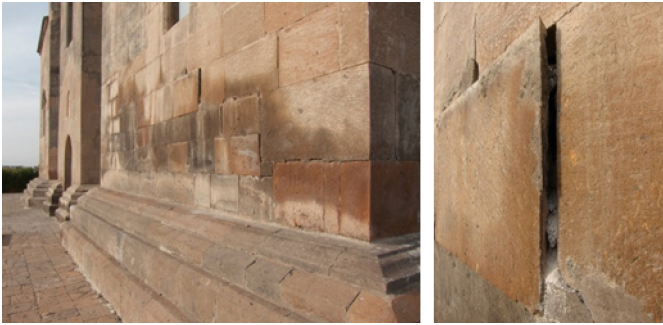
In the outer wall of the southeastern corner, color changes presumed to be based on the localized accumulation of moisture and exfoliation of an outer wall stone are seen and presumed to have advanced in a comparatively short time (Fig. 8). It is judged that the

portion concerned is clear also in the history of repair, and the specification and measures to deal with the cause that is presumed to be the elution of internal mortar are required.

Fig. 8. Degradation of the outer wall in the southeastern corner

The implementation of a detailed evaluation of damage and degradation is desired based on the internal investigation by non-destructive testing.

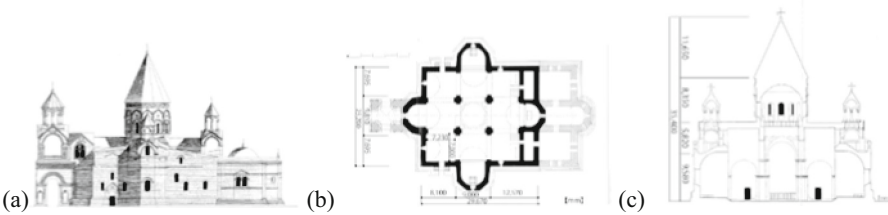
The configurations of Etchimiadzin Cathedral are shown in Fig. 9 To maintain the accuracy of expression of axial and flexural rigidities, a fine element subdivision was required. In the computation, a total of 1,045,000 elements and 218,000 nodes with 654,000 d.o.f. were used for the full 3-D simulation model shown in Fig. 10.

Fig. 9. Configurations of Etchimiadzin Cathedral: (a) South Elevation, (b) Plan, (c) North-South Section

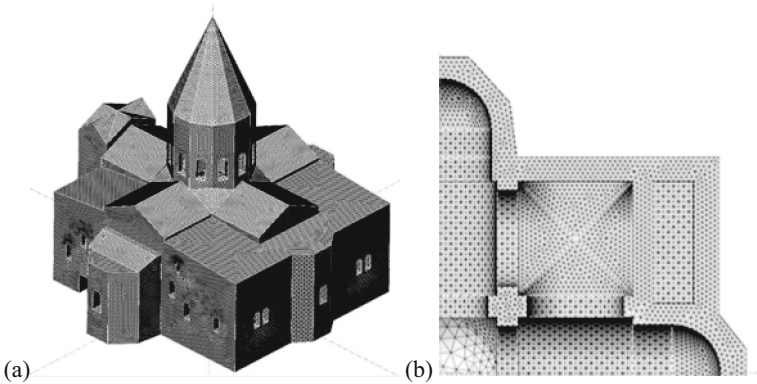
Fig. 10. FE mesh for the simulation of Etchimiadzin Cathedral: (a) outline of appearance, (b) outline of inner view

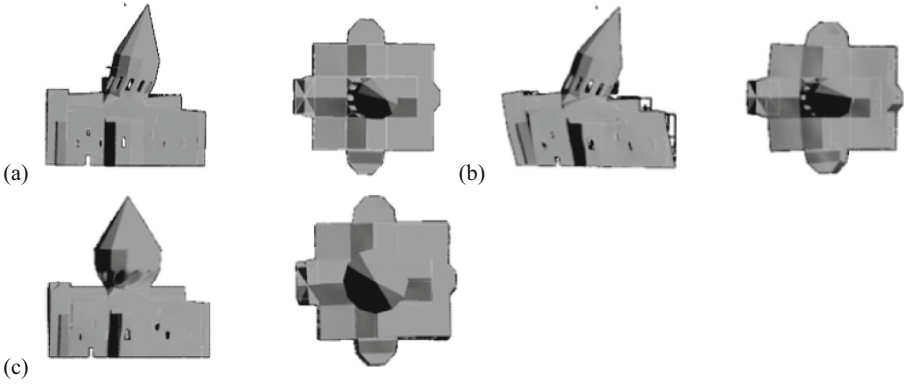
Identification of Eigenmode. By the eigenvalue analysis, calculated eigenmodes and natural periods corresponding to the total five modes are shown in Fig. 11 and Table 3,

respectively. At present, the identification of the eigenmode using the data measured by the microtremor survey (Morikawa, 2013) is under analysis. In Table 3, index “A” denotes the E–W direction and index “B” denotes the N–S direction, caused by the asymmetry in the plan.

Fig. 11. Eigenmode of Etchimiadzin Cathedral: (a) mode 1A; first, E-W direction, translational, (b) mode 2A; second, E-W direction, translational, (c) mode 3; drum torsional

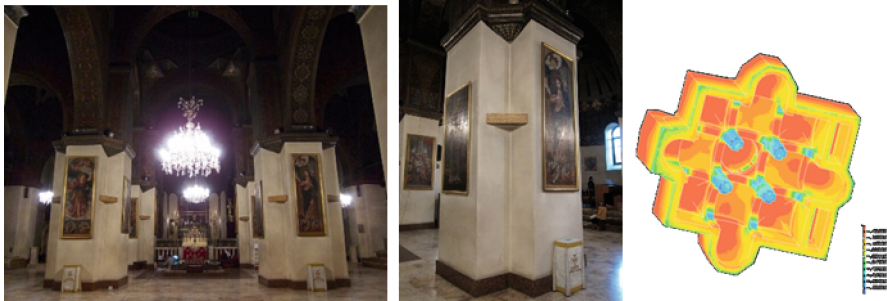
In this church, the whole interior surface is covered by ornamentation so the inside is in the situation of being hard to check for damage to the structure owing to the presence of four independent pillars, and this feature is shown in Fig. 14.

Fig. 14. Inside views and an estimated stress concentration for pillars (von Mises stress for D.L.)

The long-term axial force of the four columns is relatively large, and this serves as a point of evaluation of these structural properties. An examination of the influence of long-term creep and the influence of different subsidence are indispensable.

When a pillar becomes a point of reinforcement on future examination, the method by the addition of the reinforcing member and/or confinement by a steel plate, a carbon fiber, etc. will also be assumed. In the case of examination, a prior structural analysis will be directly effective.

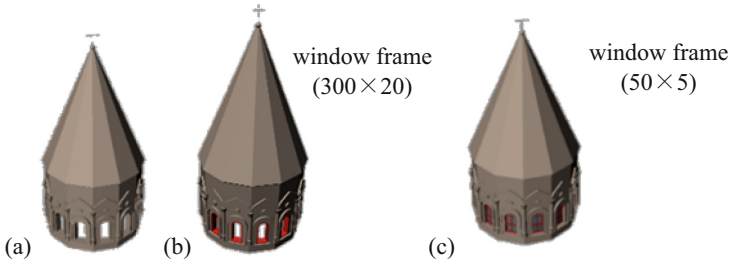
Since the damage around the opening of the drum part is considered to be sizable, a continuous reinforcement plan was drawn up by closing the opening shown in Fig. 18, and the reinforcement method was evaluated by numerical analysis. Reinforcement Plan

A reinforces the inside of the opening with steel materials, and reinforcement plan B uses the opening with a grid-like frame and window glass.

Fig. 18. Reinforcement plans: (a) before reinforcement, (b) Plan A, (c) Plan B

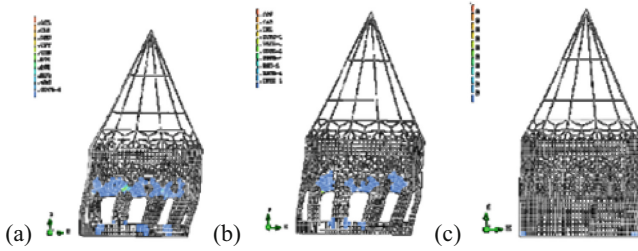
The reinforcement effect is evaluated by response analysis. As an input waveform, a .0 Hz sinusoidal acceleration was gradually increased and input. Table 4 shows the maximum input acceleration, and Fig. 19 shows the deformation and cracks. Reinforcement plan A collapsed with an input less than the maximum input acceleration, but reinforcement plan B was able to withstand up to about twice the input before reinforcement. From the deformation and cracks, it was confirmed that deformation and damage to the opening were not suppressed in reinforcement plan A, but deformation and damage to the opening were suppressed in reinforcement plan B. In this report, a proposal for the reinforcement of the dome and drum was proposed and evaluated by numerical analysis. It was confirmed that the lattice-like frame and window glass reinforcement at the opening have continuity and are effective.

Fig. 19. Deformation and cracks: (a) before, (b) Plan A (c) Plan B
