Paul L. Rodham, Vasileios Giannoudis,
and Peter V. Giannoudis

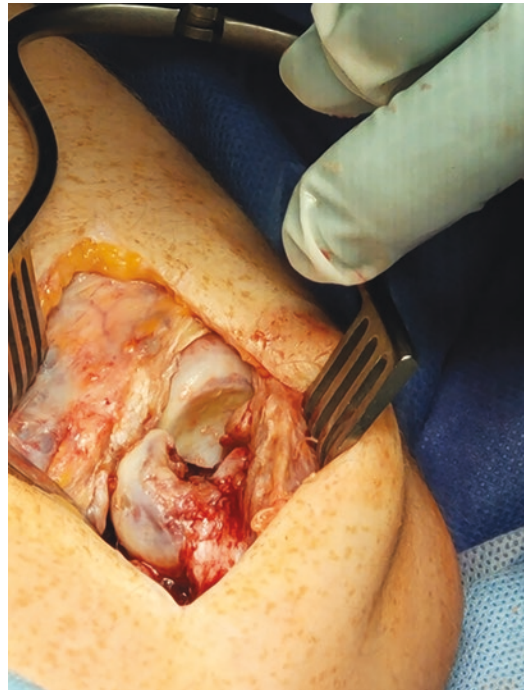
Fig. 12.6 The capitellum fragment was approached through the original incision, and mobilised to facilitate reduction

The previous incision was re-opened and extended distally by 1 cm to facilitate access. A plane posterior to the previous Kaplan approach was opened and developed to allow access to the fracture whilst also protecting the insertion of the lateral collateral ligament. The fracture site was found to have a small amount of callus within which was debrided to free up the capitellar fragment.

The original 2.4 mm screws were removed following which the capitellum was reduced and held with two K-wires perpendicular to the plane of the fracture (Figs. 12.6 and 12.7). The articular reduction was confirmed under direct vision and with the image intensified following which two 3.5 headless compression screws with a continuously varying pitch achieved maximal compression (Figs. 12.8 and 12.9).

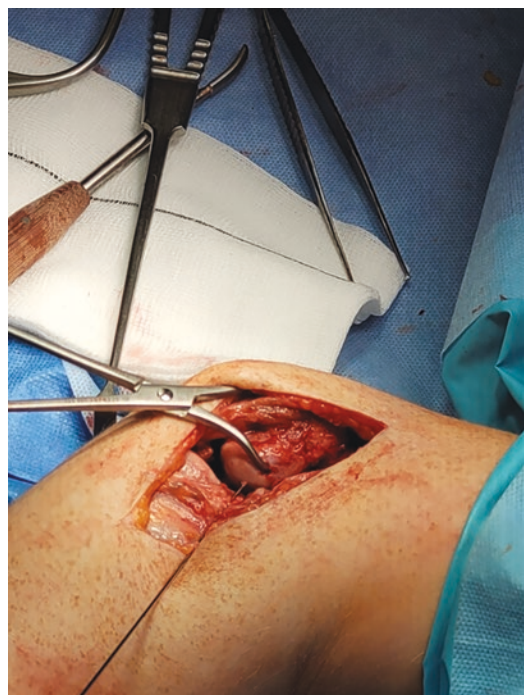
Fig. 12.7 Once mobilised the capitellum fragment was reduced and held with a pointed reduction clamp, at which point two K-wires were passed orthogonal to the plane of the fracture
