Evaluation of Damage Caused by Soil Settlements in a Historical Masonry Building

Ali Fuat Genç, Ahmet Can Altunışık, and Esin Ertürk

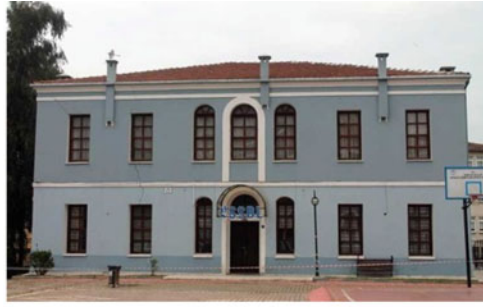
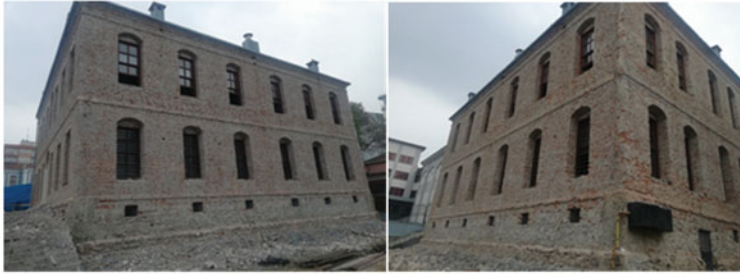
Fig. 2.1 Views of the building

Comprising a rectangular layout, the building encompasses three levels: a basement, a ground floor, and a standard floor. Its total vertical extent measures 14.3 m, with the first floor at 2.64 m, the second at 4.26 m, and the third at 4.59 m. The structural support system of the building is characterized by a load-bearing masonry framework, fashioned using brick materials. Within the standard storey, interior walls were introduced as timber frames. Wall thickness is approximately 0.7 m at the basement level, while higher sections exhibit varying thicknesses ranging from 0.45 to 0.60 m. Timber elements were used for the construction of the slabs and roof system. Visual representations and façade depictions of the building can be observed in Fig. 2.1.

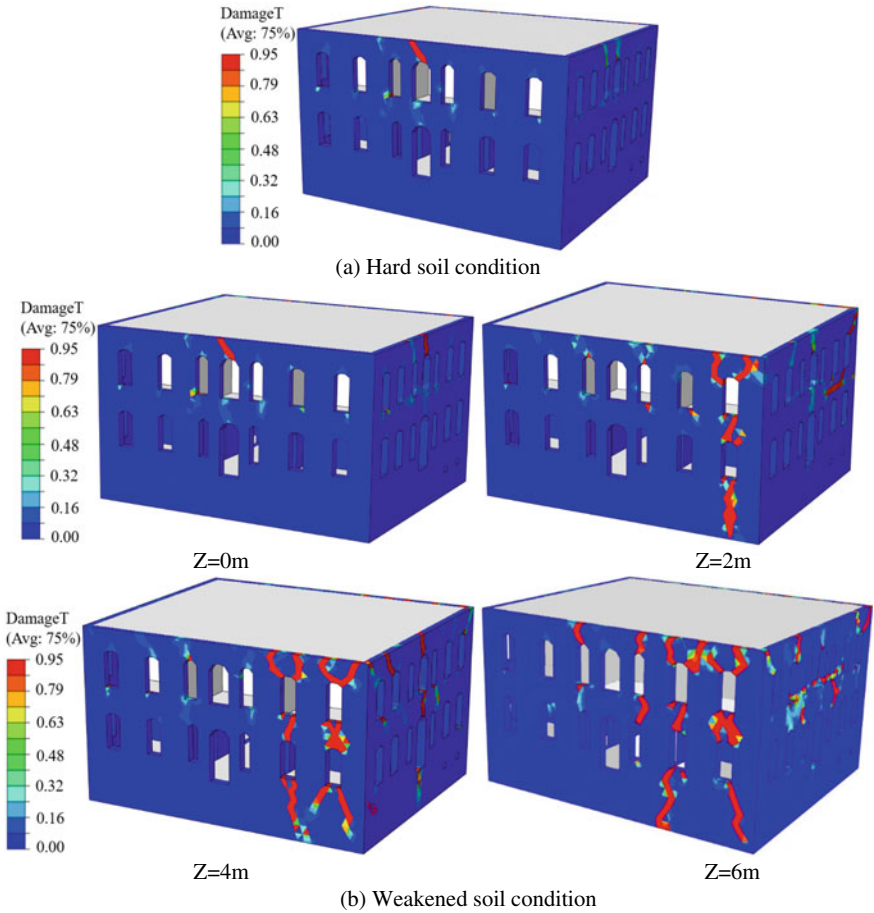
The damages, which can be occurred based on different settlements, slips and deformations at the foundation due to the weakening of soil properties, were explained with tensile damage. Tension damage results for SSI systems are given in Fig. 2.6. The number of damaged elements obtained numerical analyses are given in Table 2.6. It should be noted from the Table 2.6 and Fig. 2.6 that the building is almost undamaged in hard soil condition and 0 m of weakened soil condition. On the other hand, cracks occurred, and the number of damaged elements increased as

weakened soil distance increased. The structural damages occurred window openings and roof joints. The number of damaged elements constitutes 0.53% of the total number of elements in the hard soil condition. On the other hand, percentage of damaged elements are 0.54%, 1.20%, 1.70% and 2.23% for 0.0 m, 2.0 m, 4.0 m and 6.0 m of weakened soil condition, respectively.

Fig. 2.6 Tension damage level for **a** hard soil and **b** weakened soil condition

- The building is almost undamaged in hard soil condition and 0 m of weakened soil condition. The number of elements, which reaches damage parameter, 0.53% and 0.54% for these conditions. So, the building can be considered almost undamaged. On the other hand, percentage of damaged elements are 1.20%, 1.70% and 2.23% for 2.0 m, 4.0 m and 6.0 m of weakened soil condition, respectively. It was observed that cracks occurred and the number of damaged elements increased as weakened soil distance increased.

- The main structural damages occurred near the window openings.
