ADVANCES IN PYROMETALLURGY: FURNACE CONTAINMENT

Advances in Pyrometallurgy

Furnace Containment

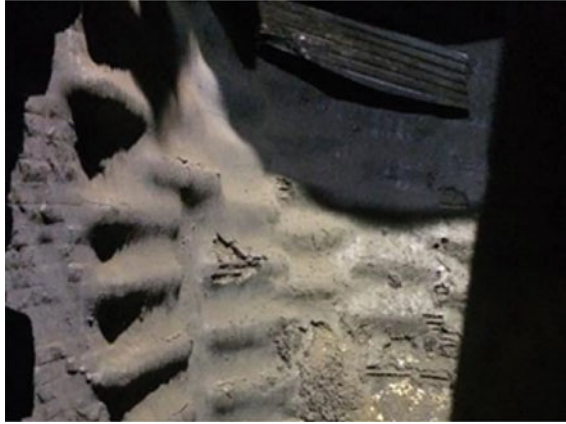
Fig. 4 Worn refractory wall with horizontal plate coolers to arrest wear [1]

Providing a thick wall with an allowance for wear at a projected rate is a historical approach. This was based on known rates of material loss for a particular process. If cooling blocks are used to arrest refractory loss, then they must be spaced close enough to ensure that the system is stable. As shown in Fig. 4, if the coolers were to be spaced further apart, then the residual wall thickness may be too thin for the expected operating conditions.

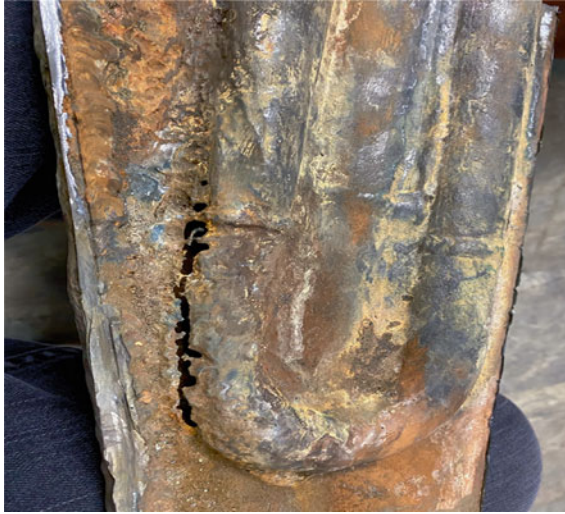
Fig. 2 Sulphur dioxide dewpoint corrosion of boiler tube due to ingress air

Boiler leaks are commonly caused by out-of-specification deionized water, excess thermomechanical stresses, dew point corrosion (commonly caused by undesired ingress air), undesired impacts (commonly caused by the process or rappers), and poor-quality control (manufacturing or install). Water quality is managed by periodically sampling and addition of necessary chemicals. Water conductivity is continuously monitored with the process variable having alarm limits set in the human-machine interface. The potential for explosions caused by combustion of natural gas or volatiles can be prevented with effective operating procedures and process automation (Fig. 2).

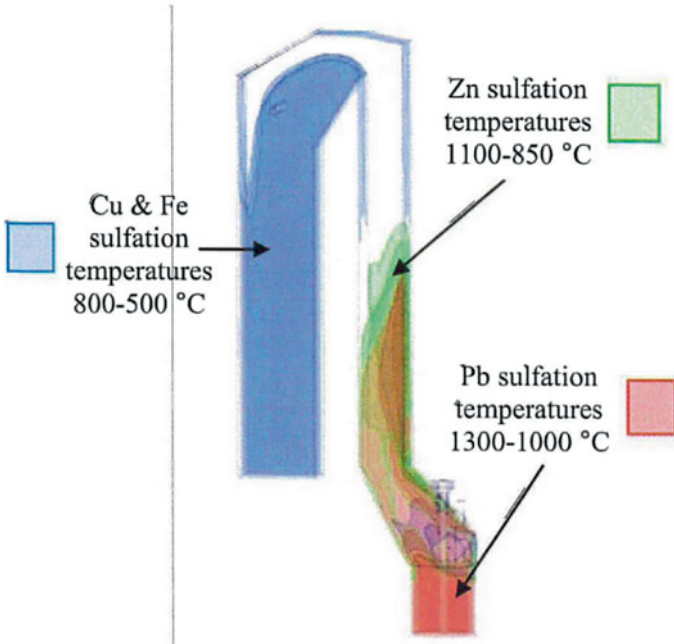
Fig. 7 Approximate dust sulfation locations in a top-submerged lance furnace (TSL) off-gas system (at -10 Pa) [3, p. 9]

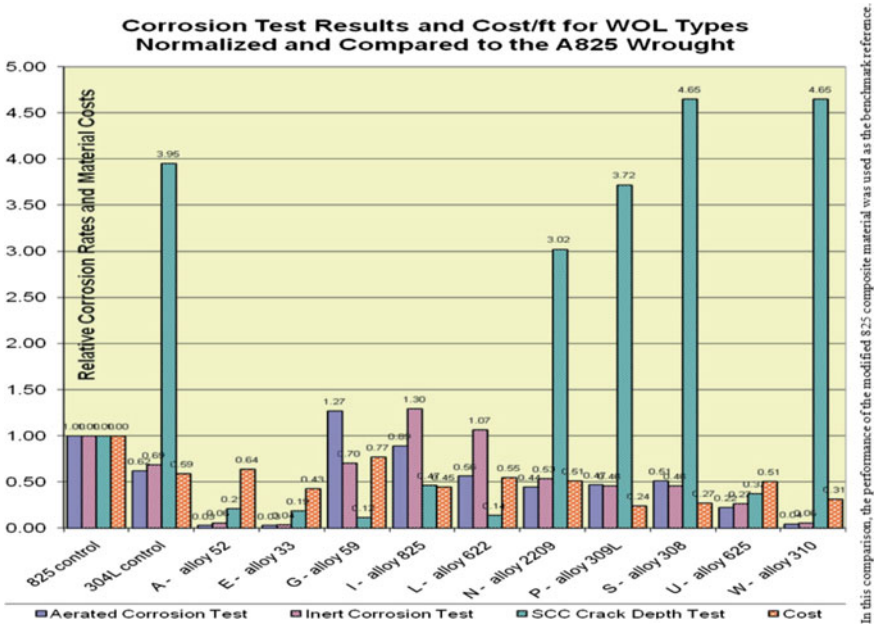
Fig. 14 Weld overlay materials corrosion testing [4, p. 3]

The boiler will corrode and start leaking at areas where the temperature of the boiler walls drops under the acid dew point; typical places are the concentrate feed port, lance port, doors, and where you have gaskets—leaking cold air into the boiler, e.g., in the dust hopper. Overlay welding protects against corrosion, erosion, and adds wall thickness to prolong lifetime. Alloy 33 overlay has been successfully utilized at the Miami Smelter to reduce corrosion damages and leaks. Alloy 33 has a high chrome concentration (28%) which offers the basis for excellent corrosion resistance in oxidizing media. A low addition of molybdenum improves phosphorus acid resistance and simplifies sulfuric acid passivation (Figs. 13 and 14).

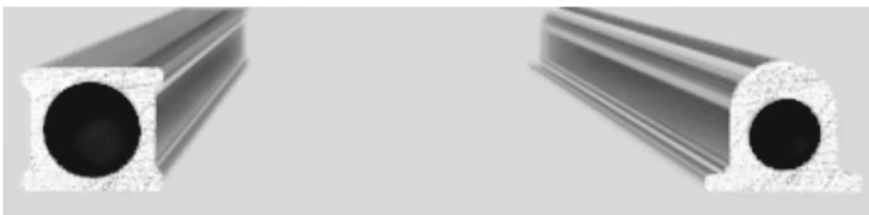
Fig. 15 Double omega tube on left; single omega on right

The Miami Smelter boiler uses membrane walls with overlay welding, omega panels, and double omega panels. Additionally, overlay welding on critical parts on the omega tubes. A wall with a smooth surface on the inside (normal omega tube) is preferred for a region like in the hood uptake which encounters slag from splashing. Double omega can be utilized in places that are difficult to reach, like in the apex. The double omega is stiffer than the single omega and is used in hoppers where we expect large accretions falling and bending the tubes (Figs. 15 and 16).

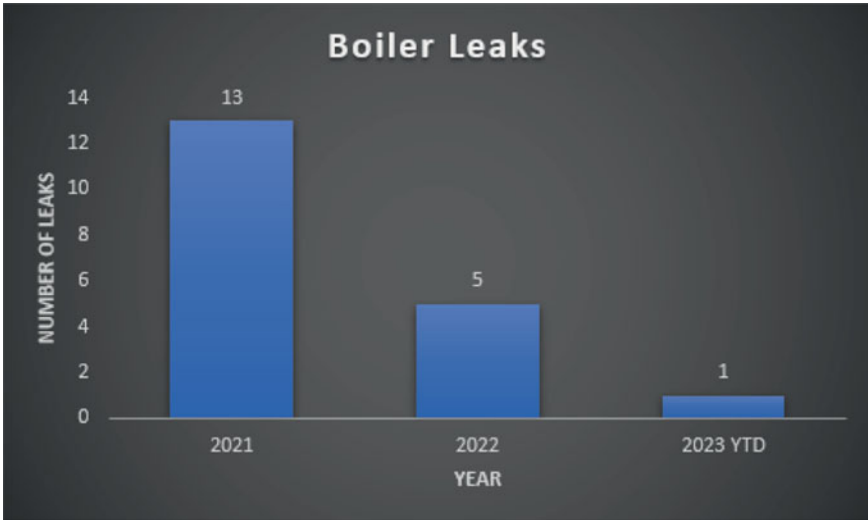
Fig. 21 Chart showing reduction in boiler leaks

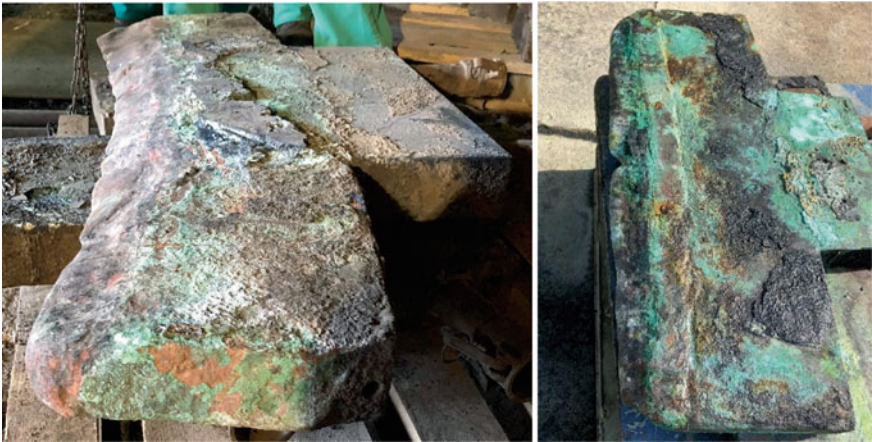
Fig. 1 Examples of corroded copper plate coolers removed from Sibanye-Stillwater Furnace 2

Water-cooled copper cooling elements installed in PGM smelting furnace sidewalls adjacent to the slag-charge interface suffer from severe corrosion. Examples of worn sidewall copper plate coolers removed from one of the Sibanye-Stillwater smelting furnaces are shown in Fig. 1. Labile sulphur and small quantities of chlorides contained in the dried, un-calcined concentrates that are fed to the furnace have been identified as the culprits. The corrosion mechanism is best described as ‘chloride-accelerated sulphidation’ whereby the labile sulphur reacts with the copper to form copper sulphide as the main corrosion product, and where the corrosion process is likely accelerated by the presence of chloride-bearing species. The corrosion of water-cooled copper cooling elements in PGM smelting furnaces, as well as the sulphidation corrosion mechanism most likely responsible, has been well documented by others [1–5]. Tenova Pyromet independently commissioned test work to better understand the corrosion mechanism and kinetics, and to test a surface protection layer to potentially inhibit the corrosion process [6].

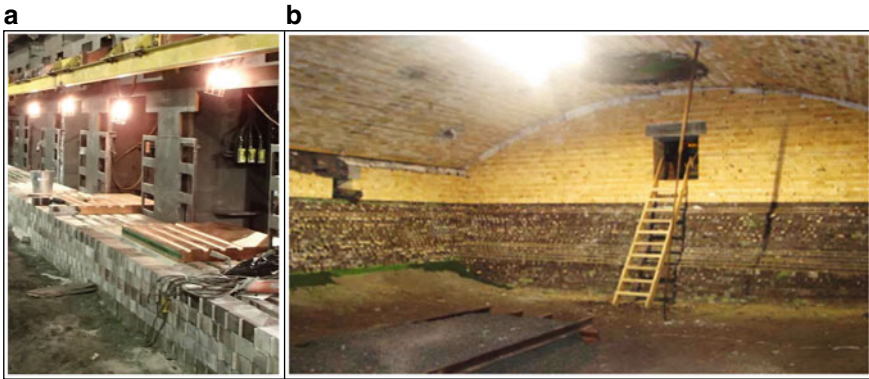
Fig. 3 a 2004 rebuild—upgrade to drilled Cu plate coolers. View along north wall. b 2004 rebuild—roof and matte endwall completed

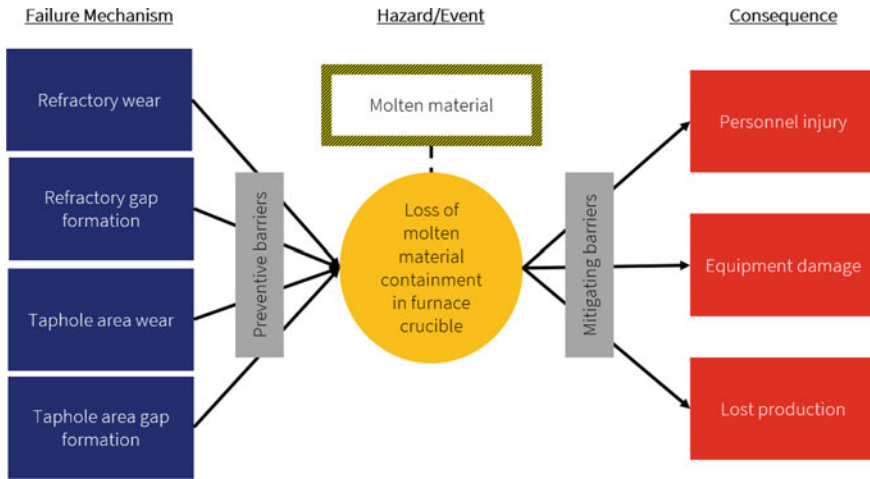
Fig. 2 Simplified bowtie diagram
