Implications of Pyrite Oxidation for Engineering Works

A. Brian Hawkins
University of Bristol
Bristol
UK

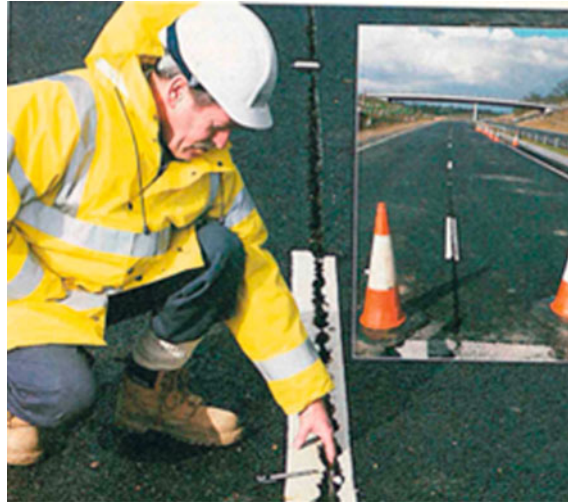
Fig. 55 Distress in the A10 (north of London) following lime stabilisation of sulphate-rich soils (New Civil Engineer 25 March 2004)

Although the original site investigation indicated the presence of some sulphur and sulphates, a decision was made to lime stabilise the glacial boulder clay to form the capping layer. During the general earthworks, pyritiferous boulder clay was exposed and further sulphates developed in the warm, conditions of 2003, which was the fourth driest summer in England and Wales since records began in 1914 (see Hawkins 2013).

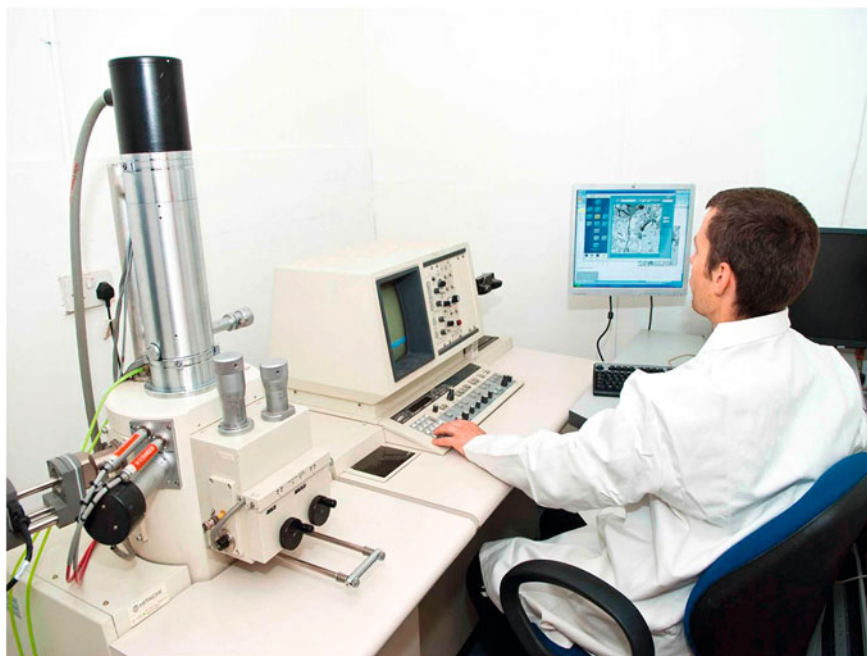
Fig. 10 Scanning electron microscope fitted with an energy dispersive X-ray microanalysis system for making chemical analyses

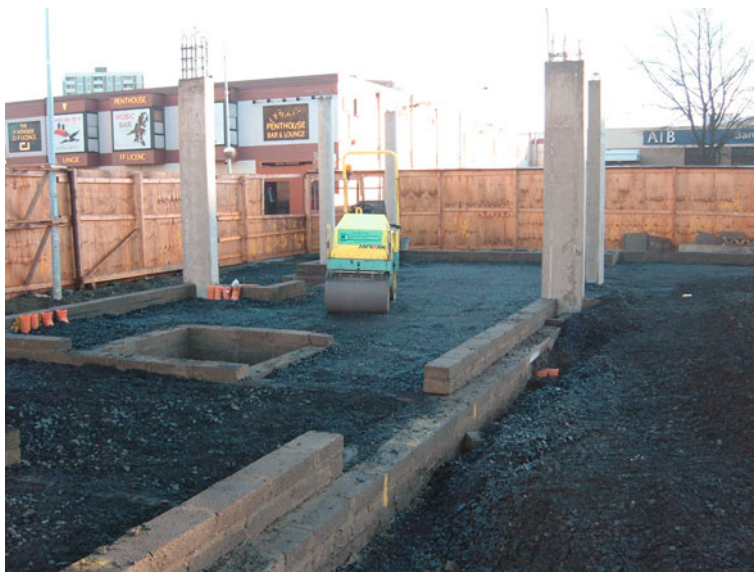
Fig. 5 Fill being compacted by roller, December 2004

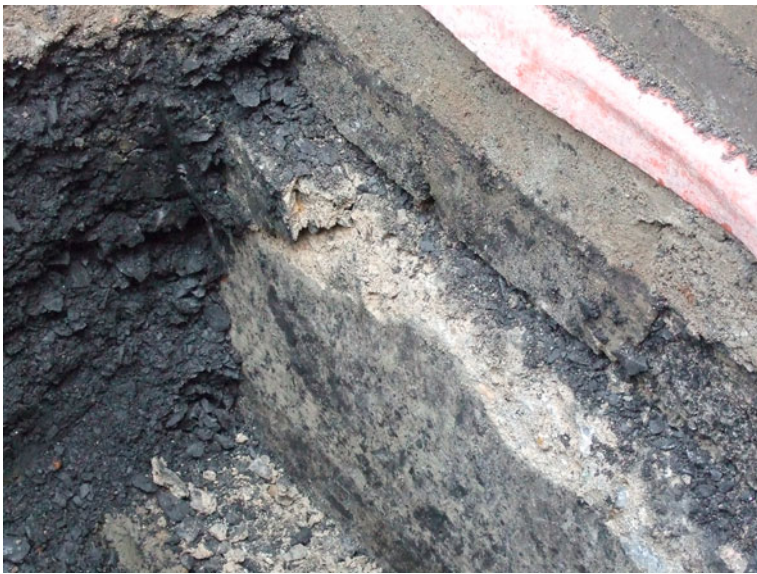
Fig. 28 Deterioration of concrete at the top of the beam, TP 11, and the nature of the dark deleterious fill adjacent to it

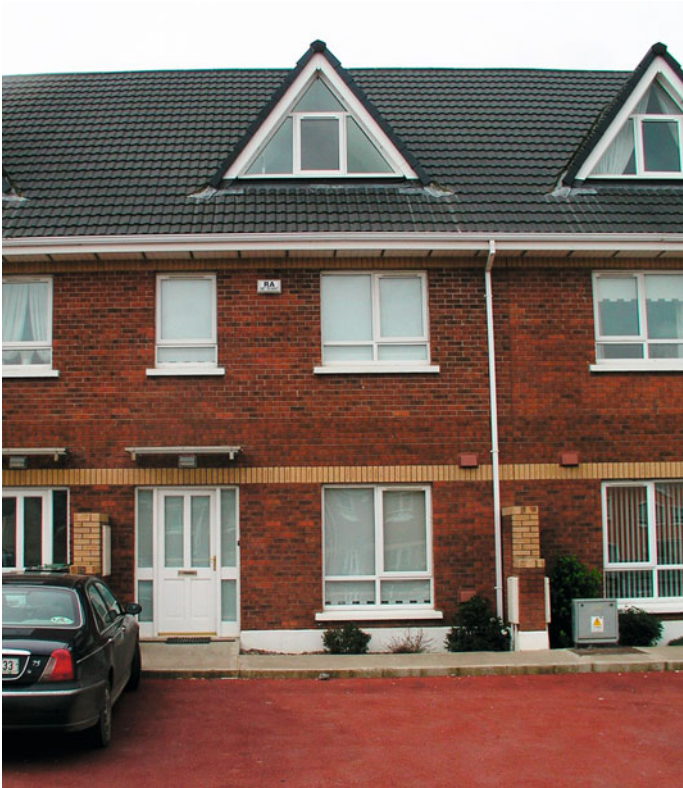
Fig. 3 The second reported house in Ireland with pyrite-induced floor heave, Dublin

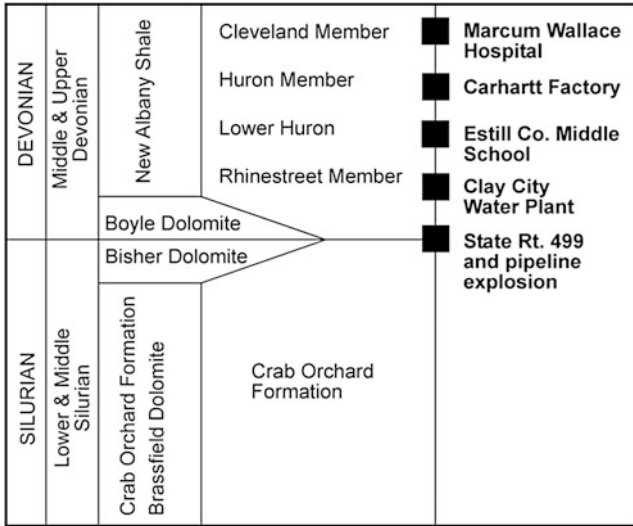
Fig. 4 Stratigraphic column showing pyrite zones within the Cleveland or Huron Member of the New Albany (Chattanooga and Ohio) Shale, which are a common factor in the foundation problems

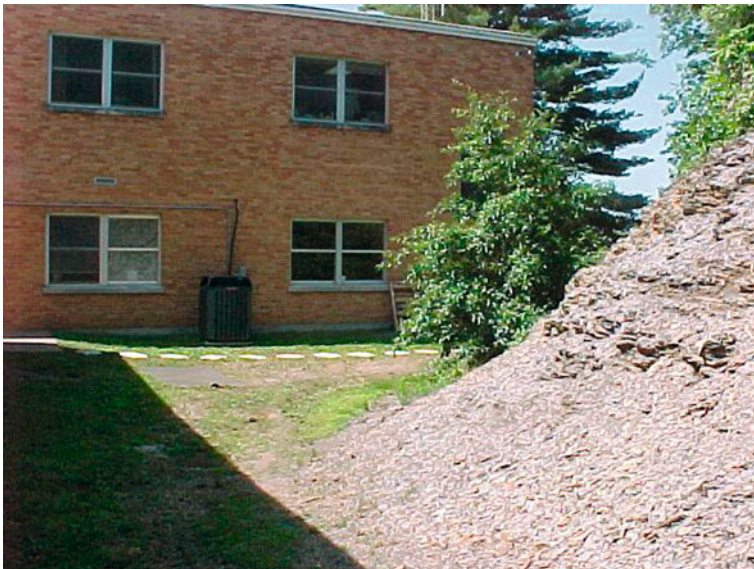
Fig. 26 Exterior of the Marcum and Wallace Hospital office wing and an adjacent outcrop of the Cleveland Member of the Chattanooga (Ohio) Shale. Note the absence of cracks or offsets in the load bearing walls and exterior brickwork of rooms with heaved floor slabs
