# Engineering Implications of the Oxidation of Pyrite: An Overview, with Particular Reference to Ireland

A. Brian Hawkins

In the last decade, major problems have occurred in numerous buildings in the Dublin area which were constructed on fill containing pyrite/pyrrhotite. This paper provides a background to the process by which the oxidation of iron sulphides can lead to distress in structures, with particular reference to the problems which have occurred in the Dublin area in the 2000s. It discusses the formation of pyrite and pyrrhotite and the chemical processes involved in their oxidation, the effects of the oxidation process, and how its by-products can lead to both heave and/or the degradation of concrete.

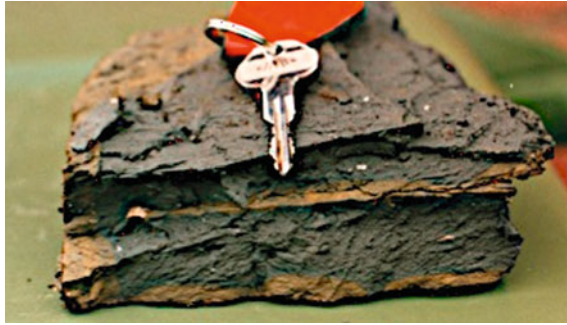
**Fig. 10** Oxidation along discontinuities in the London Clay

Oxidation takes place when oxygen and moisture can move into an unsaturated rock. As seen in Fig. 10, the oxidised zones are distinctly brown in colour compared with the very dark unweathered mudstone.

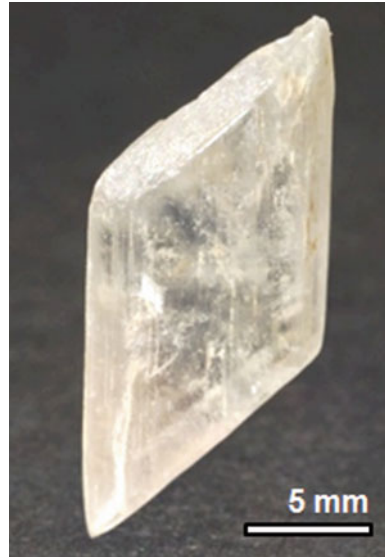
**Fig. 25** Typical museum selenite crystal

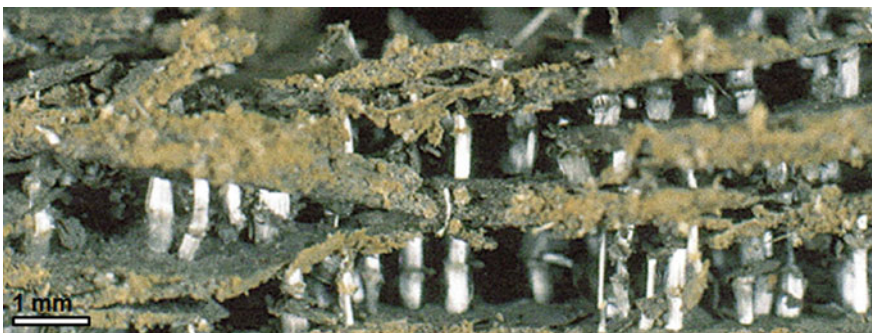
**Fig. 34** Fibrous crystals with pronounced median line which developed when a sample of Carboniferous mudrock was kept in a humid oven at 30 °C

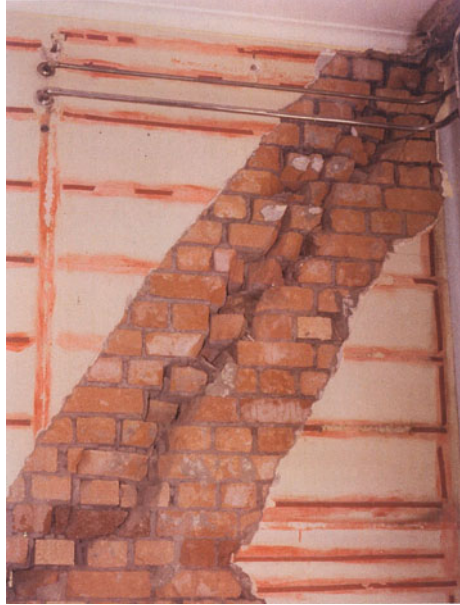
**Fig. 43** Selenite crystals up to 8 mm long on a bedding surface at 1.6 m depth (Westbury Beds)

crystals were seen over some 20 % of the surface of the bedding laminations (Fig. 43). The growth of these crystals had clearly caused expansion of the in situ strata, resulting in heave of the overlying floors and damage/distress to the ward above. Outward deflection of the walls also occurred as the inner leaf had been constructed on the floor slab.

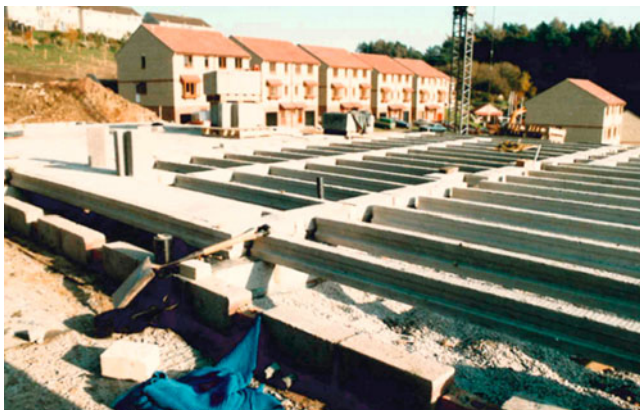
**Fig. 45** Suspended floor slabs recommended for houses constructed over pyrite-rich Westbury Beds at Radstock, N Somerset

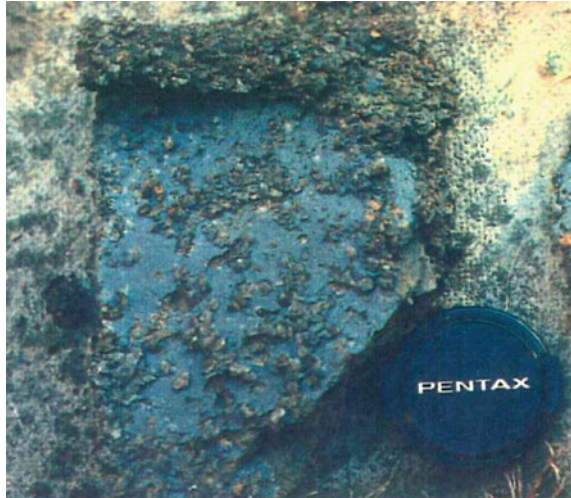
**Fig. 48** Gypsum growth in bedding and joints in the Lias Clay at Hucclecote

were almost touching and appeared like veins (Fig. 48). Where these new crystals were present the “pseudo veins” accounted for 8 % of the vertical profile.

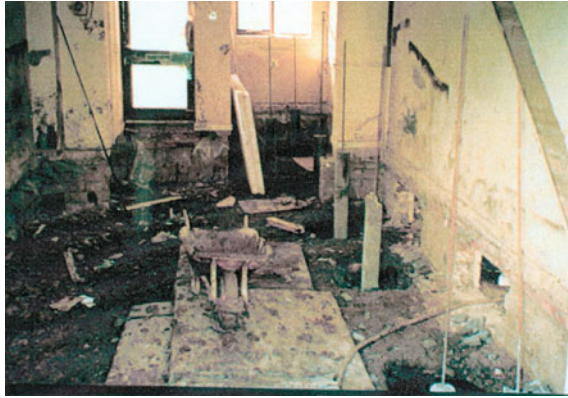
**Fig. 49** Remediation included installation of piles to support suspended floor slabs at Hucclecote

It was agreed that sulphate development was the prime cause of the distress and a decision was made to remediate all 39 houses by removing the Lias Clay and/or fill within a metre of the floor and installing reinforced dense concrete mini-piles to support the new concrete slab (Fig. 49). Although every effort was made to keep inconvenience to the occupiers to a minimum, in some cases the houses had to be

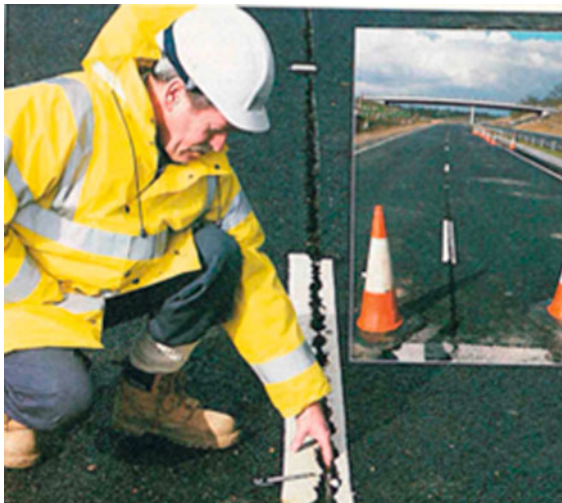
**Fig. 55** Distress in the A10 (north of London) following lime stabilisation of sulphate-rich soils (New Civil Engineer 25 March 2004)

Despite the warnings by such workers as Sherwood (1993), Barber (1996) and Perry et al. (1996) as well as numerous papers from other parts of the world, a further major problem occurred with lime stabilisation on the A10 north of London where 25 % of the 7.5 km long new dual carriageway buckled, cracked and ridged (see Fig. 55).

Although the original site investigation indicated the presence of some sulphur and sulphates, a decision was made to lime stabilise the glacial boulder clay to form the capping layer. During the general earthworks, pyritiferous boulder clay was exposed and further sulphates developed in the warm, conditions of 2003, which was the fourth driest summer in England and Wales since records began in 1914 (see Hawkins 2013).

By November 2003, the road had been black-topped and the road marking undertaken in anticipation of opening in December, some eight months ahead of schedule. However, in late November undulations were noted in the road surface and extensive investigations were undertaken in early 2004. As with the M40, ettringite and thaumasite were identified in the capping layer—a clear indication that the lime had reacted with the sulphates and aluminium clay minerals in the boulder clay, resulting in heave. During the ensuing discussions, attention was drawn to a Technical Memorandum produced by the National Lime Association of the USA and Canada in 2000. This identified five classes of risk related to the amount of sulphate present in material to be lime stabilised (Table 9).

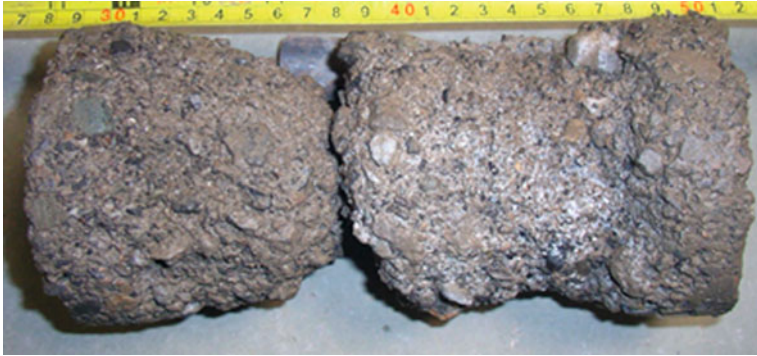
**Fig. 61** Degraded concrete with thaumasite developed in poor quality block in a rising wall

the inside face. Figure 60 shows thaumasite has developed at a depth of 9.4 mm into a concrete block where the sulphate content was up to 19.4 % SO<sub>4</sub>. Figure 61 shows a core from a flat-lying concrete block which indicates significant deterioration of the concrete had taken place within five years of placement. It was not possible to obtain a good quality core either because of a lack of cement in the middle part of the block and/or the presence of thaumasite which weakened/disintegrated the material.

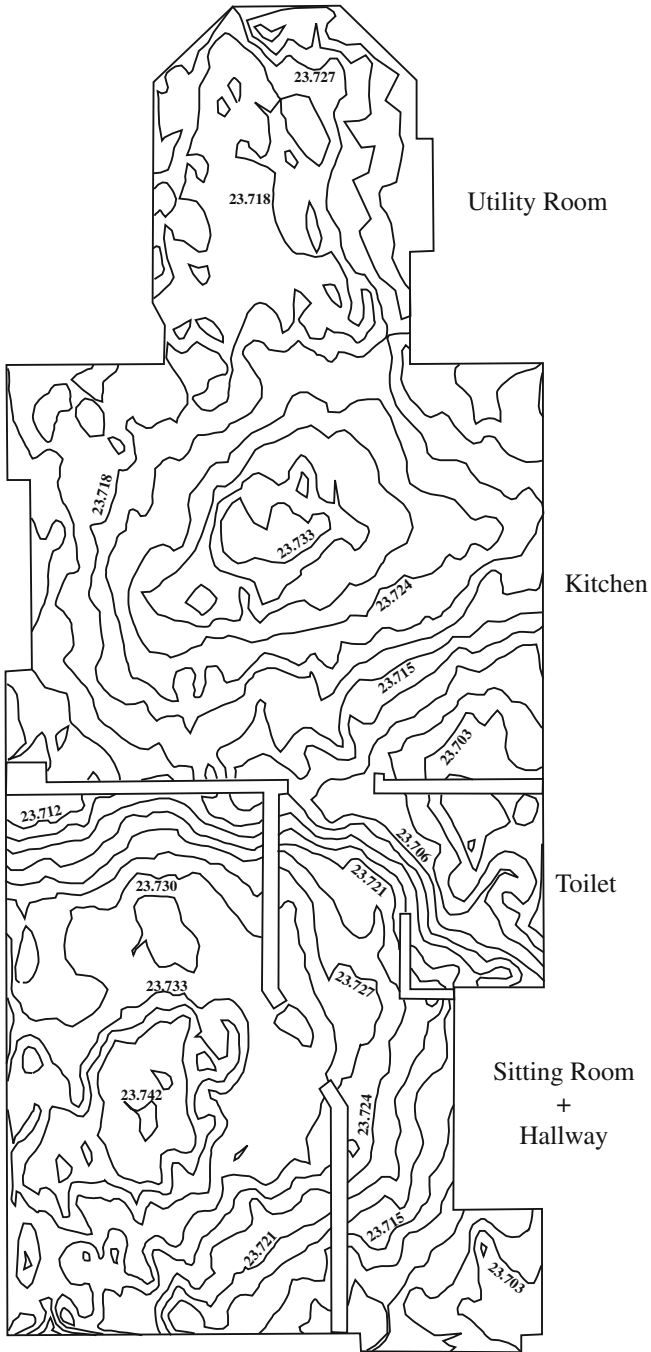
**Fig. 68** Laser scan of a ground floor affected by sulphate-generated heave. Note the dome shape in the kitchen and the rise extending across the sitting room/corridor constructed on a single slab
