The Canadian Pyrite Experience and Comparisons with the Irish Problems

Michael L. J. Maher

Introduction

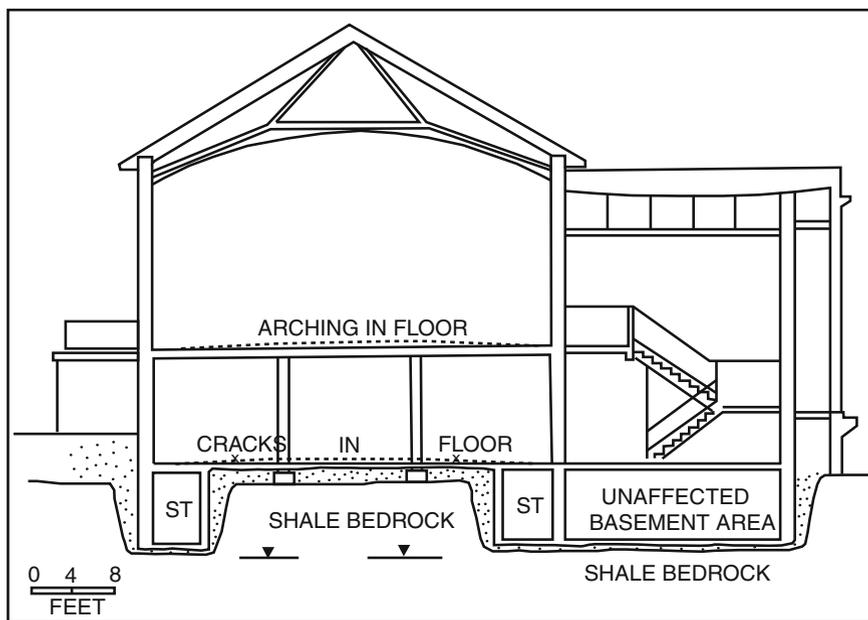
Fig. 1 Cross-section of Rideau Veteran's Home illustrating heave in the ground and second floor slabs (from Quigley and Vogan 1969)

The phenomenon of swelling shale bedrock affecting building performance was first recognized in Canada in the late 1960s. The therapy treatment building at the Rideau Health and Occupation Centre (later known as the Rideau Veteran's Home) on Smyth Street in Ottawa experienced heave in one section of the building (Quigley and Vogan 1969). The portion of the building that developed a problem was a two-storey section with a service tunnel and no basement. This portion of the building was adjacent to a building section that had a basement area and swimming pool (Fig. 1).

The building was founded in the Lorraine Shales that overlie the Billings Shale in the area. Because the service tunnel and basement were at a lower elevation, the ground water was lowered, which allowed the unexcavated shale beneath the ground floor in the two-storey section of the building to drain and facilitated the oxidation of the fine grained pyrite within the shale. The resulting heave occurred in the ground floor slab as well as in the second floor slab which was also supported on column footings within the Lorraine Shale.

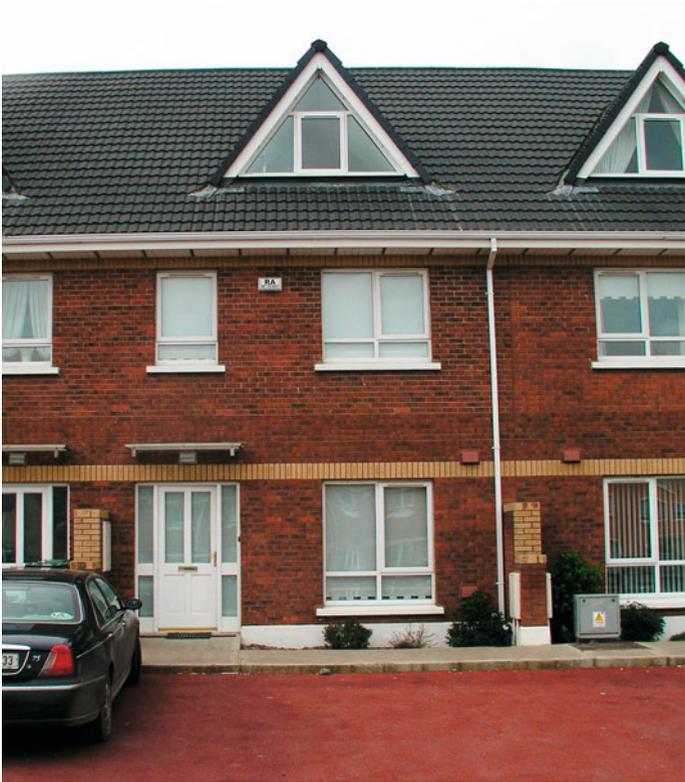
Fig. 3 The second reported house in Ireland with pyrite-induced floor heave, Dublin

The first case of suspected pyrite-induced floor heave identified in Ireland was in late 2006. The second recorded case was a house in a housing estate in north Dublin which began construction in 2003 (Fig. 3). In March 2007 it was confirmed that the cause of the cracked and heaved floors and cracked partition walls reported in the house was swelling of the underlying crushed rock fill beneath the floor slabs. The damage was confined to the floors and internal partition walls with no visible damage on the exterior of the house. Testing on the fill material confirmed it to be a crushed calcareous mudstone (Fig. 4), with estimated original pyrite concentrations of about 2.6 %. The Petrographic Number (CSA A23.2-15A, 2004 and ASTM C295, 2011) for a sample of the underfloor aggregate was found to be 250, confirming very low physical–mechanical quality.

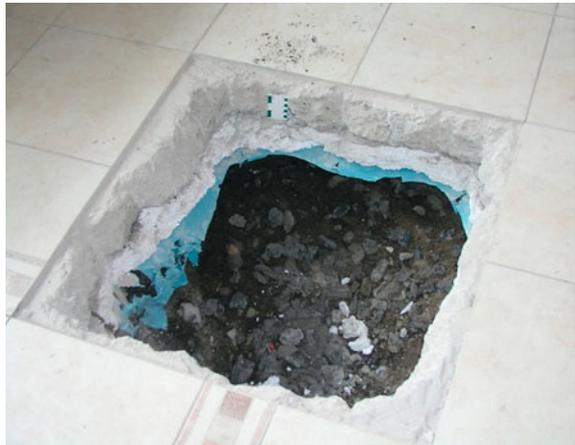
Fig. 4 Trial pit through kitchen floor exposing problematic underfloor fill

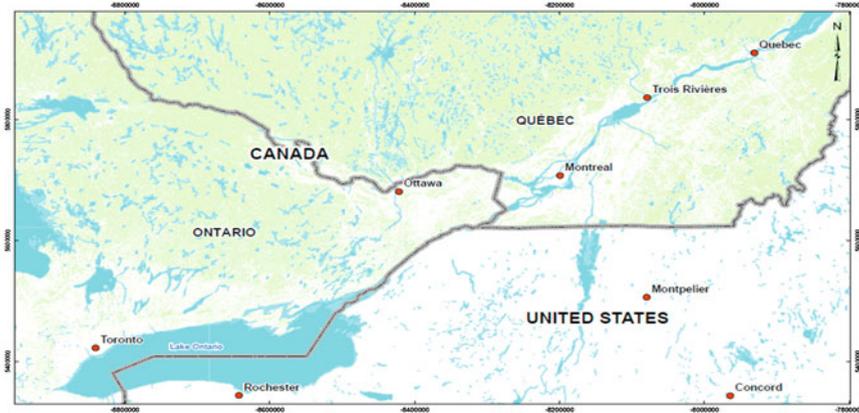
Fig. 5 Key plan showing Ottawa, Montréal and Québec City

widespread pyrite-related problems, on the scale of an epidemic, were reported in the Montréal area. As can be seen from Fig. 5, these areas trend in a northeasterly direction parallel to the St. Lawrence River.

In the early 2000s, 30 owners of relatively new homes in the Trois-Rivières area, 140 km east of Montréal (Fig. 5), began experiencing problems with cracking and deterioration of the exposed concrete in their basement walls (Roy 2011). Following investigation, it was established that the coarse aggregate used in the making of the concrete was an anorthositic gabbro that contained typically

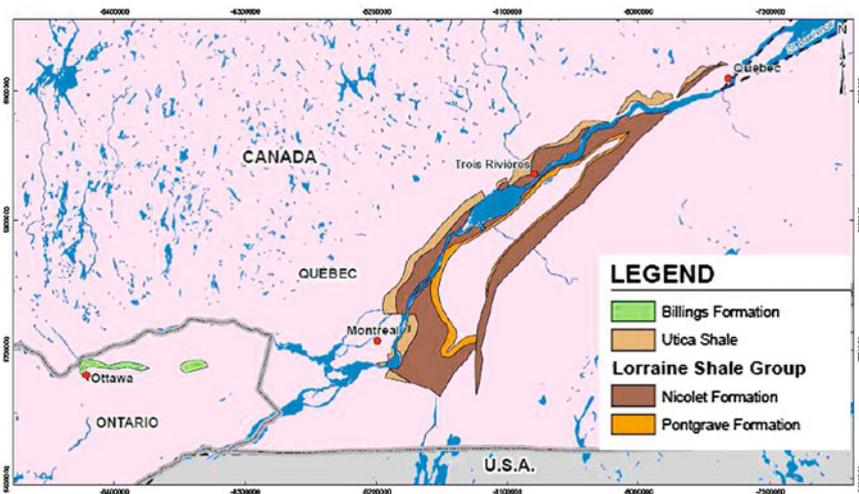
Fig. 6 Areas of shale bedrock in areas reporting pyrite-related problems (from MNR NRVIS, 2004, CANMAP 2006 & Ontario Ministry of Natural Resources, 2008)

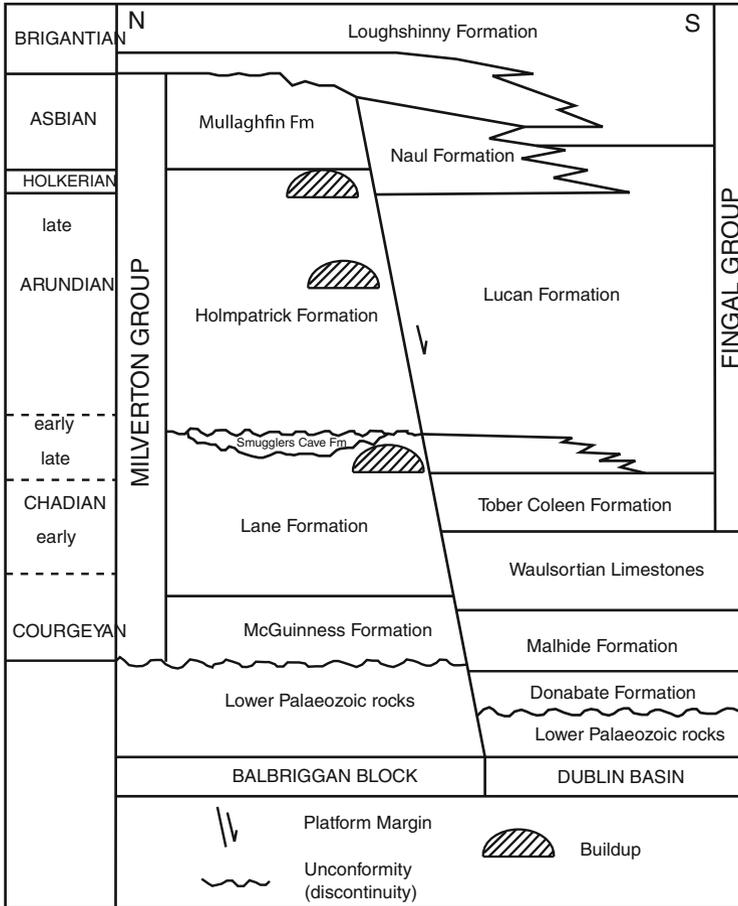
Fig. 9 The Dinantian successions in north Co. Dublin (from GSI 2001)

Extensive testing carried out on samples of the material recovered from buildings during remedial works demonstrate that the aggregate from Quarry B failed to meet the Liquid Limit, Coarse Aggregate Water Absorption, Magnesium Sulphate Soundness and Ten Percent Fines Value for Clause 804. This is not surprising when it is considered that the quarry is located within the Tober Colleen Formation that is described as dark grey, calcareous, commonly bioturbated mudstones and subordinate thin micritic limestones (GSI 2001). The Tober Colleen Formation is of Lower Carboniferous age and is the lowest unit within the Calp Limestone. Quarry M, located further north of Quarry B, is within the Loughshinny Formation. This rock is described as argillaceous, pyritic, locally cherty micrites and graded calcarenites, interbedded with dark grey to black shale (GSI 2001).

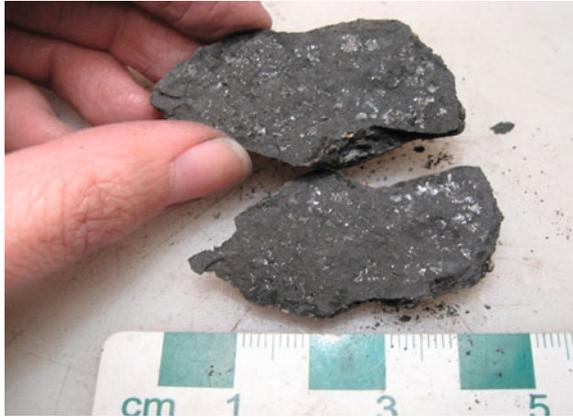
Fig. 10 Particle from Quarry B opened on a lamination reveals gypsum clusters

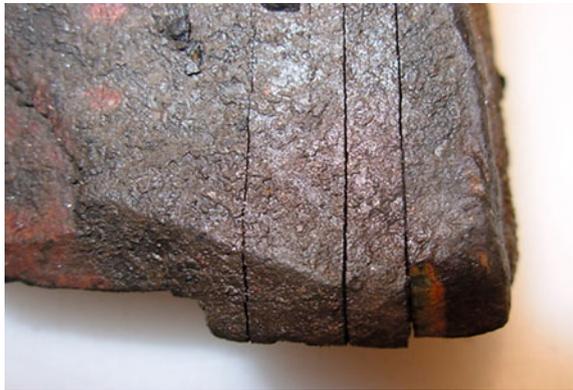
Fig. 11 Aggregate particle from Quarry T with laminations propped open with gypsum

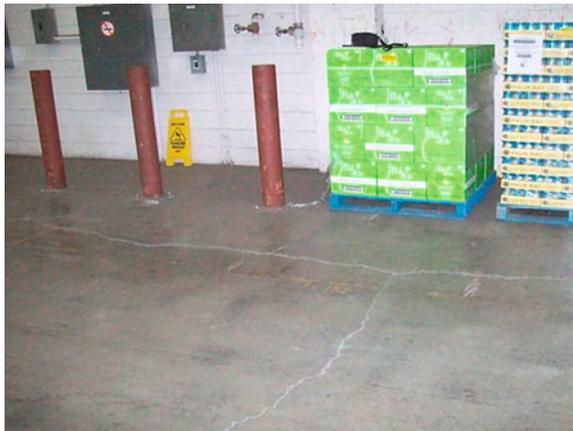
Fig. 12 Intersecting floor cracks indicative of upward heave of the slab

This case study relates to a two-storey warehouse building in the City of Ottawa. The building was constructed in the 1960s and damage in the form of floor cracking and unevenness was first noted in the 1980s. There was a relatively high water table at the site so a sump and pump had been installed some 3.6 m below the floor slab. In addition, there was an elevator shaft that extended approximately 2 m below the floor slab. Damage was first noted in the area of the building near the sump (refer to Figs. 12 and 13). Over the intervening years, the floor heave continued to progress and was estimated to be approaching 100 mm in total heave displacement. Some temporary repairs were undertaken but eventually more extensive rehabilitation was deemed necessary as the operations of the fork lift trucks were being affected.

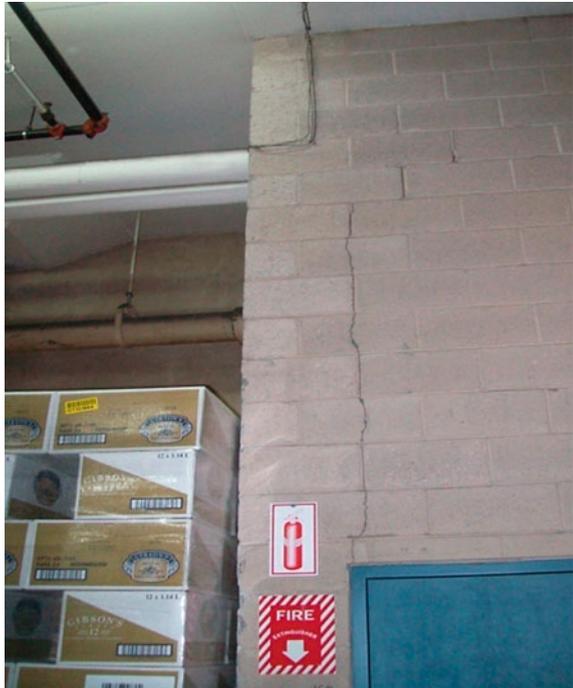
Fig. 13 Cracking in internal block wall supported on floor slab

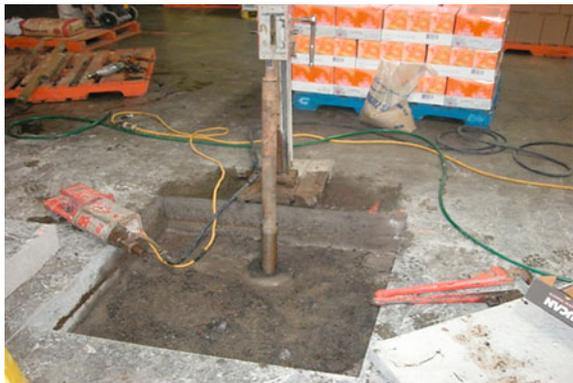
Fig. 14 Cut-out through floor slab

The investigation confirmed (Figs. 14 and 15) that only a thin layer (<100 mm) of compacted granular base separated the underside of the floor slab from the underlying bedrock surface. The lowering of the local water table in the vicinity of the sump had allowed the pyrite in the upper portions of the shale bedrock to oxidize and for gypsum to develop between laminations (Fig. 16). It could be clearly seen from visual examination that the laminations within the shale were being prised apart by the growth of gypsum.

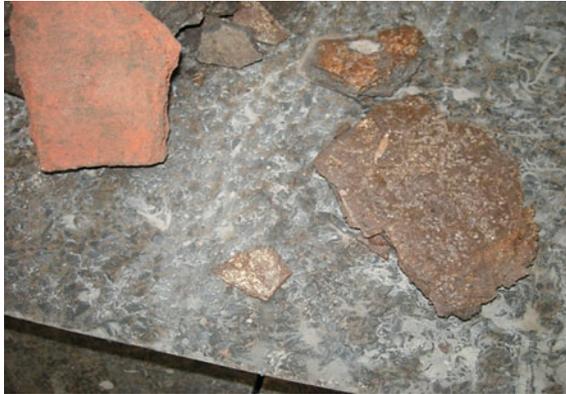
Fig. 15 Chunks of shale bedrock extracted from beneath floor slab

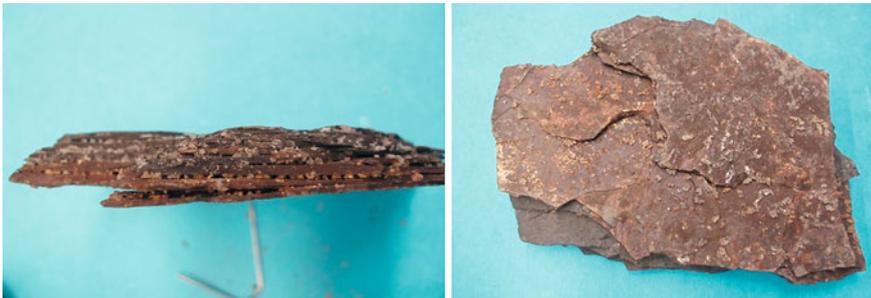
Fig. 16 Close-up views of chunk of brown Billings Shale with clusters of gypsum crystals on lamination surface

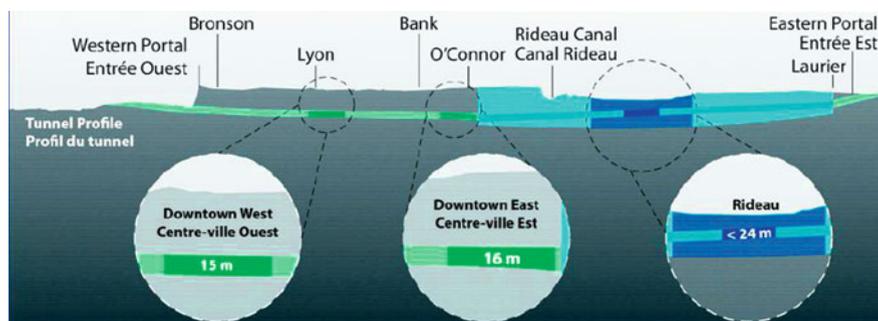
Fig. 17 Proposed tunnel section of extension to OLRT (from OLR 2012)

also include a Downtown Area Underground Section. The Downtown Area Underground Section will be approximately 2.5 km long and will include three new stations (Fig. 17). Construction of the OLRT is scheduled to commence in 2013.

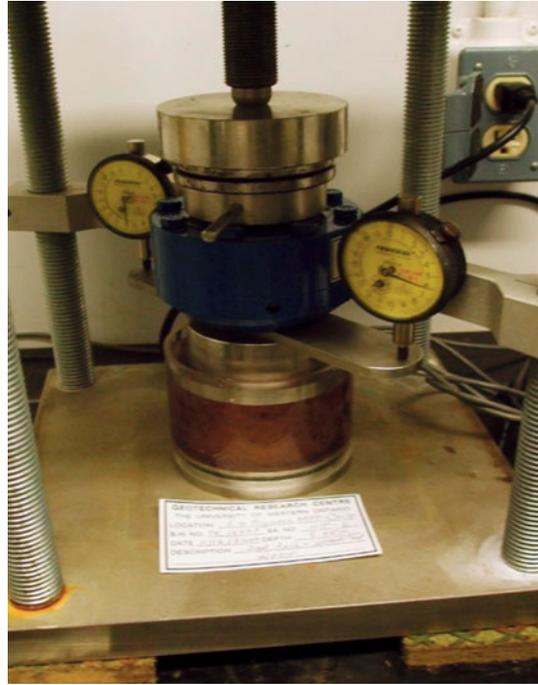
Fig. 18 Null swell test apparatus at the University of Western Ontario

The data obtained from the FSTs and the SCSTs are analysed by plotting the swelling strain versus the logarithm (to the base of 10) of elapsed time (in days). After the initial stabilization period, the swelling strain versus logarithm of time plot approximates a linear relationship. Following the method used by Lo et al. (1978), the average slope of such a plot (taking the approximately linear portion of

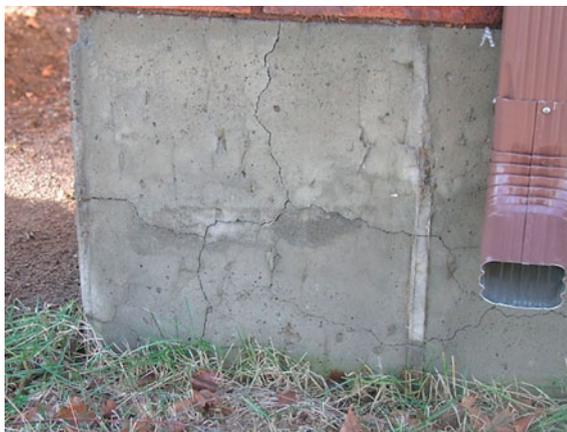
Fig. 20 Typical damage in exposed house concrete, Trois-Rivières, Québec

Subsequently, in 2009, several new cases of early deterioration of concrete in houses were reported, also in the Trois-Rivières region (Fig. 20). The aggregate used was predominantly an anorthositic gabbro or norite containing calcic plagioclase feldspars, biotite, and pyroxene with various proportions of pyrite, chalcopyrite and pyrrhotite (Duchesne and Fournier 2011). The pyrite and pyrrhotite contents vary significantly and are reported to be as high as 5–7 %. The houses were generally 4–6 years old at the time damage occurred.

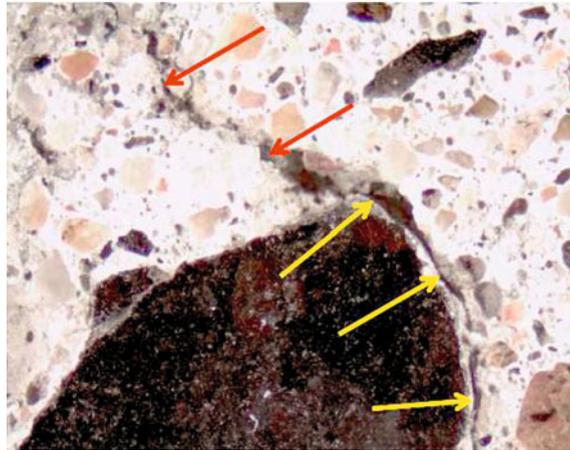
Fig. 21 Photomicrograph showing crack in concrete at coarse aggregate and paste interface

The rocks in question were fine grained sedimentary rocks containing high levels of reactive sulphide minerals primarily in the form of pyrite (FeS_2), but also including chalcopyrite (CuFeS), arsenopyrite (FeAsS) and sphalerite (ZnS). The reactions generated from the presence of these minerals in the mine waste aggregate resulted in deterioration and cracking of concrete. The resulting damage to the houses was attributed to the oxidation of the sulphides in the presence of moisture and oxygen. The production of limonite, or more commonly goethite, and the formation of gypsum result in an expansion in solid volume with an associated

breaking of the bond between the aggregate and the cement paste and the propagation of cracks to accommodate the expansive products.

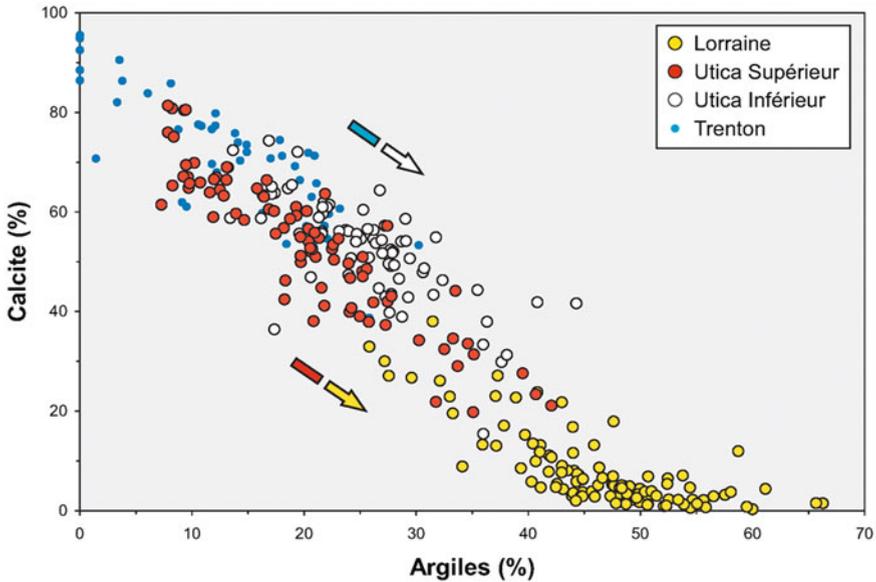
Fig. 22 Diagram showing calcite and clay (argiles) contents for Québec shales (from Thériault 2012)

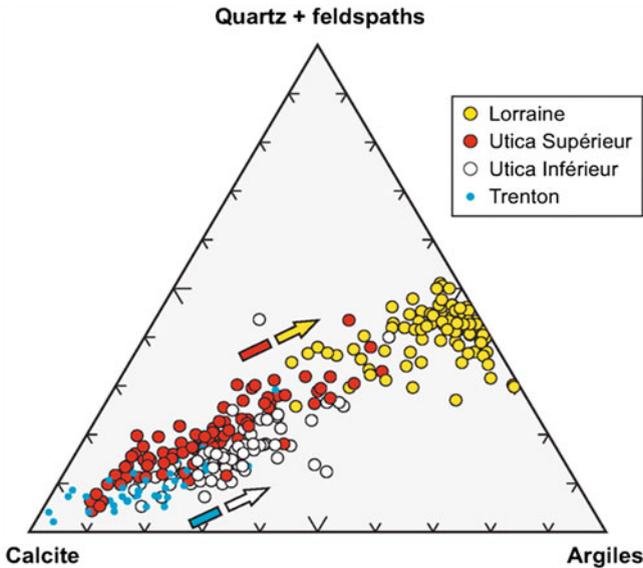
Fig. 23 Trilinear diagram showing composition of Québec shales in terms of quartz and feldspars (feldspars) calcite and clay (from Thériault 2012)

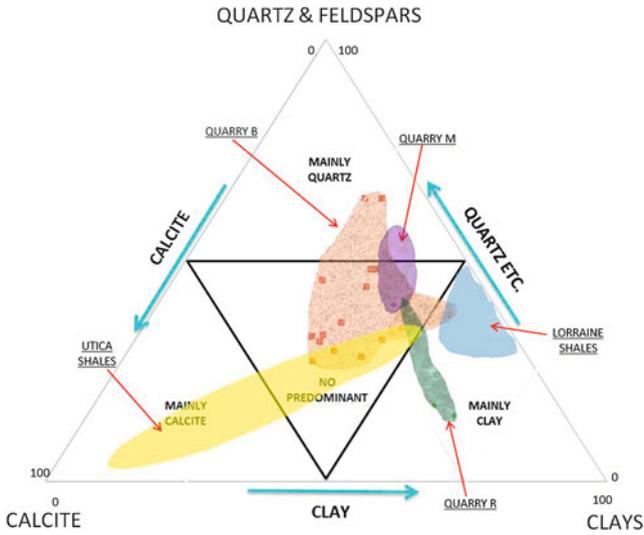
Fig. 24 Comparison between Utica and Lorraine Shales and Irish mudstones that cause pyrite-induced heave

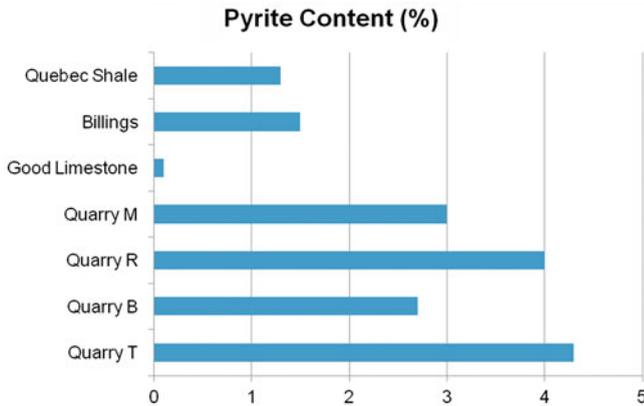
Fig. 25 Comparison of estimated pyrite contents in problematic mudstones and shales

In our experience with these problematic shales and mudstones, the pyrite content is not the controlling factor since there is typically more than sufficient sulphides available to sustain the reactions if the other enabling conditions are present.

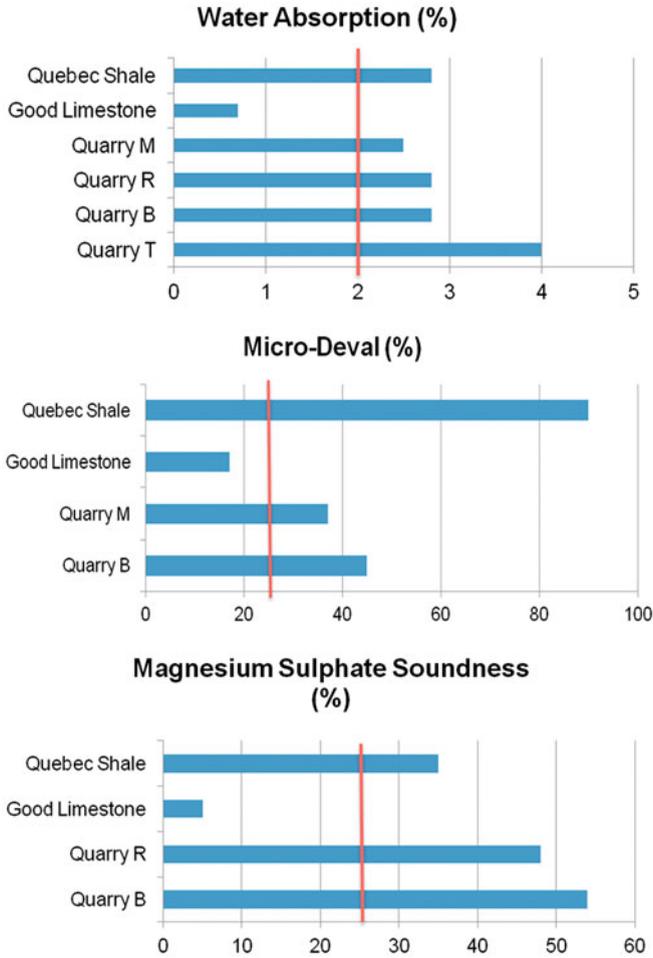
Fig. 26 Typical results for water absorption, micro-deval and magnesium sulphate soundness for problematic shales and mudstones. *Red line* indicates the values generally exceeded with these materials

The low quality of the aggregates prone to pyrite-induced heave can be confirmed from conventional aggregate suitability testing. The most indicative tests are coarse aggregate absorption/water absorption, Micro-Deval and Magnesium Sulphate Soundness. Figure 26 shows typical test results for these problematic aggregates with the red line indicating the test limits generally exceeded by these

materials. Physical testing undertaken as part of a research study for the Canada Mortgage and Housing Corporation (Bellaloui et al 2003) obtained Micro-Deval results for Québec shales ranging from 90 to 97 % and coarse aggregate water absorption ranging from 2.8 to 3.7 %.

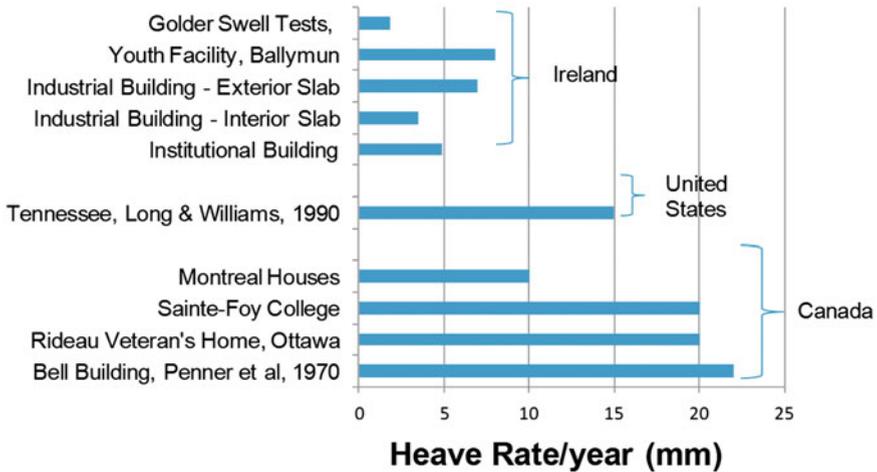
Fig. 27 Recorded heave rates in buildings due to pyrite-induced heave

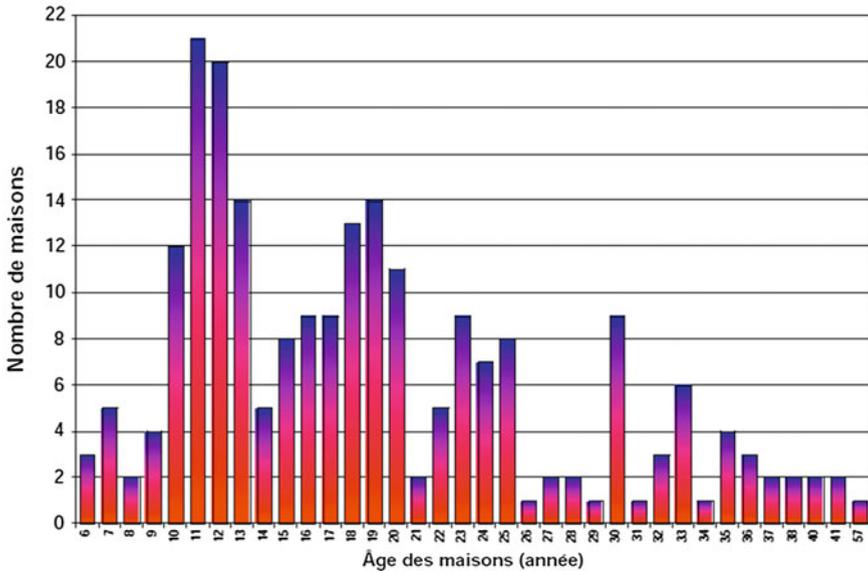
Fig. 28 Age distribution of houses with pyrite-induced damage from the Montréal area study (from Pépin 2000)

practice, the length of time from placement of compacted fill to the development of damage in a building is extremely variable. The main variables will relate to the nature of the compacted fill as listed above, the climatic conditions and local groundwater and temperature regime in the building, and most importantly, the nature of the structure, its rigidity and the fill confinement conditions. Anecdotal evidence suggests that in Québec, damage in houses related to pyrite took typically 10 years to occur. This is corroborated by a study of 224 houses in the Montréal area (Pépin 2000). Figure 28 shows the distribution of houses by age from that study which indicates that houses in the 10–13 year old category were the most frequent.

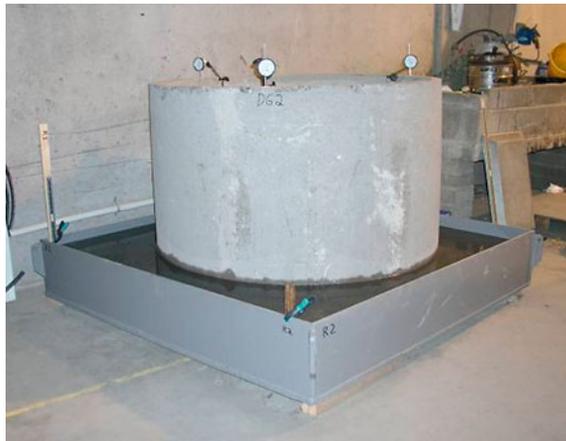
Fig. 29 Initial large scale laboratory swell test

There was no base installed in the pipe as it was assumed that the mass of the concrete pipe and fill would be adequate to force the heave to occur at the top of the fill. This assumption proved wrong. Within seven weeks of commencement of the test it was noted that the entire test cylinder had tilted slightly on the base, due to the expansion of the fill and the friction acting on the inside of the concrete pipe. After 17 weeks, a vertical hairline crack developed in the side of the concrete pipe. After 50 weeks, the vertical crack had expanded to 12 mm (Fig. 30).

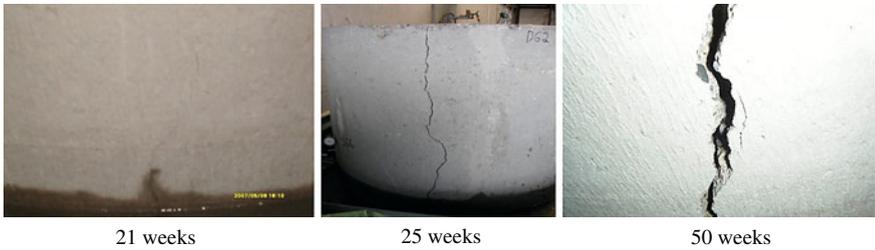
Fig. 30 Progression of vertical crack in concrete manhole ring in 21, 25 and 50 weeks. At 33 weeks it was 12 mm wide

Using analytical and numerical techniques, the pressure produced inside the pipe at rupture was back-calculated and established to be about 600 kPa. Figure 31 illustrates various estimates of pressures generated from pyrite expansion. It can be seen that the back analyzed value from the Golder swell test of 600 kPa is in line with estimates made by Spanovich (1969).

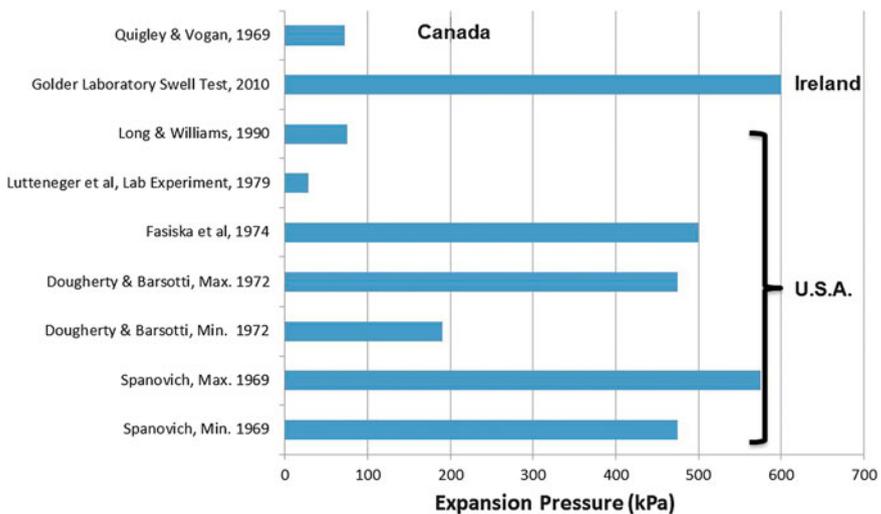
Fig. 31 Comparison of estimated pyrite heave pressures from a literature review

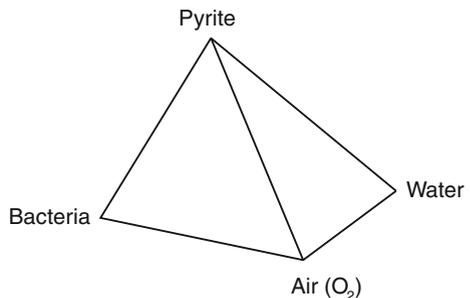
Fig. 32 The ARD tetrahedron (from Gusek 1994)

Based on this, Gusek et al (2008) have proposed a new approach to in situ remediation for problems caused by pyrite oxidation. We can visualize each requirement for ARD generation being positioned at a corner of a tetrahedron (Fig. 32). If any of these primary ingredients are missing, isolated, or chemically

neutralized, ARD will not occur. The active ingredients to disrupt the tetrahedron and thereby prevent ARD, include liquids, solid particles, gases, and living microbes.

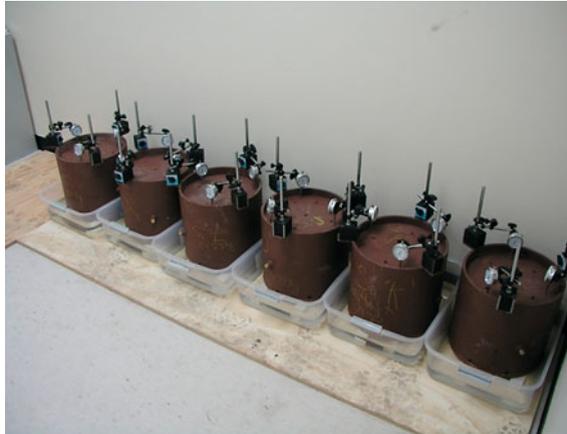
Fig. 33 Series of six Golder swell tests, five containing compacted swelling mudstone and one containing inert limestone

The test cylinders contain samples that are 336 mm in diameter and 302 mm high (Fig. 33). The bases of the cylinders are perforated to allow moisture to enter the sample from the water trough in which it stands.

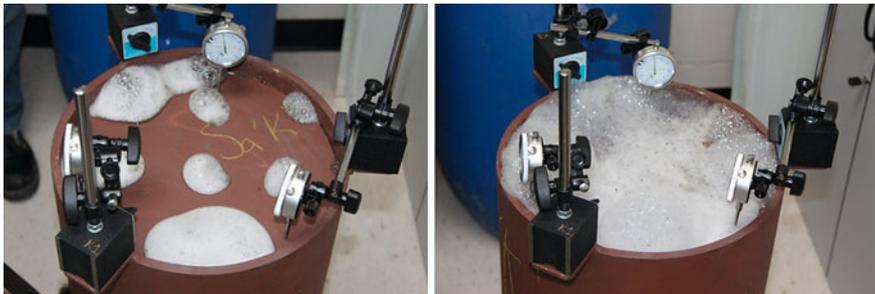
Fig. 34 Foaming trial showing foam injected from the *bottom* of the sample escaping through and around the *top* plate

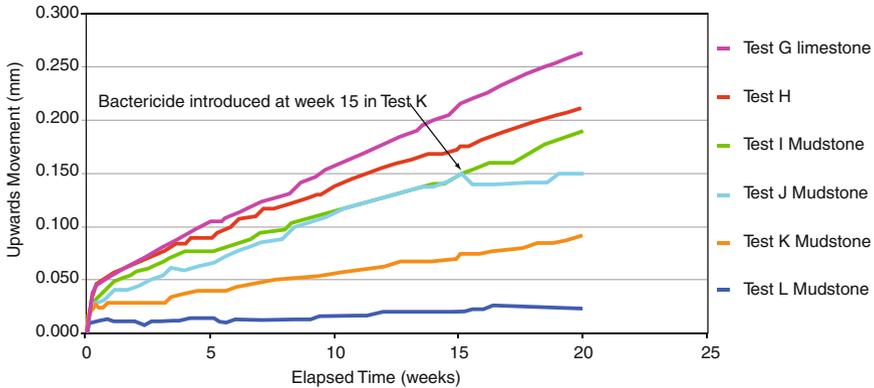
Fig. 35 Results of swell tests showing effect of introducing bactericide into swelling mudstone

While this testing program is ongoing, the early results are very encouraging. We have confirmed that the Golder swell tests develop a steady state rate of heave within 5–10 weeks in compacted mudstone. We have also demonstrated that pHoam™ is effective in permeating compacted crushed mudstone with dry densities as high as 1.90 Mg/m³ and fines contents (passing 75 μm) of 11 %. We have

also demonstrated that the introduction of a bactericide suppresses pyrite-induced heave for at least a period of five weeks. This indicates the importance of bacteria in supporting the reactions.
