Chapter 1

Reappraisal of Concepts Underlying Reinforced-Concrete Design

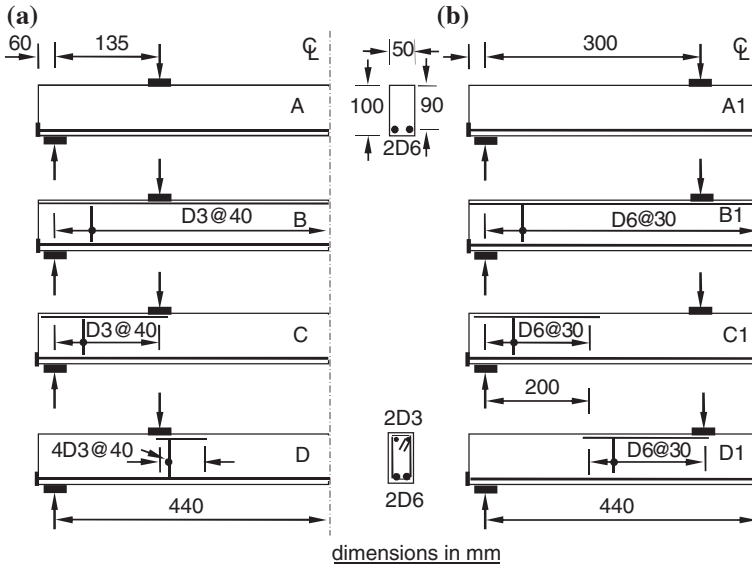
Fig. 1.2 Beams under two-point loading [21]. Design details (beams differ in the arrangement of stirrups only): **a** beams with $a_v/d \approx 1.5$; **b** beams with $a_v/d \approx 3.3$

The validity of the concept of auxiliary mechanisms of shear resistance has been investigated experimentally by testing simply-supported beams under two-point loading (see Figs. 1.2 and 1.3) [21–23]. Figure 1.2a and b depict the geometric characteristics, together with the reinforcement details, of two types of beams with values of the shear span-to-depth ratio equal to approximately 1.5 and 3.3, respectively. The beams have the same geometric characteristics and longitudinal reinforcement but, with regard to the transverse reinforcement, they have beam classified as beams A, B, C, and D in Fig. 1.2a and beams A1, B1, C1 and D1 in Fig. 1.2b. The beams in Fig. 1.3 are similar to beams A in Fig. 1.2a or A1 in Fig. 1.2b, but they differ in the longitudinal reinforcement arrangement as indicated in the figure.

In accordance with current code provisions, for all beams, the load-carrying capacity corresponding to flexural capacity is significantly larger than the load-carrying capacity corresponding only to the contribution of the auxiliary mechanisms to shear resistance. Moreover, it should be noted that, for the beams in Fig. 1.2, the transverse reinforcement provided is sufficient, in accordance with current code provisions, to safeguard against “shear” types of failure within the portions of the beams where it is placed. Since, therefore, the shear capacity of the portions of the shear span without transverse reinforcement corresponds to a value of the applied load significantly smaller than that leading to flexural failure, it would be expected that the load-carrying capacity of beams A and D in Fig. 1.2a and beams A1, C1, and D1 in Fig. 1.2b corresponded to shear capacity.

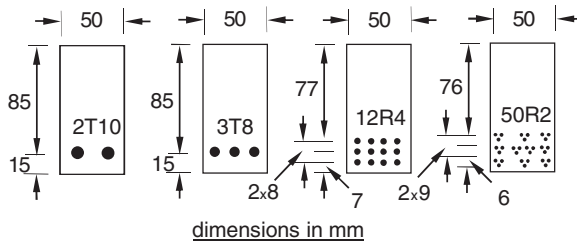
Fig. 1.3 Cross-sectional details of simply-supported beams tested under two-point loading in order to investigate the validity of the hypothesis of “dowel action” [23]; (2T10, two 10 mm dia. high-yield deformed bars; 3T8, three 8 mm dia. high-yield deformed bars; 12R4, twelve 4 mm dia. mild steel smooth bars; fifty 2 mm dia. mild smooth bars)

A similar conclusion is drawn for the case of “dowel action” from the results obtained from the tests on the beams of Fig. 1.3 [23]. “Dowel action” is effected by the bending and shear stiffness of a steel bar, and, as a result, it must be affected by the diameter of such bars. A reduction in bar diameter should lead to a considerable reduction of the flexural and transverse stiffnesses and, hence, it is realistic to expect a significant reduction in the contribution of “dowel action” to shear capacity. However, a reduction in the diameter of the bars used as longitudinal reinforcement for beams, such as beams A and A1 in Fig. 1.2, in a manner that maintains the total amount of longitudinal reinforcement essentially constant (see Fig. 1.3), was found to have no effect on the shear capacity of the beams (see Fig. 1.5) [23].

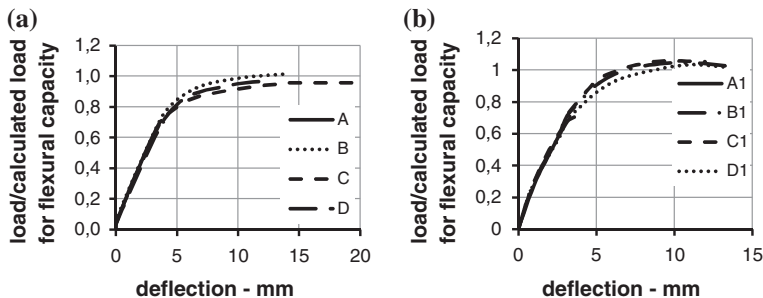
Fig. 1.4 Experimental load-deflection (of the mid cross-section) curves of the beams in Fig. 1.2 [21]: a beams with $a_v/d \approx 1.5$; b beams with $a_v/d \approx 3.3$

Yet, the experimental results depicted in Fig. 1.4 show that, in contrast with beams A and A1, which did indeed fail in “shear”, beams D, C1 and D1 exhibited a flexural mode of failure. It may also be noted that the load-deflection curves of beam D and beams C1 and D1 are similar to those of beams B and C and beam B1, respectively, the latter being designed in accordance with current code provisions.

The ductility which characterises the behaviour of beam D1 is directly related to the large width of the cracks forming within the tensile zone as the beam approaches its ultimate-limit state. It is important to note that the width of the inclined crack which formed within the portion of the shear span without shear reinforcement exceeded 1 mm [21]. It has been established experimentally that such a crack width

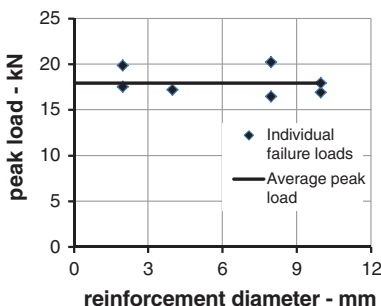
Fig. 1.5 Variation of failure load of beams in Fig. 1.3 with the size of the diameter of the longitudinal bars [23]

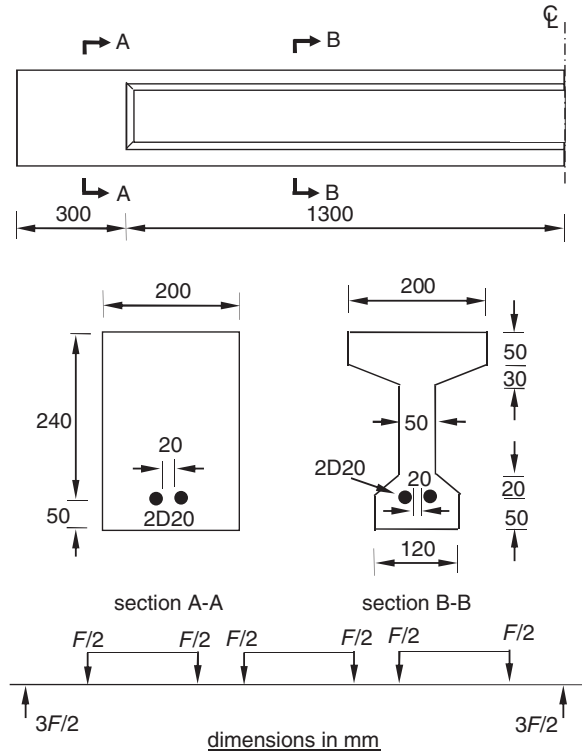
Fig. 1.6 Design details and loading arrangement of RC T-beam tested under six-point loading [27]

element. The causes for such behaviour may be explained by using the results obtained from tests on RC T-beams tested under six-point loading (see Fig. 1.6) [27]. Figure 1.7 shows typical crack patterns of such an RC T-beam for values of the applied load equal to 63 and 135 kN. The former of the applied values is nearly double the value predicted by current codes, while the latter is about four times larger than the code prediction of load-carrying capacity.

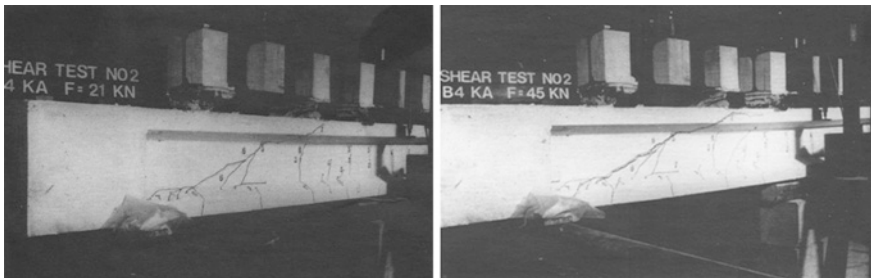
Fig. 1.7 Crack patterns of RC T-beam in Fig. 1.6 under a total load equal to 63 kN (left) and 135 kN (right) [27]

It is interesting to note in the figure that, in spite of the considerable increase of the applied load, the crack patterns differ only in the width of the inclined crack,

which attained a value exceeding 3 mm for the case of the higher load [27]. As for the case of beam D1 in Fig. 1.2b, such a crack width precludes “aggregate interlock” along the crack surfaces [24]. However, the main characteristic of the crack pattern—in both cases—is the deep penetration of the inclined crack into the compressive zone which, at the cross-section including the tip of the inclined crack, has a depth of merely 10 mm. For the two values of the applied load considered above, the shear force acting at this cross-section attains values of 10.5 and 25 kN, respectively. As the size of the crack width precludes any contribution to shear capacity other than that of the compressive zone, the mean values of shear stress corresponding to the above values of shear force are 5.25 and 12.5 MPa, respectively. These values of shear stresses are indicative of the magnitude of the tensile stresses expected, in accordance with current design methods, to develop within the compressive zone in the region of the tip of the deep inclined crack. As the magnitude of the tensile stresses exceeds by a large margin the tensile strength (f_t) of concrete ($f_t \approx 0.1 \times f_c = 0.1 \times 32 = 3.2$ MPa, where $f_c = 32$ MPa the compressive strength of the concrete used for manufacturing the beams), failure should have occurred well before the lower of the values of the applied shear force considered above was attained.

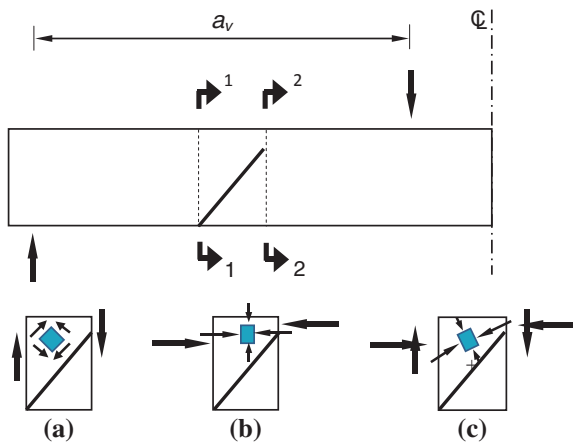
Fig. 1.8 Schematic representations of the stress conditions in the region of a deep inclined crack: **a** due to shear force; **b** due to compressive force caused by bending; and **c** due to combined action of compressive and shear force

However, current design methods ignore the existence of a triaxial compressive-stress field, within the region between the extreme compressive fibre and the location of the tip of the deepest inclined crack, which, as discussed later, is inevitably caused by the local volume dilation of concrete under the large longitudinal compressive stresses developing on account of bending at a cross-section with a small depth of the compressive zone [1, 20]. The existence of such a triaxial compressive stress state counteracts the tensile stresses due to the shear forces acting in the same region in the manner schematically described in Fig. 1.8; hence, the stress conditions remain compressive in this region, in spite of the presence of

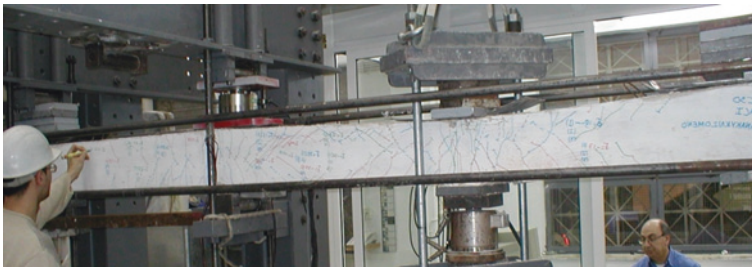
Fig. 1.9 Crack pattern of a linear RC structural element under transverse cyclic loading

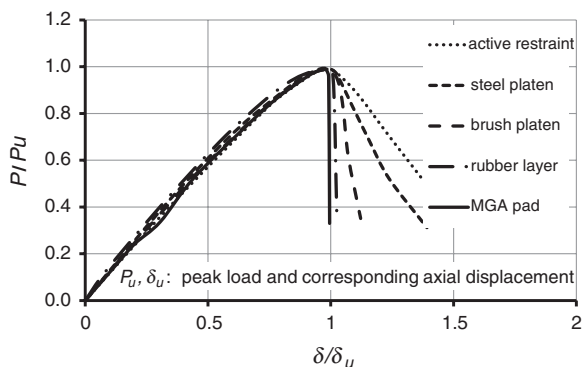
Fig. 1.10 Axial stress-axial strain curves obtained from uniaxial-compression tests on concrete cylinders using various means to reduce friction at the specimen-loading platen interfaces [30]

to reduce friction, the slope of the descending branch increases with the efficiency of the friction-reducing medium employed. In fact, the increase in slope is such that it leads to the conclusion that, if it were possible to eliminate friction entirely the descending branch would have a 90° slope, which is indicative of an immediate and complete loss of load-carrying capacity as soon as the peak stress is attained.

It appears from the above, therefore, that the “softening” branch of a stress-strain curve essentially describes the interaction between specimen and loading platens and *not*, as widely considered concrete behaviour. Concrete behaviour is described only by the ascending branch of an experimentally established $\sigma - \varepsilon$ curve, and loss of load-carrying capacity occurs in a brittle manner. (A similar conclusion may also be drawn from the experimental information presented in Ref. [31], as well as that obtained from an international co-operative project organised by RILEM TC-148SSC [29].) Due to its brittle mode of failure, therefore, concrete does not have sufficient residual strength that would allow the formation of inclined cracks within an RC structural element’s web.

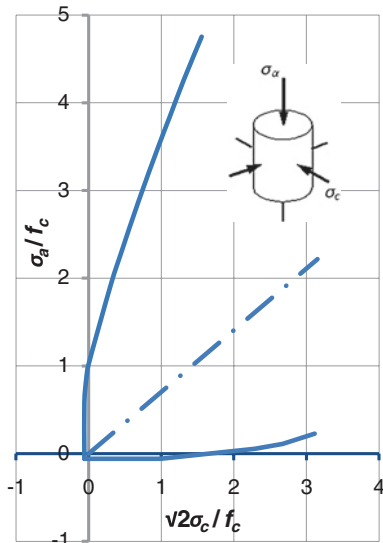
Fig. 1.11 Strength envelope of concrete of concrete under axisymmetric states of stress

behaviour [20]. In fact, Fig. 1.11 shows that a transverse stress of the order of $0.1 f_c$ may either increase load-carrying capacity by over 50 %, when compressive, or reduce it to zero, when tensile.

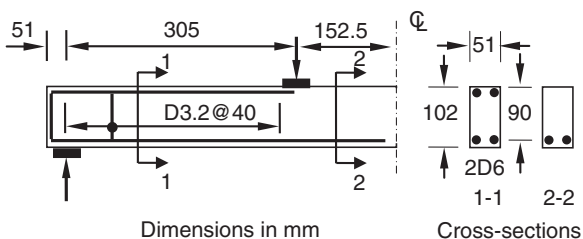
Fig. 1.12 RC beams under two-point loading: design details [32]

Further to the discussion of the post-peak behaviour of concrete in Sect. 1.2.3, the irrelevance of strain softening to structural-concrete behaviour may be demonstrated by reference to the results obtained from tests on three simply-supported RC beams, with a rectangular cross-section, subjected to two-point loading [32]. The details of a typical beam are shown in Fig. 1.12, with the central portion in pure flexure constituting one-third of the span. Besides the load measurement, the deformational response was recorded by using 20 mm long electrical resistance strain gauges and linear-voltage differential transducers (LVDTs). The strain gauges were placed on the top and side surfaces of the beams in the longitudinal and transverse directions as shown in Fig. 1.13. The figure also indicates the position of the LVDTs which were used to measure deflection at mid-span and at the loaded cross-sections.

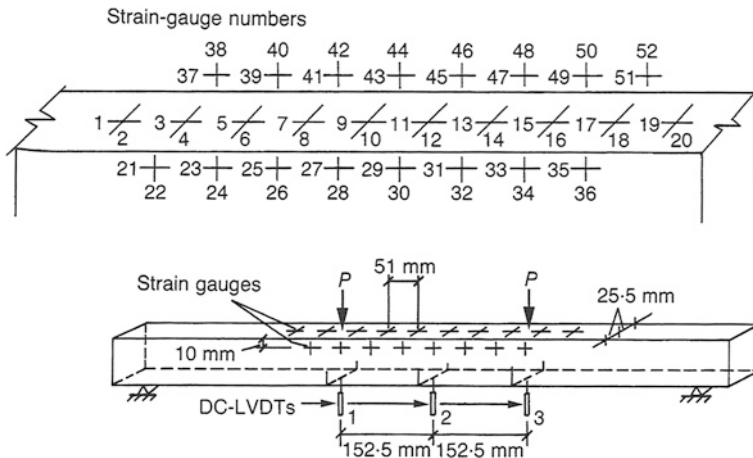
Fig. 1.13 RC beams under two-point loading: beam instrumentation [32]

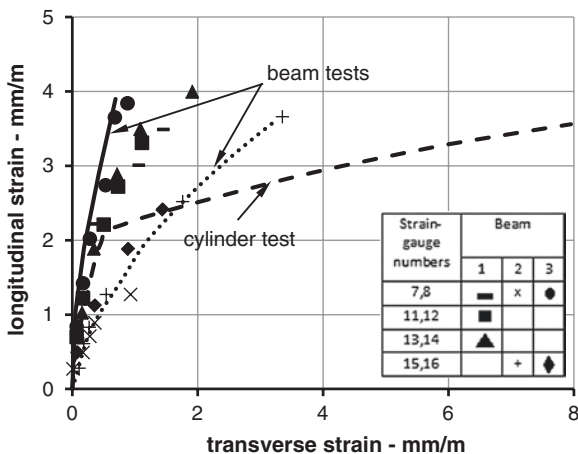
Fig. 1.14 Relationships between longitudinal and transverse strains measured on the top surface between the load points of the RC beams in Fig. 1.12 (for strain gauge locations see Fig. 1.13) [32]

the beam width) strains, as measured on the top surface of the girders, throughout the middle third of the beam span. Also plotted in the figure is the relationship between longitudinal and transverse strains derived from $\sigma - \epsilon$ relationships (shown in Fig. 1.15) established from tests on cylinders under uniaxial compression [1]. Now, if the relationships of Fig. 1.15 were to provide a realistic description of concrete behaviour in the compressive zone of the beams tested in flexure, then one would expect the relationships between longitudinal and transverse strains measured on the top surface of the beams to be compatible with their counterparts established from the cylinder test. Furthermore, longitudinal

An indication of the causes of behaviour described by the relationships of Fig. 1.14 may be seen by reference to Fig. 1.16, which shows the change in shape of the transverse deformation profile of the top surface of one of the beams (but typical for all beams tested) with load increasing to failure [32]. The characteristic feature of these profiles is that, within the ‘critical’ central portion of the beam, they exhibit large local tensile strain concentrations which develop in the compressive regions of the cross-sections where primary flexural cracks, that eventually cause collapse, occur. Such a large and sudden increase in transverse expansion near the ultimate load is indicative of volume dilation and shows quite clearly that, even in the absence of stirrups, a triaxial state of stress can be developed in localised regions within the compressive zone. The local transverse expansion is restrained by concrete in adjacent regions (as indicated by the resultant compression forces F in Fig. 1.16), a restraint that has been found to be equivalent to at least 10 % of f_c [32]; hence, as Fig. 1.11 indicates, the compressive region in the

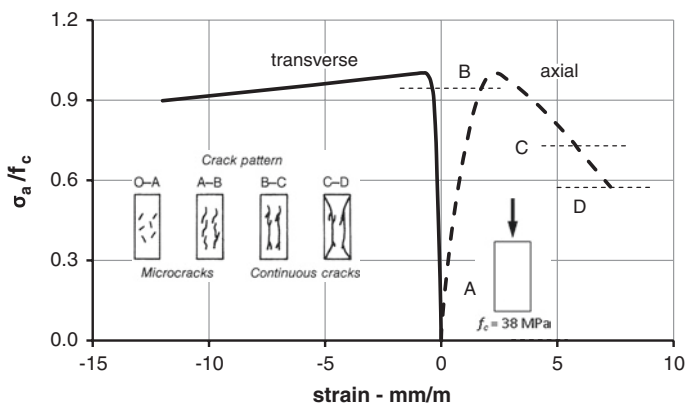
Fig. 1.15 RC beams under two-point loading: stress–strain relationships and crack patterns under uniaxial compression for the concrete mix used [1]

macrocracks ought to appear on the top surface of the beams, as indicated in Fig. 1.15, where typical crack patterns of axially-compressed concrete cylinders around (B–C) and beyond (C–D) the peak-load level are depicted schematically. It is apparent from Fig. 1.14, however, that, for the region of the cross-section including a primary flexural crack, only the portion of the deformational relationship based on the uniaxial cylinder test up to a level (B) close to the peak-load level can provide a realistic description of the behaviour of concrete in the compressive zone of the beam. Beyond this level, there is a dramatic deviation of the cylinder strains from the beam relationships. Not only does such behaviour support the view that the post-peak branch of the deformational response of the cylinder in compression does not describe material response but, more importantly, it clearly proves that, while uniaxial $\sigma - \varepsilon$ data may be useful prior to the attainment of the peak stress, they are insufficient to describe the behaviour of concrete in the compressive zone once this maximum-stress level is approached.

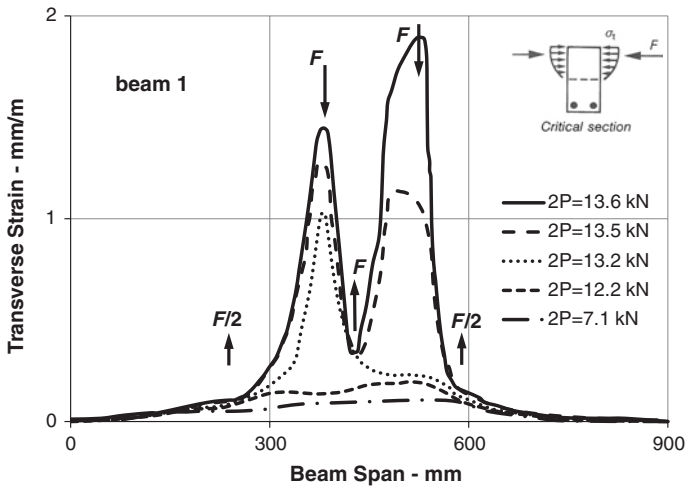
Fig. 1.16 Typical variation of the deformation profile of the loaded face of the RC beams in Fig. 1.12 with increasing total load (2P) and schematic representation of resulting forces (F) and stresses (σ_1) [32]

plane of the main flexural crack is afforded a considerable increase in strength so that failure does not initiate there. Concurrently, the expanding concrete induces tensile stresses in the adjacent regions (these are indicated by the resultant tension forces F and $F/2$ in Fig. 1.16), and this gives rise to a compression/tension state of stress. Such a stress state reduces the strength of concrete in the longitudinal direction, and collapse occurs as a result of horizontal splitting of the compressive zone in regions between primary flexural cracks, as illustrated schematically in Fig. 1.17. Concrete crushing, which is widely considered to be the cause of flexural failure, thus appears to be a *post-failure* phenomenon that occurs in the compression zone of cross-sections containing a primary flexural crack due to loss of restraint previously provided by the adjacent concrete.

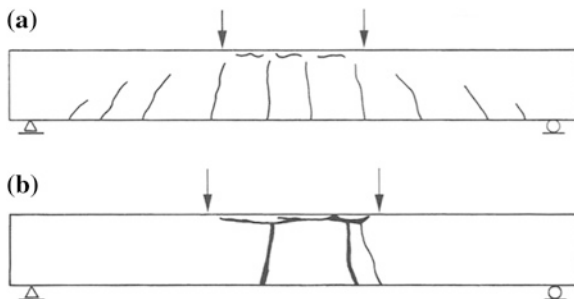
Fig. 1.17 Typical failure mode of RC beams in flexure: **a** a schematic representation of crack pattern at collapse; **b** observed failure of test beams following collapse [32]

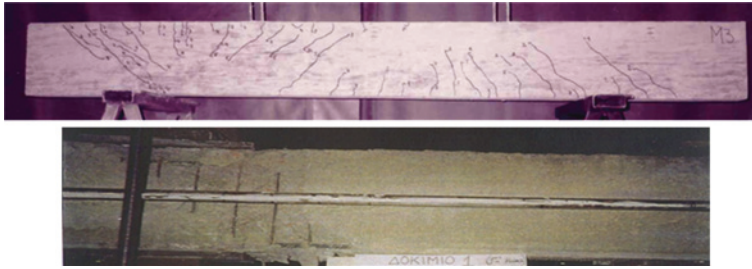
Fig. 1.18 Failure of the critical region of a simply-supported RC beam with overhang exhibiting point of contraflexure (*top*) [9], and a two-span linear RC element under the action of a constant axial force combined with cyclic lateral loading (*bottom*) [6]

However, there has been published experimental evidence [6, 9], in recent years, obtained from tests on beam/column elements exhibiting points of contraflexure, which shows that there are cases for which the additional amount of transverse reinforcement may cause a brittle type of failure, rather than safeguard ductile structural behaviour. Such types of failure, which are characterised by the presence of inclined cracks penetrating deeply into the compressive zone of the critical regions, are indicated in Fig. 1.18 (top) and (bottom). The former of these figures shows the mode of failure of a simply-supported beam with an overhang, reinforced in compliance with EC2/EC8, which was subjected to sequential point loading; a point load was first applied at mid span and increased to a value close, but, not beyond, the beam flexural capacity, where it was maintained constant while a second point load was applied in the overhang and increased monotonically to failure [9]. The latter figure shows the mode of failure of the critical region of the portion of a two-span linear element, also designed in compliance with EC2/EC8, modelling to a 1:3 scale a column between consecutive floor levels [6]. This element was subjected to the action of a constant axial load combined with lateral cyclic loading.

The causes of the above brittle types of failure are considered to relate to the experimental information used by the code methods for assessing the transverse reinforcement required for the critical regions of RC beam-like elements. This experimental information was obtained from uniaxial-compression tests on concrete cylinders or prisms subject to lateral confinement through the use of spiral or stirrup reinforcement. And yet, unlike the cylinders or prisms which are subjected to uniaxial compression, the critical regions of beam-like elements are subject to the combined action of a bending moment and a shear force which causes the formation of inclined cracks. Such cracks penetrate deeply into the compressive zone and have the tendency to extend near horizontally (in the direction of the maximum principal

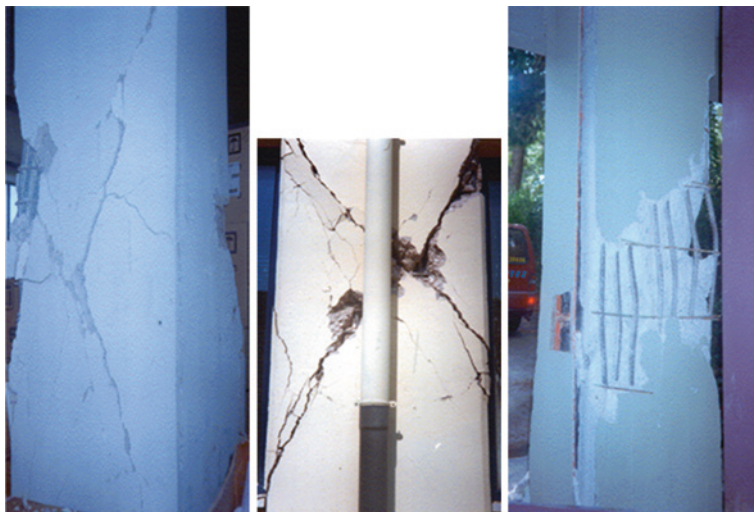
Fig. 1.19 Examples of damage suffered by columns of RC structures during the 1999 Athens earthquake [5]

The relevant feature of the modes of failure shown in Fig. 1.19 is not the occurrence of criss-crossing diagonal cracking, but the location of the region where cracking occurred. In all cases, the location of failure was found to lie within the region of the point of contraflexure. Such an event could not be simply attributed to coincidence, since, as discussed above, this location of failure repeatedly characterises a large number of structural elements that suffered the above type of damage during the 7/9/99 earthquake in Athens.

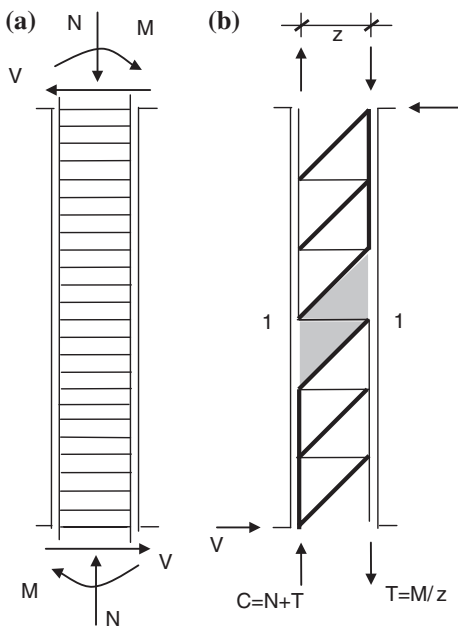
Fig. 1.20 Truss modelling a column subjected to the combined action of axial force (N), bending moment (M) and shear force (V) at its end faces

depicts a truss modelling a vertical linear structural element subjected at its end-faces to the combined action of an axial force (N), a bending moment (M) and a shear force (V). The figure shows that the vertical element is modelled by means of two antisymmetric trusses, connected in the region of the location of the point of inflection with a transverse tie. The shaded portions of the trusses represent the flow of the compressive stresses from the cross-sections with zero bending moment to the cross-sections with a near-constant depth of compressive zone.

The above model implies that in the region of the point of inflection concrete is locally subjected to a *direct transverse tensile*, rather than shear, force causing failure when the tensile strength of the material is exceeded. This type of failure may be prevented by specifying stirrups, forming the transverse tie indicated in Fig. 1.20, in a quantity sufficient to sustain the tensile force in excess of that which can be sustained by concrete alone, and this being a simple strength requirement. Here, it is essential to appreciate that contraflexure (i.e. points of inflection) is associated with the kind of response exhibited by a beam-column in a building subjected to lateral sway (but applicable to any beam or frame with a point of inflection) as shown in Fig. 1.21: it is evident that the tie is needed to prevent separation of the two ends of the constituent members.

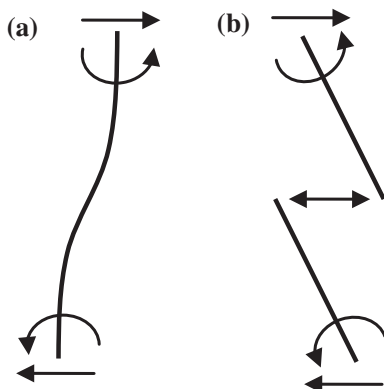
Fig. 1.21 Beam-column exhibiting a point of inflection in a structure (*left*) and illustration of an internal tie needed at contraflexure in order to prevent separation of the two ends of the constituent members
