Glacier Retreat, Lakes Development and Associated Natural Hazards in Cordillera Blanca, Peru

Adam Emmer, Vít Vilímek, Jan Klimeš and Alejo Cochachin

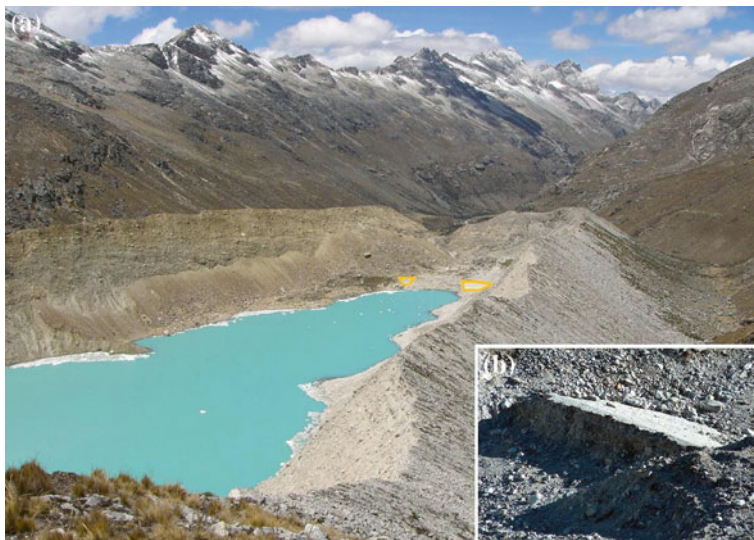
Fig. 5 View on lake Palcacocha with two artificial dams (*highlighted by the orange line*); steep nearly vertical lateral moraines are visible on both sides surrounding the lake. The detail picture (Part **b**) was taken after the 2003 event and captures the damaged artificial dam

department, was blocked by sediment-laden currents and also an artificial dam of the lake was partly damaged (Fig. 5b). The landslide left no significant accumulation on the lakeshore. A secondary debris flow originated from the highly saturated material from the upper part of the moraine slope and produced a small accumulation cone. Field mapping around the glacial lake showed that the right lateral moraine on the opposite side of the lake shows signs of rather fresh but smaller planar landslides.

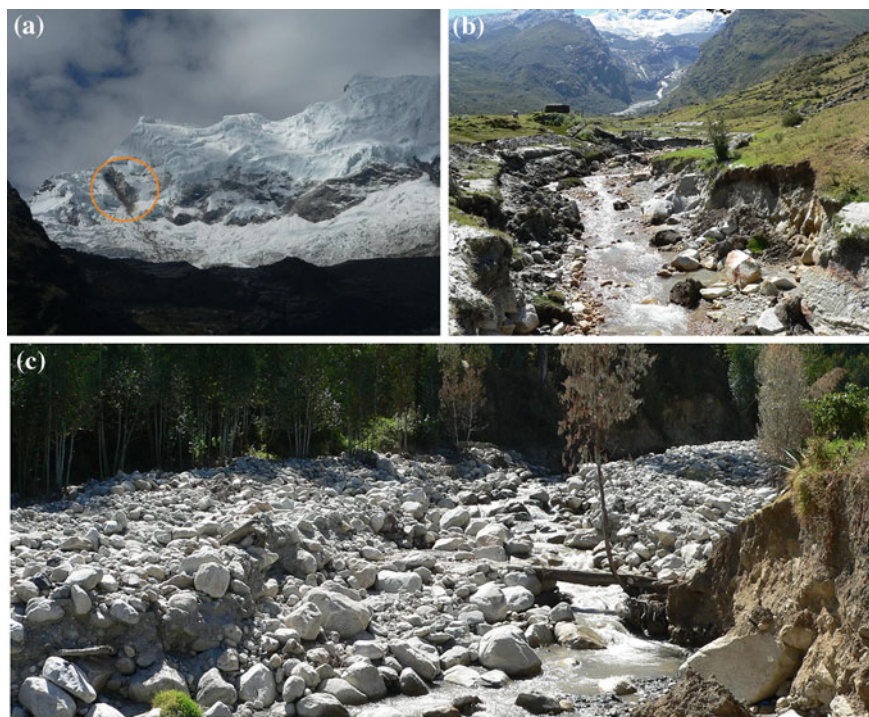
Fig. 6 Part **a** shows Hualcán massif above Lake No. 513; the source area of 2010 ice and rock avalanche is *highlighted* by *orange circle*. Part **b** shows a part of Chucchún valley with dominance of erosional processes and part **c** shows a part of valley with dominance of accumulation processes

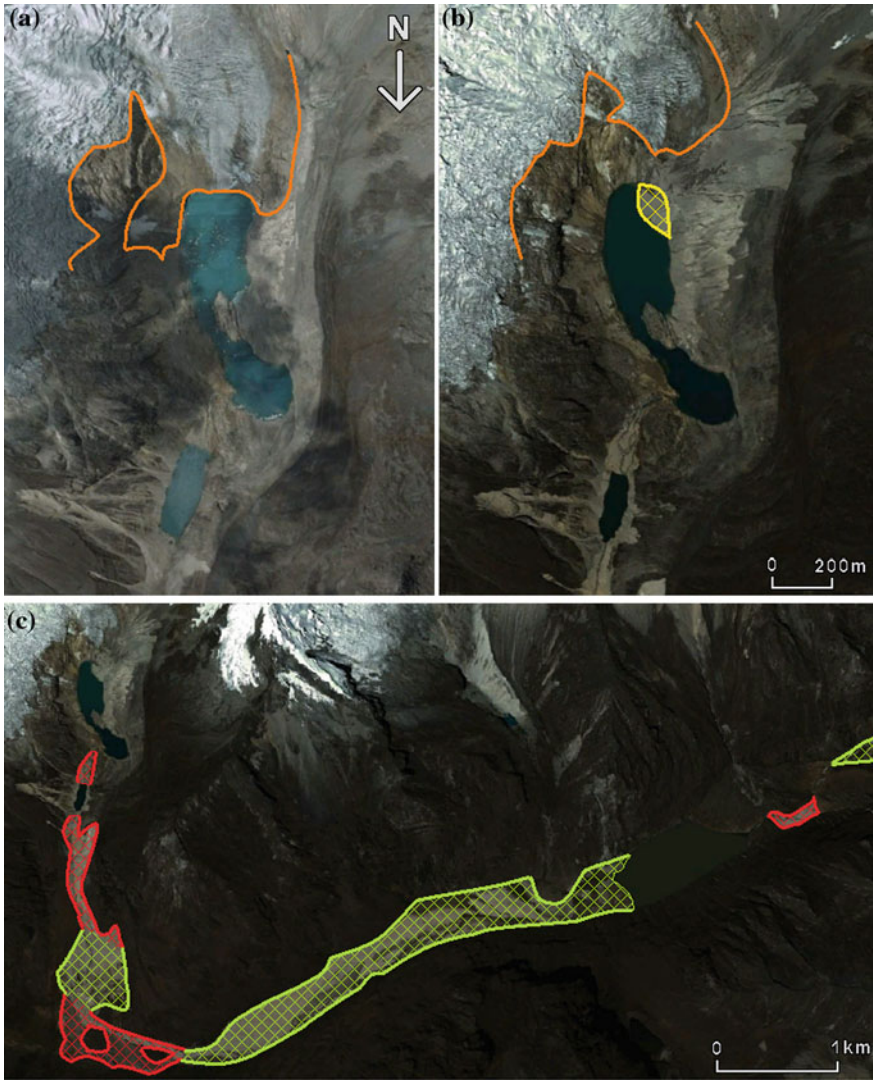
Fig. 7 Lakes Artizon Alto and Artizon Bajo in 2003 before (part **a**) and in 2012 after (part **b**) the 2012 GLOF event. The *orange highlighted line* represents the extent of the glacier. Please note the significant glacier retreat. The *yellow color* in part **b** represents the accumulation of landslide of a lateral moraine, which entered the lake Artizon Alto on 8th February 2012. Part **c** demonstrates the dominant processes in the valleys Artizon and Santa Cruz after water release (*red color*—parts of the valley with erosion processes dominant; *green color*—parts of the valley with accumulation processes dominant) (Source Google Earth Digital Globe 2013)

bedrock dammed Lake Artizon Alto is about 750 m long and 200 m wide, with a significant rock peninsula which divides the lake into two sub-basins (Fig. 7a)

4. On 8th February 2012, a landslide of the left lateral moraine (approximate volume in order of $3\text{--}8 \times 10^5 \text{ m}^3$) into Lake Artizon Alto occurred (Fig. 7b), generating a displacement wave

7. Escaped water transported a large amount of moraine material and significantly affected the Artizon valley (erosion in the upper part of the valley and deposition in the form of an alluvial fan in the mouth of the valley into the Santa Cruz valley. The central part of the Santa Cruz valley was also affected, mostly by accumulation processes, sand bar formation, and partial transfer of stream channel (Fig. 7c).

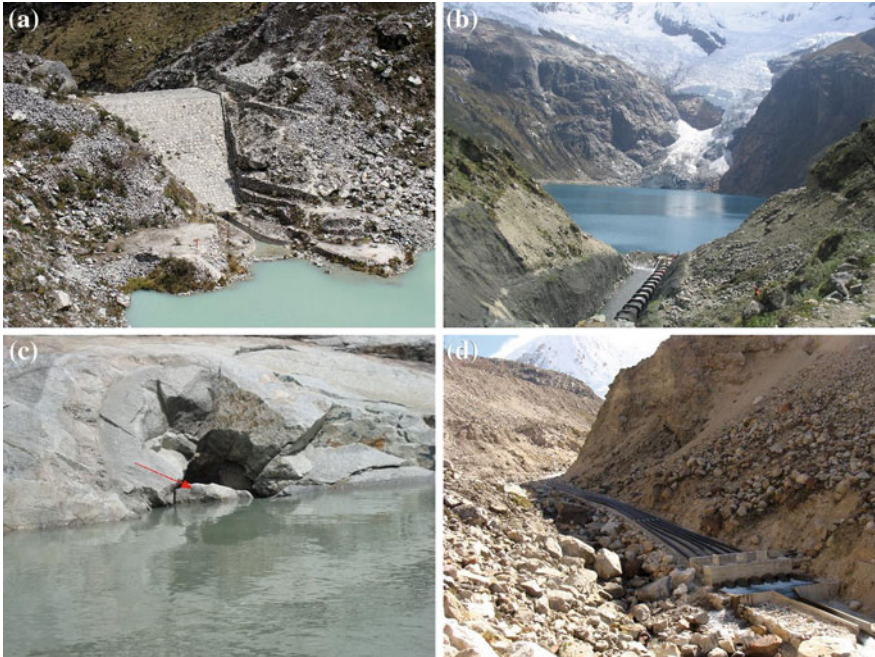
Fig. 9 Examples of remedial works. Part **a** shows artificial dam and concrete outlet of lake Llaca in the central part of the Cordillera Blanca; dam freeboard is 12 m. Part **b** captures ongoing work on the dam of lake Rajucolta in 2004. Part **c** shows the entrance to the tunnel excavated in the bedrock dam of lake No. 513 (*red arrow*). Part **d** shows six siphons installed in fall 2011 to drain and lower the water level of lake Palcacocha

2. Artificial dam—The main purpose of an artificial dam is to increase dam freeboard and thus enable the dam to be resistant against displacement waves generated by dynamic slope movements into the lake. Most significant glacial lakes within the Cordillera Blanca were remediated by a combination of a concrete outflow and an artificial dam [e.g. Lake Llaca (Fig. 9a), or Lake Rajucolta (Fig. 9b)]

3. Tunnel—Tunnels are used to decrease and limit the water level of bedrock-dammed lakes (e.g. Lake No. 513; Fig. 9c), or of moraine-dammed lakes with a naturally high freeboard but without a natural surface outflow (e.g. Lake Safuna Alta).
